# ARBORICULTURAL SURVEY (BS 5837:2012)

ESSO EG SHIRLEY  
490 CHEETHAM HILL ROAD  
CHEETHAM HILL  
MANCHESTER  
M8 0PL

July 2022

Job Number 5064

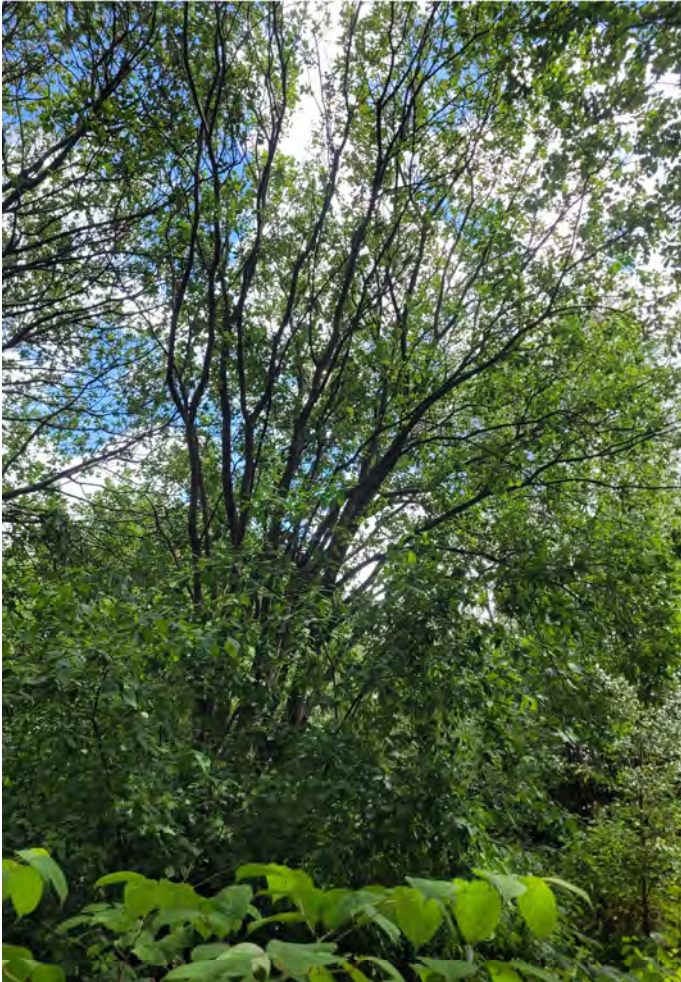
| Tree No. | Species | Dbh (mm) | Height (m) | Age | Crown Spread | | | | Crown C | Cond R | Observations and Comments | Preliminary Recommendations | ERC (Yrs) | TQC R | RPA (m²) | RPA Circle Radius (m) |
|---|---|---|---|---|---|---|---|---|---|---|---|---|---|---|---|---|
| T10 | Goat Willow | 500 | 10 | M | 2 | 4 | 7 | 5 | 2 | B | A one-sided minor specimen within group. Reasonable vigour. | n/a | 10+ | C1 | 113.10 | 6.00 |

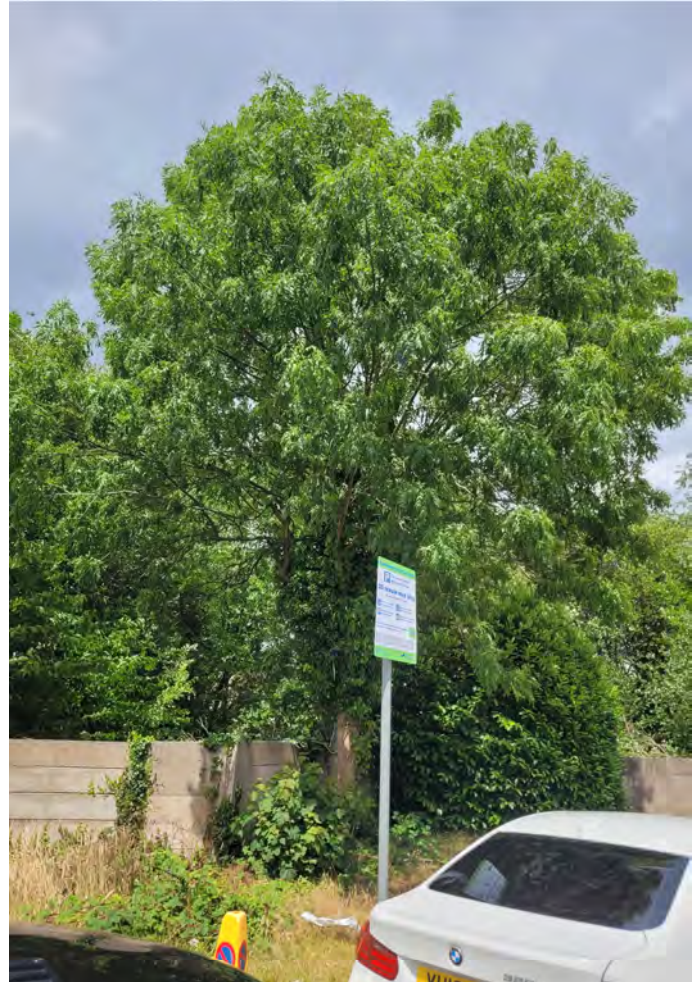
T1 Ash

| Tree No. | Species | Dbh (mm) | Height (m) | Age | Crown Spread | | | | Crown C | Cond R | Observations and Comments | Preliminary Recommendations | ERC (Yrs) | TQC R | RPA (m²) | RPA Circle Radius (m) |
|---|---|---|---|---|---|---|---|---|---|---|---|---|---|---|---|---|
| T1 | Ash | 500 | 12 | M | 6 | 6 | 7 | 6 | 2 | B/C | Located on edge of group on site side of wall. Swamped in Ivy, possibly previously topped near bole. Reasonable vigour but high likelihood of contracting Ash Dieback. | <b>Sever Ivy at base to 1m.</b> | 10+ | C1 | 113.10 | 6.00 |

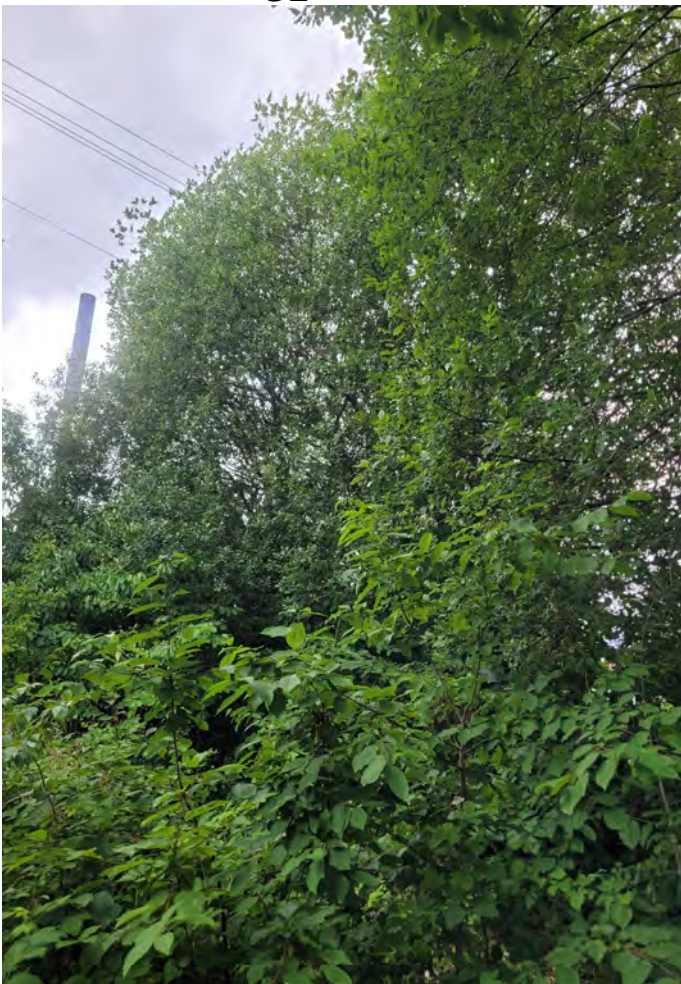
| Tree No. | Species | Dbh (mm) | Height (m) | Age | Crown Spread | | | | Crown C | Cond R | Observations and Comments | Preliminary Recommendations | ERC (Yrs) | TQC R | RPA (m²) | RPA Circle Radius (m) |
|---|---|---|---|---|---|---|---|---|---|---|---|---|---|---|---|---|
| G2 | Group - Goat Willow | 500 | <12 | M | 7 | 7 | 7 | 7 | 0 | B/C | A close group of scrub Willow stems forming a large overall crown. No access to bases. | <b>n/a</b> | 10+ | C2 | 113.10 | 6.00 |

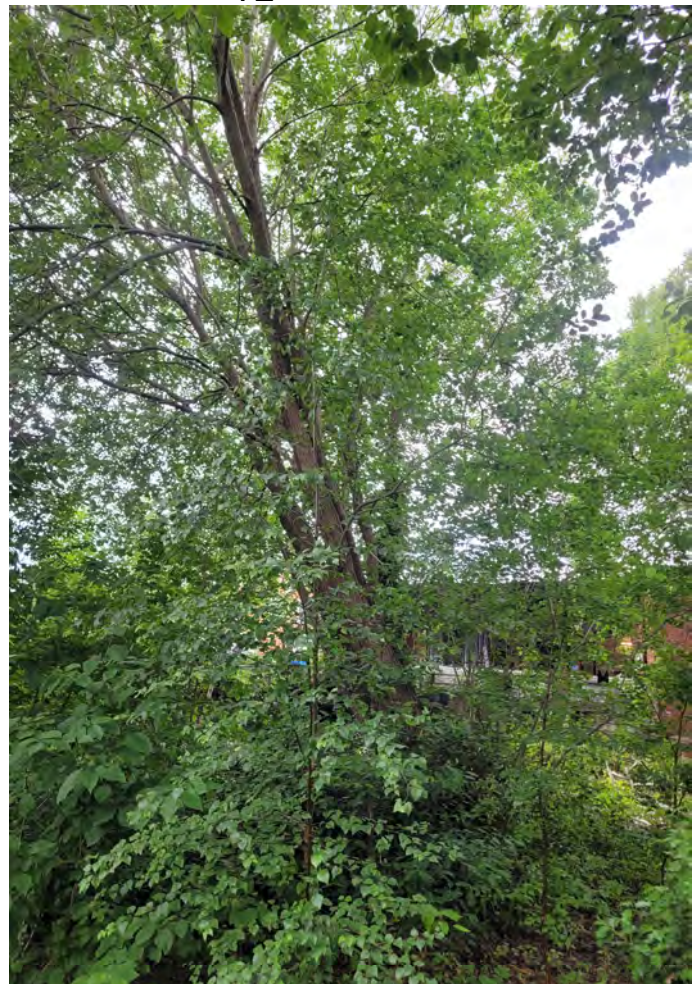
| Tree No. | Species | Dbh (mm) | Height (m) | Age | Crown Spread | | | | Crown C | Cond R | Observations and Comments | Preliminary Recommendations | ERC (Yrs) | TQC R | RPA (m²) | RPA Circle Radius (m) |
|---|---|---|---|---|---|---|---|---|---|---|---|---|---|---|---|---|
| T2 | Goat Willow | 800 | 12 | M | 3 | 6 | 7 | 7 | 2 | B/C | A co-dominant one side specimen. Multiple stems near base. Possibly an old, coppiced stump. Some decay at base, crossing limbs in crown. | <b>n/a</b> | 10+ | C2 | 289.53 | 9.60 |

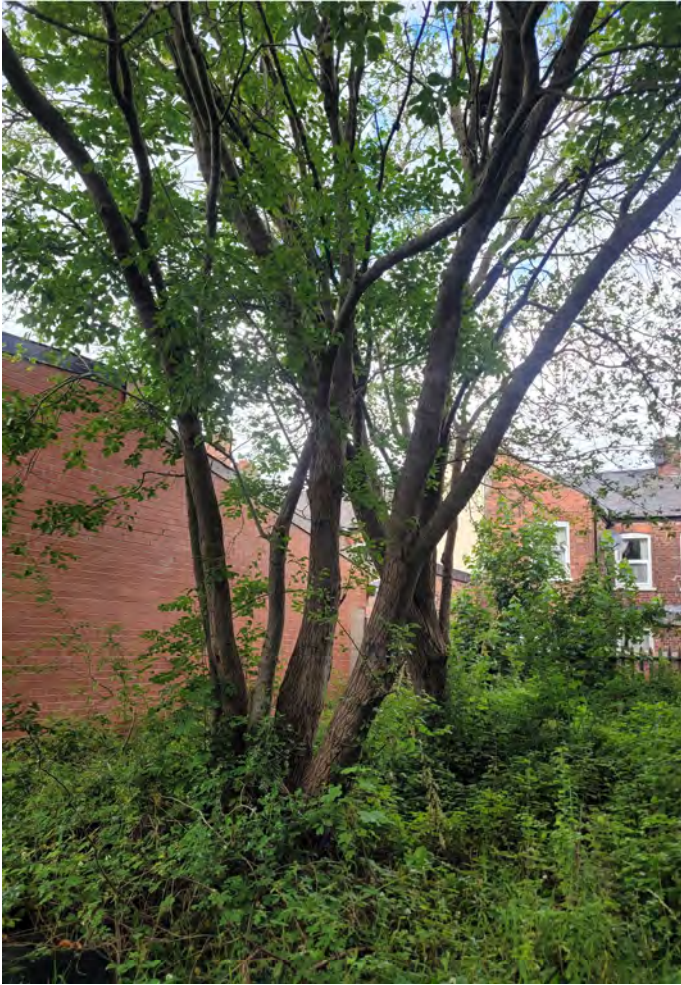
| Tree No. | Species | Dbh (mm) | Height (m) | Age | Crown Spread | | | | Crown C | Cond R | Observations and Comments | Preliminary Recommendations | ERC (Yrs) | TQC R | RPA (m²) | RPA Circle Radius (m) |
|---|---|---|---|---|---|---|---|---|---|---|---|---|---|---|---|---|
| T4 | Goat Willow | 650 | 10 | M | 5 | 5 | 6 | 5 | 3 | C | A twin-stemmed co-dominant specimen located close to building. Very poor tree with major decline in crown. Girdled root at base. | <b>Fell to ground level.</b> | 0-5 | U | 191.13 | 7.80 |

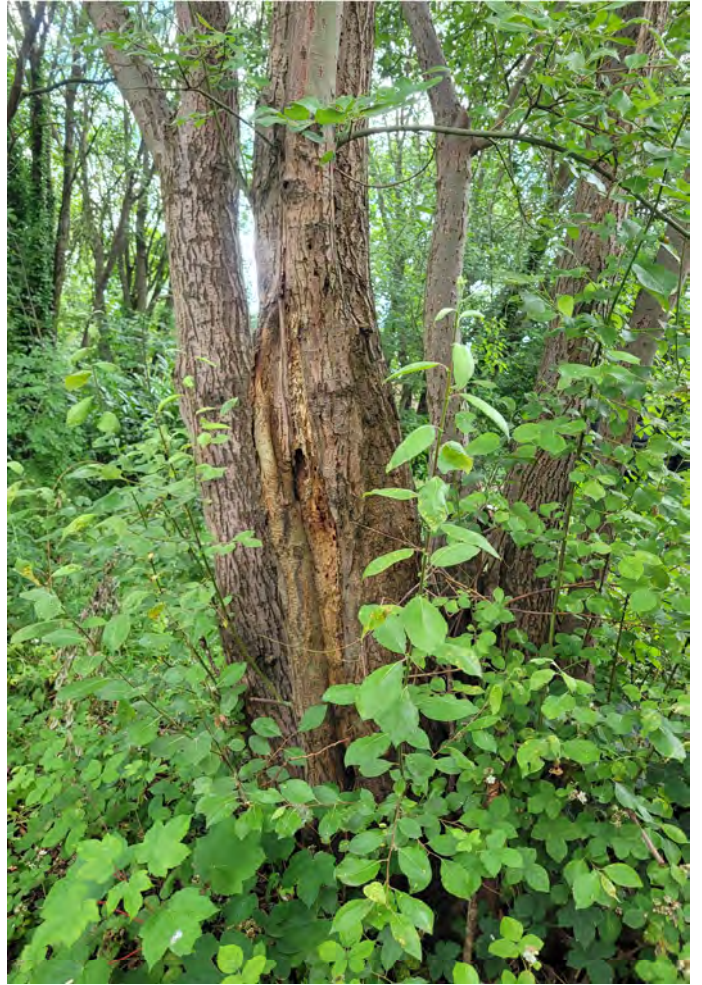
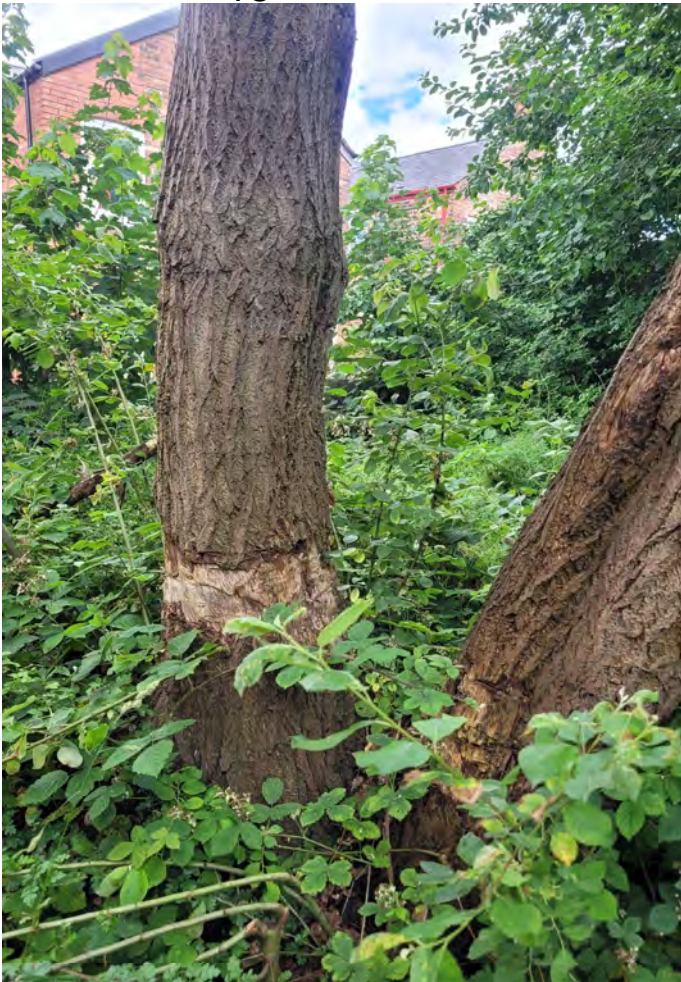
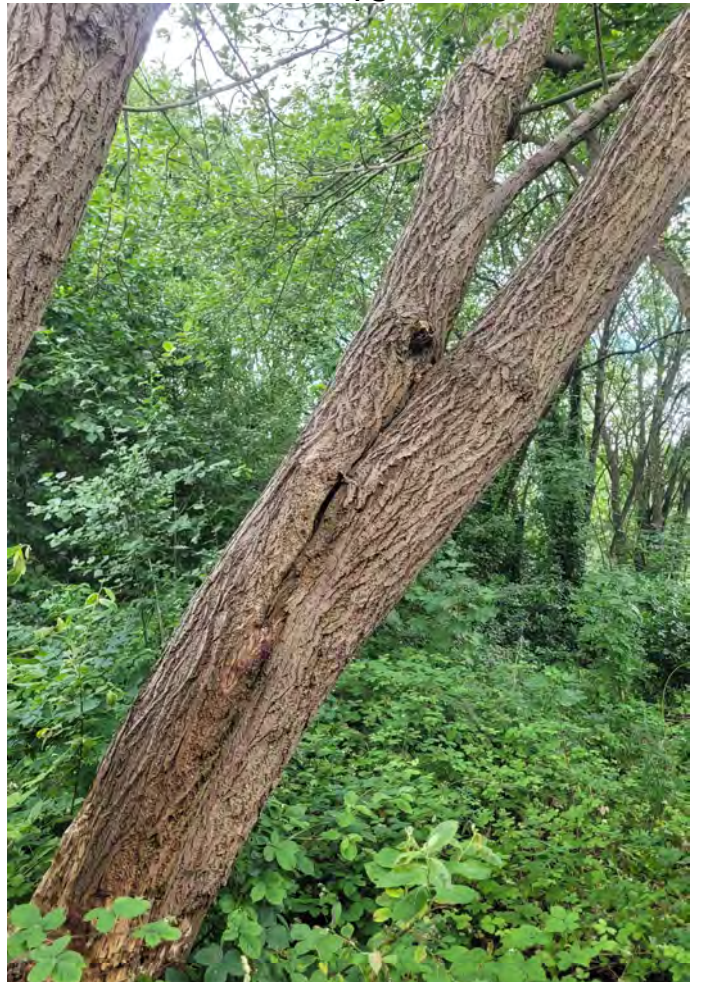
| Tree No. | Species | Dbh (mm) | Height (m) | Age | Crown Spread | | | | Crown C | Cond R | Observations and Comments | Preliminary Recommendations | ERC (Yrs) | TQC R | RPA (m²) | RPA Circle Radius (m) |
|---|---|---|---|---|---|---|---|---|---|---|---|---|---|---|---|---|
| T3 | Goat Willow | 700 | 10 | M | 0 | 6 | 7 | 6 | 3 | C | A multi-stemmed co-dominant specimen located close to building. Very poor tree with major stem decay and split in trunk. | <b>Fell to ground level.</b> | 0-5 | U | 221.67 | 8.40 |

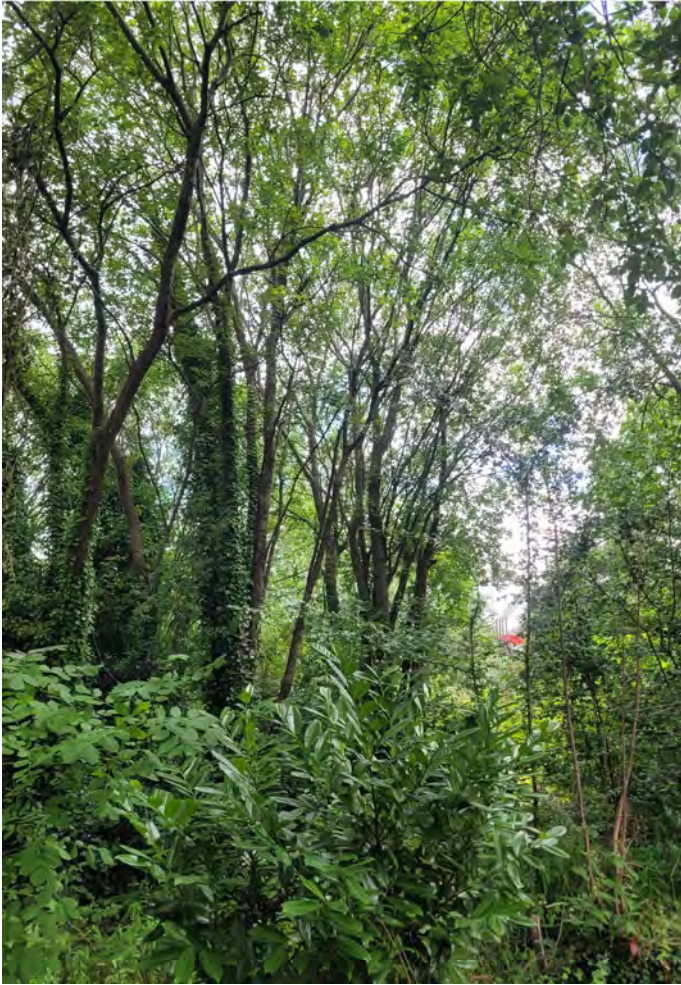
T5, T6 & T7

| Tree No. | Species | Dbh (mm) | Height (m) | Age | Crown Spread | | | | Crown C | Cond R | Observations and Comments | Preliminary Recommendations | ERC (Yrs) | TQC R | RPA (m²) | RPA Circle Radius (m) |
|---|---|---|---|---|---|---|---|---|---|---|---|---|---|---|---|---|
| T5 | Goat Willow | 650 | 10 | M | 7 | 7 | 0 | 6 | 3 | B/C | A co-dominant closely spaced one side specimen. Multiple stems near base. Swamped in Ivy. Previous removal of lower limbs. | <b>n/a</b> | 10+ | C2 | 191.13 | 7.80 |
| T6 | Goat Willow | 500 | 10 | M | 7 | 7 | 2 | 4 | 3 | B/C | A co-dominant closely spaced specimen. Multiple stems near base. Swamped in Ivy. Previous removal of lower limbs. Minor deadwood. | <b>n/a</b> | 10+ | C2 | 113.10 | 6.00 |

| Tree No. | Species | Dbh (mm) | Height (m) | Age | Crown Spread | | | | Crown C | Cond R | Observations and Comments | Preliminary Recommendations | ERC (Yrs) | TQC R | RPA (m²) | RPA Circle Radius (m) |
|---|---|---|---|---|---|---|---|---|---|---|---|---|---|---|---|---|
| T7 | Goat Willow | 600 | 11 | M | 2 | 7 | 8 | 6 | 3 | B/C | A co-dominant closely spaced one side specimen. Multiple stems near base. Swamped in Ivy. Previous removal of lower limbs. Minor deadwood. | n/a | 10+ | C2 | 162.86 | 7.20 |

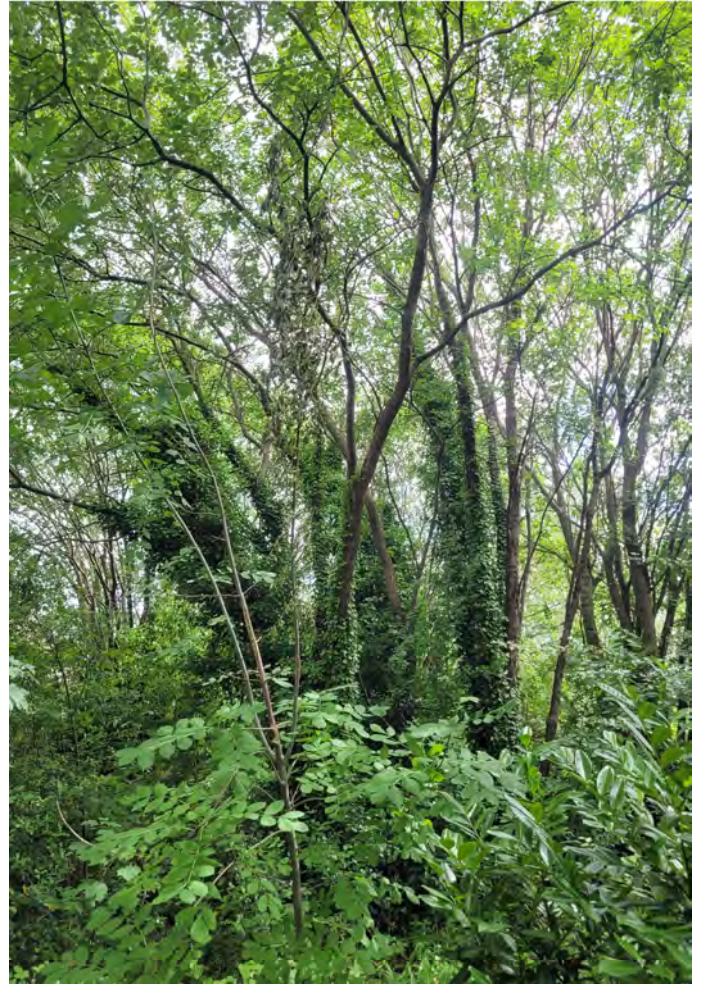
| Tree No. | Species | Dbh (mm) | Height (m) | Age | Crown Spread | | | | Crown C | Cond R | Observations and Comments | Preliminary Recommendations | ERC (Yrs) | TQC R | RPA (m²) | RPA Circle Radius (m) |
|---|---|---|---|---|---|---|---|---|---|---|---|---|---|---|---|---|
| T8 | Goat Willow | 700 | 12 | M | 7 | 6 | 4 | 6 | 3 | B | A large multi-stemmed specimen within no access to base. Swamped in Ivy. Reasonable form and vigour. | n/a | 10+ | C1 | 221.67 | 8.40 |

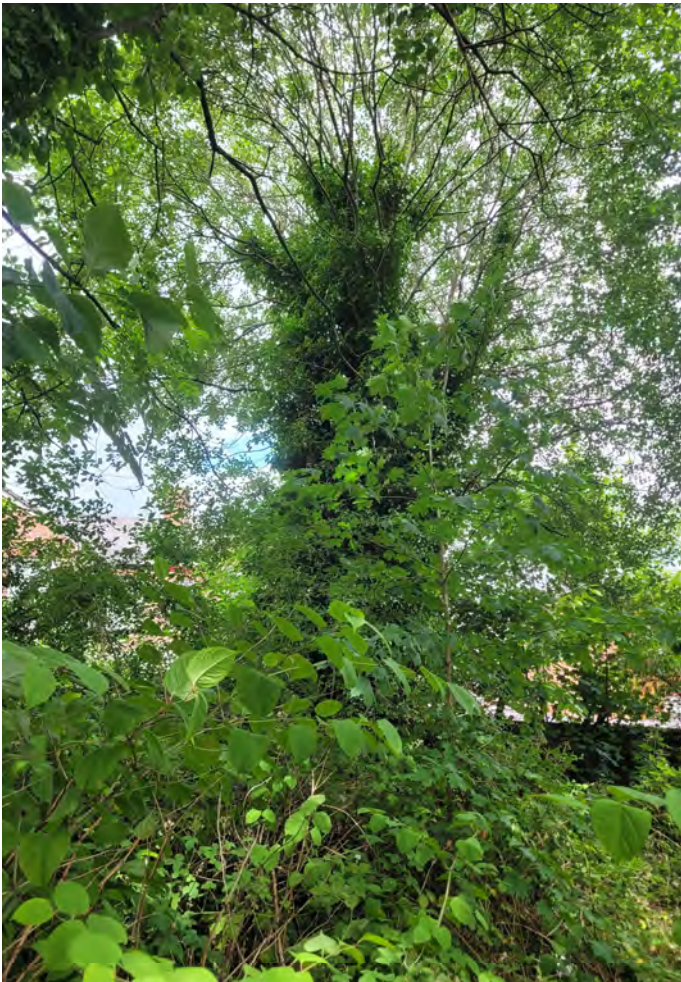
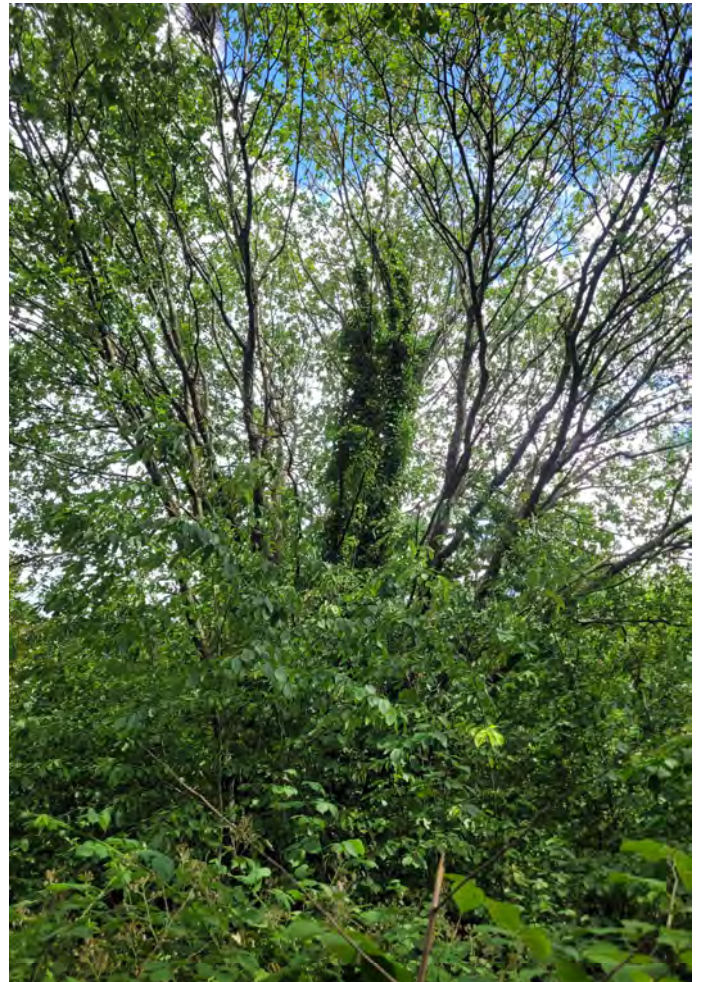
| Tree No. | Species | Dbh (mm) | Height (m) | Age | Crown Spread | | | | Crown C | Cond R | Observations and Comments | Preliminary Recommendations | ERC (Yrs) | TQC R | RPA (m²) | RPA Circle Radius (m) |
|---|---|---|---|---|---|---|---|---|---|---|---|---|---|---|---|---|
| T9 | Goat Willow | 1000 | 12 | FM | 7 | 7 | 8 | 7 | 3 | B | A large multi-stemmed specimen within no access to base. Swamped in Ivy. Reasonable form and vigour. | n/a | 10+ | C1 | 452.39 | 12.00 |

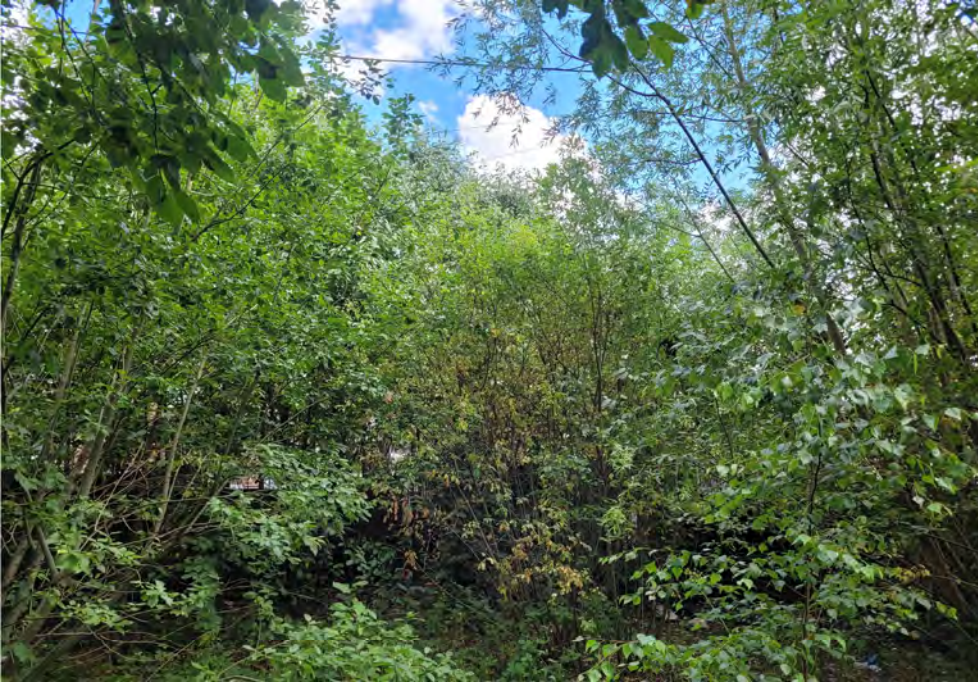
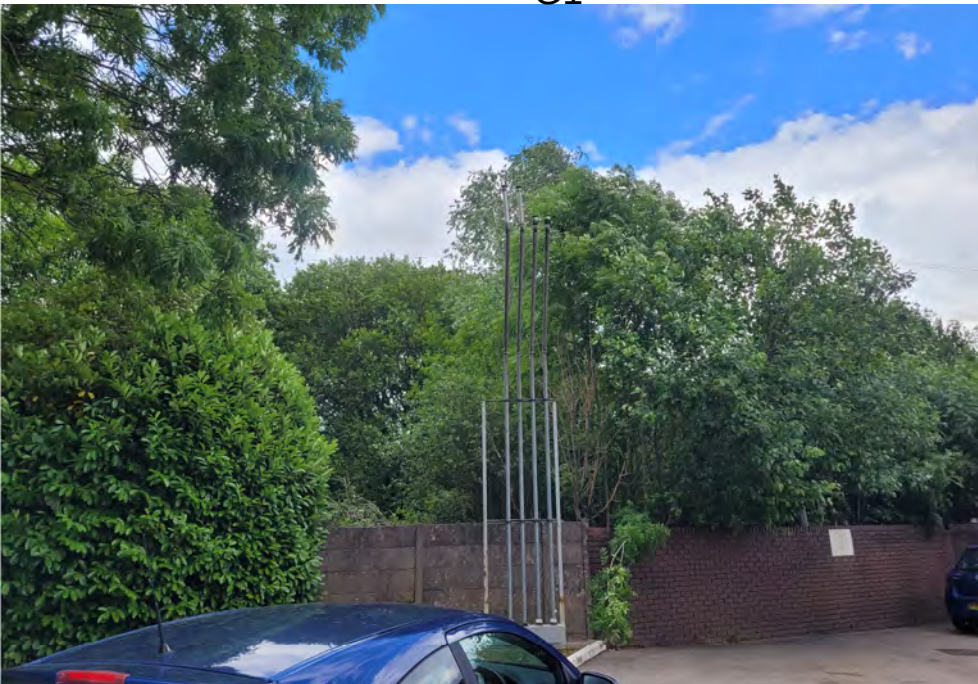
| Tree No. | Species | Dbh (mm) | Height (m) | Age | Crown Spread | | | | Crown C | Cond R | Observations and Comments | Preliminary Recommendations | ERC (Yrs) | TQC R | RPA (m²) | RPA Circle Radius (m) |
|---|---|---|---|---|---|---|---|---|---|---|---|---|---|---|---|---|
| G1 | Group - Ash, Hawthorn, Cherry, Willow, Silver Birch, Whitebeam, Sycamore, Rowan & Bramble | 200 | 0-5 | Y-SM | 2 | 2 | 2 | 2 | 1 | B | The site is very overgrown with profuse Cherry suckering and various self-sown trees and shrubs scattered across the site mostly concentrated on the south-east boundary. Inert material dumped across the site including building waste and tyres. | <b>n/a</b> | 10+ | C2 | 18.10 | 2.40 |
