# Heritage Statement

1830 Warehouse  
south elevation  
openings and  
essential repairs,  
Museum of Science  
and Industry  
Manchester

February 2023 | Project Ref 4700H

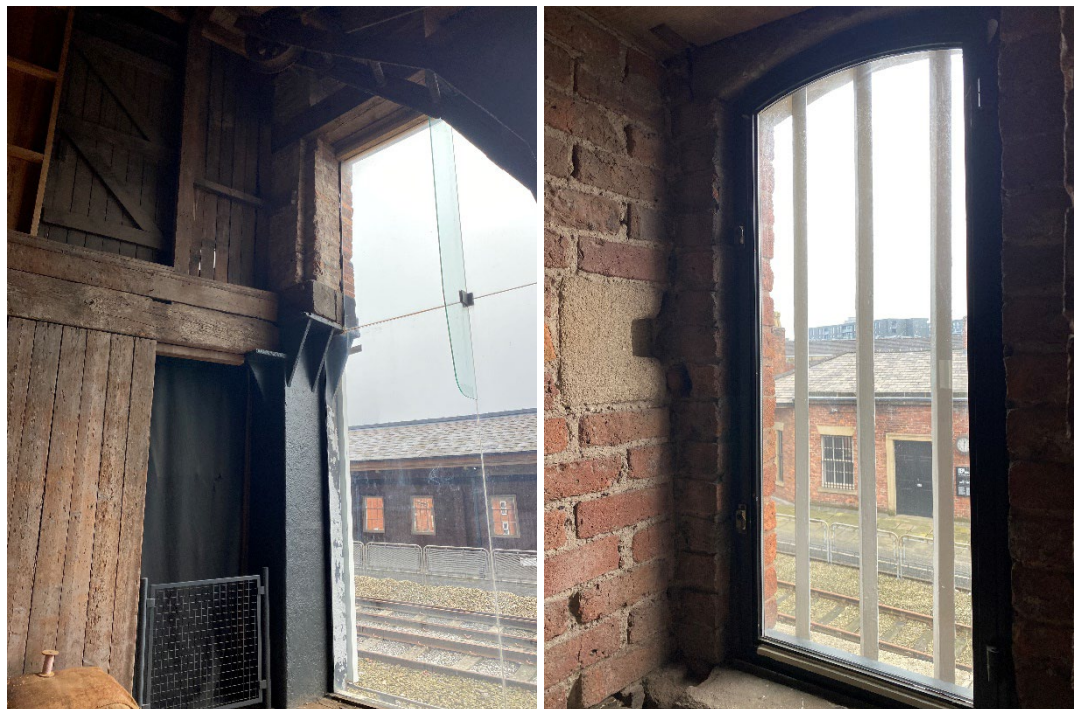
*Figure 8-9: (left) frameless system installed within Bay 2; (right) example of typical framed windows inserted within the smaller windows in Bays 1-3.*

- 4.3** The glazing within Bays 1 and 2 has failed and requires action to halt ingress of water, damage and degradation of surrounding fabric, and minimise risk from collapse of the large structural glass infills. Bay 3 features a similar glazing detail and it is the opinion of the architectural and structural engineering team that it is likely, in due course, to fail in a similar way.

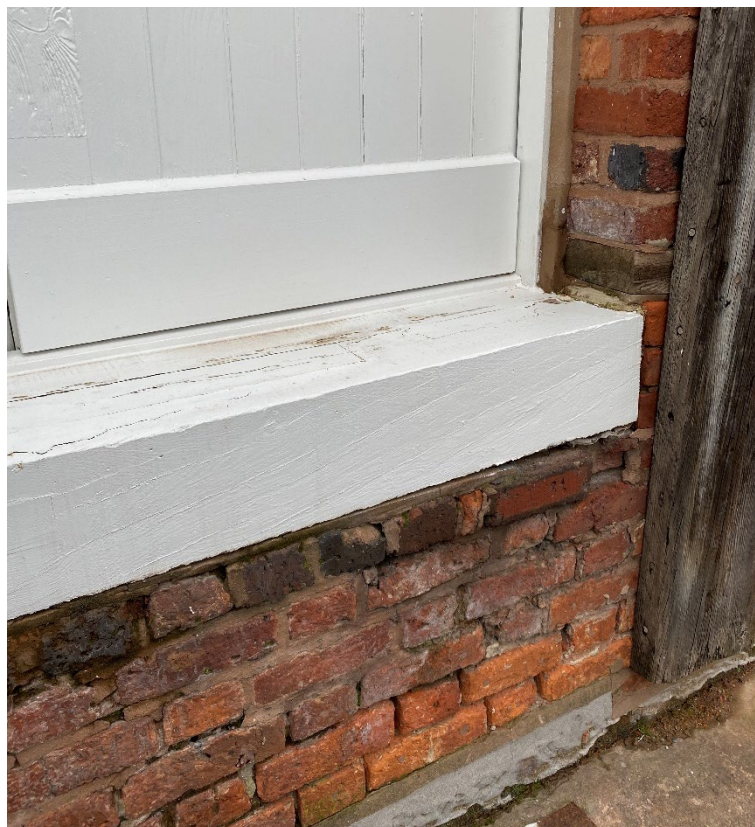
*Figure 10: timber lintel on south façade showing past pieced in repair to upper surface, and damage and discolouration to historic brickwork beneath.*

- 4.24** The sills are failing and their design is flawed. They do not cast water off their top surface adequately and as their front face is flush with surrounding brickwork. The sills are softwood and are assumed to date from the 1990s restoration, along with almost all of the cargo doors themselves renewed at the same time. Brickwork beneath the sills is discoloured, mould and moss growth encouraged, and water and frost damage occurring due to water flowing directly down the building façade because of the lack of a drip detail (see Figure 10).

- 4.26** The proposed replacement is a slightly different detail to that in place today. Fabric affected is modern and the overall aesthetic of the southern façade cargo doors will be maintained. The width of the sills, or their depth in relation to the doors will not

change. The proposal will prevent damage and ongoing degrading of the brickwork beneath the cargo doors limiting and preventing the need for future repair work to actual historic brickwork of High heritage significance. The proposals will sustain heritage values and limit the potential for further damage.

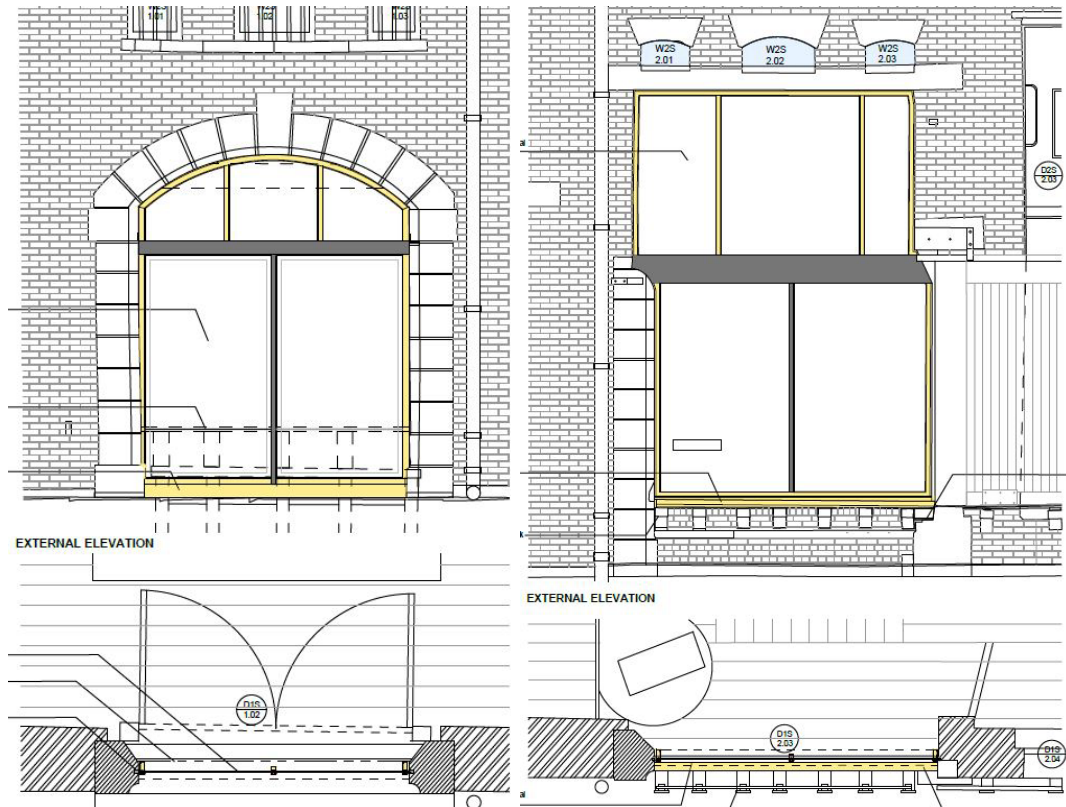
Figure 11: Extracts from Studio Downie Design proposals for Bays 1 and 3 (left) and Bay 2 (right). See Design Approach Report for full captions and figure detail. (Figures not to scale)

- Introduced slim aluminium uprights and a heavier central transom. The design was overtly intended as a visual contrast to historic forms and opening subdivisions but to provide a family of details that might be extended to other openings, should the need arise, to ensure consistency across the façade.

**4.20** In proposing a lighter weight framed system the advantages of such a system are maintained but the degree of visual change is minimised. The proposals to replace the glazing systems within the wagon arches will sustain heritage significance and, in responding to officers' comments at MCC, minimise the degree of visual change within the southern façade.

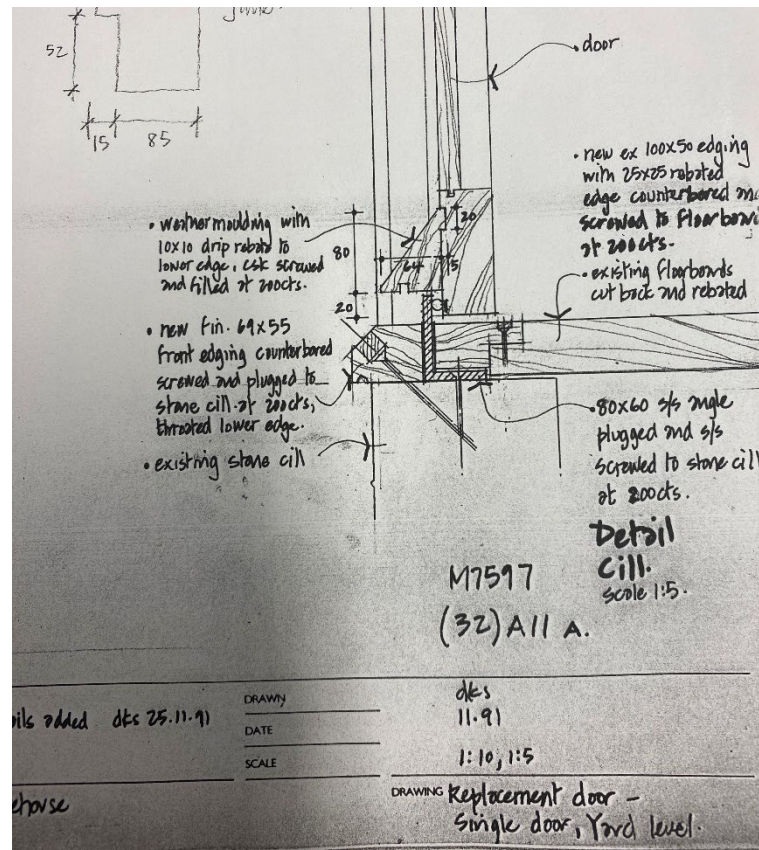
Figure 12: 1991 detail for replacement door sill showing a throated lower edge with drip detail. (source SIM Archive, Building Design Partnership 1991)
