**Site Tree Appraisal**  
***48 Wilton Road, Crumpsall M8 4EL***

**‘BS 5837 2012: Trees in Relation to Design, Demolition and Construction – Recommendations’**

| Ref: | RTS/08042022 |

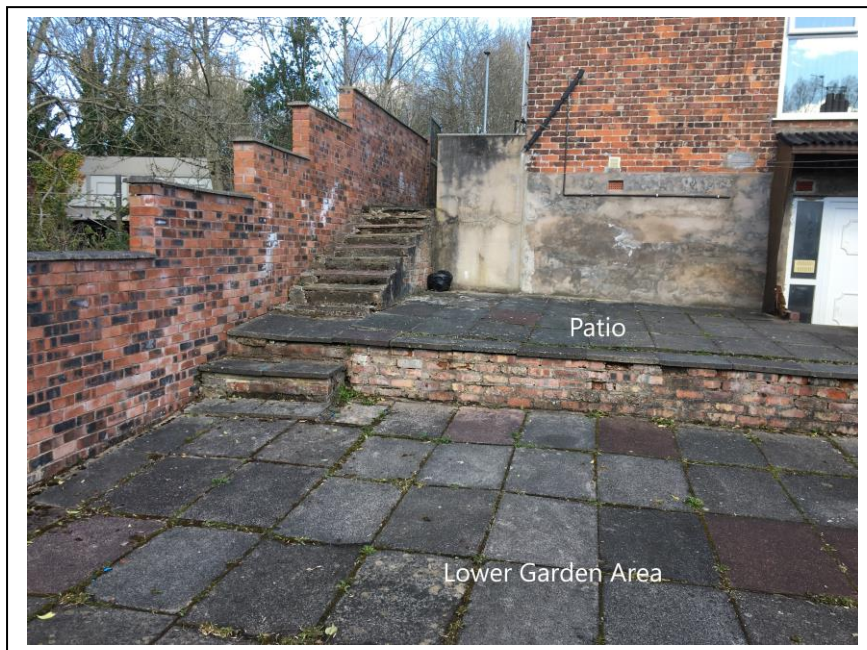
Photo 01:

- The front of the properties are north facing.
- The gardens are relatively level from Wilton Road to the rear of the house, with only a gentle downwards slope. From here (at the rear of number 48) brick-built steps descend for approximately 1.2 metres to a paved patio area. From the 4.4-metre-wide patio there is then a further step down of 0.6 metres to the main paved garden area below, (see photo 01).

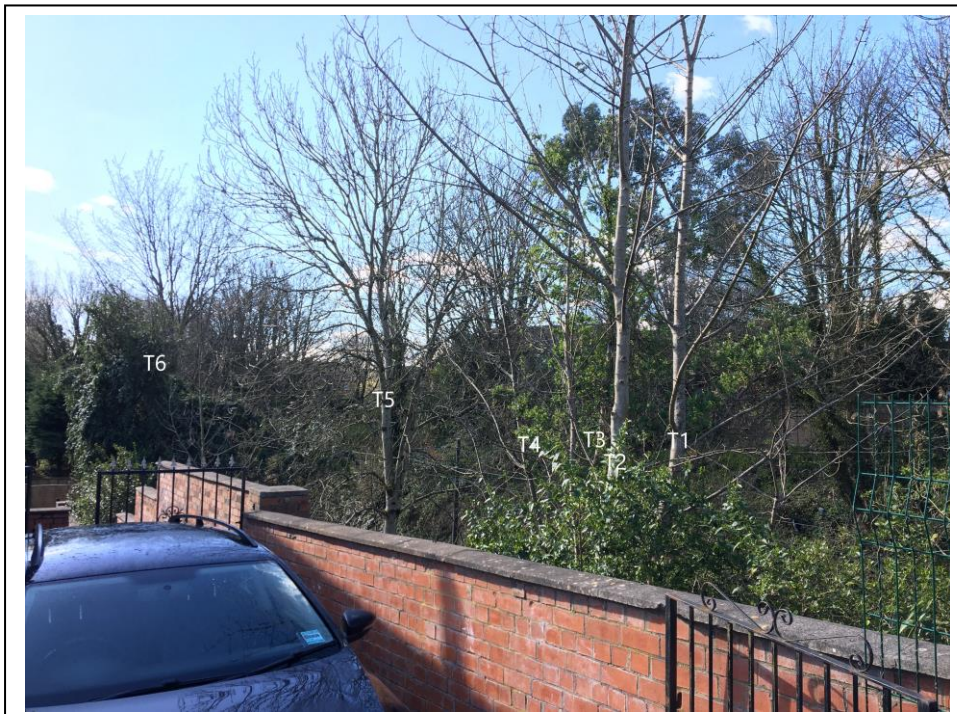
Photo 02:

- 3.5** All the adjacent trees are relatively small, either young or early mature. Their branch structures, therefore, do not overhang the boundary wall and remain confined to within the Metro-Link land (photo 02). There will be no requirement to prune any of the trees in order to facilitate the proposed extension works. Due to the trees’ isolated locations from the build area and the existing presence of the brick boundary wall, there will be no requirement to erect temporary protective fencing in order to avoid accidental damage to the trees during the build process.

**No tree branches overhang the existing boundary wall**
