# Blackfriars House, Manchester

## 12738\_R01a\_Preliminary Roost Assessment -Daytime Bat Survey

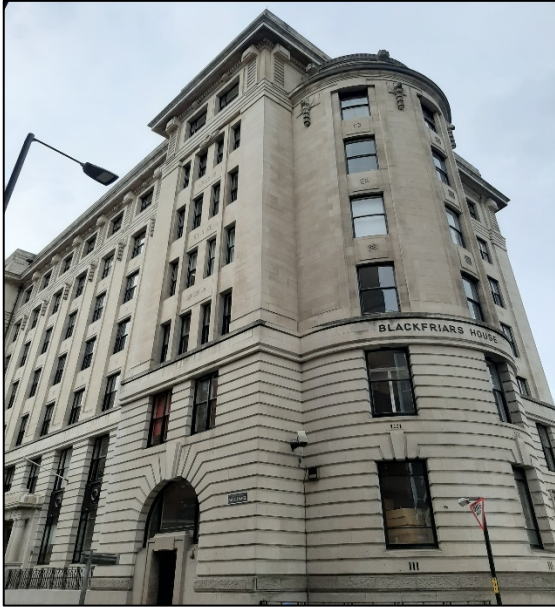
- 3.1. The descriptions provided below should be read in conjunction with the photographic record reference and provided in **Appendix 2**.
- 3.2. Blackfriars House is a multi-story office space building constructed of stonework and is generally in excellent condition (see **Photograph 1**). The roof of Blackfriars House, which will be the main subject of the proposed re-development works comprises several structures as described in turn below.

**Photograph 1 – exterior of Blackfriars House**

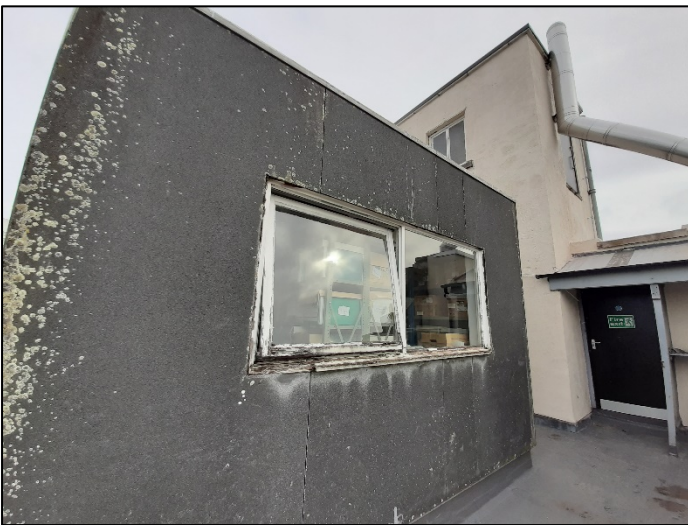
- 3.3. The structure on the main roof to be demolished was constructed of a fibre composited boarding (see **Photographs 2-5**), with a flat roof constructed of a similar fibre composite and roofing felt. The internal area was in use as an office storage unit. A very small lip was noted around the roofline of the structure, which was noted to be well sealed to the elevations of the building. No roof void was present in the building. A few very minor crevices were noted in association with this building where the external layer of the boarding was peeling away from the main structure but detailed inspection revealed they did not offer potential access points between the panels or beneath them.

**Photograph 2 – structure to be demolished**

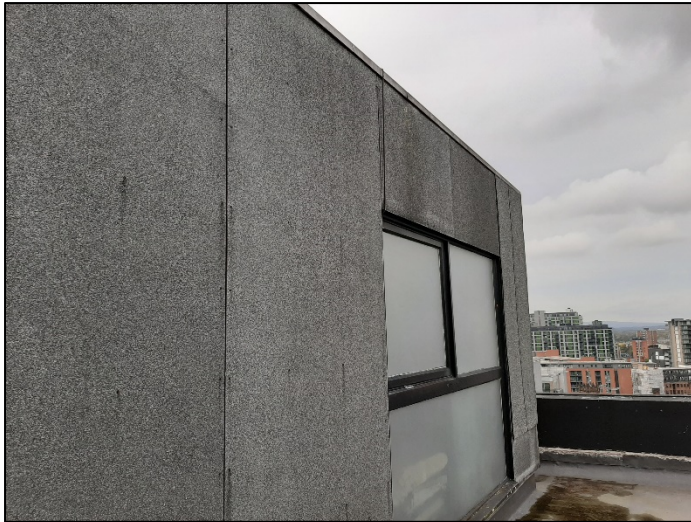
**Photograph 3 – structure to be demolished**

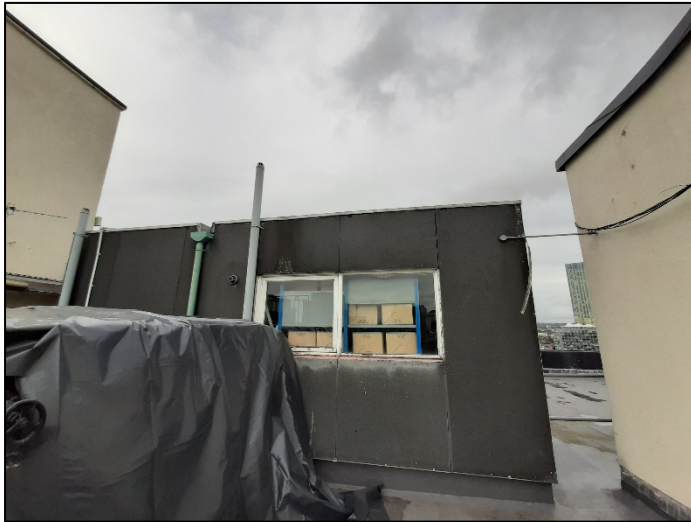
**Photograph 4 – structure to be demolished**

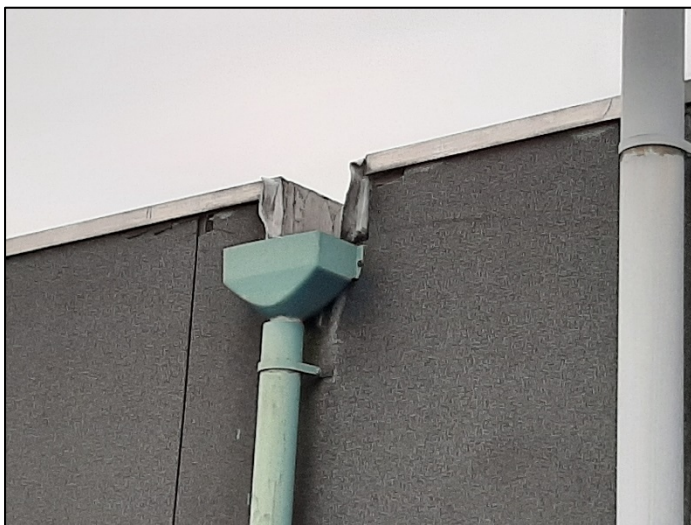
**Photograph 5 – roofline on building to be demolished**

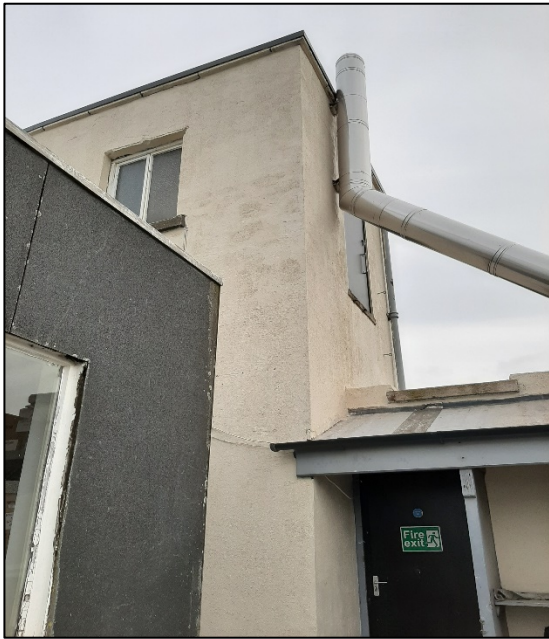
- 3.4. These roof structures were constructed of brick and rendered, with a flat roof constructed of composite boarding and roofing felt (see **Photographs 6-7**). No fascia boards or soffits were recorded on these buildings and in general they were noted to be in good condition.

**Photograph 6 – service lift building**

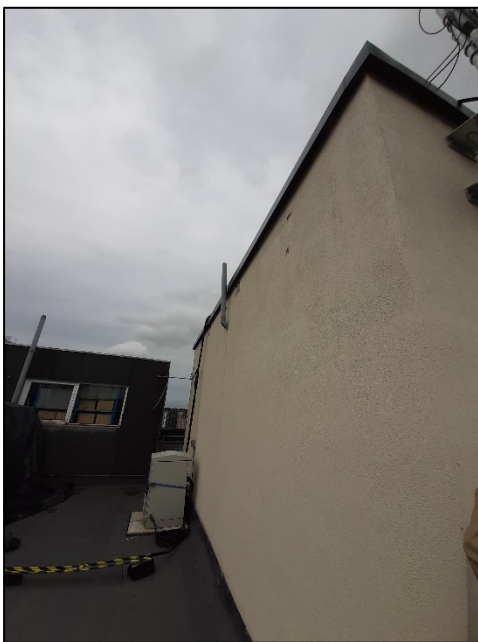
- 4.2. Although it is not to be demolished, the exterior of the service lift buildings were also surveyed as these are to be enclosed within a new external structure and are likely to be subject to disturbance/alteration. No potential roost features were observed.

**Photograph 7 – service lift building that may be disturbed**

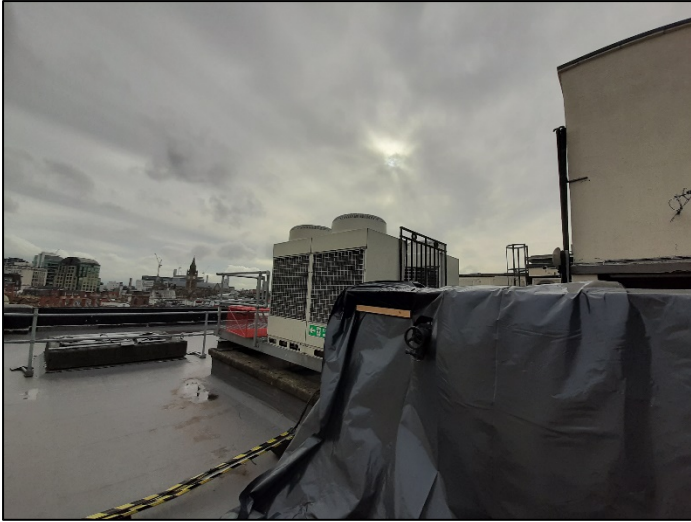
**Photograph 8 –general roof ancillary structures**
