# DESIGN STATEMENT

## BARRACKS HOUSE MANCHESTER

Revision B

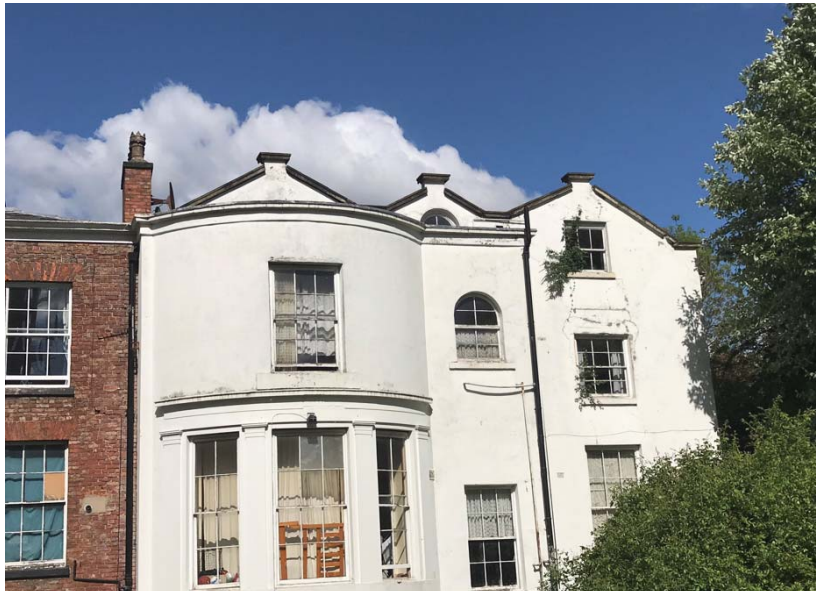
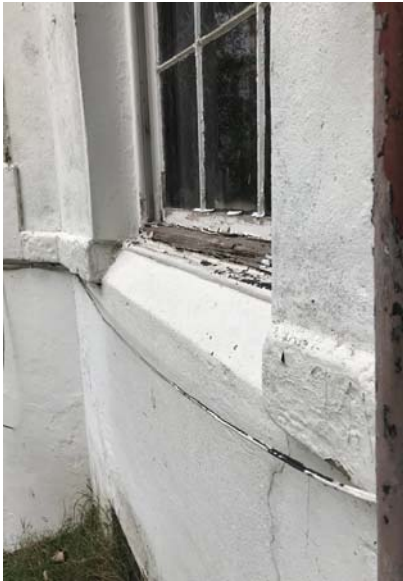
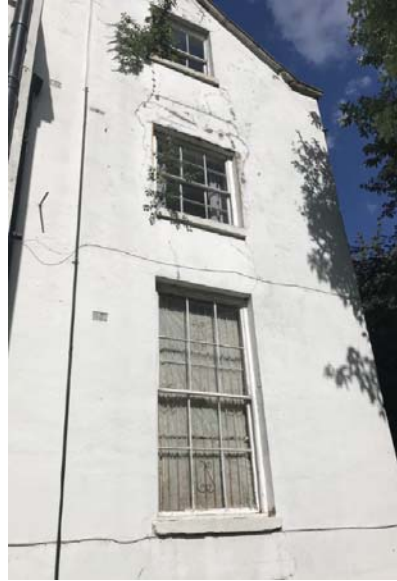
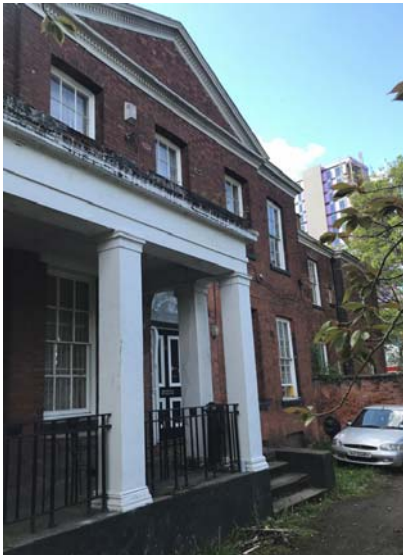
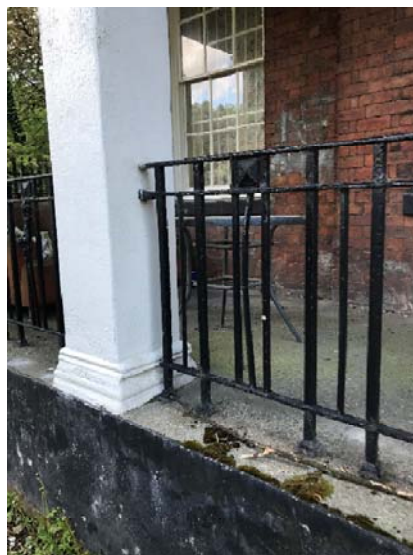
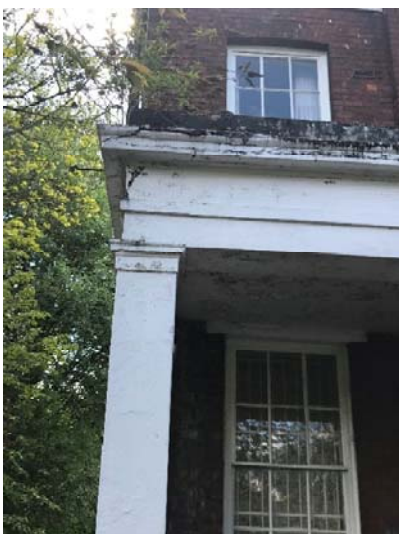
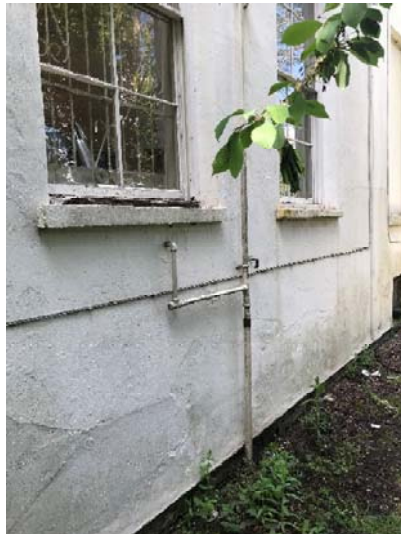
- 4.4 The render is in poor condition to most facades. There are areas where it is uneven in application and areas that are cracked and debonding. A full tap survey has not been carried out to test all areas as full scaffolding will be required.

- 4.5 The render is attached to what is considered to be solid brick walls with no cavities. Cementitious render is inappropriate in such situations as it prevents the external walls from breathing. A lime-based render would be more suitable as it is flexible and vapour permeable.

*Areas of render to the existing elevation*

- 4.6 Whilst the render in general would be better to be fully removed and replaced there are areas of render mouldings that are better to be retained and patched.

- 4.7 The recommendation for patching of external render is that a natural hydraulic lime render is used rather than a non-hydraulic lime typically of NHL3.5 – NHL5 classification under BS/EN998.

- 4.8 In this instance we are proposing using a NHL3.5 basecoat and finishing coat finished by aluminium hawk.
- 4.9 The existing render has been painted so patching will not provide a consistent colour unless fully replaced. A breathable silicate paint will be used to both new and existing render.

- 4.10 Once scaffolded a full survey of the existing render will be carried out and the extent of work fully agreed with the Conservation Officer. A sample area will be provided for the Conservation Officer to inspect and approve before carrying out work to the entire facades.

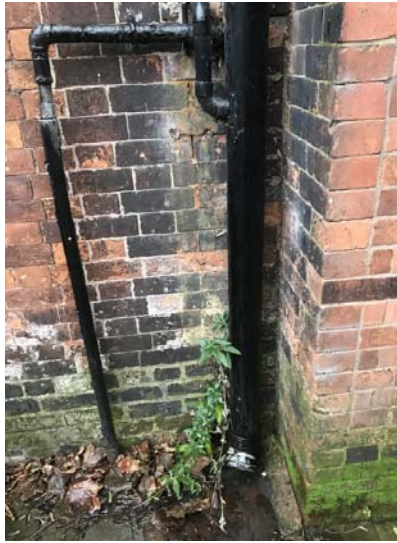
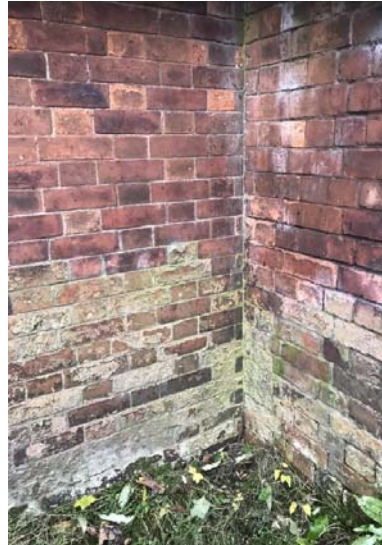
- 5.2 There are some areas where the brick has been damaged, largely by damp brick beneath leaking pipework. Spalled bricks will be removed and previously poor pointing to the walls will be repointed in a careful and more sensitive way in keeping with the original detailing.

- 5.3 Some low-level areas also show damage to the brick and will be replaced
  - 5.4 Where brick has been damaged the cause of the damage will be rectified. SO for instance leaking rainwater pipes and soil stacks will be replaced and any broken gutters repaired

*Damage to low level brick*

- 5.5 Brick will be carefully selected to match the existing and a sample panel will be provided on site for approval by the Conservation Officer
  - 5.6 Where repointing is required the joints will be manually raked out or cut with a hand saw. Power tools will not be permitted. Joints will be square cut to a minimum depth of twice the height of the joint. All dust and debris will be removed via rinsing with clean water.

- 5.7 The wall will be dampened prior to inserting new mortar. Mortar will be of a natural hydraulic lime. Excessive mortar will be sponged off prior to setting

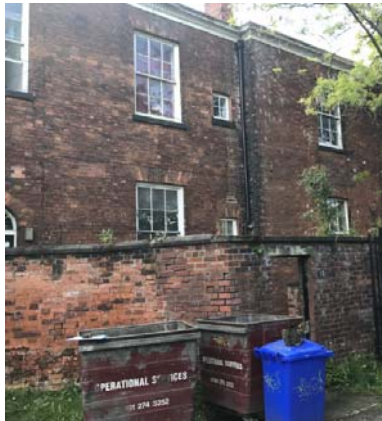
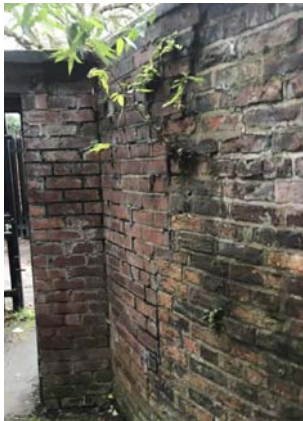
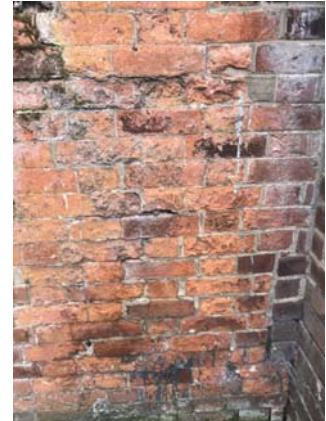
- 5.6 The existing curved garden wall to the right of the drive is in a state of disrepair with numerous spalled brick and some previously poor attempts at repointing. It is proposed that sections of this wall will be removed and rebuilt using a matching reclaimed brick with the same stone features

*Existing curved wall to side of drive*

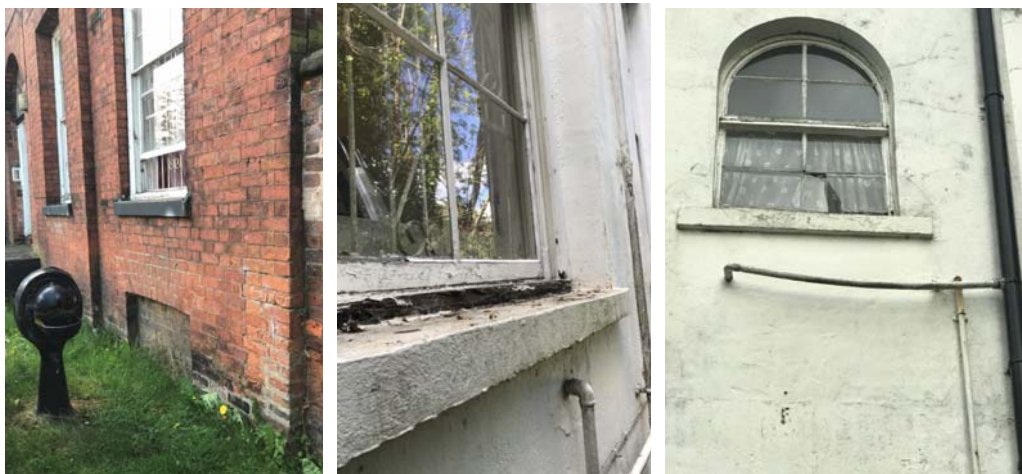
The existing windows are painted timber sash windows and are generally in a state of disrepair with signs of rot to cills in particular, damaged and missing glazing bars and slipped or broken glass.

- 6.2 The building is suffering from condensation issues typical of single glazing. The lower cill sections of the sashes in particular are showing signs of rot where the condensation has puddled

*windows in various states of disrepair with security bars to vulnerable ground floor*

- 6.11 All windows will therefore be fully repaired and redecorated, new secondary glazing will be installed throughout and the existing security bars will be retained to vulnerable windows
- 6.12 A schedule of repairs is included with the application.
- 6.13 Sample window repairs can be provided for the approval of the Conservation Officer.

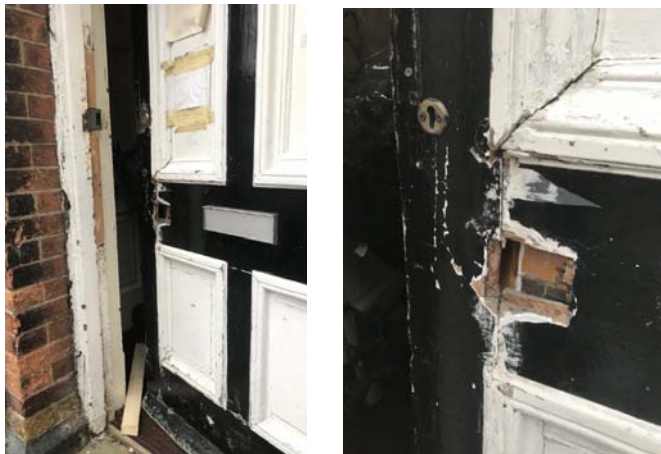
- 7.1 External doors have suffered a series of repairs over the years and are not in good condition. However, these too will be repaired and redecorated throughout including decorative mouldings and the damaged fanlight over the main entrance door

*Damage to timber panelled doors and frames*

- 7.3 Timber block infilling will be required to the excessive damage around the lock cases of both the door leaf and the door frames and elsewhere beading to the panels will be repined and filled where damaged or rotten

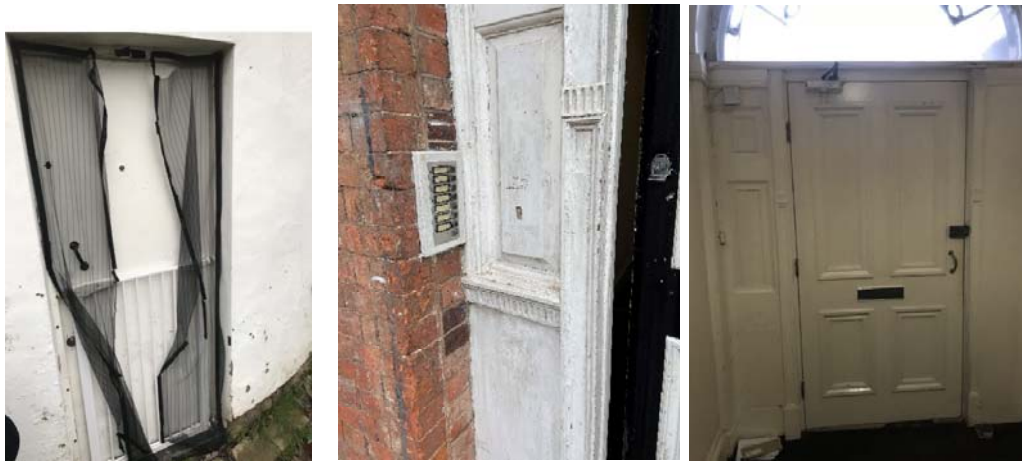
- 7.6 DG02 at the rear of the building to the basement is not an original door and is fitted with a cheap flush timber door that is not within keeping.

- 7.9 The existing intercom unit on the main entrance is currently non-functional leading to the door often being left open by tenants. The client intends to fit a new intercom unit in the same position to the side of the door

Existing DG02, intercom to front door and panel infills to main front door

- 7.4 Panels to the side of the existing front door will also be rep[aired and redecorated including the removal of previous plywood panel infills
- 7.5 Doors will be prepared and repainted in external gloss paint to a typical Georgian era single colour

- 7.7 The client proposes to change this door and provide a new durable timber Georgian style four panelled door that is more characteristic of the building and resembles the existing timber doors to the front and side elevations

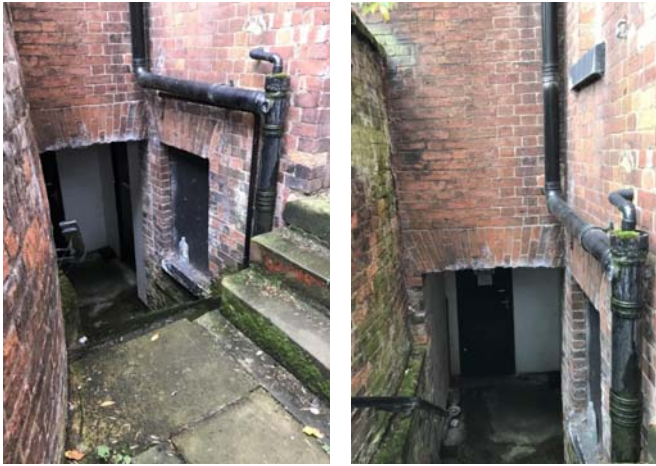
- 8.1 A number of soil stacks are showing signs of leaking at collar junction. These will be repaired where practical and where not they will be replaced with new **cast iron** pipework
- 8.2 Rainwater downpipes are also causing damage to the brickwork in some locations by virtue of the fact that the junctions are loose or, at low level, the gullies appear to be blocked and this has resulted in running water to the basement stair for instance
- 8.3 All gullies on site and all manholes will be inspected and cleared. Any damaged downpipes will be replaced with **new black cast iron pipes**

*Leaking downpipes and stacks*
