# Concord House, Wythenshawe

Assessment for Bats

**Report Title:** Concorde House, Wythenshaw  
Assessment for Bats

**Issue Date:** 03/10/2025  
**Document Ref:** 0968/Assessment for Bats

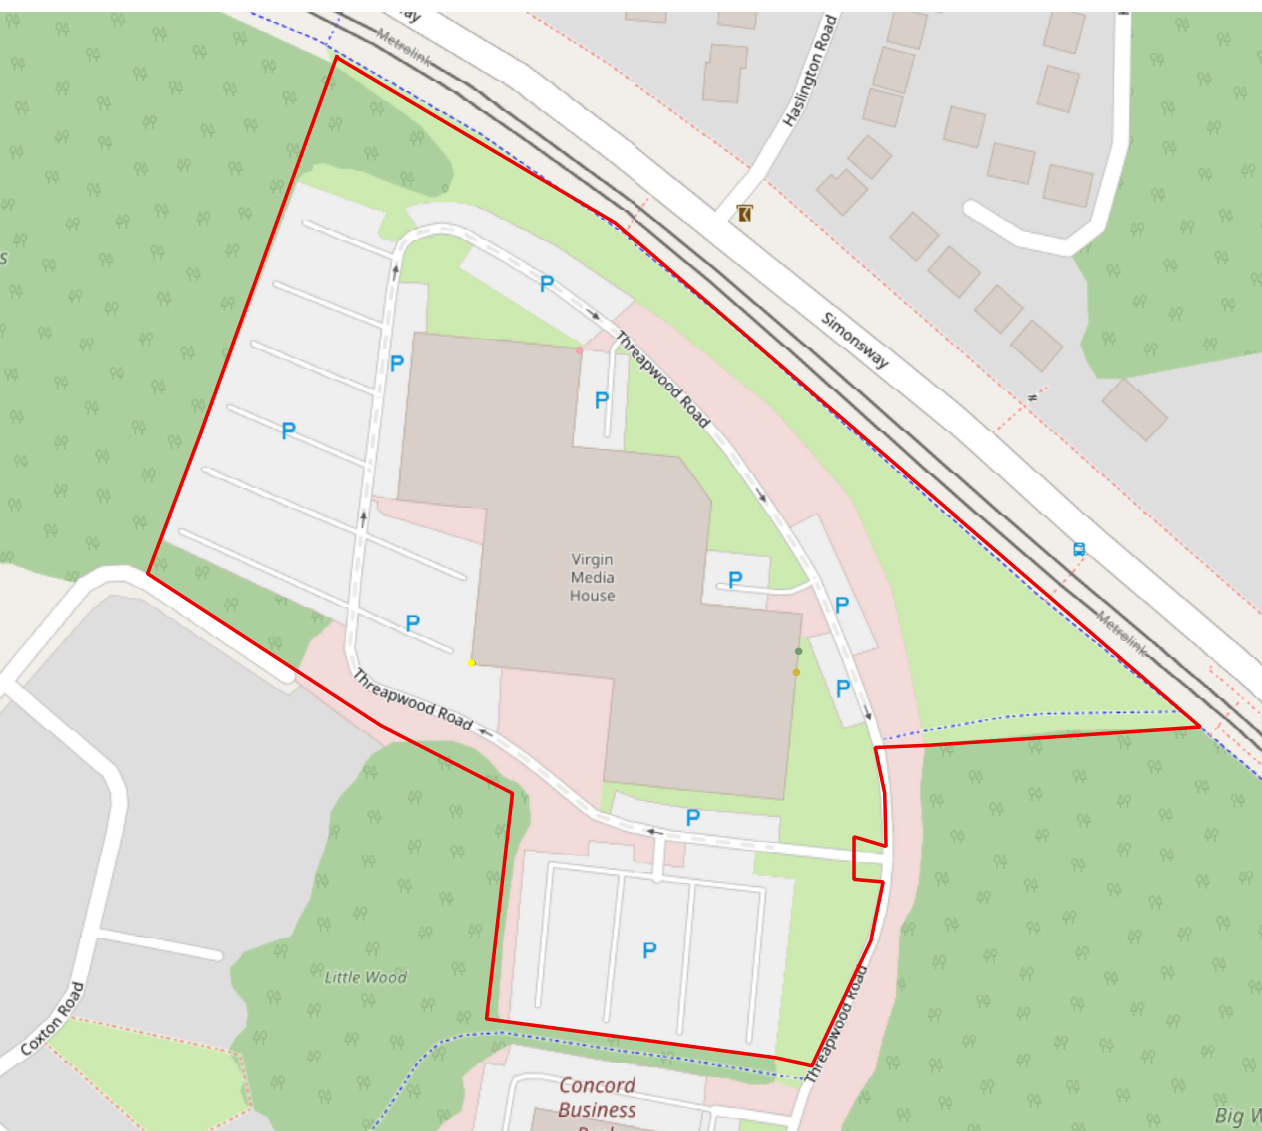
**Figure 1.** Site Boundary and location of Potential Roost Features.

- 4.3.1 The roofing unit within the plant room inspected was well sealed and insulated, with no signs of bats seen during the survey and negligible potential for roosting bats.
- 4.3.2 Four PRF's were identified on the outside of the building, with their initial assessments detailed in **Table 1** (see also **Figure 1**; **Photographs 3-6**).
- 4.3.3 In addition, all soffit boards were joined by a metallic mesh material that had perished to create many holes at various places around the building (**Photograph 7**). It was considered possible that these holes could lead into a large cavity and further inspection by MEWP was recommended.

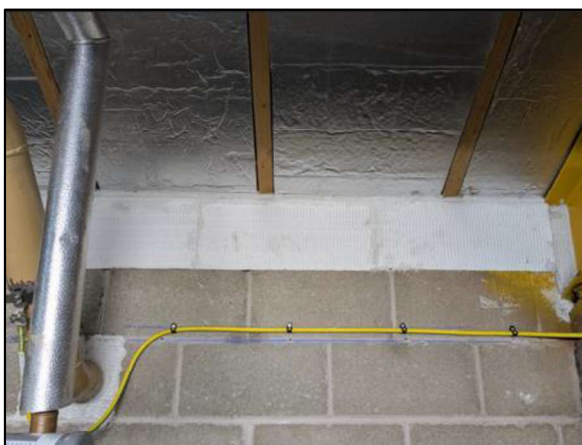
**Photograph 2.** Internal roof void.

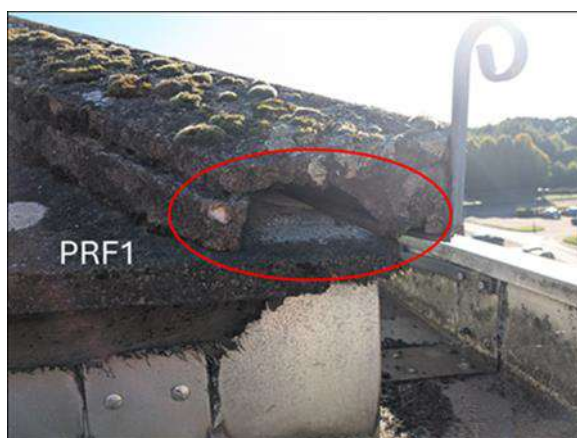
| PRF | Location (Ordnance Survey National Grid Reference) | Building Aspect | Description | Classification |
|---|---|---|---|---|
| PRF-1 | SJ8320986396 | South-west | Missing mortar allowing access into cavity under ridge tiles ( <b>Photograph 3</b> ). Further inspection by MEWP recommended. | PRF-I |

- 4.5.1 No evidence for the presence of bats was found during the building inspection with a MEWP.
- 4.5.2 PRF-1 and PRF-2 allowed access into the cavity under the ridge tiles, and their close inspection confirmed their categorisation as PRF-I. However, there was no evidence to suggest that either feature was actually used by bats.

- 5.1.2 There are two Potential Roost Features within the roof of the Virgin Media building (PRF1 and PRF2). Both have been formed where mortar has been lost from under a ridge tile, allowing access to the cavity under the ridge tile. Both were classified as PRF-I. Nevertheless, the building is considered to have negligible potential to support roosting bats because of its location and because of the low quality and disturbed nature of Site habitats for commuting/foraging bats.

**Photograph 3.** PRF1 closely inspected by MEWP.

- 5.1.5 We recommend that two bat boxes integral to the structure of any new building are provided as mitigation for loss of PRF1 and PRF2. This would maintain the potential ecological functionality of the Site.

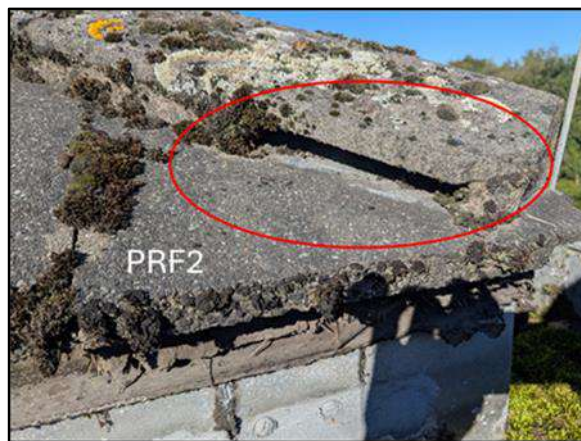
| PRF-2 | SJ8323686475 | North-east | Missing mortar allowing access into cavity under ridge tiles ( <b>Photograph 4</b> ). Further inspection by MEWP recommended. | PRF- I |

**Photograph 4.** PRF2 closely inspected by MEWP.

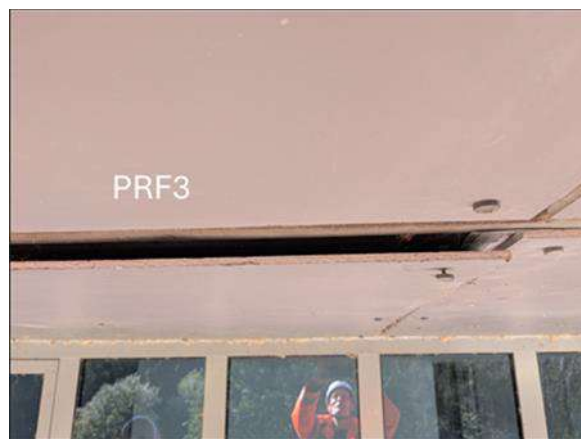
| PRF-3 | SJ8329186399 | South-east | Entire soffit panel loose, possibly leading into cavity ( <b>Photograph 5</b> ). Further inspection by MEWP recommended. | PRF-I |

- 4.5.4 PRF-3 did not allow access into the soffit cavity. It was considered to have no potential to support roosting bats. PRF-4 allowed access into the soffit cavity, but the cavity was unsuitable for bats. It was

**Photograph 5.** PRF3 closely inspected by MEWP.

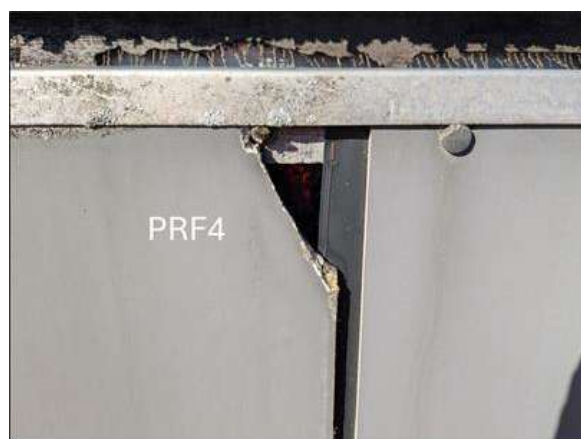
| PRF-4 | SJ8329186394 | South-east | Small hole in soffit board, possibly leading into cavity ( <b>Photograph 6</b> ). Further inspection by MEWP recommended. | PRF-I |

considered to have no potential to support roosting bats.

**Photograph 6.** PRF4 closely inspected by MEWP.

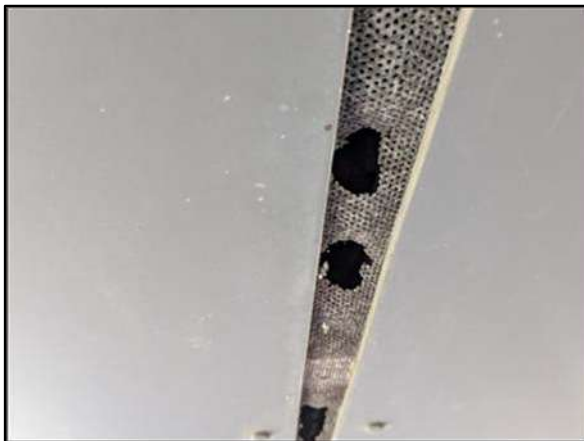
- 4.5.5 Holes in the join between soffit boards at many places around the building were considered to have no potential to support roosting bats because the soffit cavity was unsuitable for bats.

**Photograph 7.** Holes in material between soffit boards. Closely inspected by MEWP.
