## MCFC Project Taverna

### Coal Mining Risk Assessment

For: Manchester City Football Club

| <b>Report Reference:</b> | | <b>4490-02A</b> |

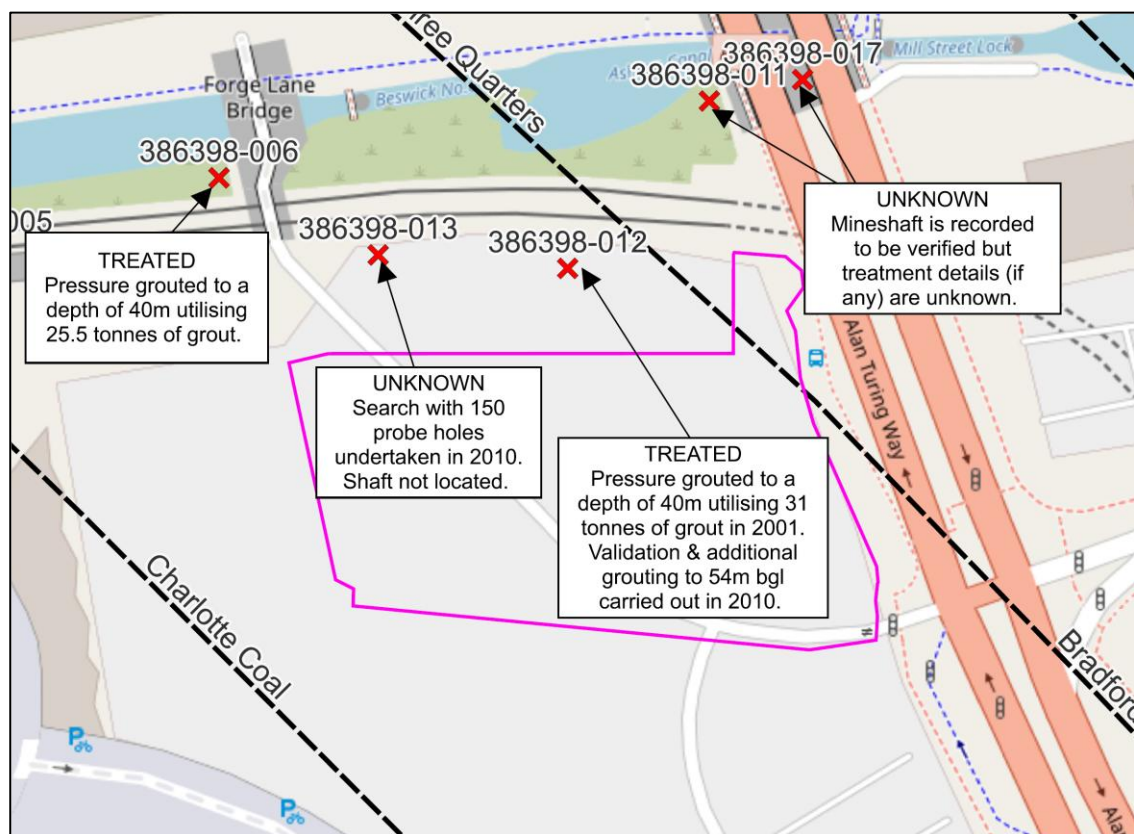
Figure 5: Extract of the Mineshaft Location & Detail Plan map showing the **Bradford Three Quarter** coal seam subcrop (black dash) and mineshafts with detail on treatment and identification.

The nearest 2 No. shafts are recorded c. 17m and 20m north of the site (Ref: 386938-012 and 386398-013). Given the relatively close distance of these mine entries from the site boundary, further consideration will be required as to whether they will have an impact on the proposed development.

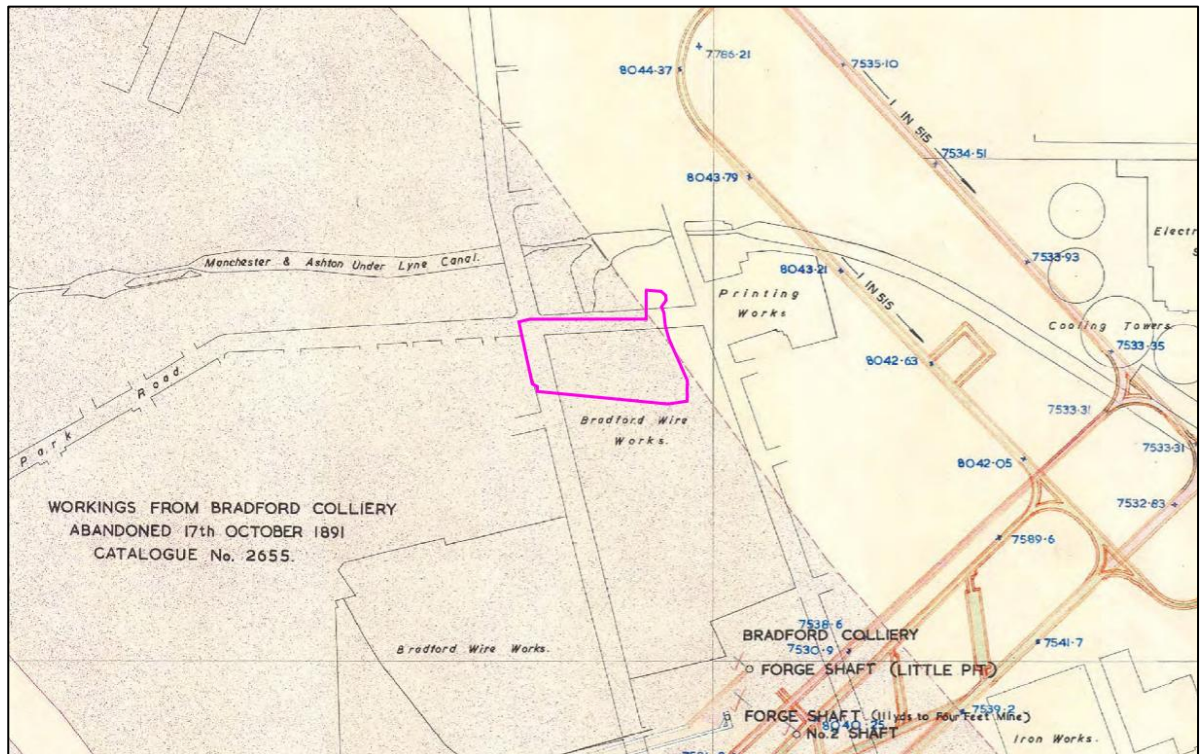
Figure 6: Extract of the **Bradford Four Foot** abandonment plan in relation to the site.

An extract of the **Bradford Four Foot** abandonment plan showing the site boundary and workings covering the majority of the site is shown below:

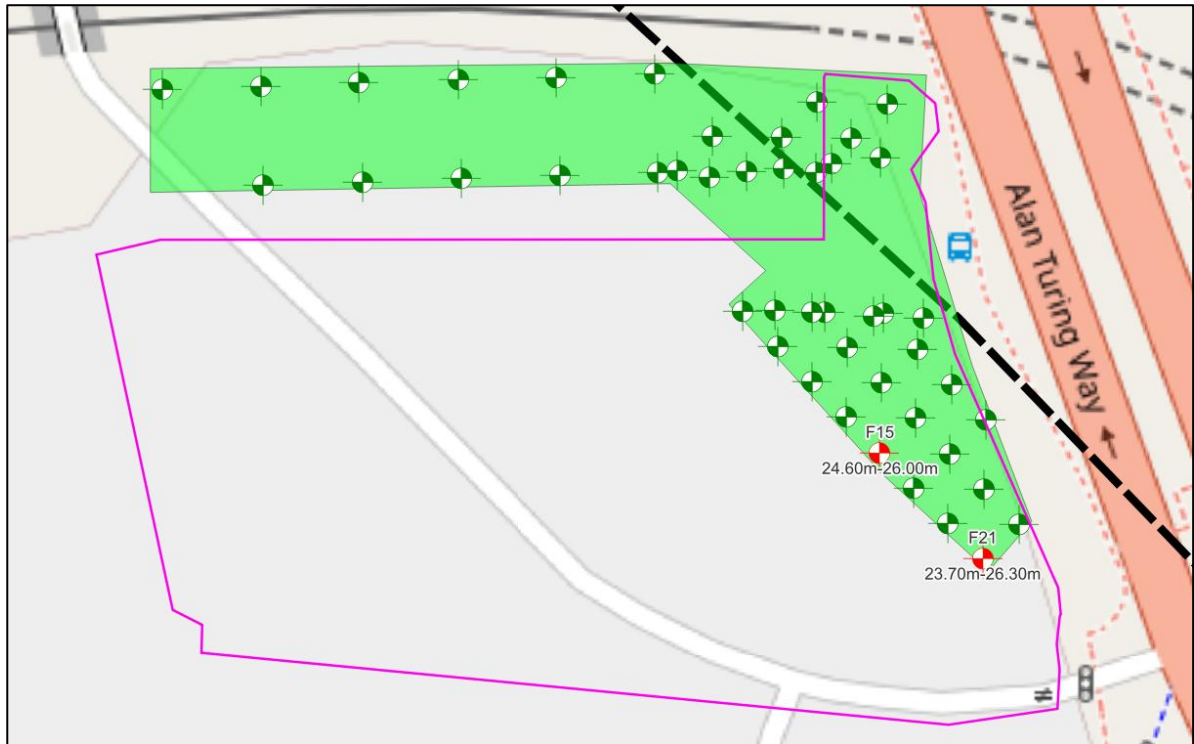
Figure 7: Location of historical drill & grout holes.

The majority of the drill holes encountered intact coal. However, broken ground combined with a loss of flush was identified in two boreholes (F15 and F21) at depths of 24.60m to 26.00m and 23.70m to 26.30m bgl, respectively. The thickness of broken ground / lost flush on these holes is greater than the intact seam thickness recorded elsewhere. There is the potential for further broken ground west of these boreholes as they were located on the edge of the treatment area as shown in Figure 7, below.

Each hole was backfilled with grout upon completion of drilling, with the majority of holes taking no more than 0.3 to 0.4 tonnes, with the average grout take being recorded at 0.33 tonne per hole. The 2 No. boreholes with identified broken ground (F15 and F21) took 0.7 tonne and 0.4 tonne, respectively.

However, broken ground, loss of flush and elevated grout takes potentially attributed with workings were recorded in drill holes F15 and F21. In these locations, the broken ground was recorded to extend to a thickness of 1.40m and 2.60m in F15 and F21 respectively. Although these holes were grouted, they were on the edge of the previous treatment area and no further holes were undertaken to the west of them. If further broken ground is present to the west of a similar thickness, then there would not be sufficient bedrock cover based on the 10T rule in this localised area.

It is recommended that further investigative works are undertaken immediately west of the previously grouted area to confirm whether additional zones of broken ground, of similar thickness to those recorded in boreholes F15 and F21, are present. The findings will determine whether supplementary grouting is required in this localised area. The 10T (10:1) cover line above the **Bradford Three Quarters** seam based solely on a 0.90 m seam thickness (rather than the greater broken ground

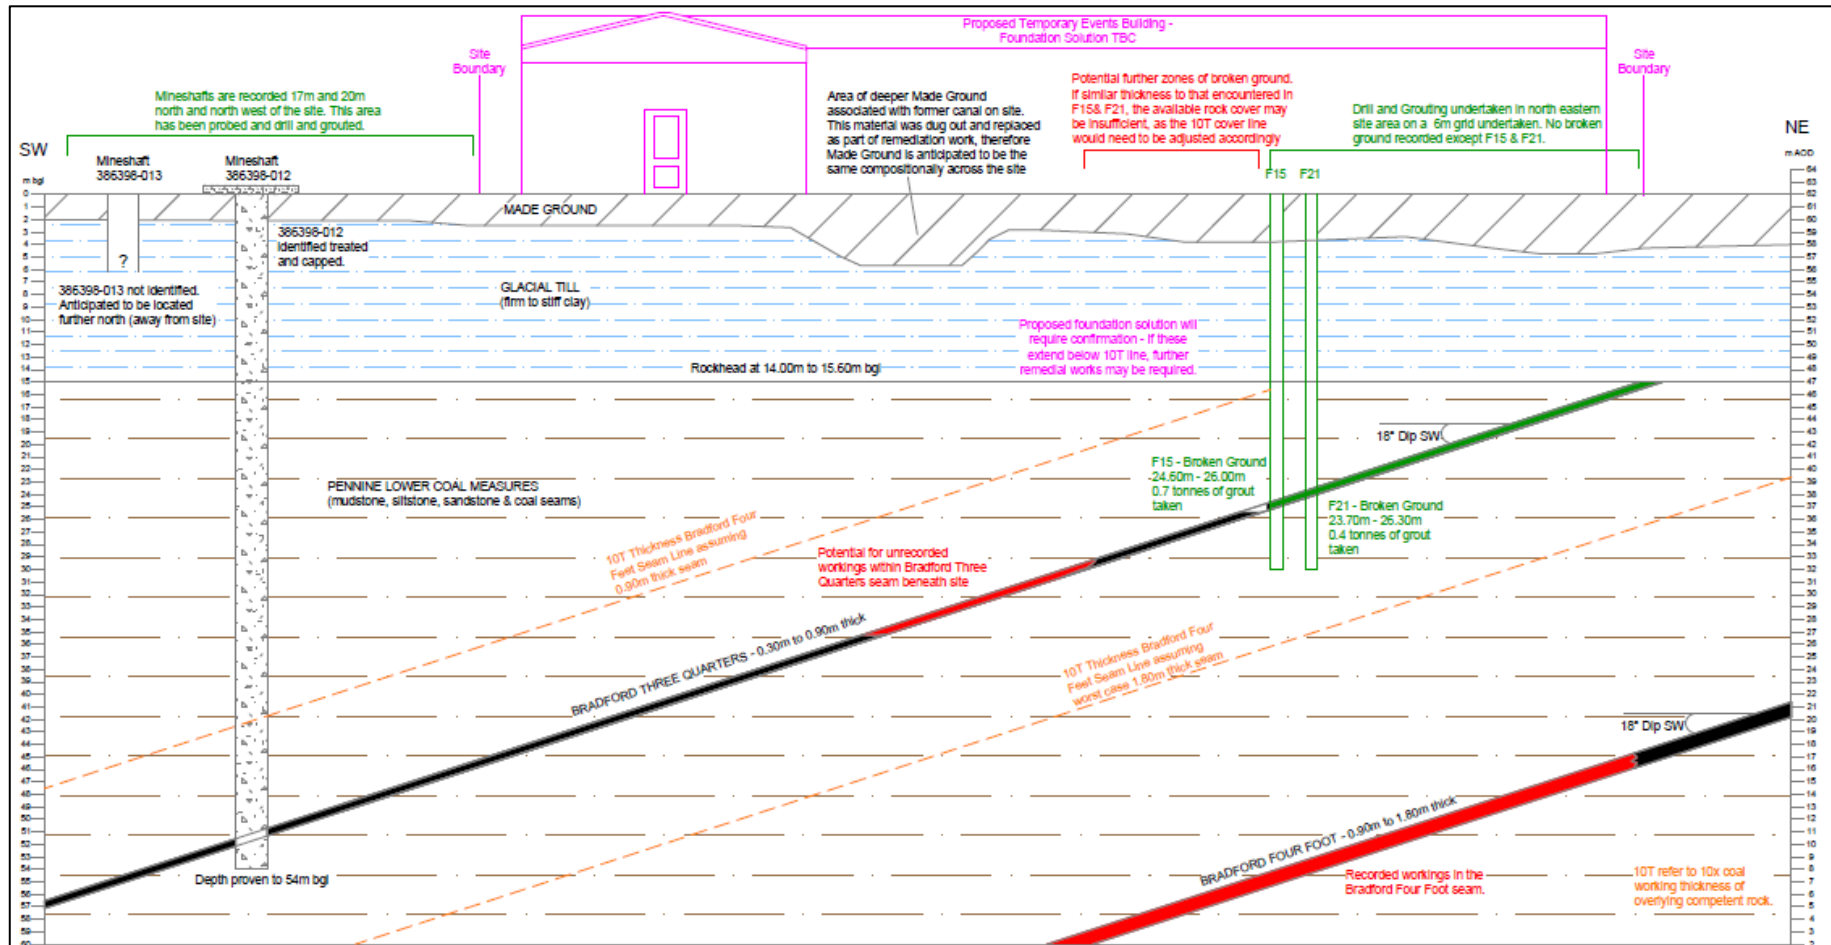
Figure 9: Extract of the conceptual ground model.

As the drilling & grouting did not encompass the full site area, it is anticipated that untreated sections of the seam remain present at depths of around 24m and greater beneath other parts of the site. Broken ground potentially attributed to workings was encountered in grout holes F15 and F21. Consequently, there is a residual risk of unrecorded historical workings within the **Bradford Three Quarters** seam outside the previously treated zone. In addition, recorded historical workings are present within the **Bradford Four Foot** seam at depths of approximately 47 m and greater beneath the site.
