# **Site Tree Appraisal**

## ***Land at Chapman Street and Cross Lane, Gorton, Manchester M18 8NY***

Date: 24<sup>th</sup> June 2025

Ref: RTS/24062025

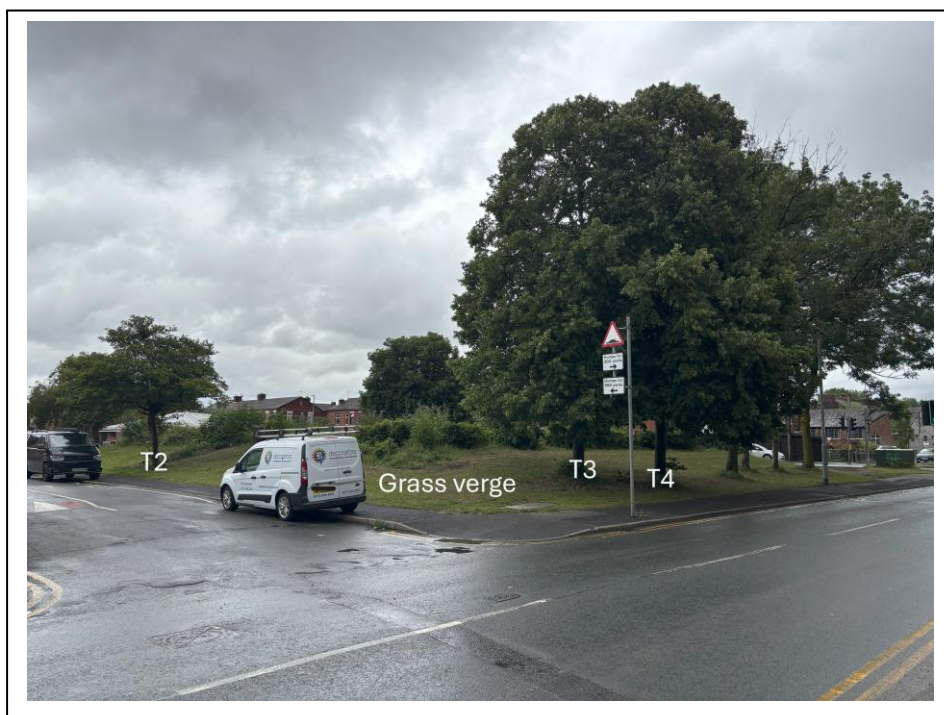
Photo 02:

**2.2 Brief site description:** The proposed development site is an unused plot of land on Chapman Street, abutting Cross Lane and Carfax Street. The central area of the site consists of a sunken rectangular hardstanding surface which is now becoming overgrown with weed scrub and self-seeded shrubs (photo 01). The outer perimeter of the plot, adjacent to Chapman Street, Cross Lane and Carfax Street is a grassed verge. There are 14 mature trees growing on this outer grass verge (photo 02).
