## Specification for Asbestos Abatement Works

Jabez Clegg

**Specification Ref Number:** INS-RP1135

## **Asbestos Survey Report 21/03/2025 - 26/03/2025**

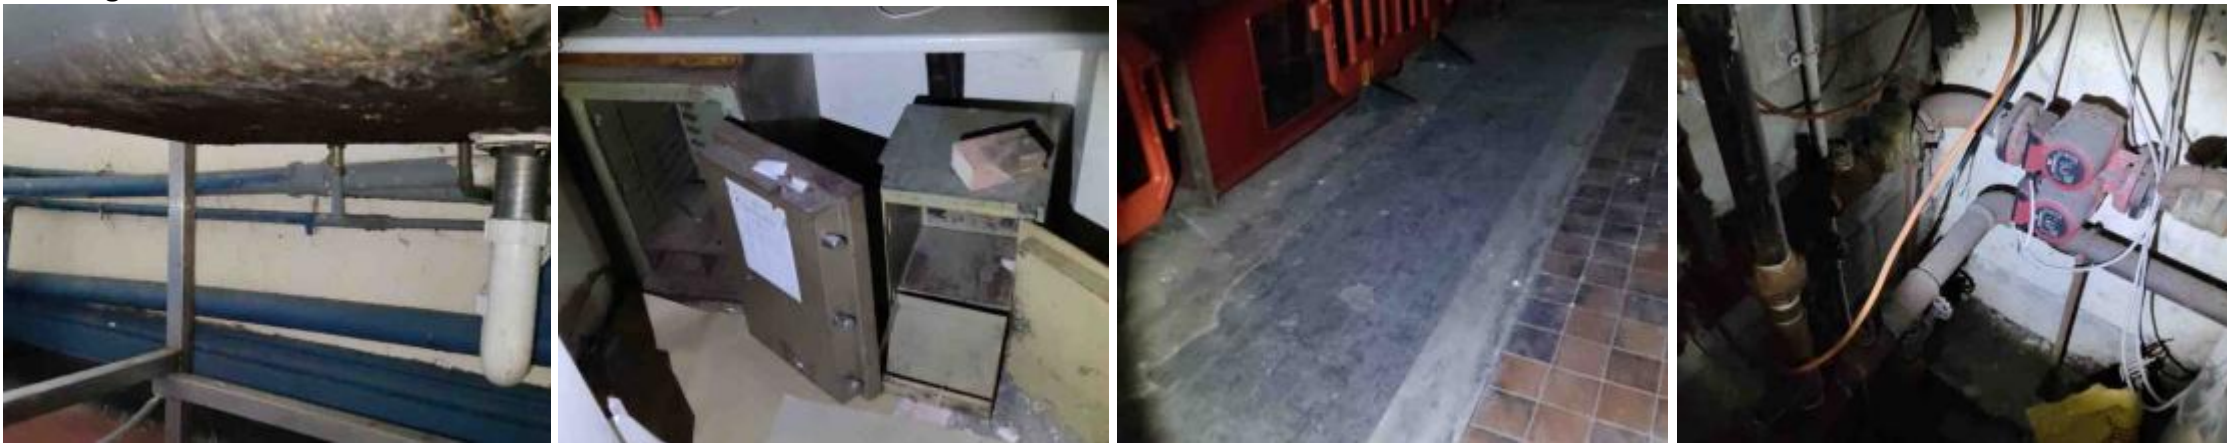
Flooring to be removed to access the void

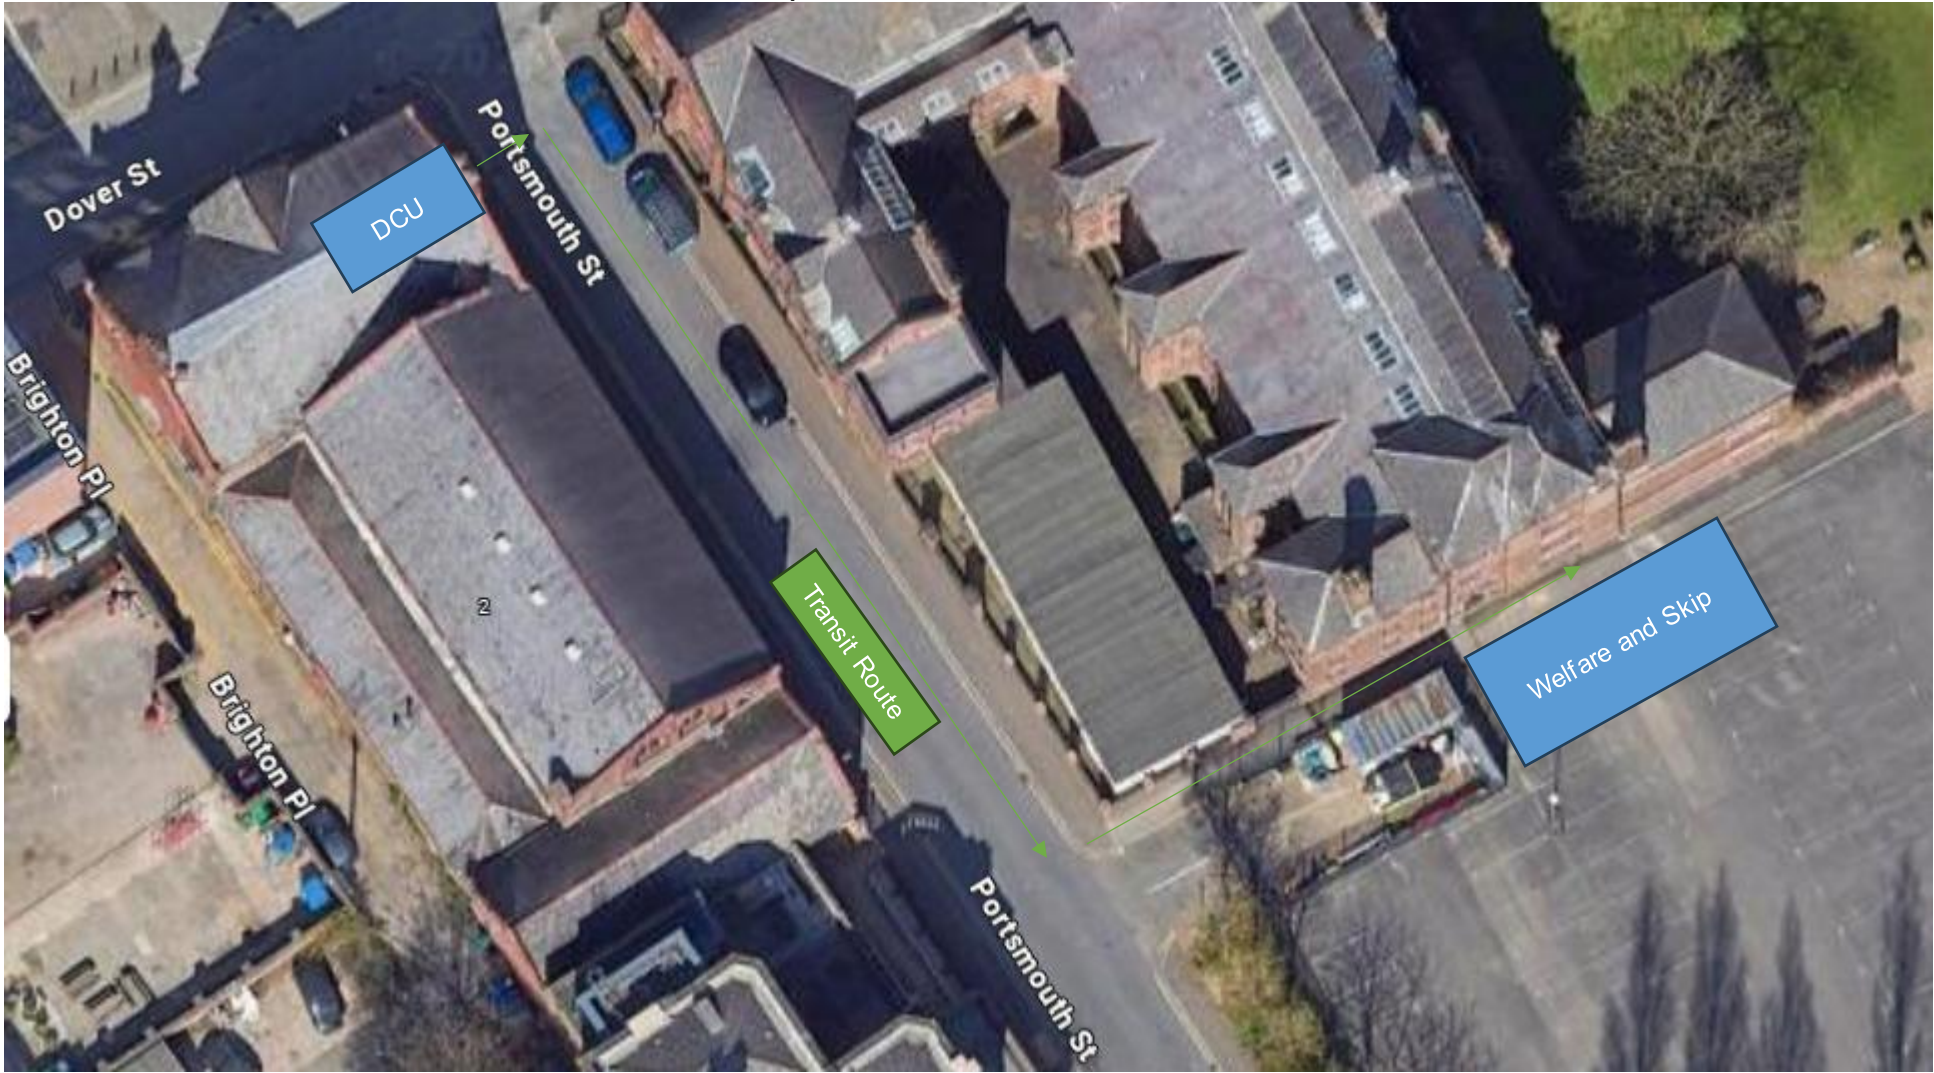
Site plan – Flooring and joists to be removed and void cleaned.

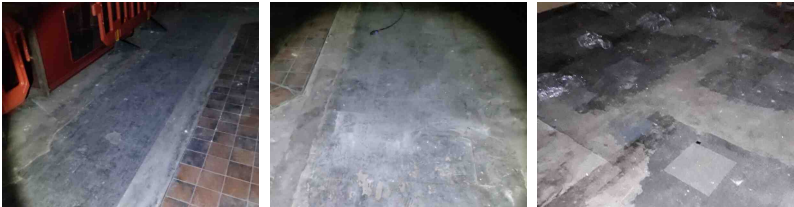
| Location | Item | Additional |
|---|---|---|
| Item ID | 002 Vinyl floor tiles(OS) | |

| Bitumen adhesive remains | |

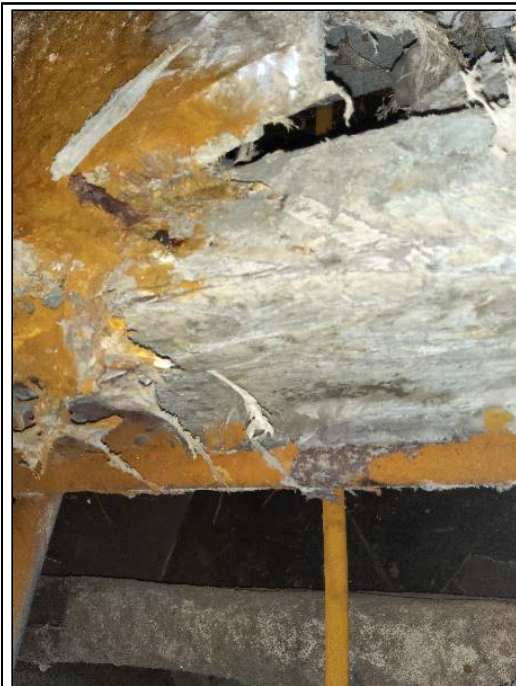
| Sample Date: | Sampled By: | Floor: | Room: |
|---|---|---|---|
| 23 Sep 2025 to 24 Sep 2025 | Peter Denby | Ground Floor | Ground - Floor Void - G/001 |

| Sample Date: | Sampled By: | Floor: | Room: |
|---|---|---|---|
| S<br>GS003141 | Chrysotile (1) | Throughout | Asbestos Insulation/Coating (3) |
| <b>Sample Location:</b> Thermal insulation lagging contamination to timber beams, surfaces. | | | |

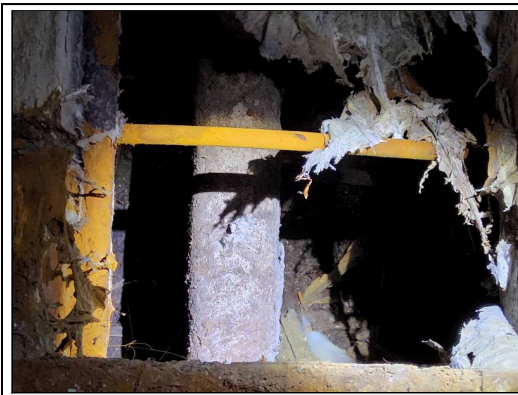
| Sample Date: | Sampled By: | Floor: | Room: |
|---|---|---|---|
| 23 Sep 2025 to 24 Sep 2025 | Peter Denby | Ground Floor | Ground - Floor Void - G/001 |

| Sample Date: | Sampled By: | Floor: | Room: |
|---|---|---|---|
| S<br>GS003142 | Chrysotile + Crocidolite (3) | 100m | Asbestos Insulation/Coating (3) |
| <b>Sample Location:</b> Thermal insulation lagging to pipework below timber floor. | | | |

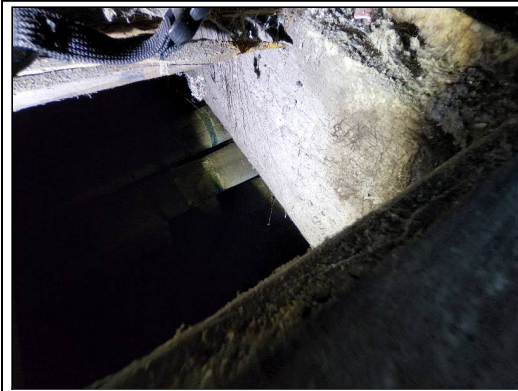
| Sample Date: | Sampled By: | Floor: | Room: |
|---|---|---|---|
| 23 Sep 2025 to 24 Sep 2025 | Peter Denby | Ground Floor | Ground - Floor Void - G/001 |

| Sample Date: | Sampled By: | Floor: | Room: |
|---|---|---|---|
| S<br>GS003143 | Amosite (2) | Throughout | Asbestos Insulation/Coating (3) |
| <b>Sample Location:</b> Thermal insulation contamination to timber beams, surfaces. | | | |

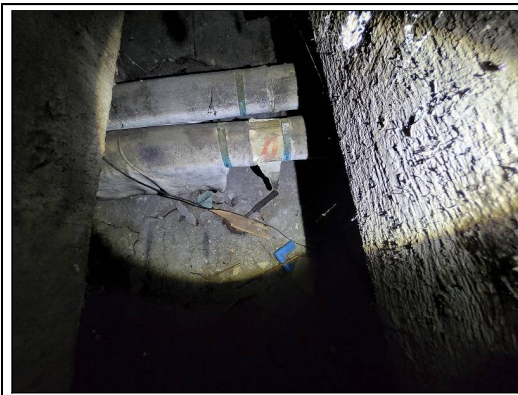
| Sample Date: | Sampled By: | Floor: | Room: |
|---|---|---|---|
| 23 Sep 2025 to 24 Sep 2025 | Peter Denby | Ground Floor | Ground - Floor Void - G/001 |

| Sample Date: | Sampled By: | Floor: | Room: |
|---|---|---|---|
| S<br>GS003144 | Amosite (2) | 100lm | Asbestos Insulation/Coating (3) |
| <b>Sample Location:</b> Thermal insulation lagging to pipework below timber floor. | | | |
