# **Heritage Statement**

## **Proposed Refurbishment**

**96 Lady Barn Road**

**Date: 9<sup>th</sup> December 2025**

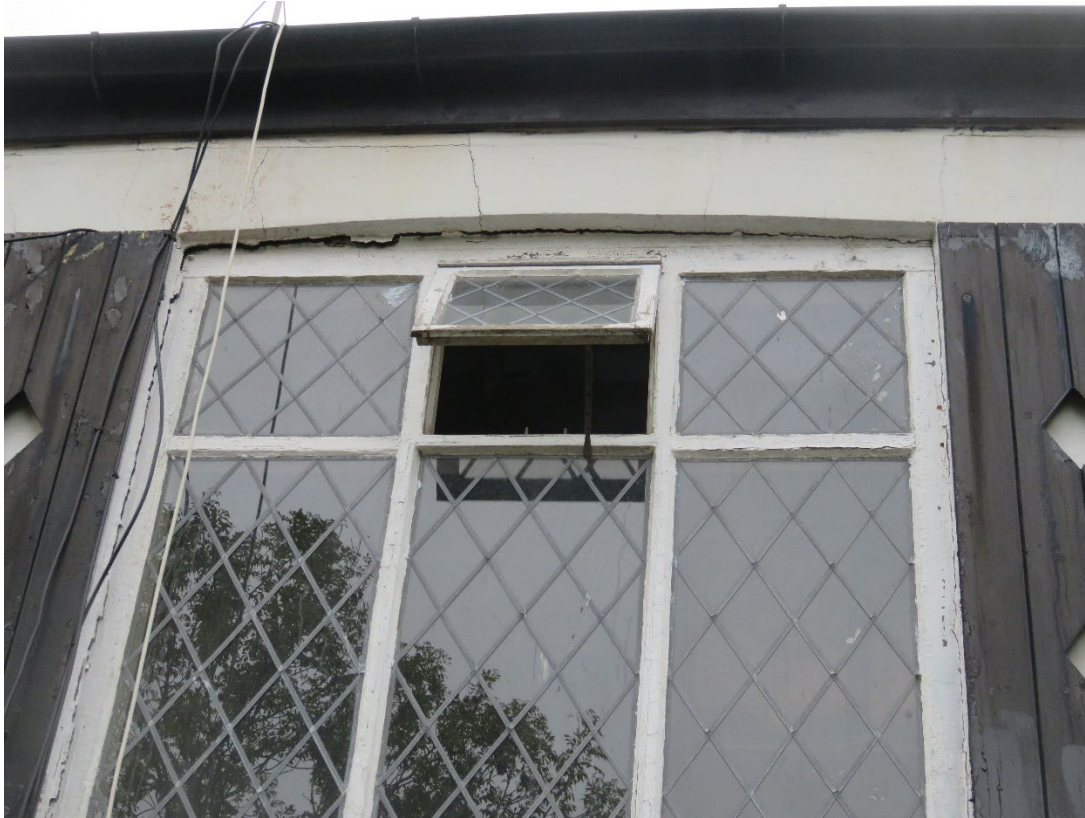
Photograph 1

Carefully remove existing render and re-render, may have to be based on the existing render, remove shutters, renew window with a slimline double glazed unit maximum 14mm in total thickness due to wet rot (W2).

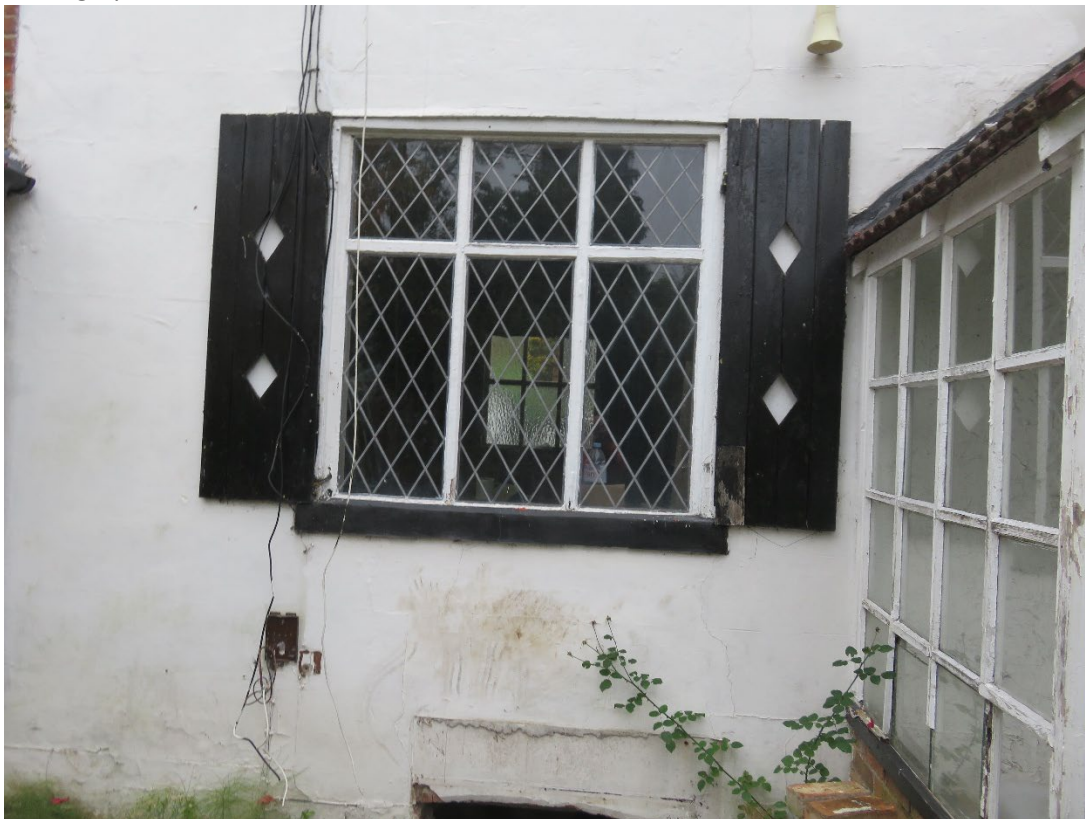
Photograph 2

Remove shutters, new window with 40mm thick double glazed unit due to wet rot (W1).

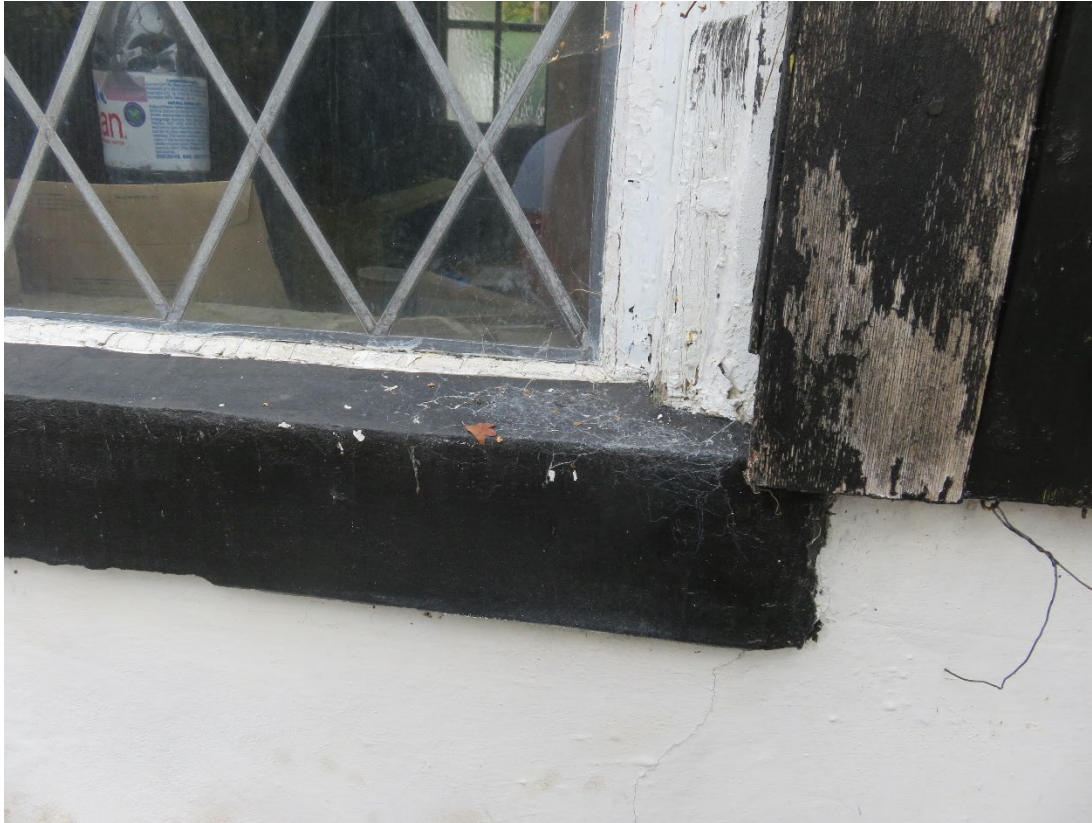
Photograph 3

Wet rot to W1.

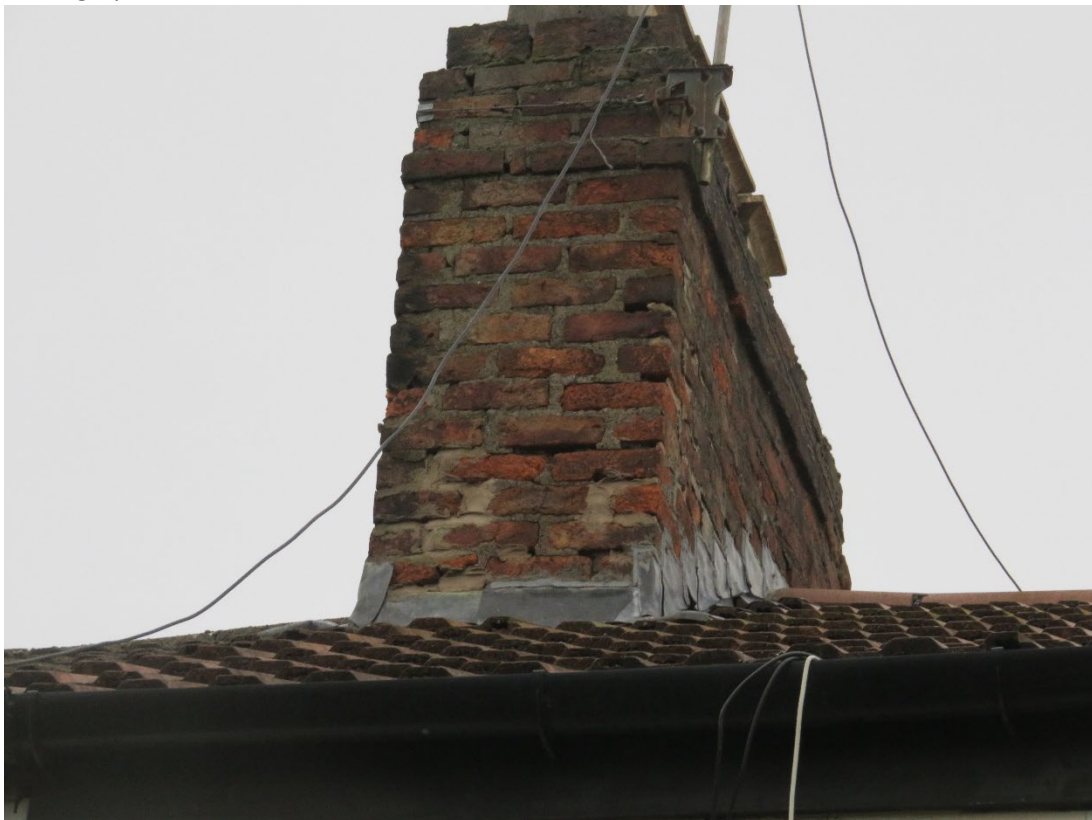
Photograph 4

Carry out patch pointing in lime based mortar to stack, do not rebuild.

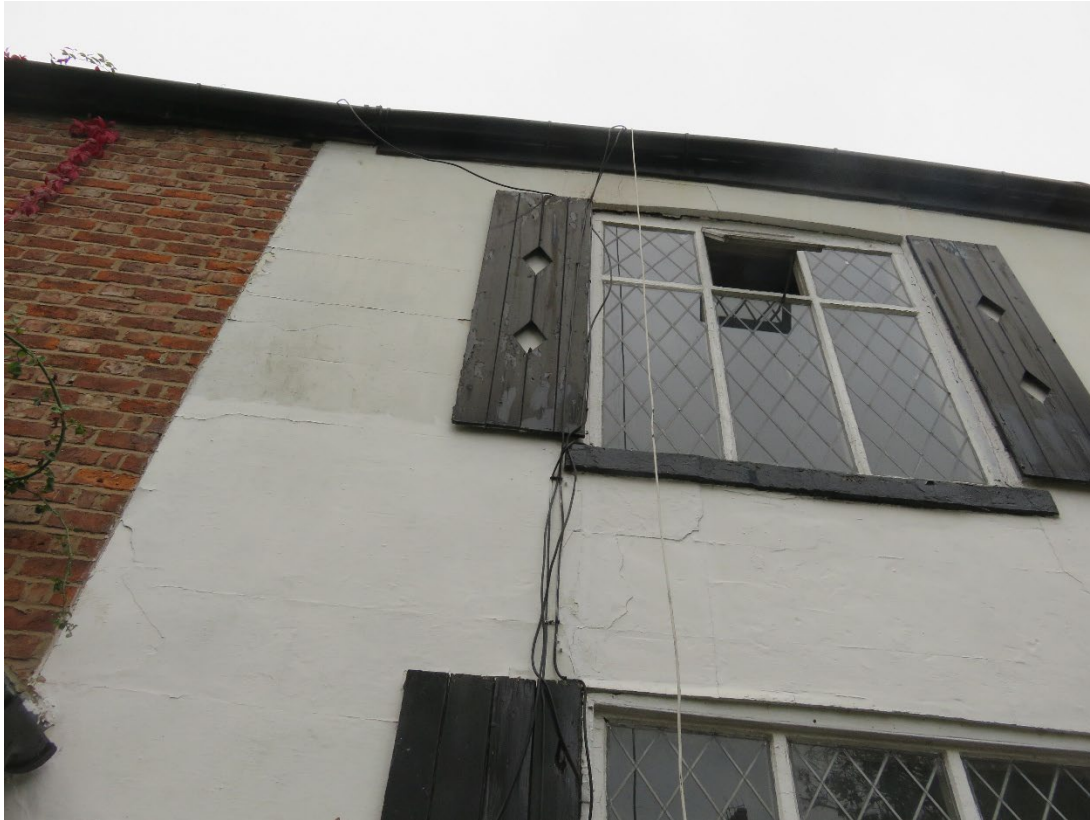
Photograph 5

Cracks in render therefore loose, carefully re-render in same mix.

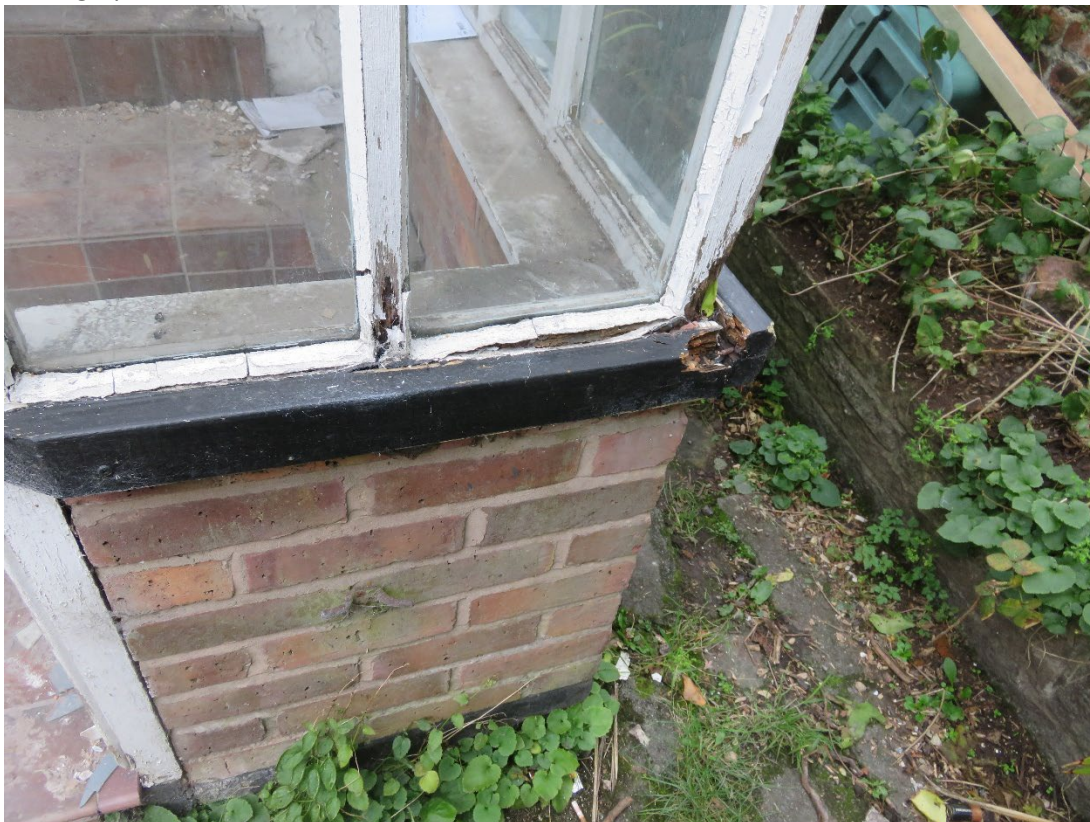
Photograph 6

Wet rot to porch, splice in new timbers.

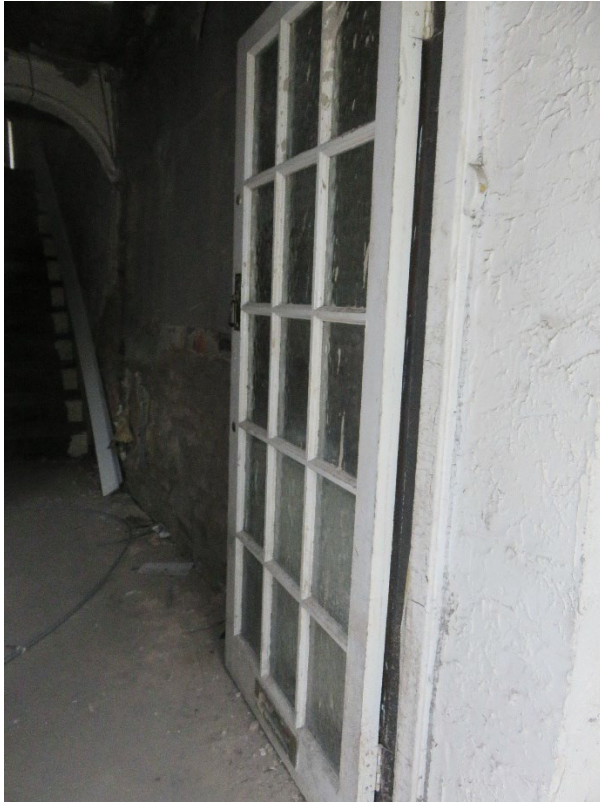
Photograph 7

Replace fully glazed door with upper glazed solid bottom panel.

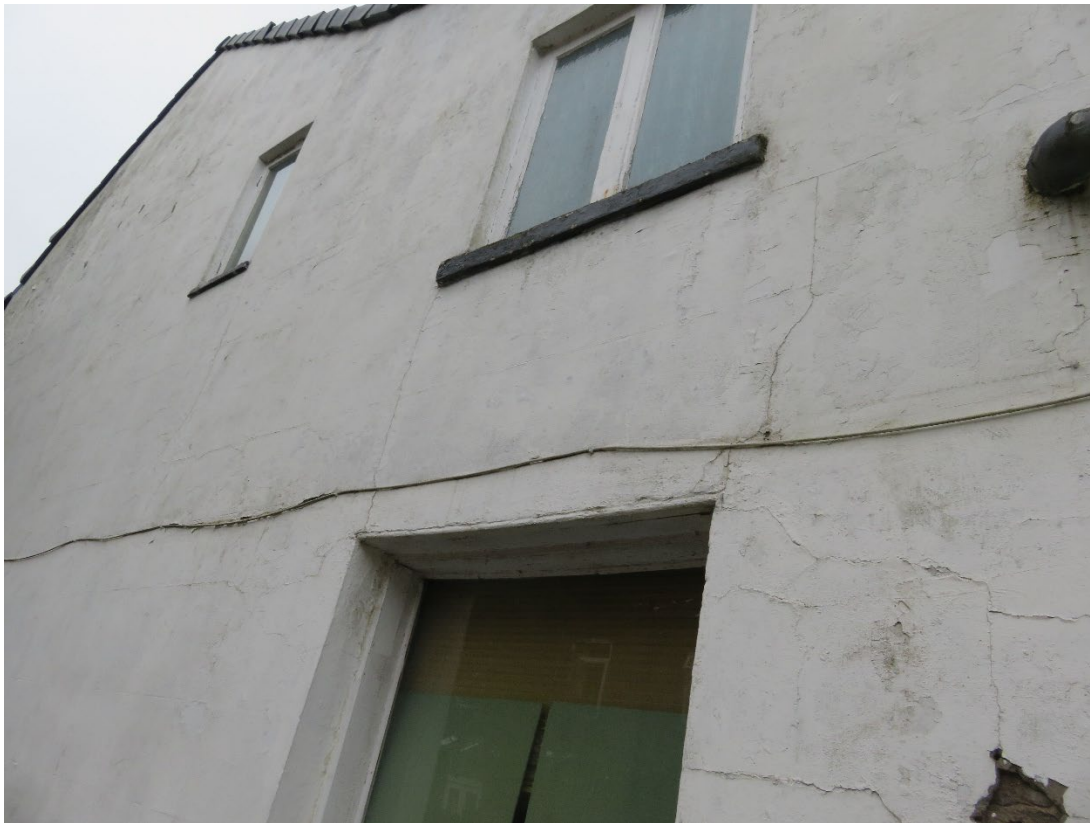
Photograph 8

Loose render around W3, remove and re-render in same mix.

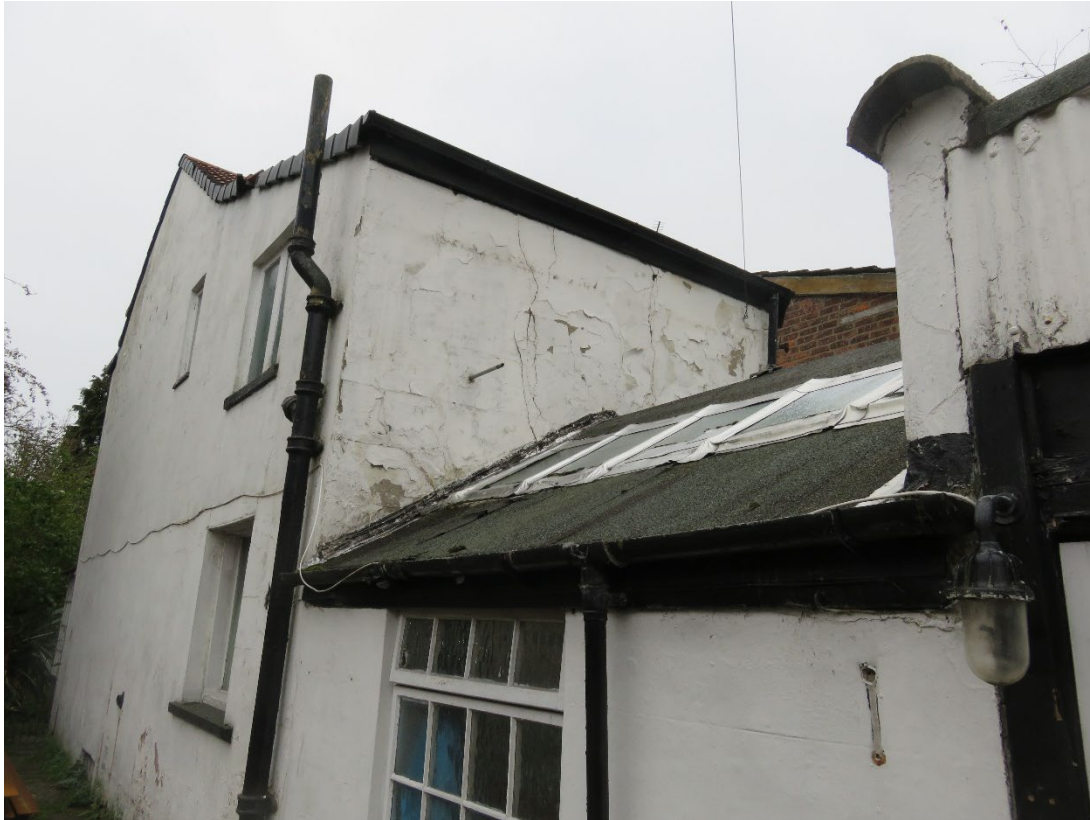
Photograph 9

Loose render, hack off and renew in lime based render.

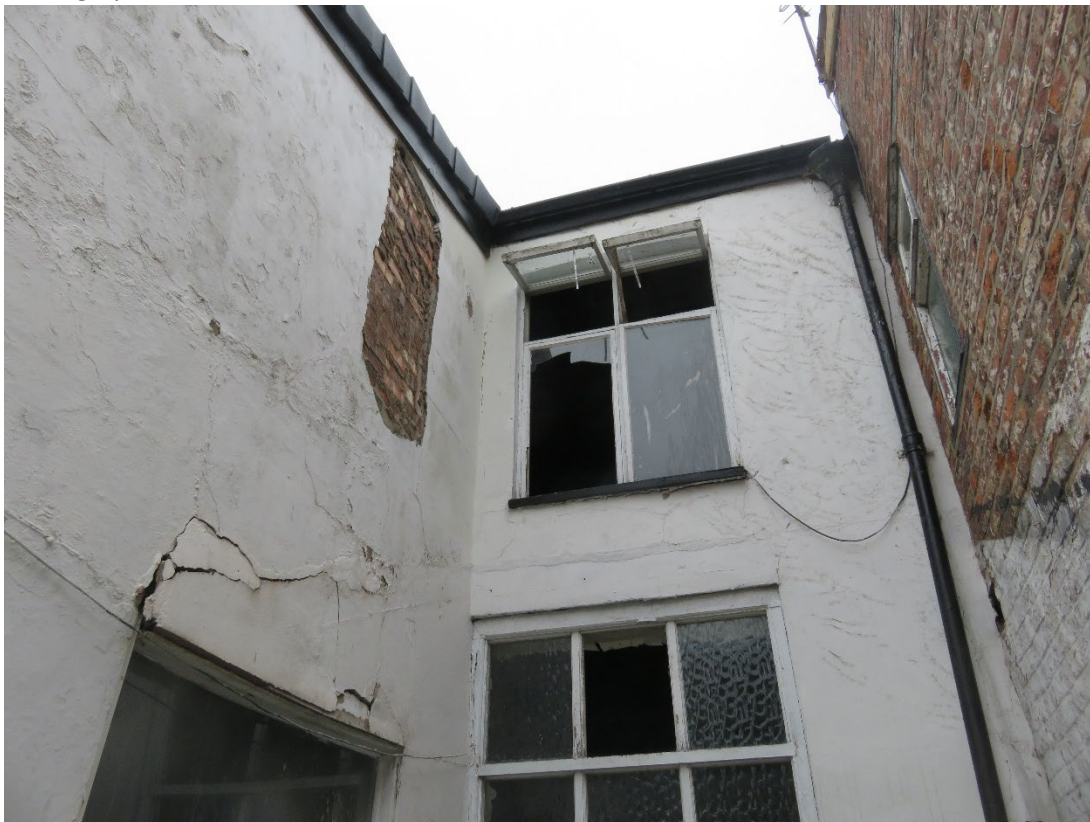
Photograph 10

Expose lintel to determine appropriate replacement and re-render.

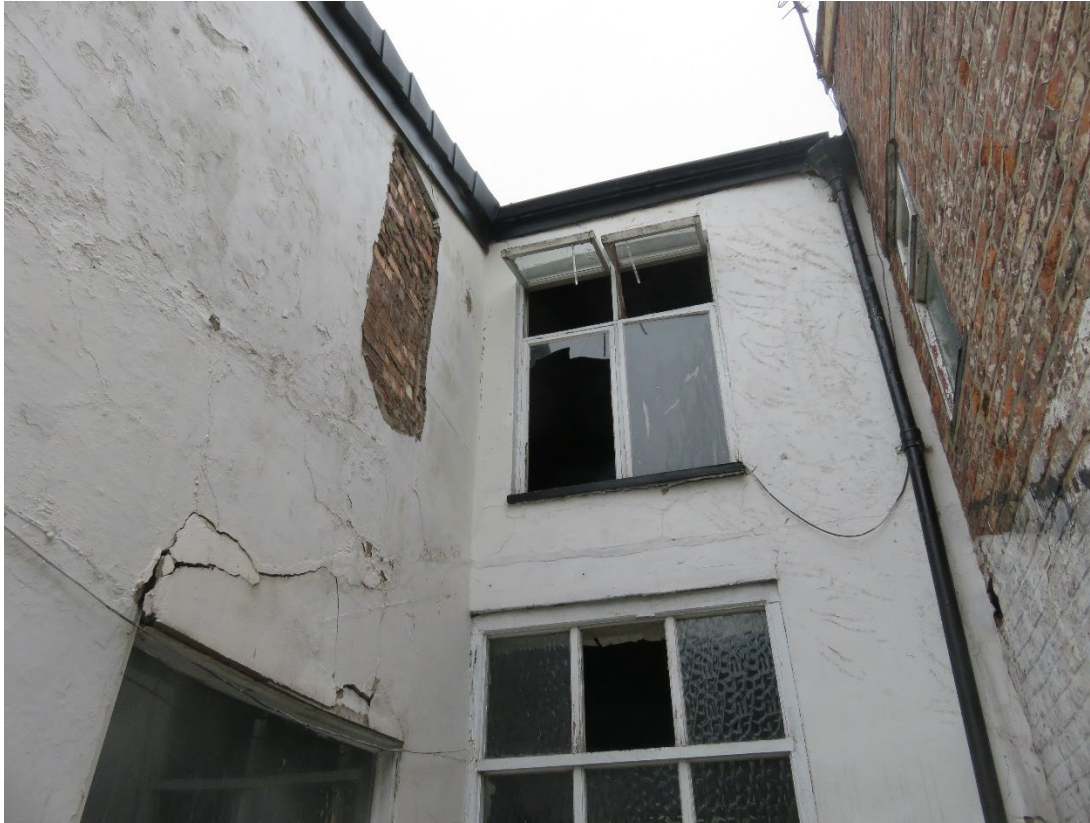
Photograph 11

Reopen window opening.

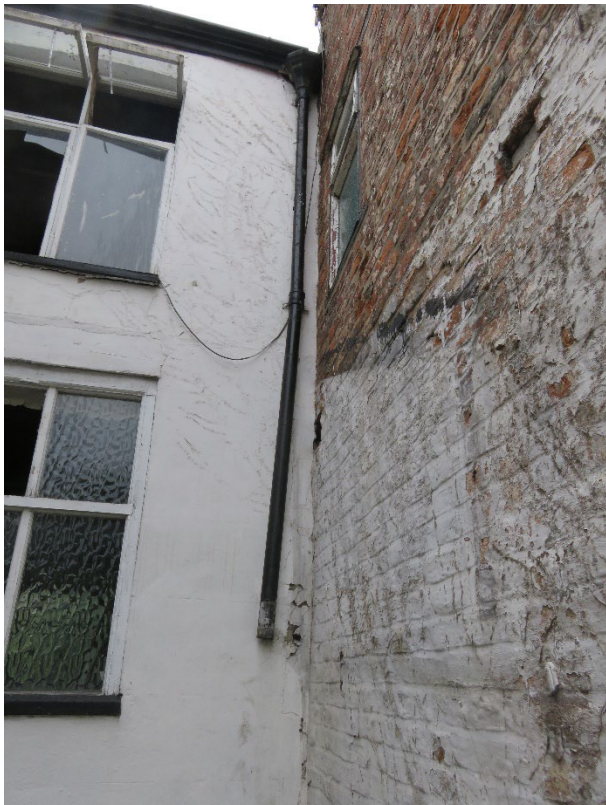
Photograph 12

Extend rainwater pipe in cast iron.

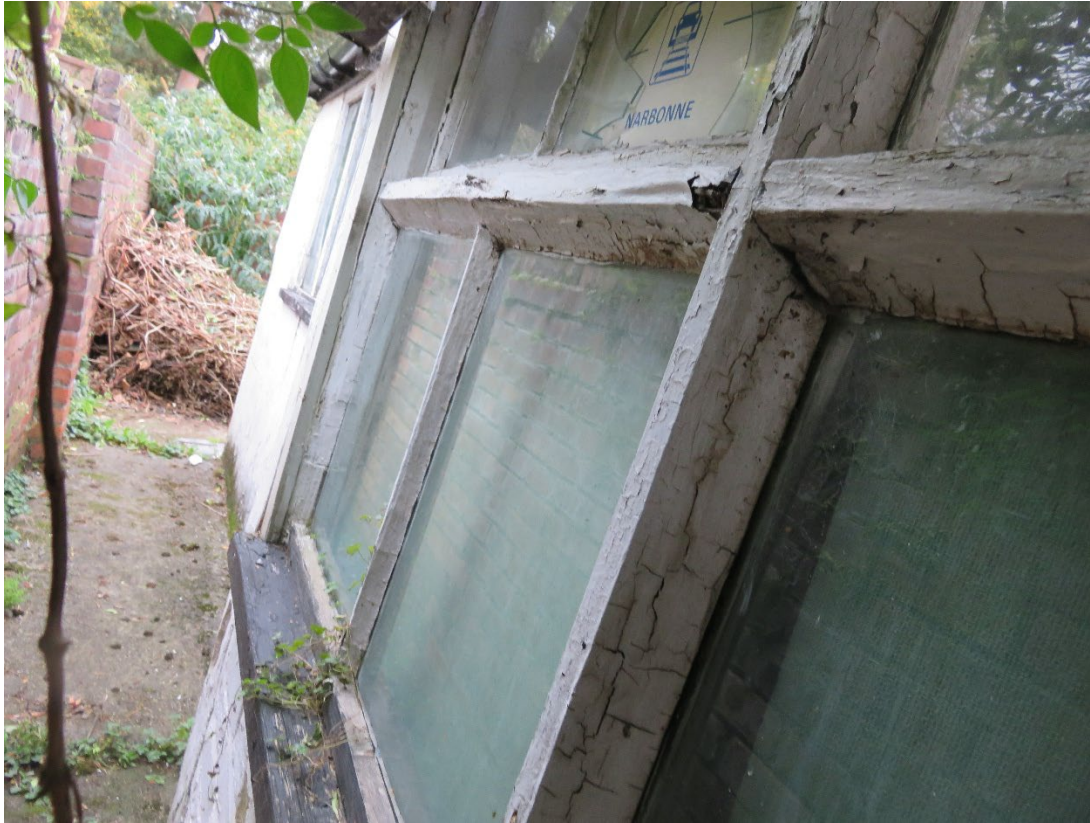
Photograph 13

Rotten window to W9.

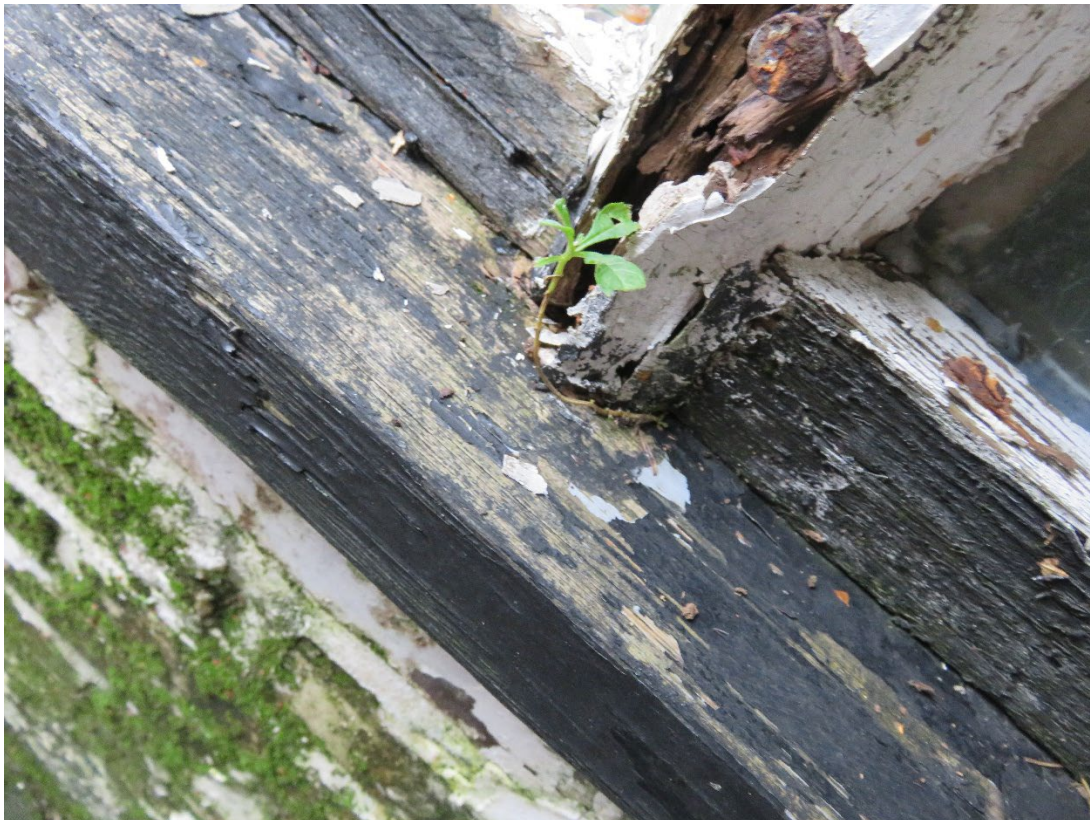
Photograph 14

Rotten window to W9.

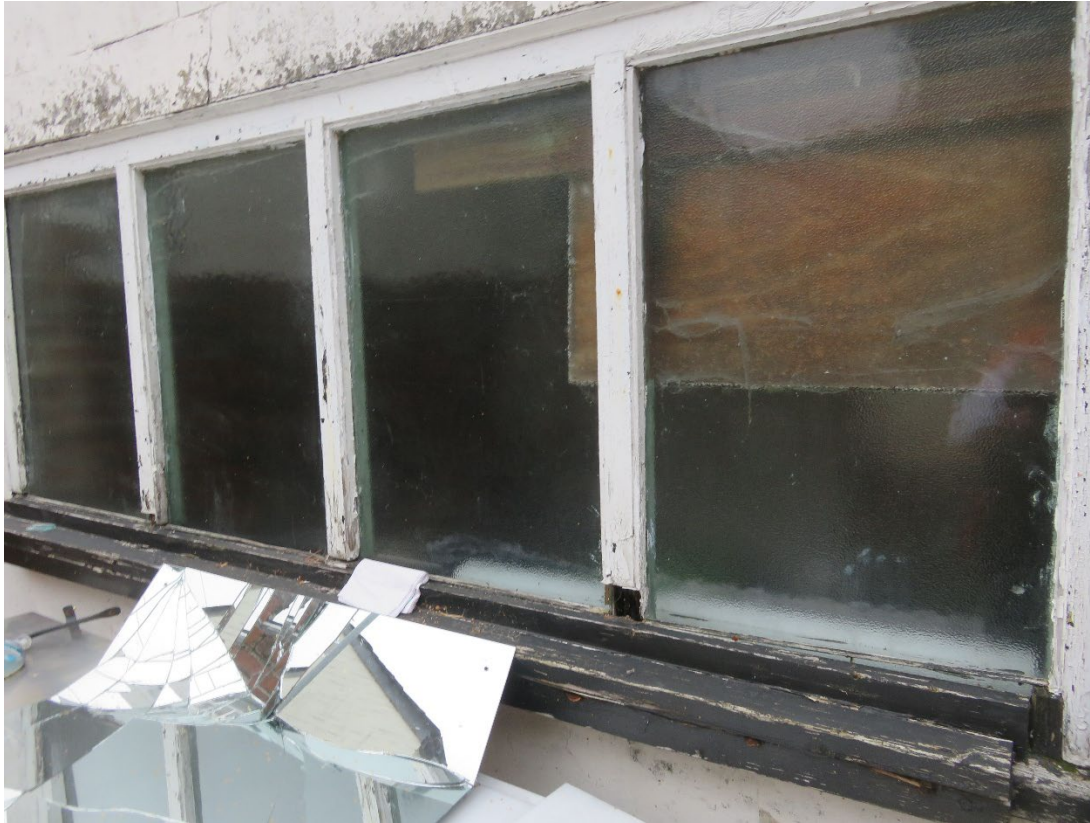
Photograph 15

Rotten window to W8.

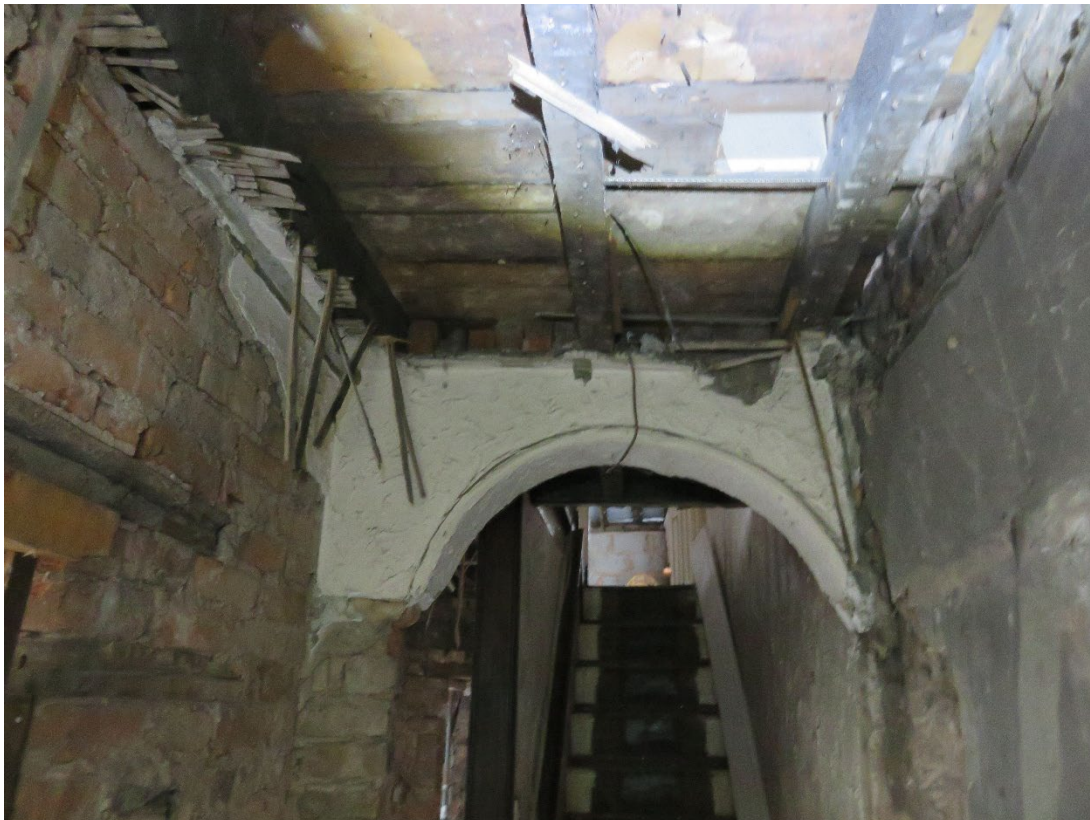
Photograph 16

Ineffective thread in stainless steel bars not retaining gable wall.

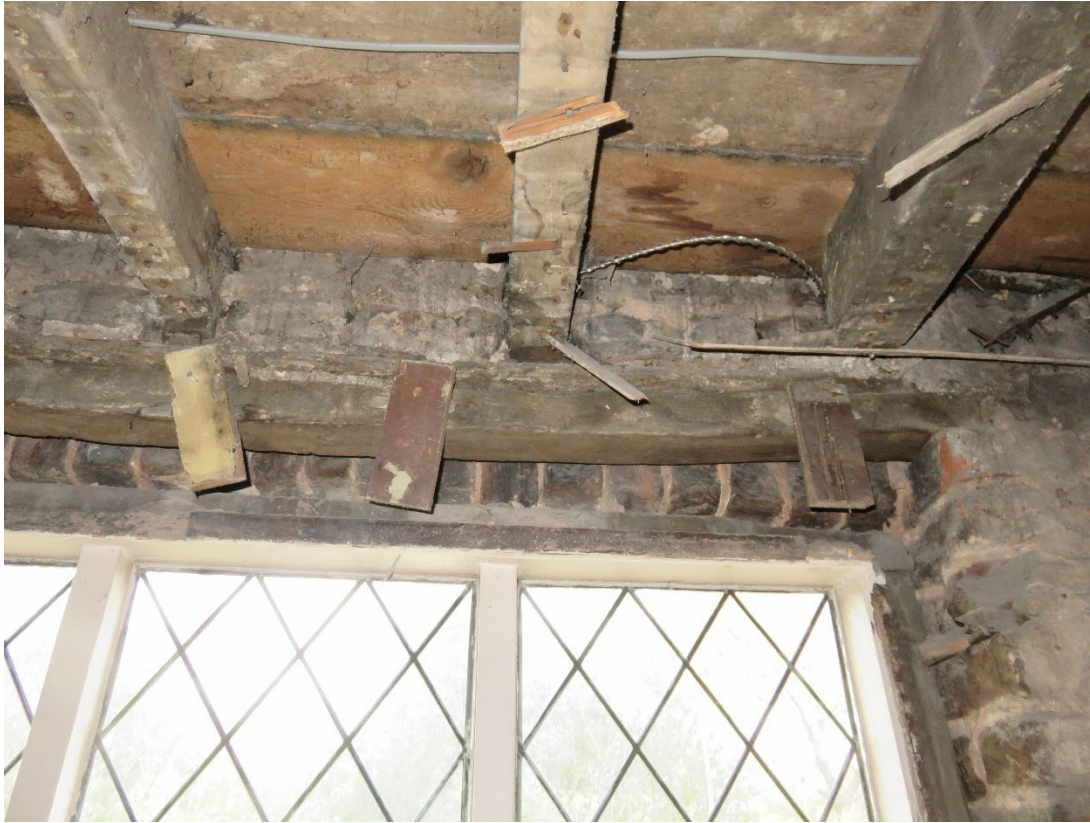
Photograph 17

Deflection in original beam, replace with 150mm by 75mm Douglas fir timber.

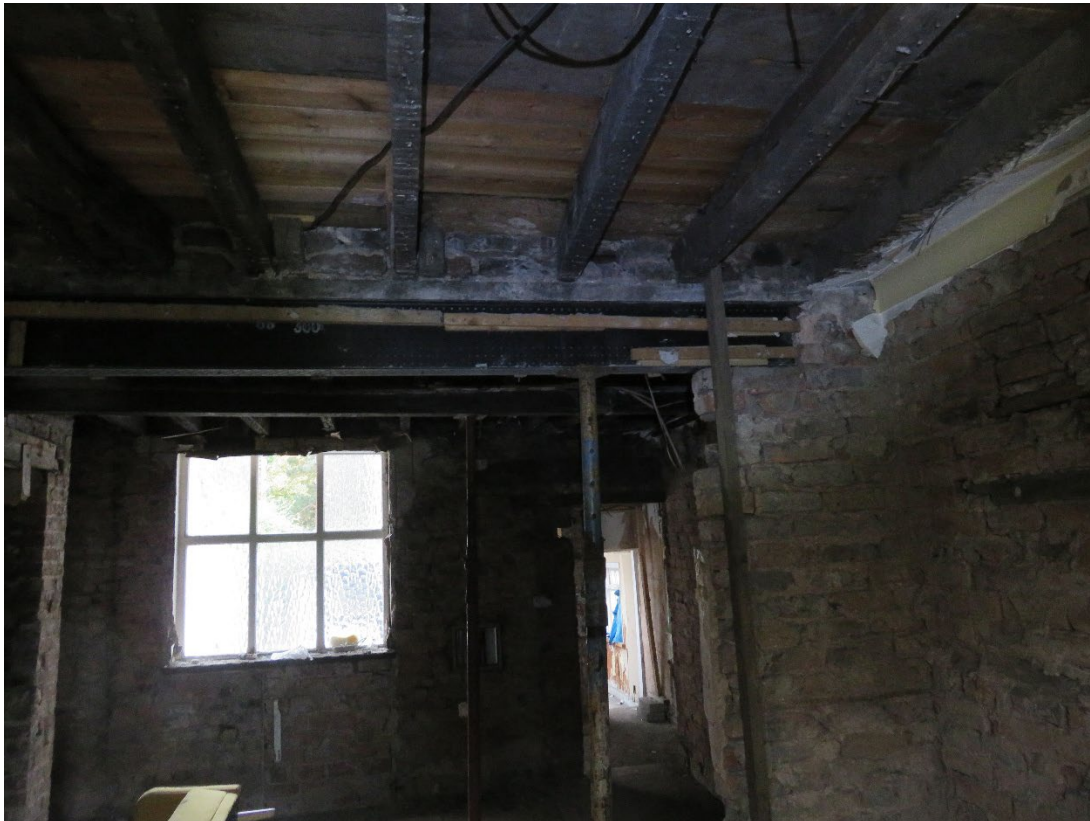
Photograph 18

Remove catnip lintel, rebuild wall in reclaimed brickwork in lime mortar complete natural bonding technique.

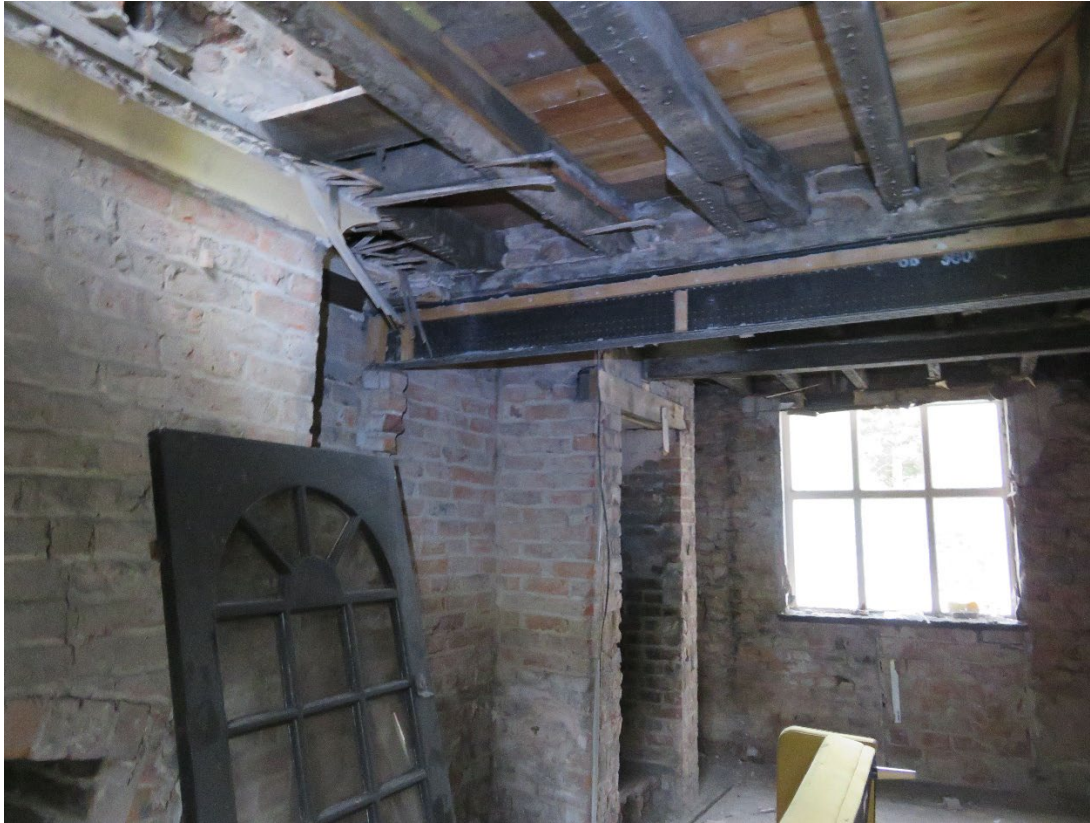
Photograph 19

Remove catnip lintel, rebuild wall in reclaimed brickwork in lime mortar complete natural bonding technique.

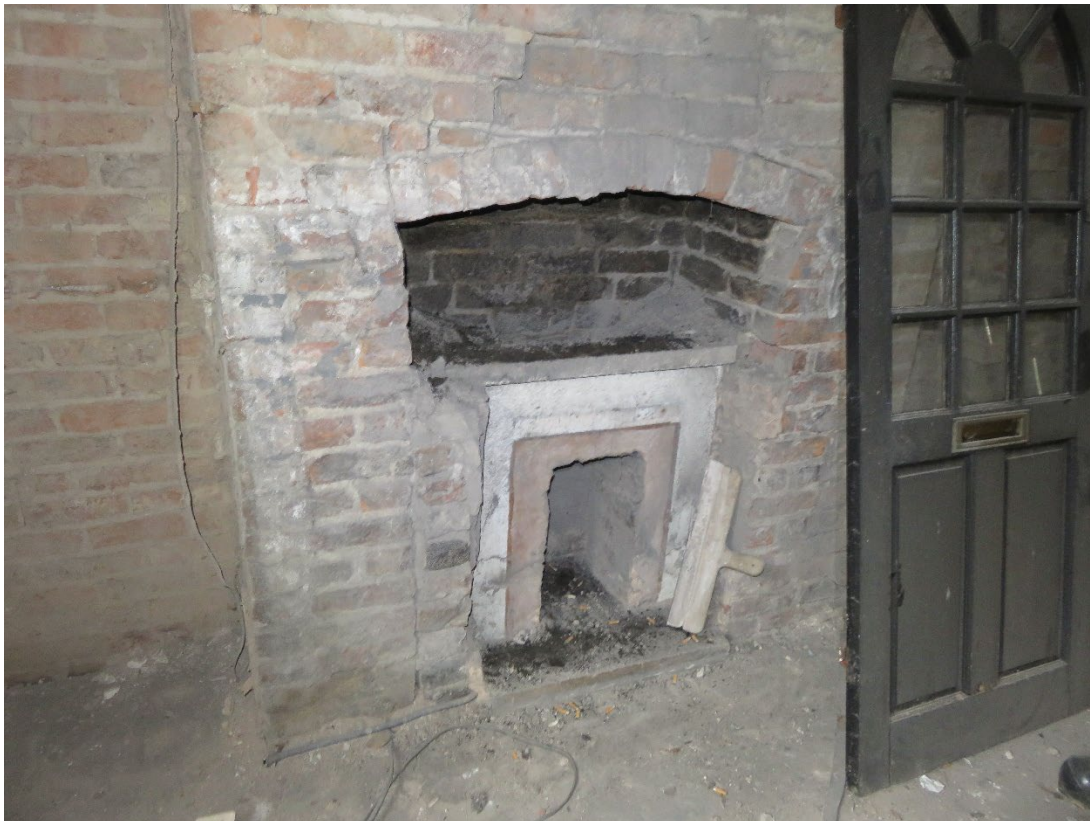
Photograph 20

Remove inner fireplace and infill brick, clean and re-plaster with recess.

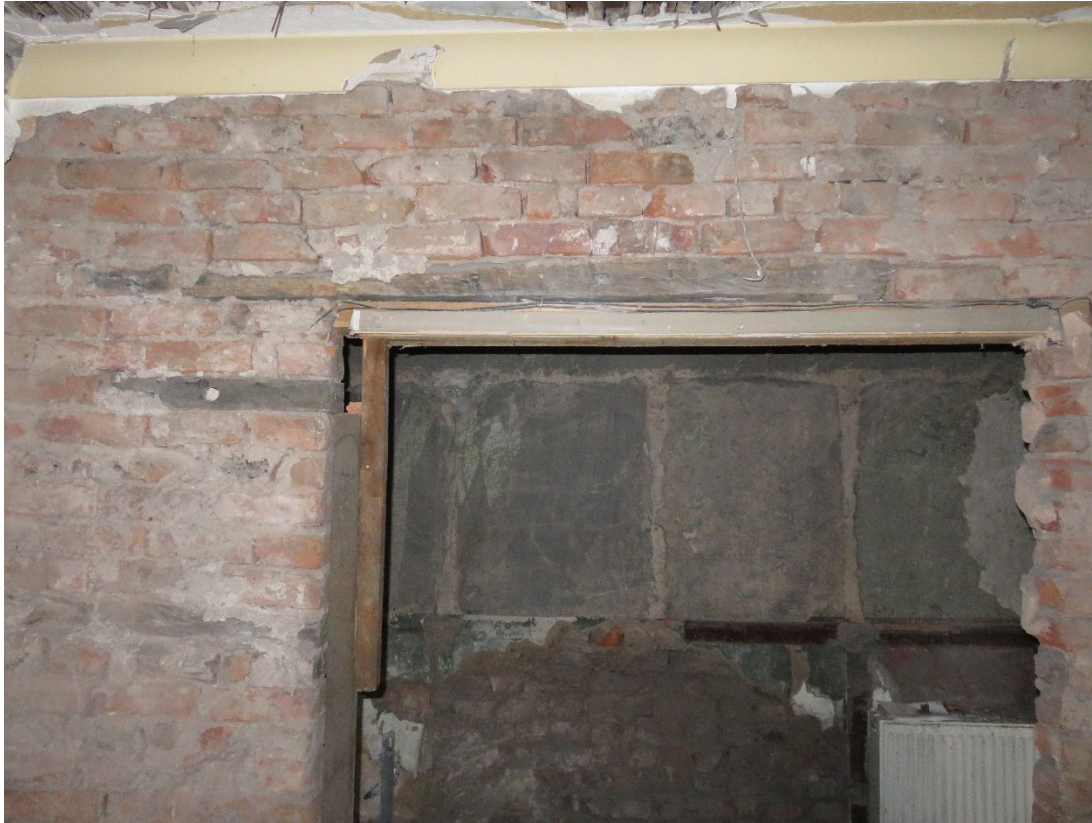
Photograph 21

Reposition door as under original lintel.

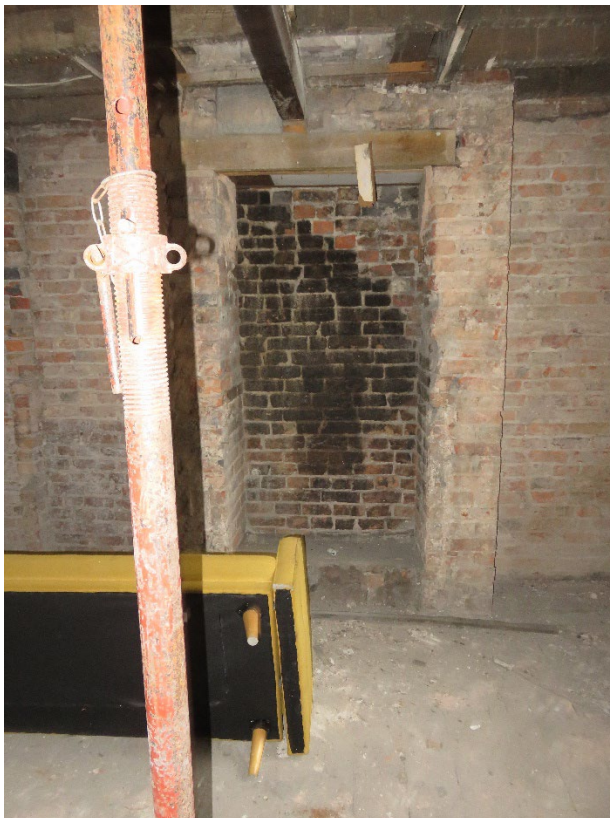
Photograph 22

Retain, reassess and re-plaster.

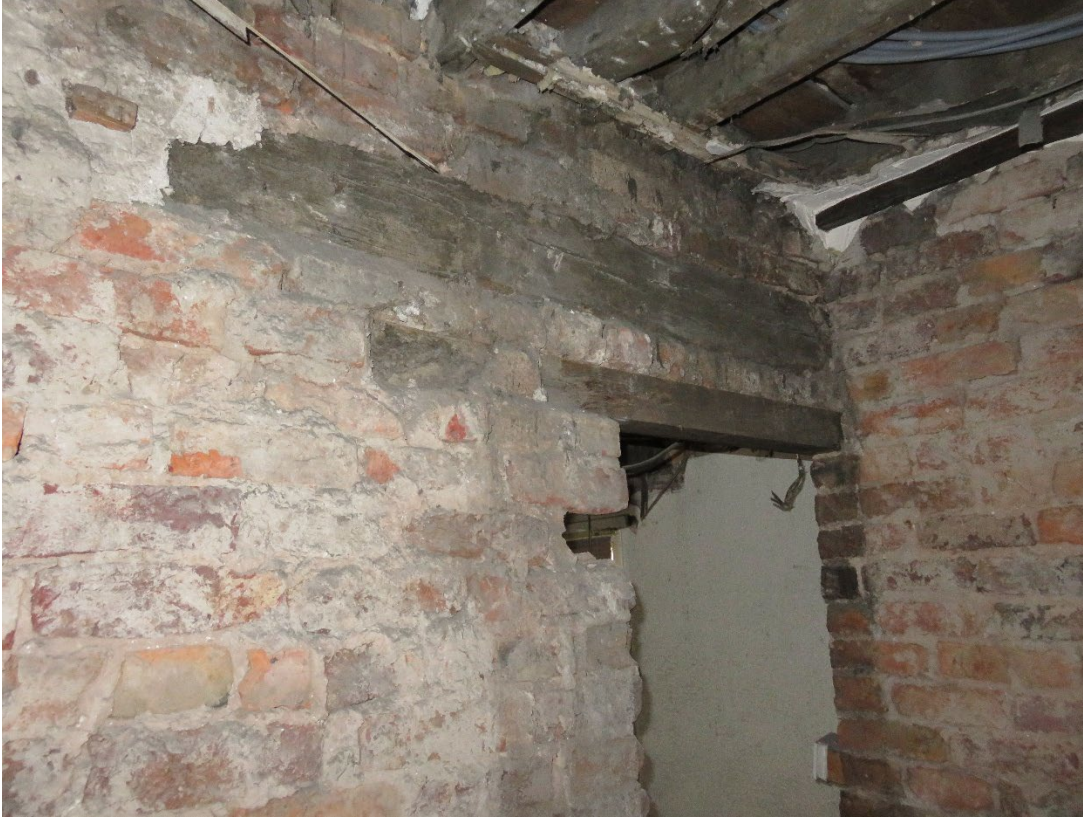
Photograph 23

Utilise existing oak lintel to create offset lobby opening.

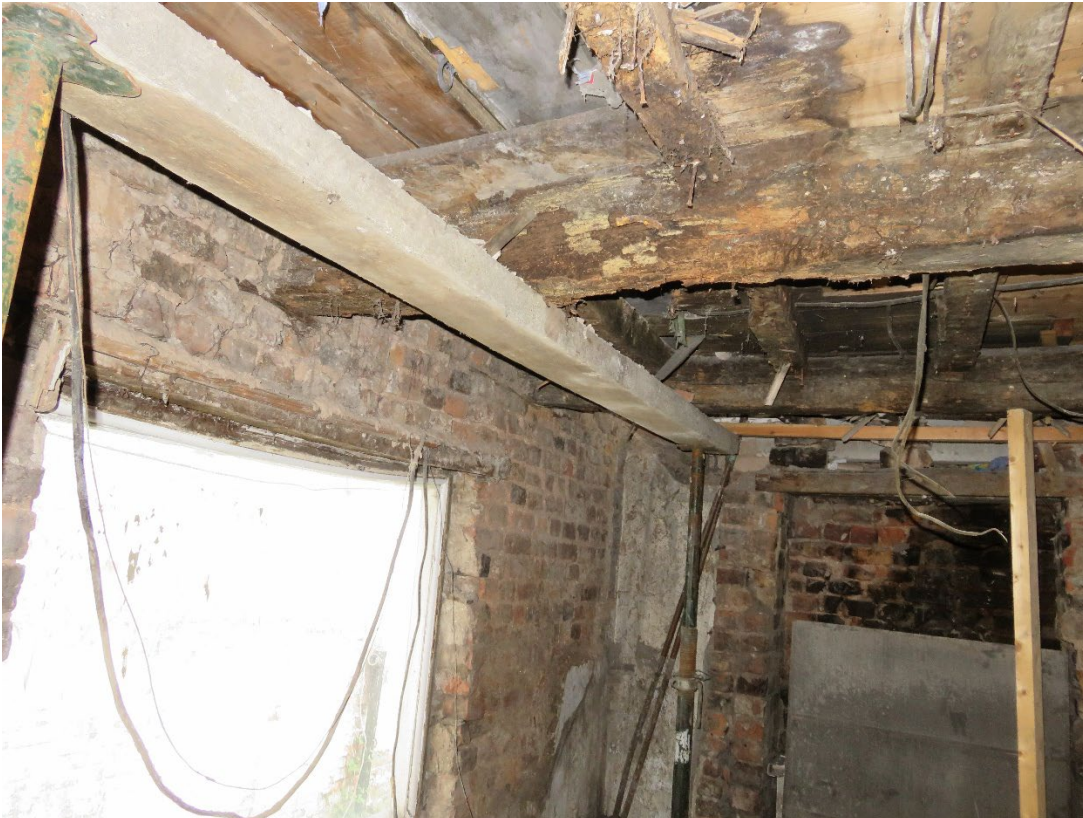
Photograph 24

Replace oak binder beam affected by rot, replace with similar in Douglas fir. Replace 2<sup>nd</sup> joist from the gable external wall and splice in as necessary.

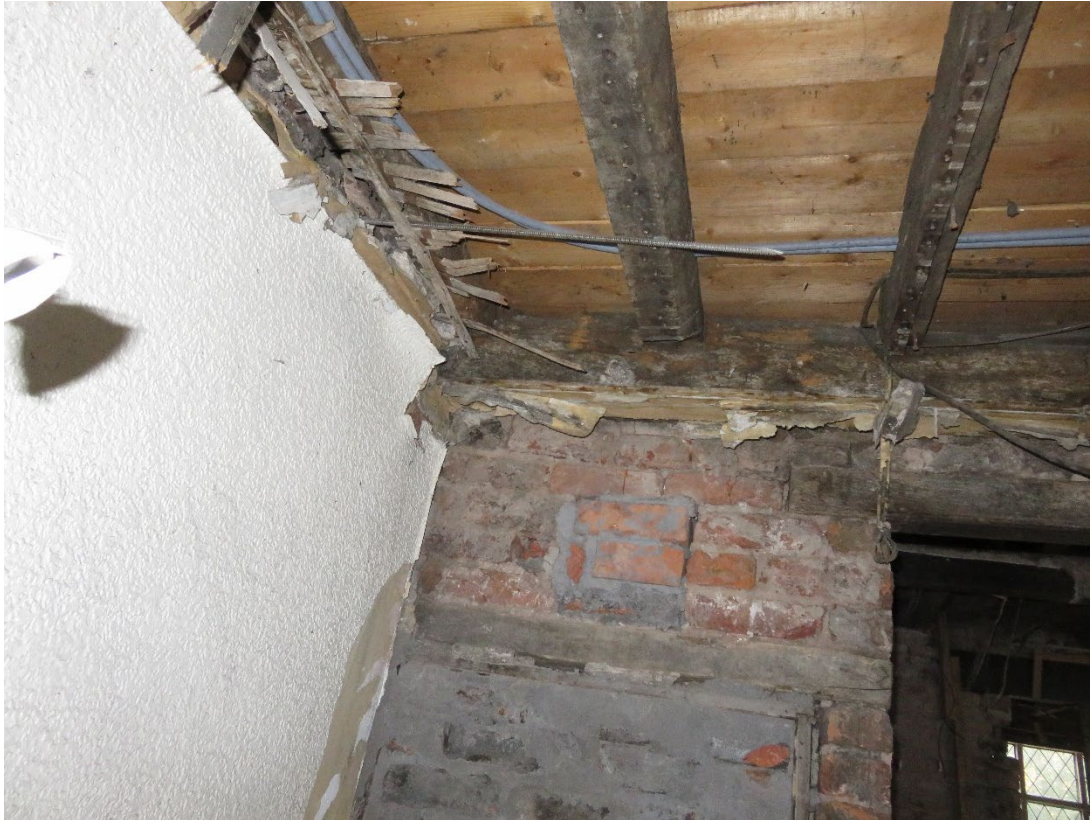
Photograph 25

Open up old opening staircase from cellar.

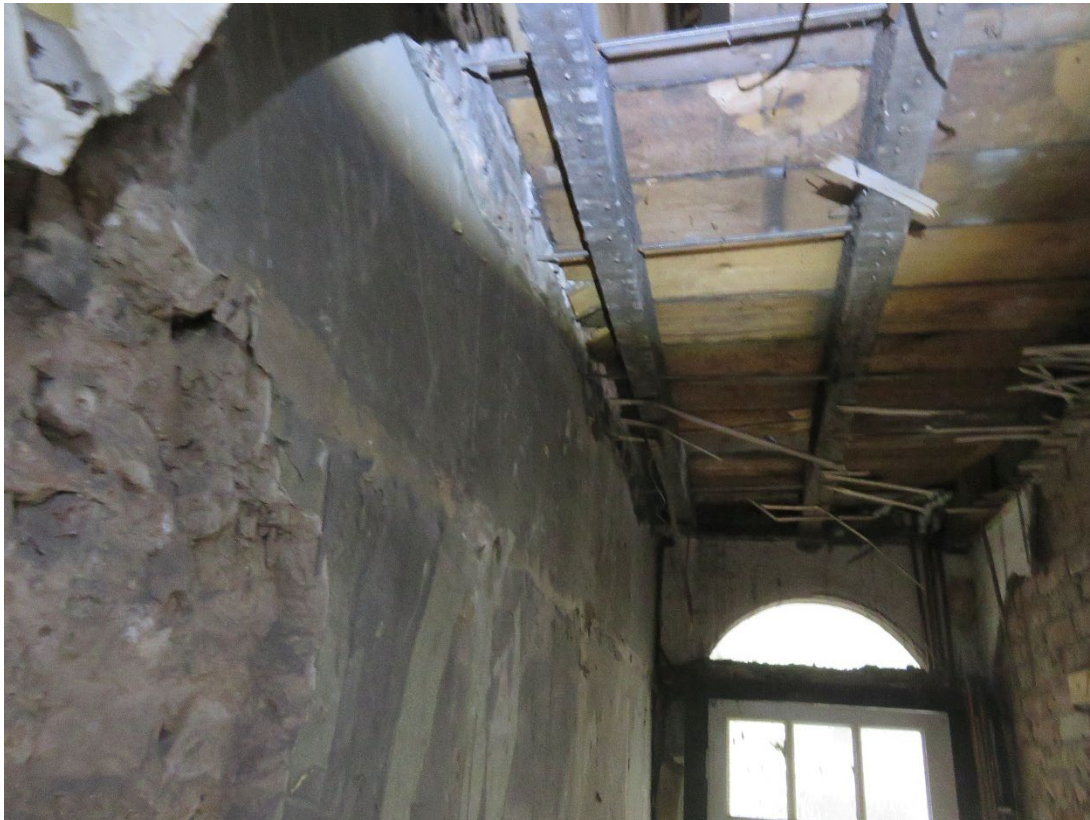
Photograph 26

Ineffective lateral restraint in hallway.
