# **Heritage Statement**

## **Proposed Refurbishment**

**96 Lady Barn Road**

**Date: 9<sup>th</sup> December 2025**

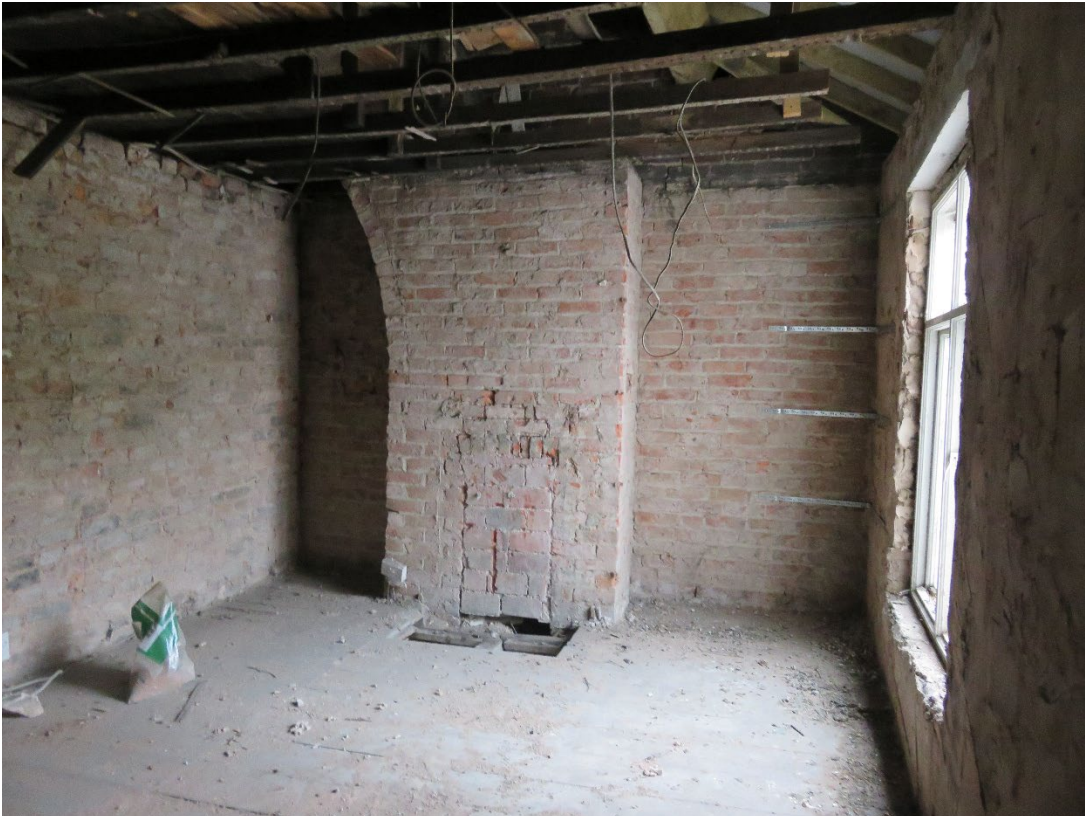
Photograph 28

Built up chimney breast.

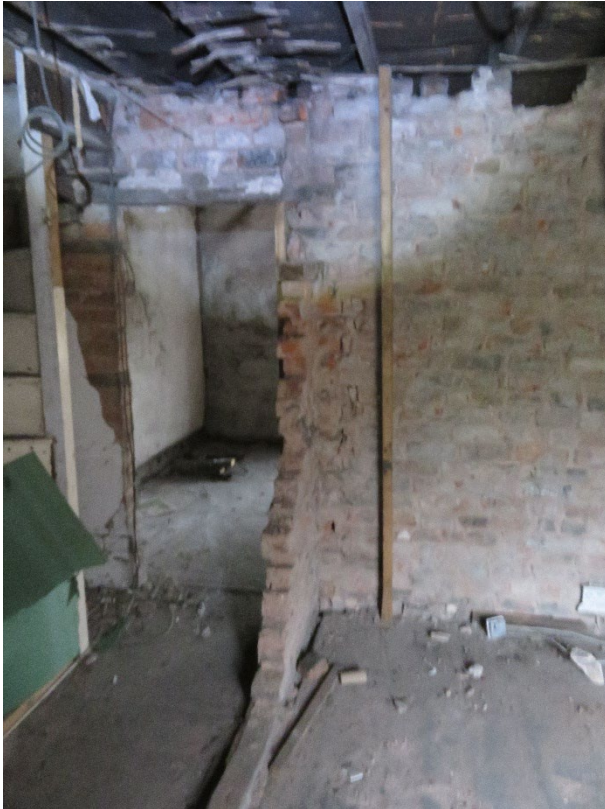
Photograph 31

Wall to be rebuilt in reclaimed brickwork.

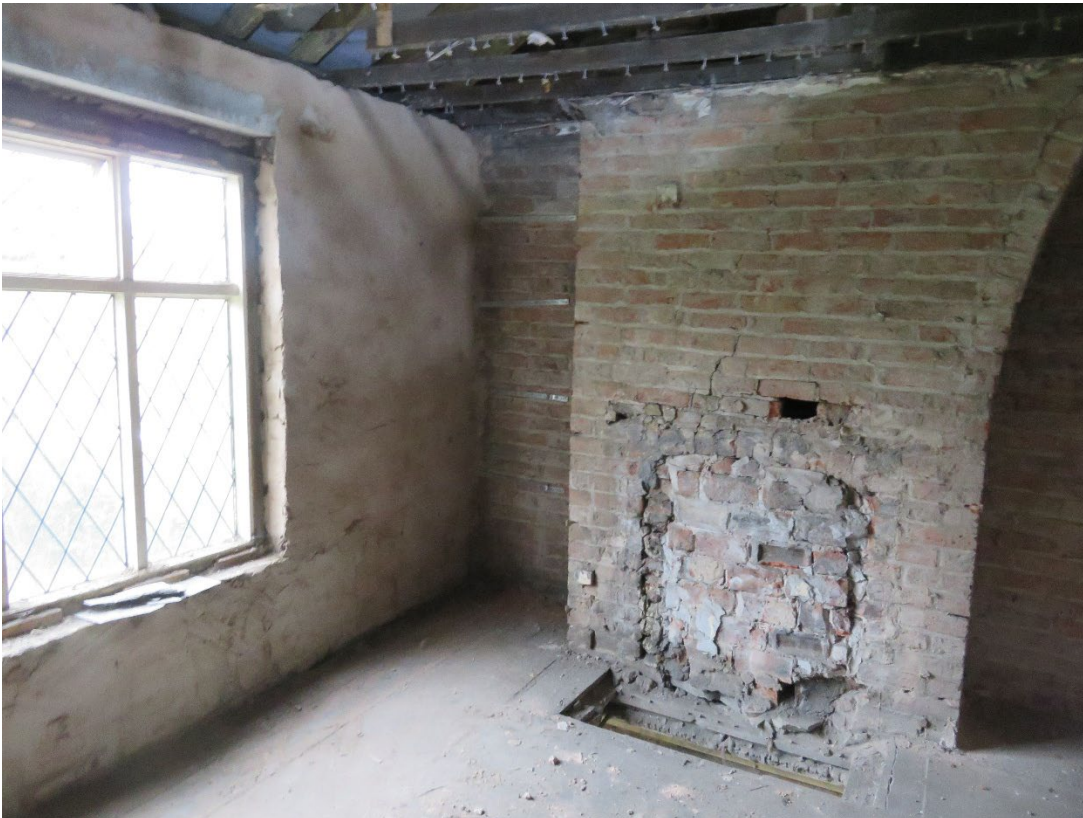
Photograph 32

Front binder beam to chimney breast to be replaced. Party wall lateral restraint strap previously installed.

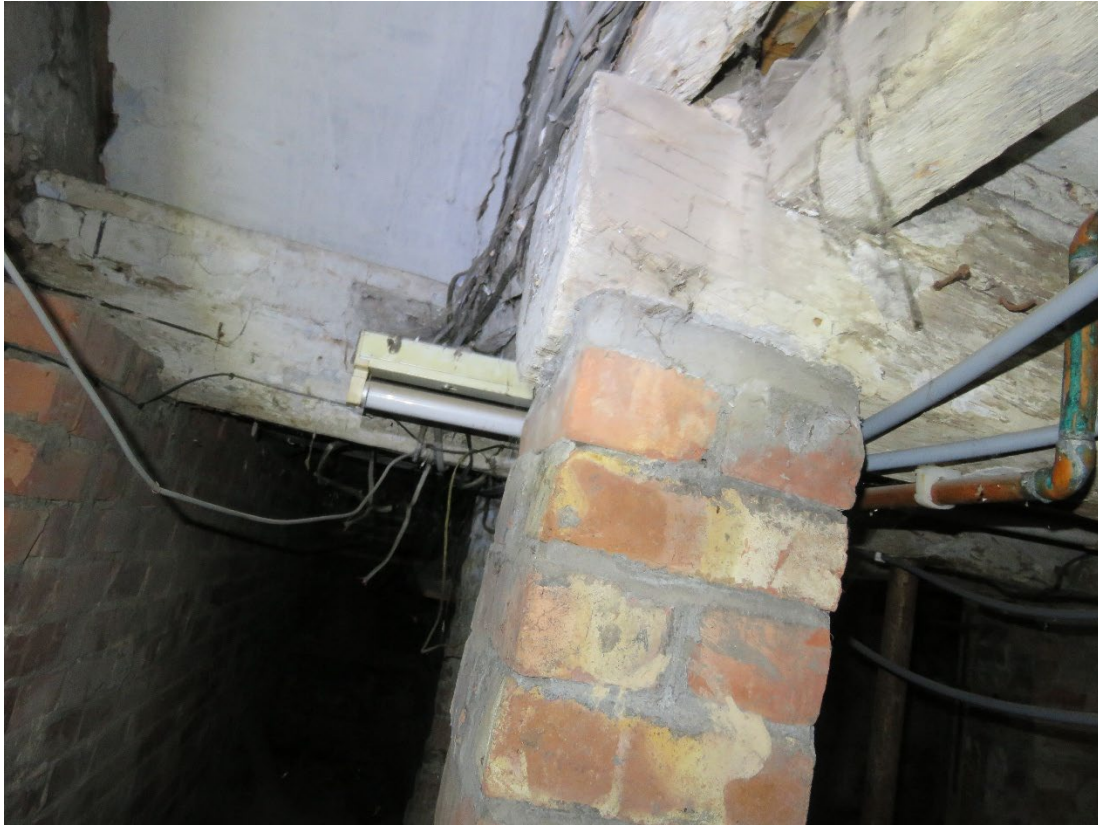
Photograph 33

Large oak binder beam in cellar trimmed back in the past, supported by a brick pillar.
