**550 Ashton New Road, Manchester, M11 4TQ**

**Further Bat Dusk Survey**

**6<sup>th</sup> June 2024**

**Report Ref: KE240606/1**

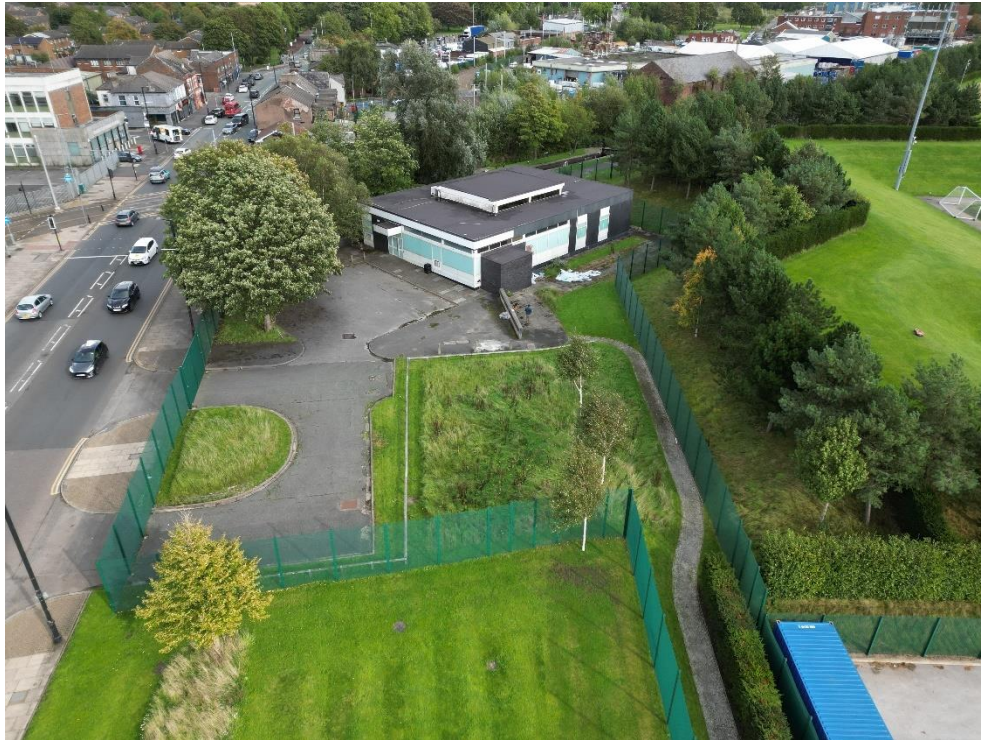
Photograph 1 - Former bank building and adjacent habitats

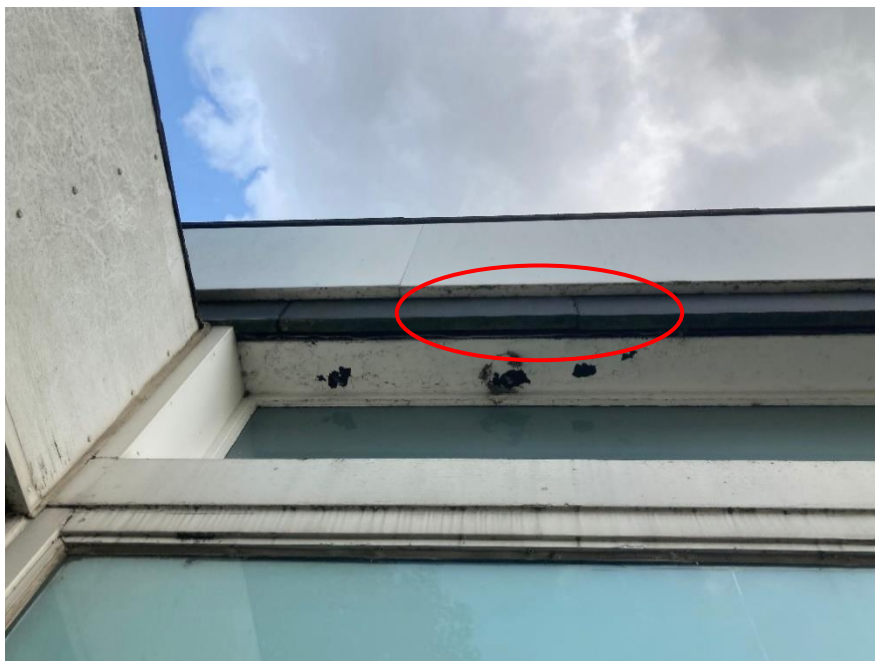
Externally, the building was mostly observed to be intact and in good condition. However, there is a crevice running behind concrete fascia panels located at the northwest face of the building. The crevice is approximately 1cm in width, extends along 1.5m of the concrete fascia and extends back approximately 60cm (Target Note 1 on Figure 1). The feature is considered to offer suitable roosting habitat for individual or small numbers of non-breeding bats.

Photograph 2 - Potential bat roosting crevice at the front of the building

Taking the previous preliminary roost assessment findings and the latest dusk survey results into account, it is considered to be very unlikely that the site supports roosting bats. Nevertheless, it is recommended that care is taken during works, with the fascia carefully removed from the bank building face. If any bats or evidence of bats are found, then works should immediately stop and further advice should be sought from an appropriately qualified ecologist.

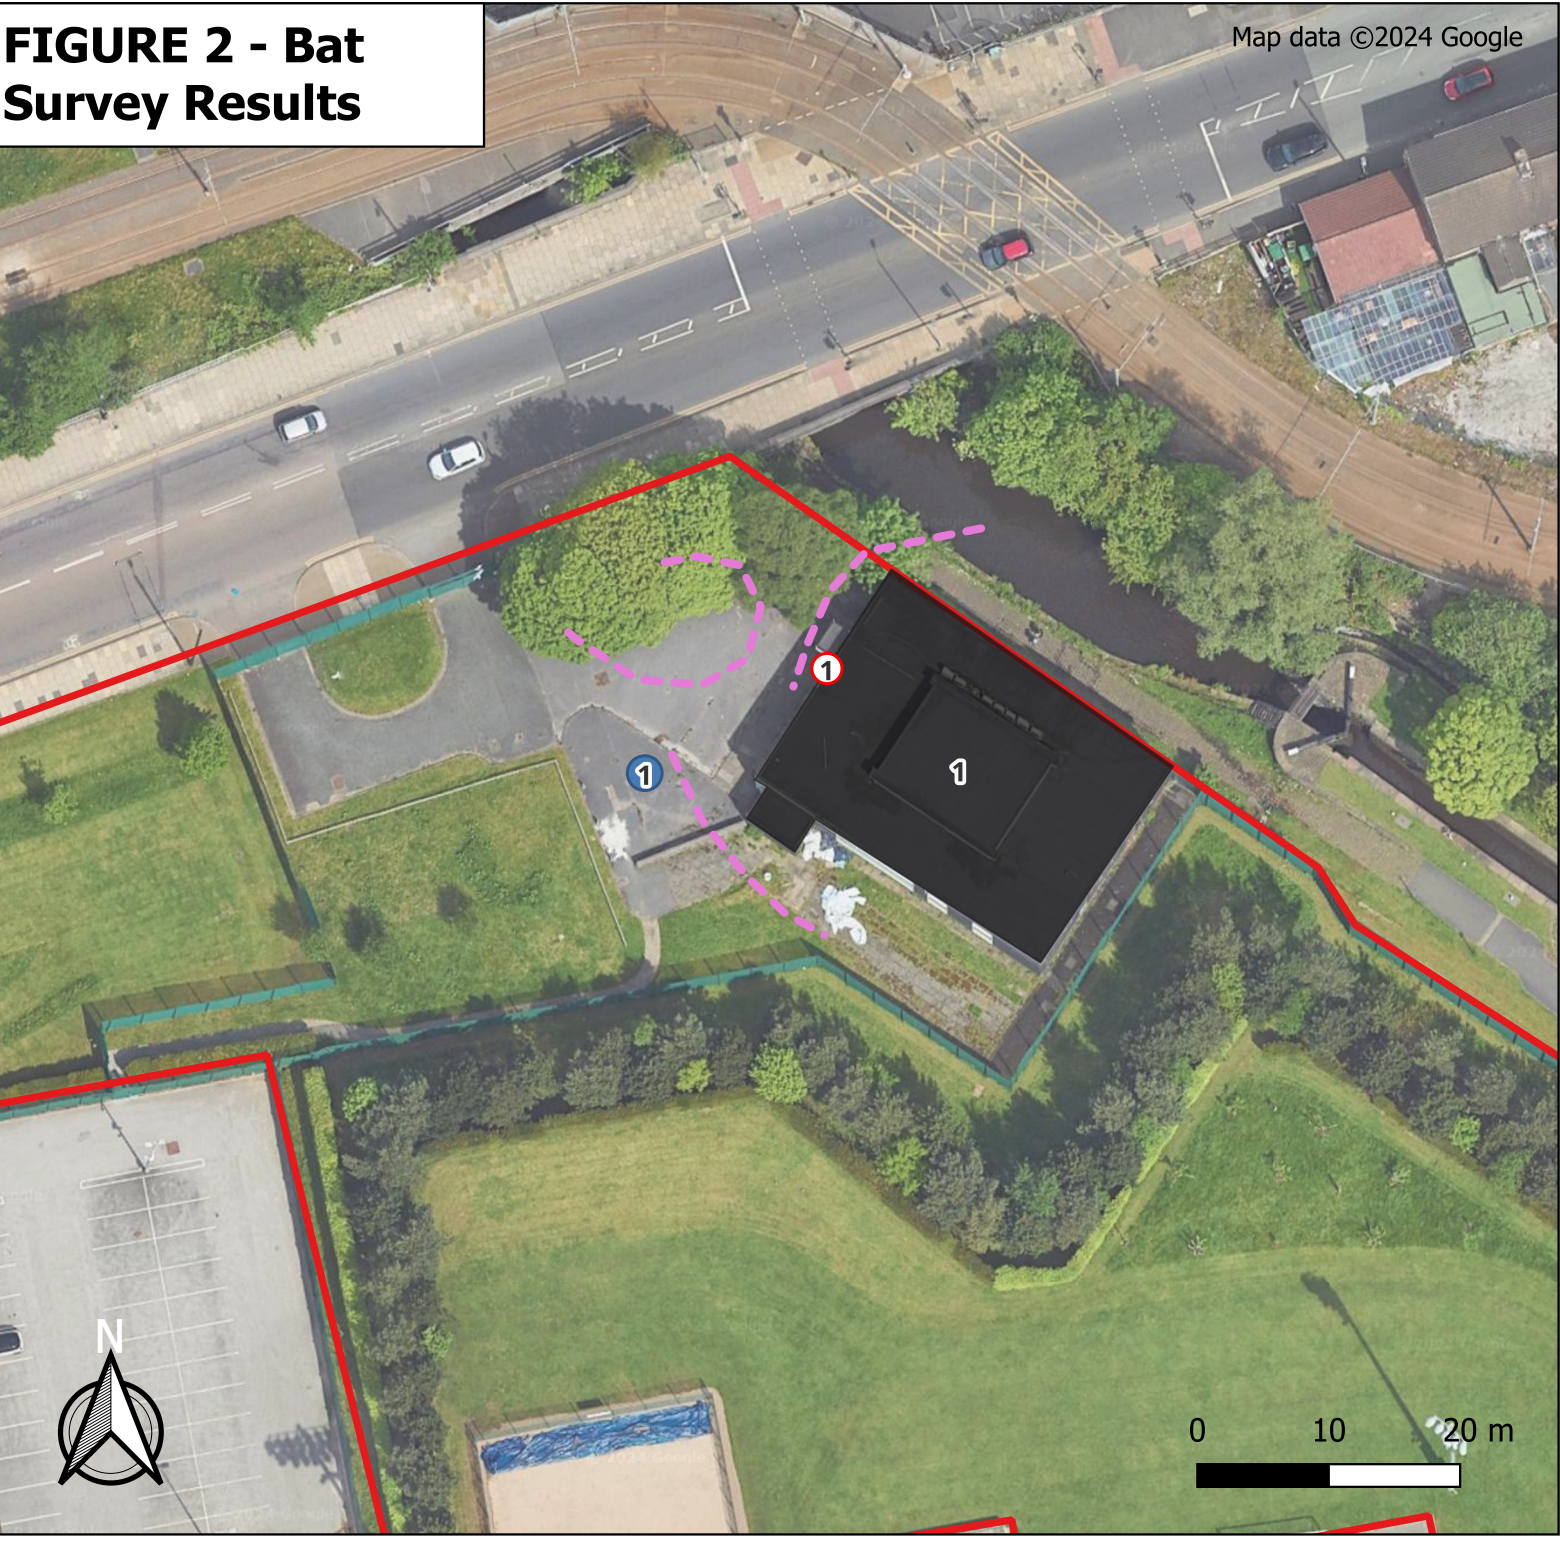
**FIGURE 2 - Bat  
Survey Results**

In summary, no bats were recorded roosting at the site. Low levels of bat activity were recorded during survey with bat activity comprising of intermittent common pipistrelle bat passes and short periods of foraging activity over the canal and around the adjacent trees. The first bat recorded was a common pipistrelle flying from north to south at 21.13. A short period of common pipistrelle bat foraging activity was recorded at the edge of the trees to the north of the bank building at 21.48.

No other bat species or significant bat activity was recorded. No roosting bats were recorded by the surveyor or on the night vision camera.
