**RESIDENTIAL DEVELOPMENT  
404 WILBRAHAM ROAD  
CHORLTON  
MANCHESTER**

# **Pre-Commencement Dilapidation Survey**

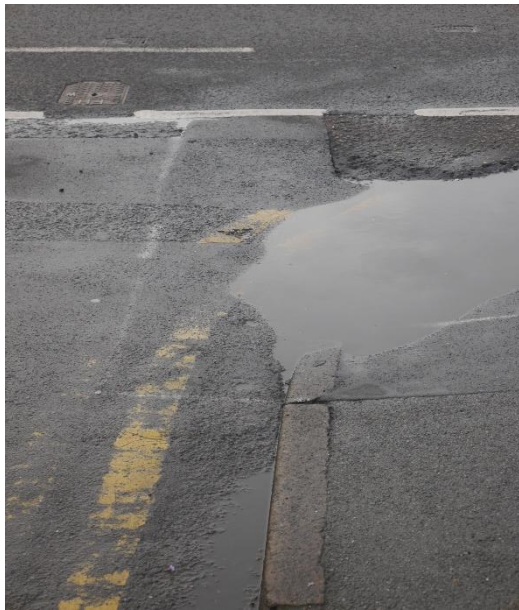
Photo 1

- 3.2 Damaged was noted at the junction of Wilbraham Road where the road has worn away forming a sump for rainwater
- 3.3 It was noted that the speed indicator signs were not aligned in the right direction and the speed sign on the lamppost was also not vertical and mis-aligned

| Area of Survey | Photo Ref | Defect/ Comment |
|---|---|---|
| Egerton Road North | 1 | Edge deterioration at junction with Wilbraham Road |

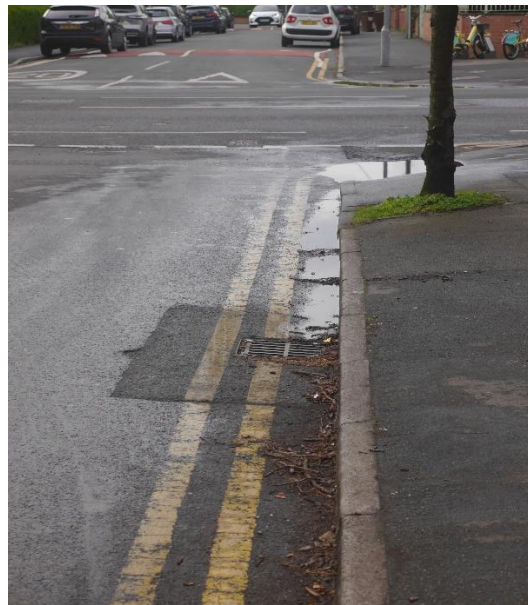
Photo 2

| Area of Survey | Photo Ref | Defect/ Comment |
|---|---|---|
| Egerton Road North | 2 | Edge deterioration at junction with Wilbraham Road |

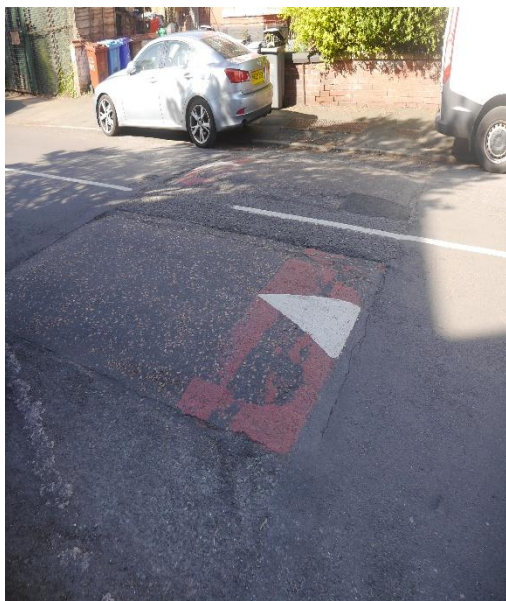
Photo 3

| Area of Survey | Photo Ref | Defect/ Comment |
|---|---|---|
| Egerton Road North | 3 | Speed restrictor worn markings |

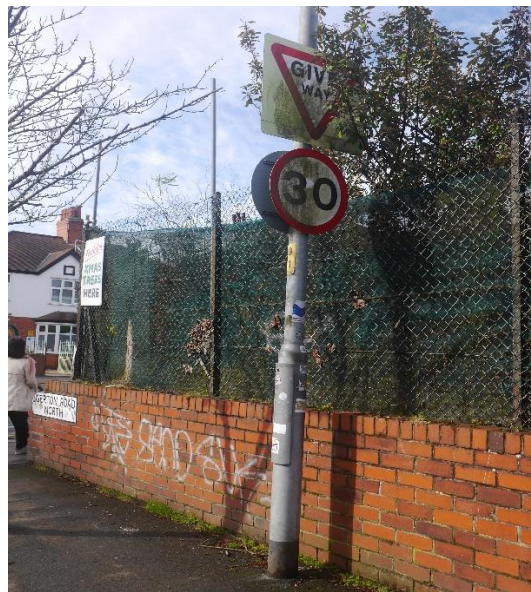
Photo 4

| Area of Survey | Photo Ref | Defect/ Comment |
|---|---|---|
| Egerton Road North | 4 | Speed sign |

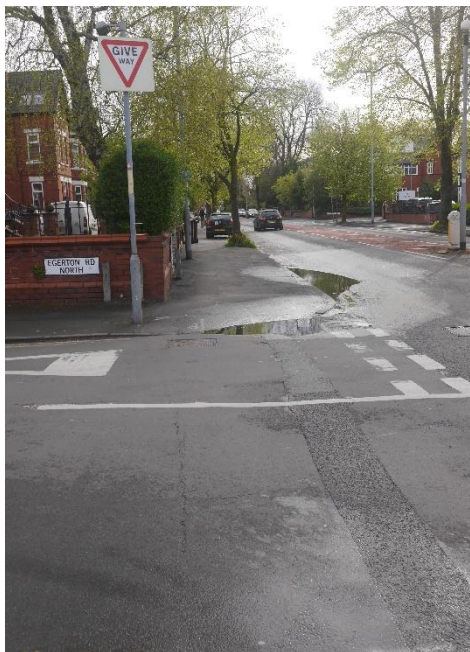
Photo 5

| Area of Survey | Photo Ref | Defect/ Comment |
|---|---|---|
| Egerton Road North | 5 | Give way sign |

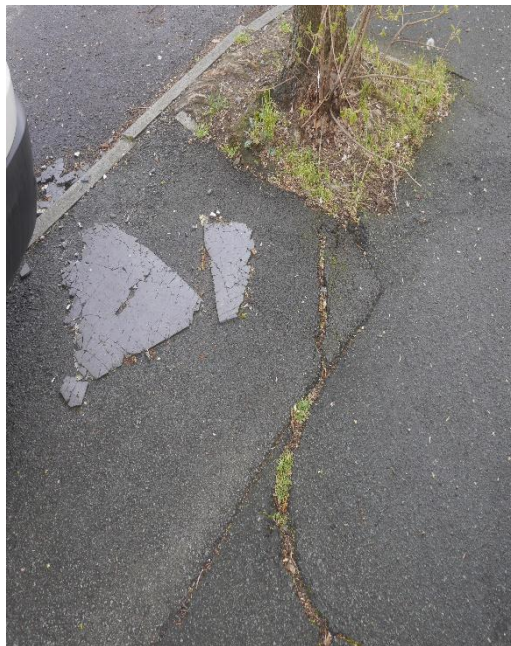
Photo 6

- 3.4 The pavements were generally in reasonable condition, with the exception of the areas around the trees set in the pavement which have deformed the pavement and also pushed the kerbs out of alignment.

| Area of Survey | Photo Ref | Defect/ Comment |
|---|---|---|
| Egerton Road North | 6 | Deformed pavement and kerb adjacent trees |

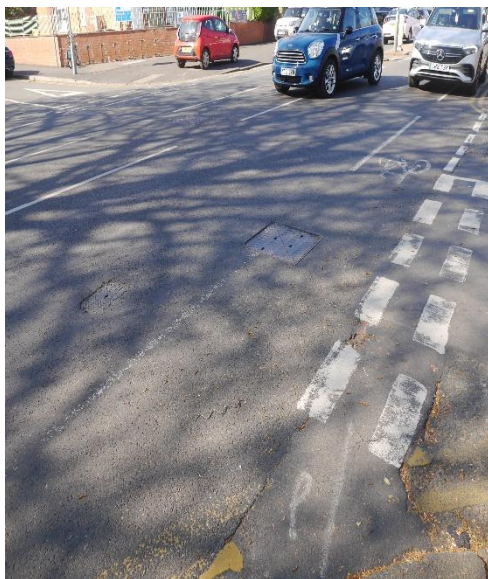
Photo 7

| Area of Survey | Photo Ref | Defect/ Comment |
|---|---|---|
| Wilbraham Road | 7 | Damage & cracking to carriageway |

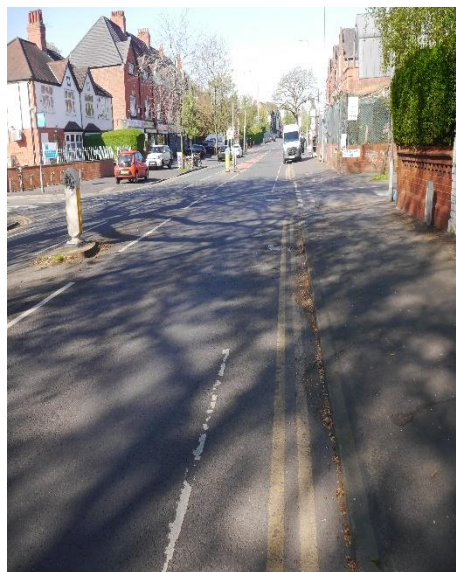
Photo 8

| Area of Survey | Photo Ref | Defect/ Comment |
|---|---|---|
| Wilbraham Road | 8 | Continuation of cracking in carriageeay |

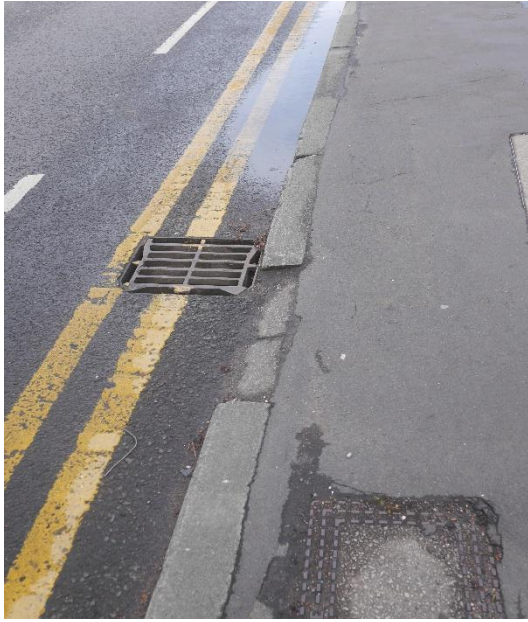
Photo 9

| Area of Survey | Photo Ref | Defect/ Comment |
|---|---|---|
| Wilbraham Road | 9 | Damage around manhole and kerbs adjacent to gulley |

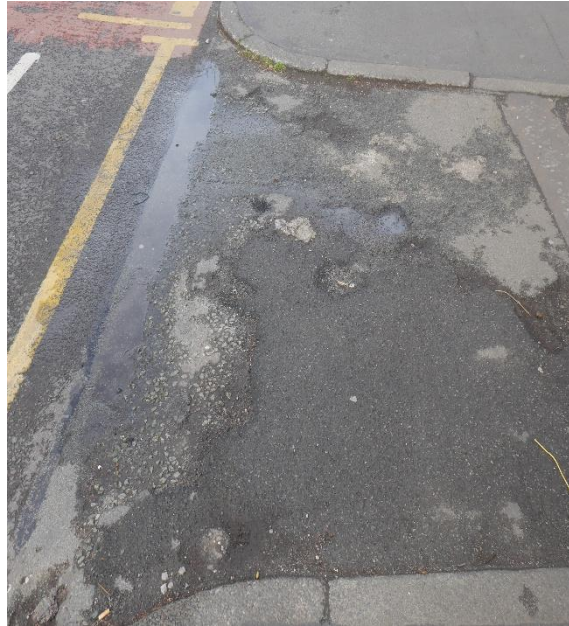
Photo 10

| Area of Survey | Photo Ref | Defect/ Comment |
|---|---|---|
| Wilbraham Road | 10 | Pavement crossing damage |

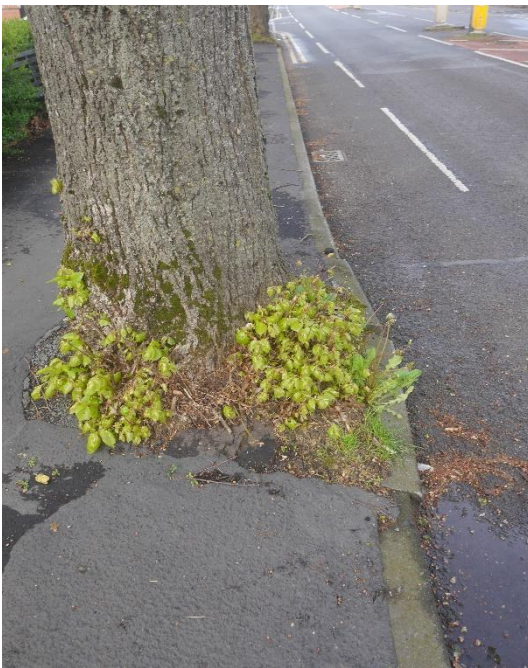
Photo 11

- 3.2 The survey showed that kerbs and carriageway were in an acceptable condition along the A6010 with exception of where the trees have deformed the pavements and kerb alignment, it not considered that these are so severe as to require remedial works prior to works starting.

| Area of Survey | Photo Ref | Defect/ Comment |
|---|---|---|
| Wilbraham Road | 11 | Damage to pavement & kerbs adjacent trees |

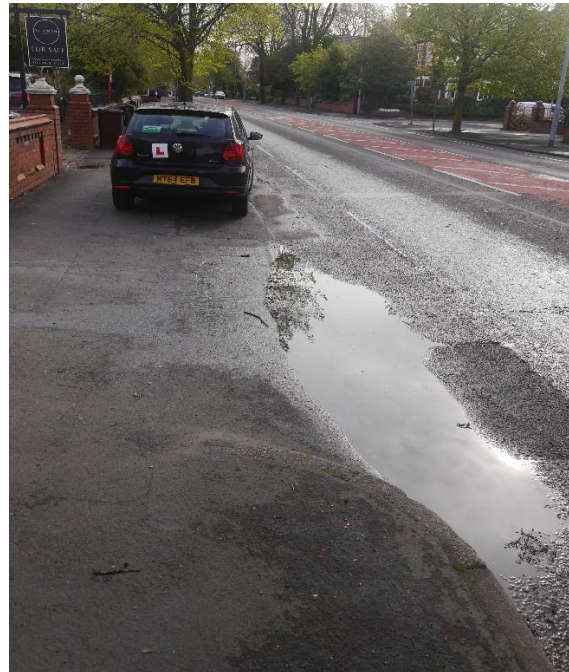
Photo 12

| Area of Survey | Photo Ref | Defect/ Comment |
|---|---|---|
| Wilbraham Road | 12 | Ponding on road |

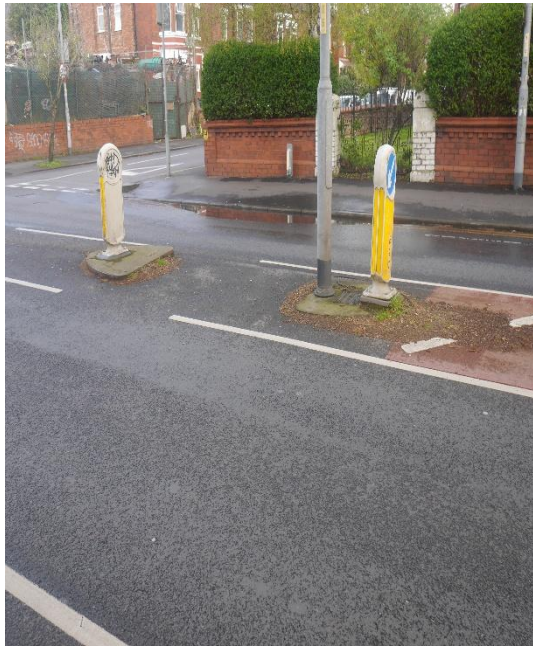
Photo 13

| Area of Survey | Photo Ref | Defect/ Comment |
|---|---|---|
| Wilbraham Road | 13 | Pedestrian refuge West Bound |

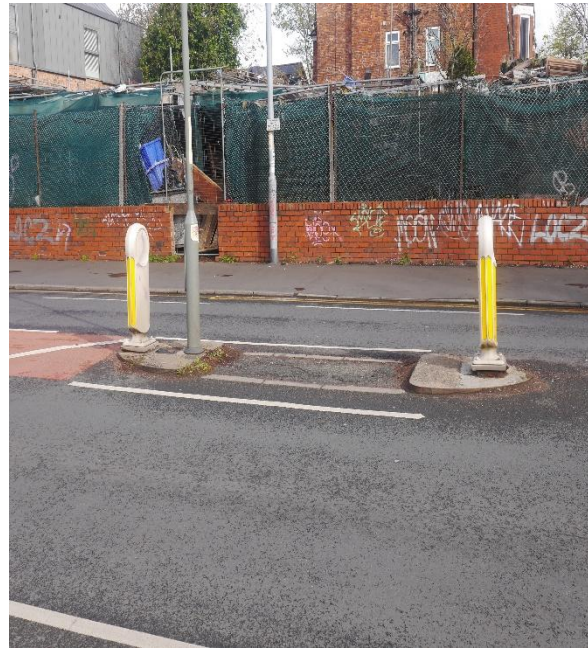
Photo14

| Area of Survey | Photo Ref | Defect/ Comment |
|---|---|---|
| Wilbraham Road | 14 | Pedestrian refuge East Bound |
