# 44-50 PORTLAND STREET, MANCHESTER, M1 4GS

## Preliminary Bat Roost Assessment Report

*April 2026*

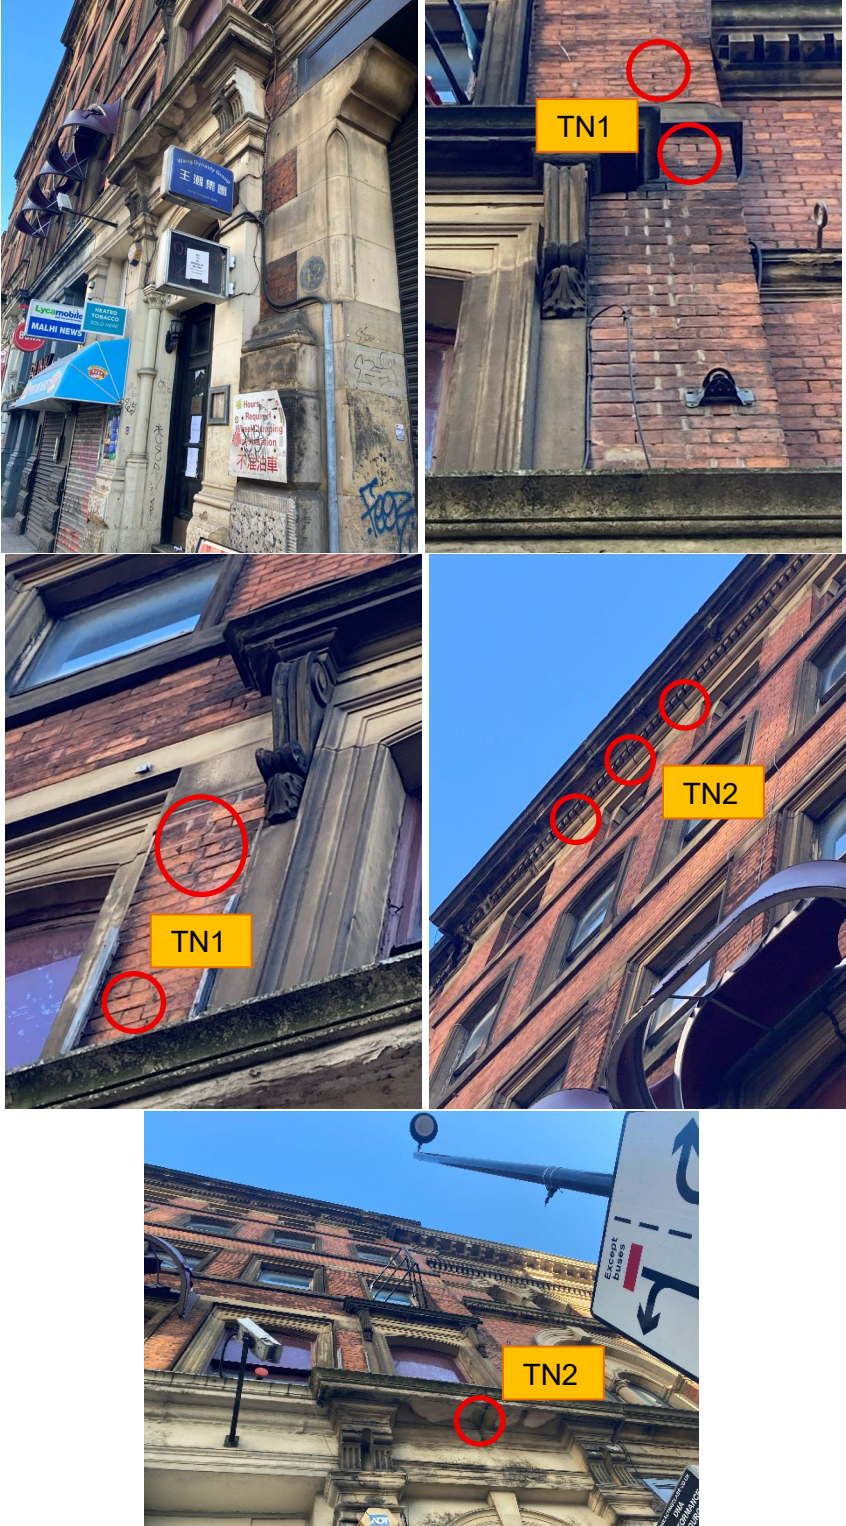
| Description | Photographs |
|---|---|
| This aspect is the front of the property situated on Portland Street. Most of the brickwork and sandstone appeared to be in largely good condition. A few minor PRFs | |

| Description | Photographs |
|---|---|
| <p>were identified that could offer roosting suitability for individual crevice roosting bats which included missing mortar in a few sections of brickwork (TN1) and some missing mortar within the sandstone features of the wall (TN2).</p> <p>The rest of the wall was found to be in good condition, and the windows and doors were also in good condition with no gaps or cracks present around their edges that bats could access. Some of the windows were found to be smashed which could allow internal access to the property for bats (see internal section for photographs).</p> <p>No field signs of bats such as droppings or staining were visible on the walls of the property.</p> <p>The roof was not visible from this aspect of the building.</p> | |

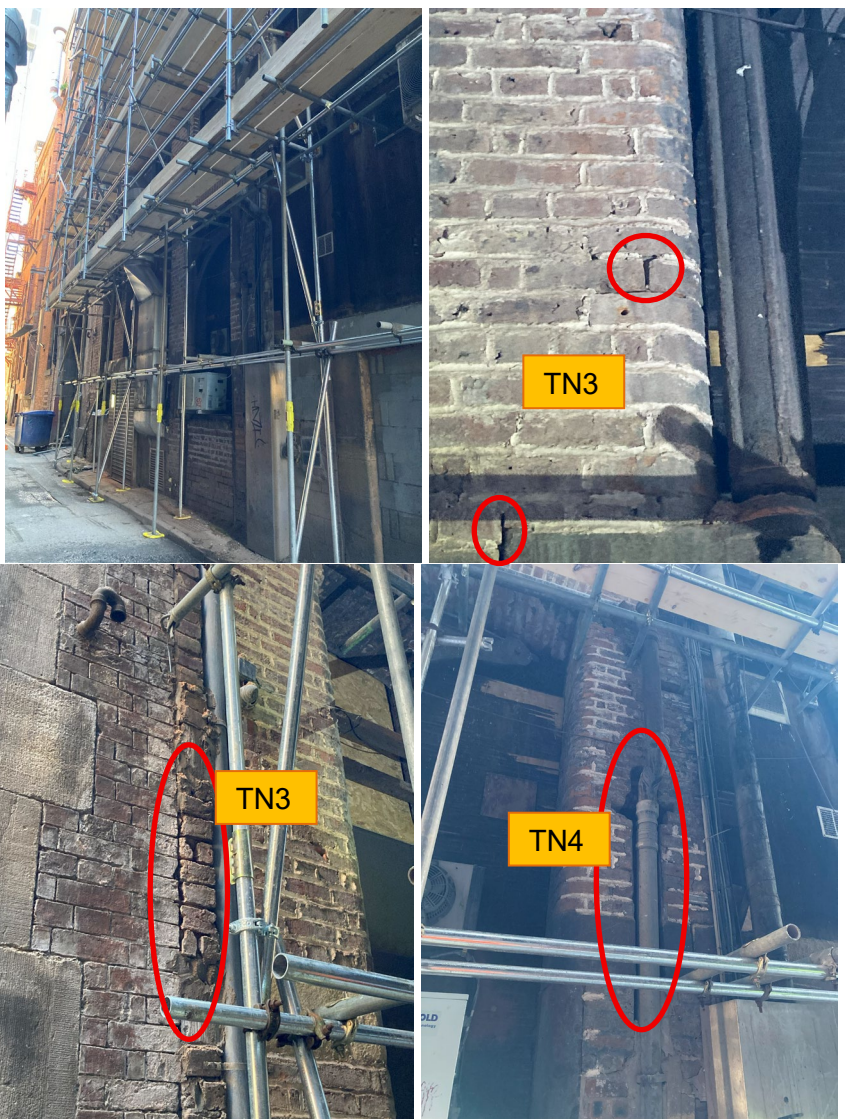
External – Northwestern Aspect

| Description | Photographs |
|---|---|
| <p>The rear of the building was entirely covered in scaffolding and the walls were comprised of red brick with one section that appeared to have been repaired with cinder blocks.</p> <p>The scaffolding meant it was not possible to fully assess this aspect due to limited visibility and the roof was once again also not visible due to the height of the building.</p> <p>In the areas that were visible on the ground floor and sections that could be seen through gaps in the scaffolding the brickwork appeared to be in overall moderate condition with a few PRFs identified in relation to missing mortar (TN3). There were also gaps identified around a pipe leading up the height of this aspect that may be suitable for a small number of crevice dwelling bats (TN4).</p> <p>It is likely that the rest of the wall is in a similar condition to those areas observed with similar PRFs suitable for individual crevice dwelling bats, although the presence of further PRFs cannot be ruled out.</p> | |

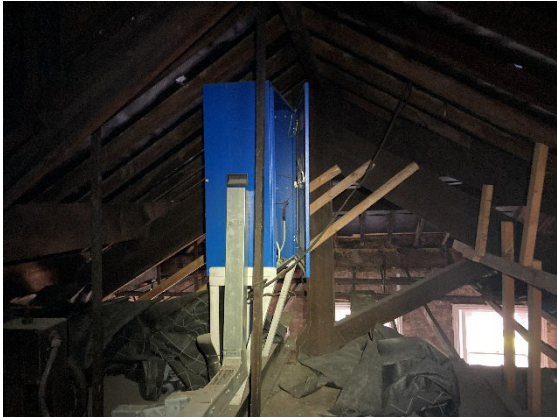
| Description | Photographs |
|---|---|
| <p>The floor to the loft space had mostly been removed meaning it was largely open to the top floor. A small section of flooring approximately 4m x 2m was left intact at the top of the staircase and lift shaft. This was accessed to get a closer look at the ceiling.</p> <p>The loft supports comprised timber beams which were all found to be in good condition with no splits or cracks observed in the beams visible. They were sat flush to the roofing felt which was also in good condition having been replaced recently with the roof. A few holes were identified cut into the roofing felt (TN5) with daylight seen coming through but these lead to vents the holes of which were too small for bats to fit through. The holes in the felt, however, would allow access for any bats inside the building into the gap between the felt and roofing tiles and offer a potential roosting feature for numerous bats. Additional gaps were noticed in between the panels of the roofing felt (TN6) that could also be utilised by crevice</p> | |

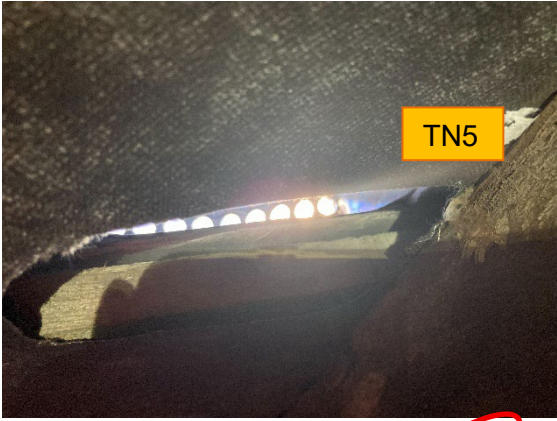
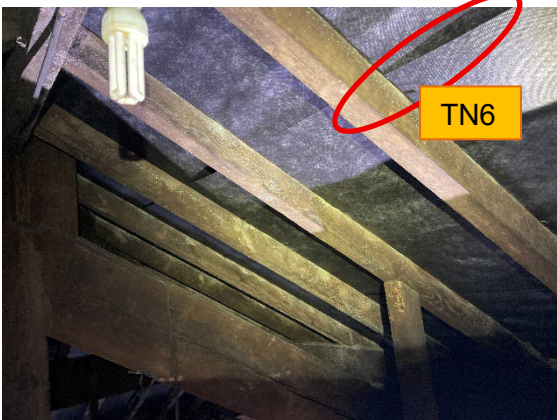
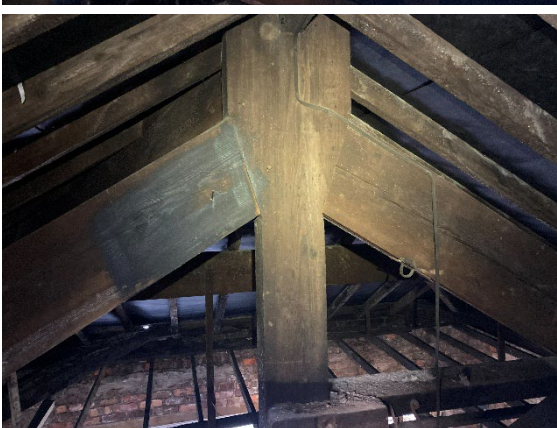
| Description | Photographs |
|---|---|
| <p>dwelling species of bats.</p> <p>Multiple skylights were located within the ceiling and these along with the windows on the top floor allow lots of natural light in, reducing the loft spaces value for roosting bats.</p> <p>No field signs of bats such as droppings or feeding remains were identified in the loft space.</p> | <p>TN5</p> <p>TN6</p> |

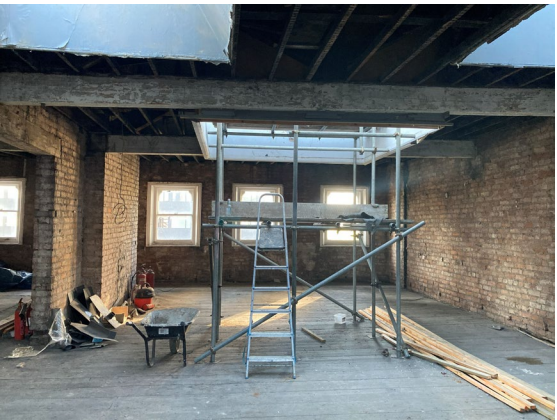
| Description | Photographs |
|---|---|
| <p>Each floor was identical in layout being split into two rooms by a brick wall with a large open archway connecting the two and a staircase and lift shaft present on the southeastern aspect. A chimney breast was present running down through the central wall although the fireplaces had been sealed off on all floors. Each floor had six windows across each external aspect and at least one window on each floor was broken and/or left open allowing potential access points for bats into the building. It would also be possible for bats to easily move between floors via the open staircase.</p> <p>The brickwork on all floors was badly damaged with several areas of missing mortar and broken or crumbled bricks with missing sections. Some of these gaps were</p> | |

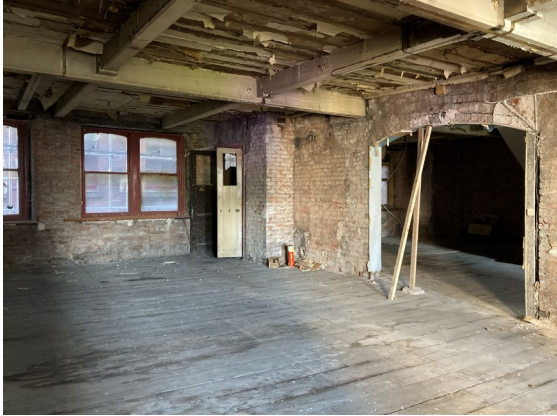
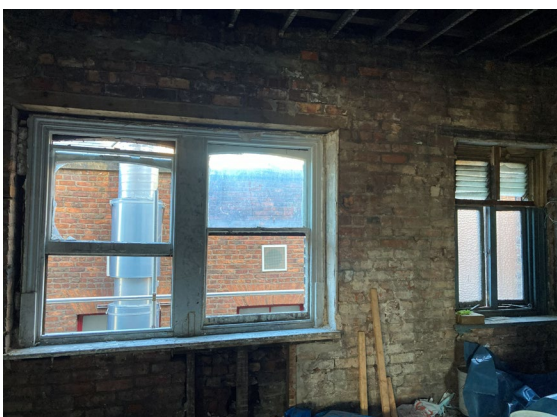
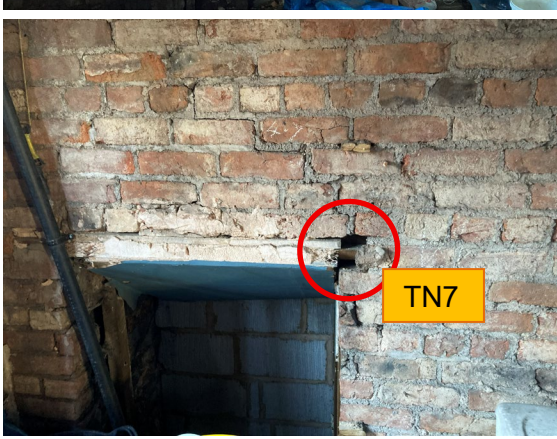
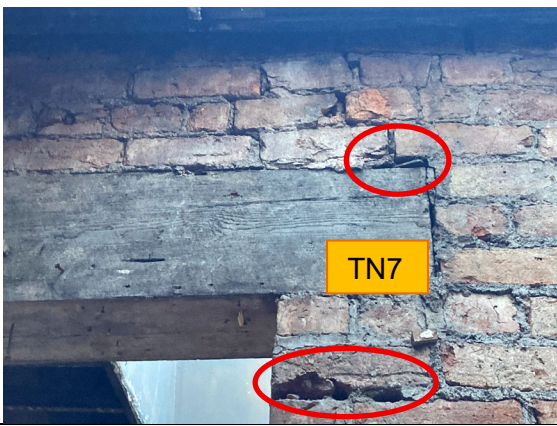
| Description | Photographs |
|---|---|
| <p>only small/shallow offering potential roosting features for individual crevice dwelling bats (TN7), however numerous gaps/cracks were also present leading into the cavity walls and chimney breast which offer potential suitability for large numbers of both crevice or cavity dwelling species (TN8).</p> <p>On the fourth-floor wooden panels/boxes were present underneath windows on the front aspect of the building. There were gaps identified around the edges of a couple of these potentially allowing bats access into a small cavity present behind them (TN9). These would be suitable for roosting for a small number of bats.</p> <p>The ceilings in each room comprised of wooden panels or boards that were in various conditions with some appearing old with layers of paint peeling off while others seemed much newer and better condition. Overall, though, all ceilings were found to be well sealed with no holes or gaps in any of the wooden boards and therefore no PRFs were identified in relation to the ceilings.</p> <p>No field signs of bats such as droppings or feeding remains were identified on any of the floors and there were no signs of bat roosting such as staining on the walls.</p> | |

- 4.1.1. The building was found to have **moderate bat roosting potential** and therefore in accordance with best practice guidance (Collins, 2023), a minimum of **two nocturnal bat surveys** should be undertaken between May-September (inclusive), with at least one of the surveys between May-August, to determine usage by roosting bats.
- 4.1.2. The results of the further surveys will determine if any mitigation is required for roosting bats. If roosting bats are located within any of the buildings, a Natural England Mitigation Licence may be required for development to proceed. The Licence can only be obtained once planning permission has been granted and all wildlife conditions discharged. However, the bat emergence surveys must be undertaken prior to planning permission being applied for as they are a material consideration
