# 8 Minshull Street

## Architectural Features Report

Revision P05 - 14.11.2025

This architectural heritage assets report has been prepared by Horizon fletcher-Rae in support of the planning application and listed building consent for the alteration and conversion of 8 Minshull Street and 42 Bloom Street, Manchester.

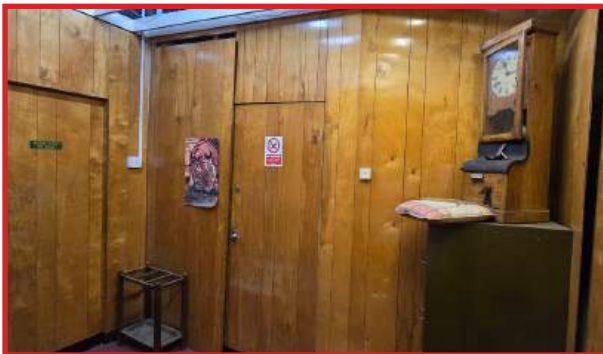
### UG - 8 Internal partition

To be removed to open space in the apartment. The wood-colored screens are missing several panels and are in poor condition
