**Leicester**

**Haymarket Towers  
Humberstone Gate**

**Kitchen Extract System  
Post Clean Report**

**25th January 2022**

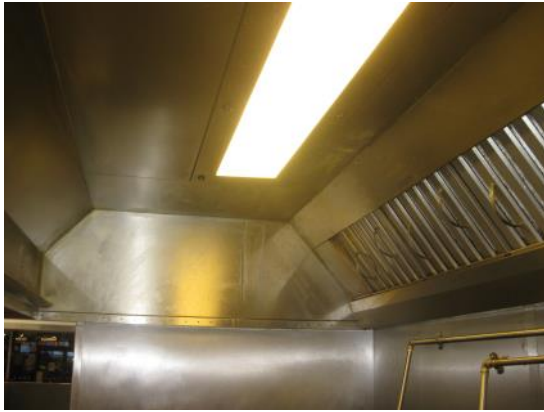
1.CANOPY 1 PRE CLEAN

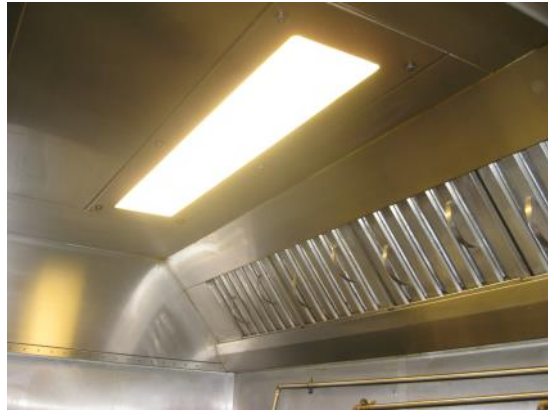
2. POST CLEAN

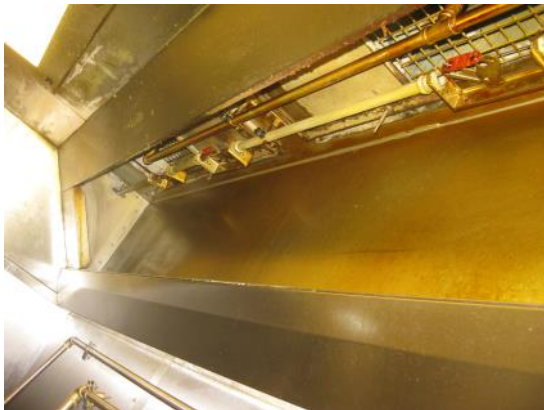
3. CANOPY AND OPEN PLENUM LEFT  
PRE CLEAN

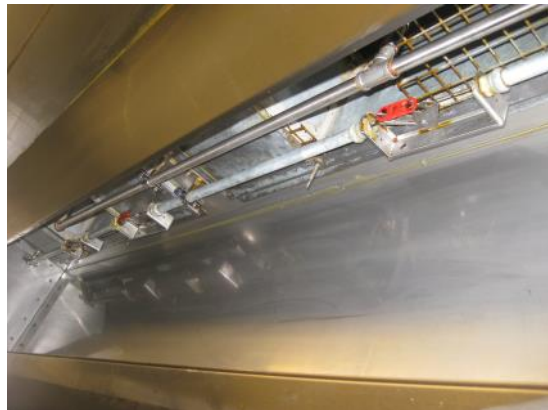
4. POST CLEAN

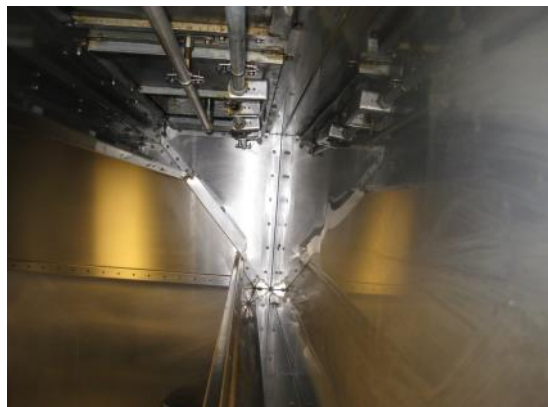
6. POST CLEAN

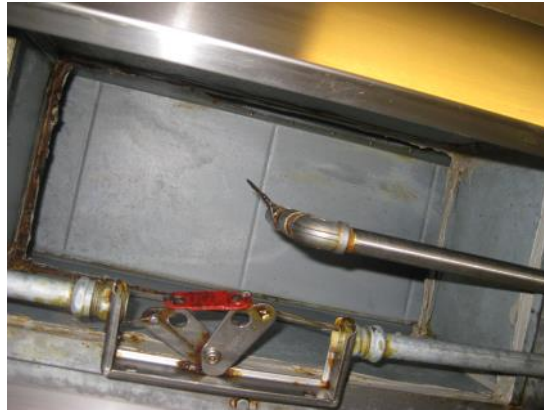
8. POST CLEAN

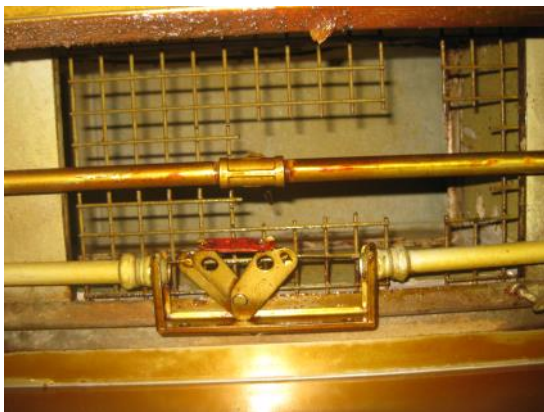
9. TYPICAL SPIGOT TO HEADER ABOVE  
PRE CLEAN

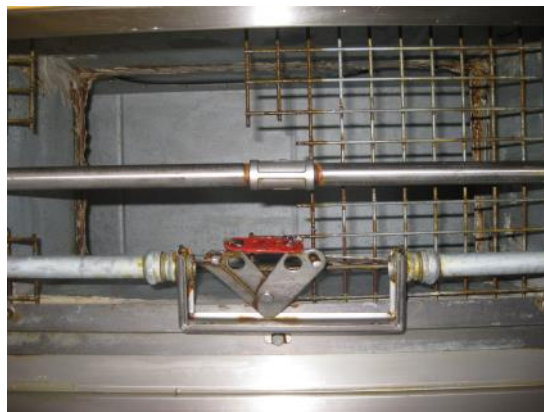
10. POST CLEAN

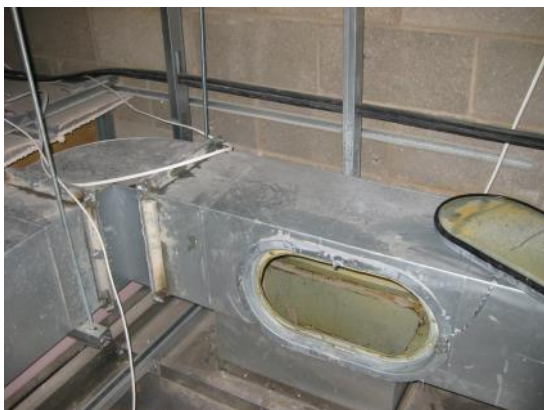
11. ACCESS TO 1ST HEADER DUCT  
PRE CLEAN

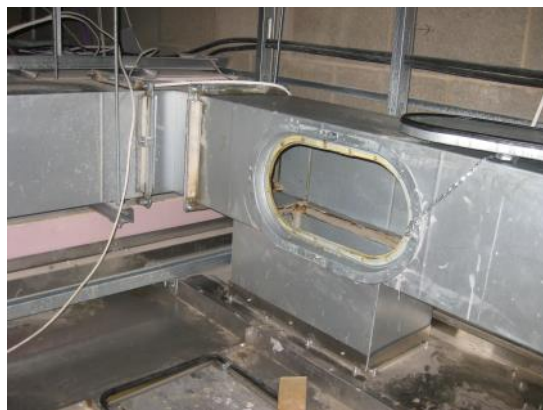
12. POST CLEAN

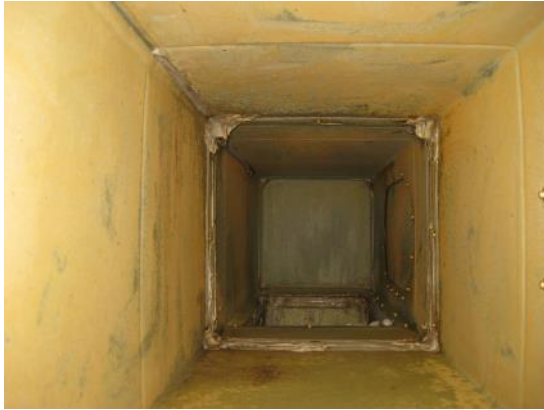
13. HEADER DUCT ABOVE CANOPY  
LOOKING TO DEAD END PRE CLEAN

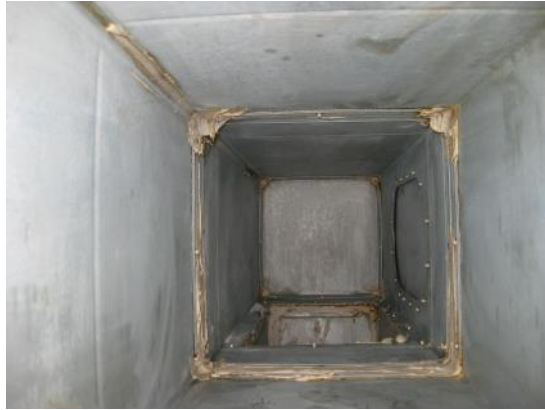
14. POST CLEAN

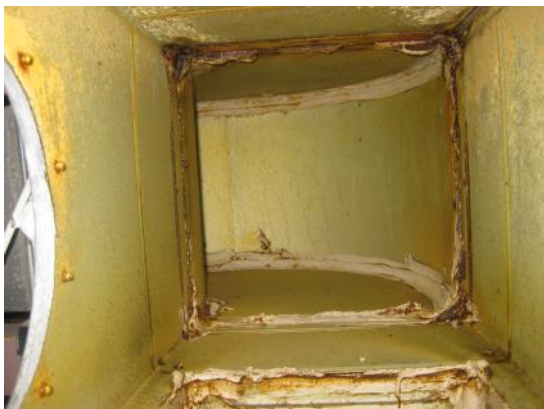
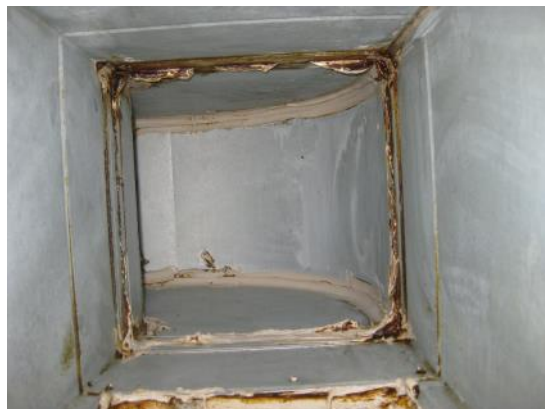
15. HEADER DUCT LOOKING TO TURN OVER  
KITCHEN TO 2ND HEADER PRE CLEAN

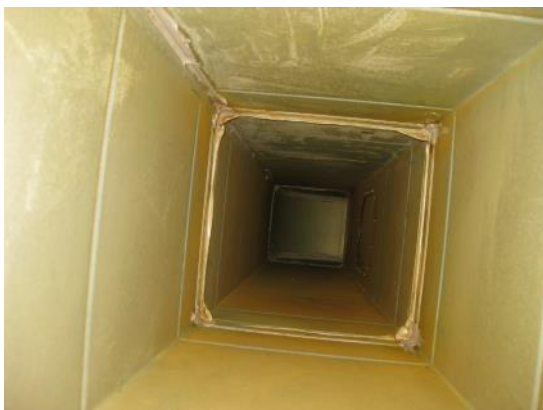
17. LOOKING BACK TO TURN FROM  
HEADER DUCT ONE PRE CLEAN

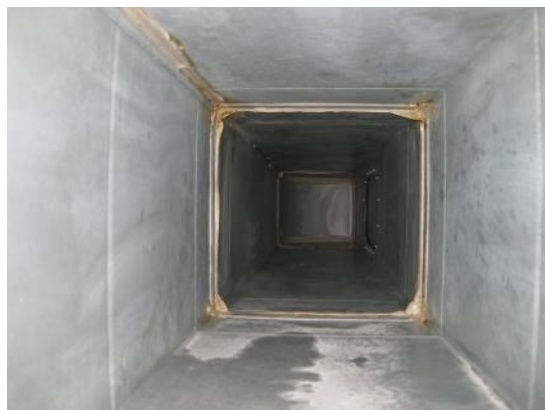
18. POST CLEAN

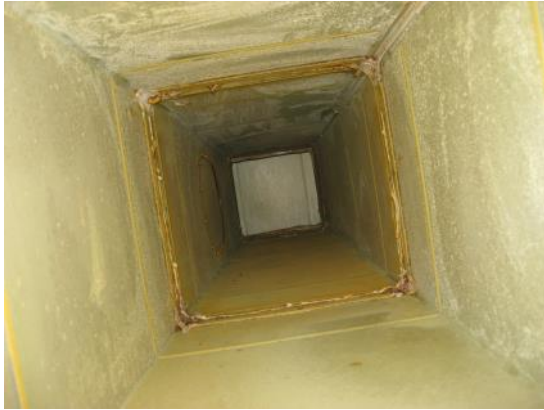
19. LOOKING TOWARD JOIN TO 2ND  
HEADER DUCT PRE CLEAN

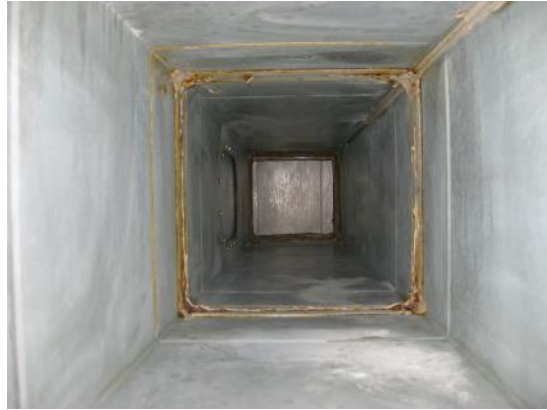
20. POST CLEAN

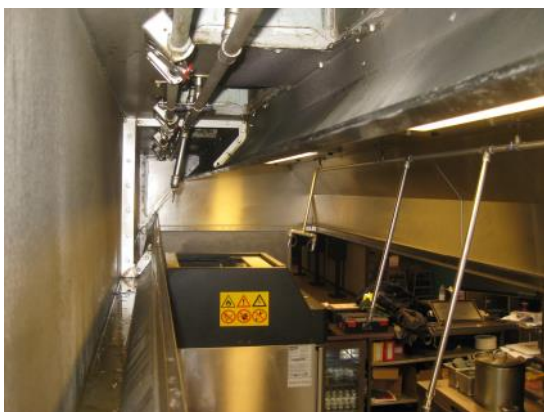
23. INTERIOR OF PLENUM TO THE RIGHT  
PRE CLEAN

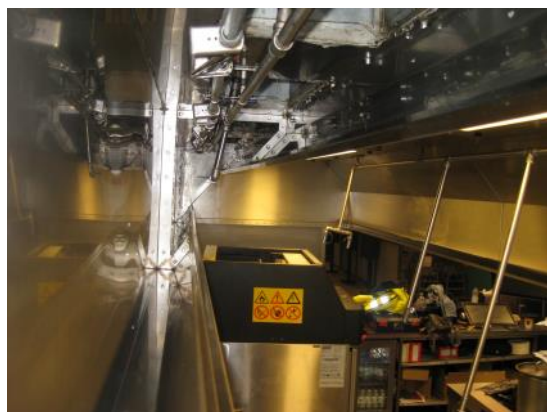
28. POST CLEAN

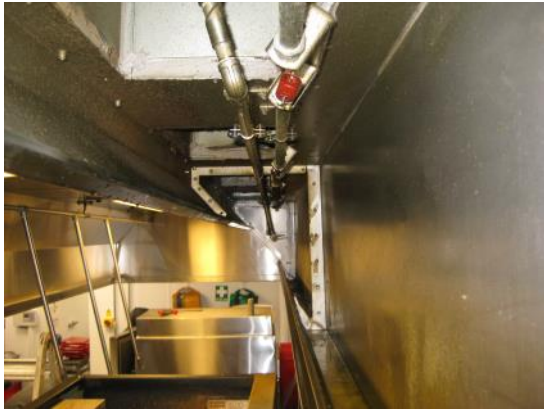
29. INTERIOR OF PLENUM TO THE LEFT  
PRE CLEAN

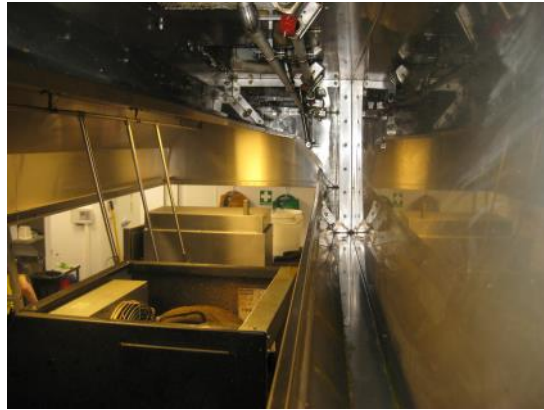
30. POST CLEAN

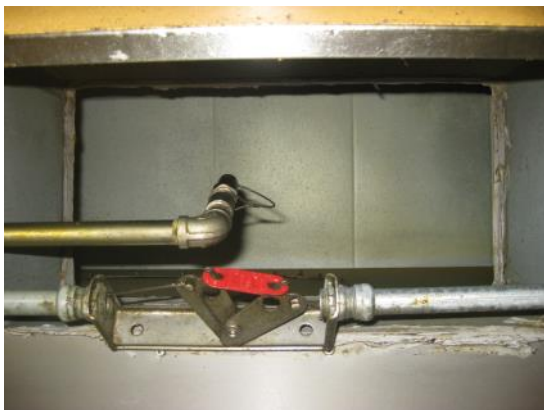
31. TYPICAL SPIGOT TO THE HEADER  
ABOVE PRE CLEAN

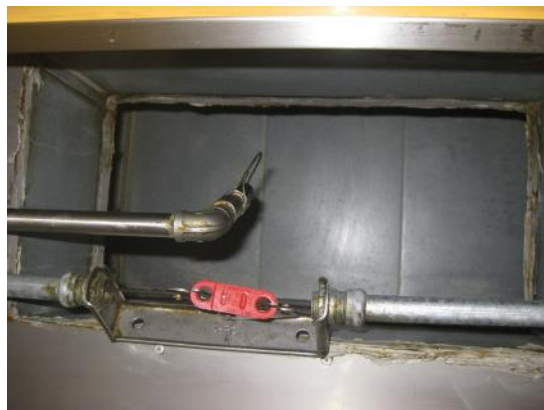
32. POST CLEAN

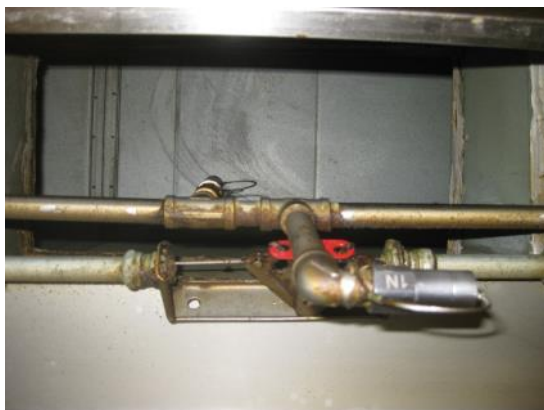
33. TYPICAL SPIGOT TO THE HEADER  
ABOVE PRE CLEAN

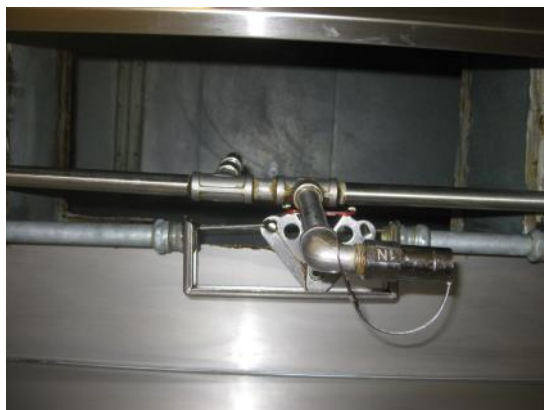
34. POST CLEAN

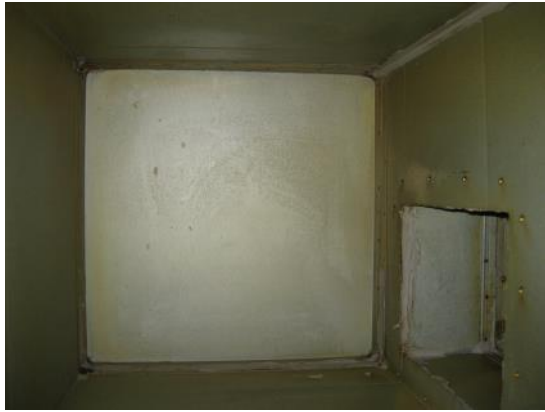
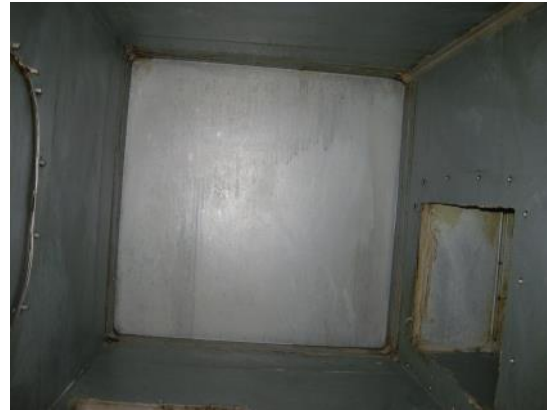
35. 2ND HEADER DUCT TOWARD DEAD END AND INTAKE FROM CANOPY 1 PRE CLEAN

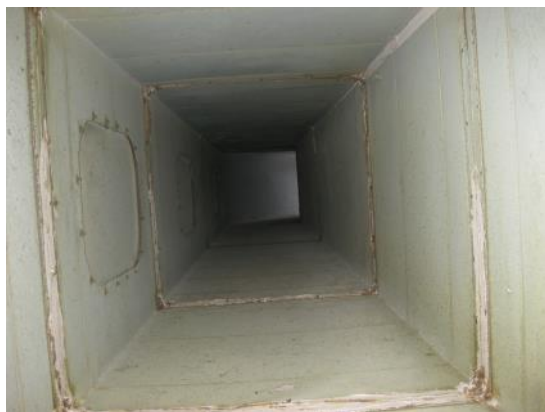
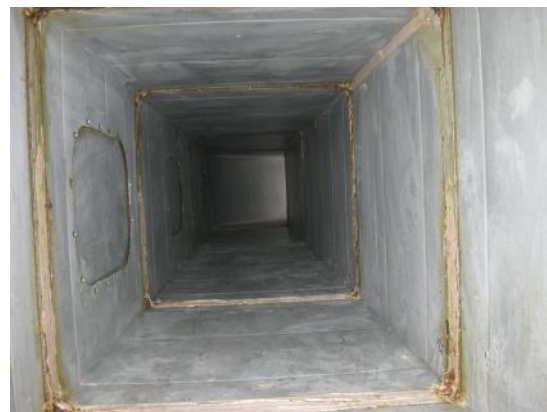
37. 2ND HEADER DUCT TOWARD BASE OF RISE PRE CLEAN

38. POST CLEAN

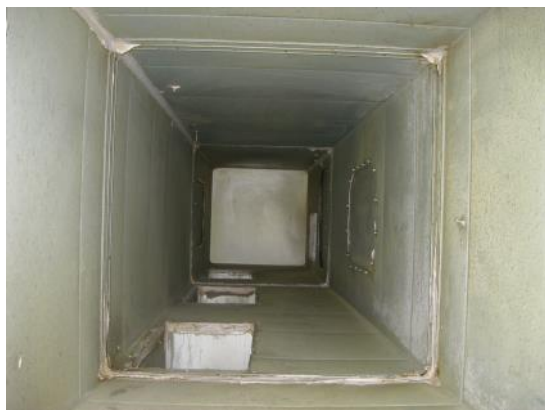
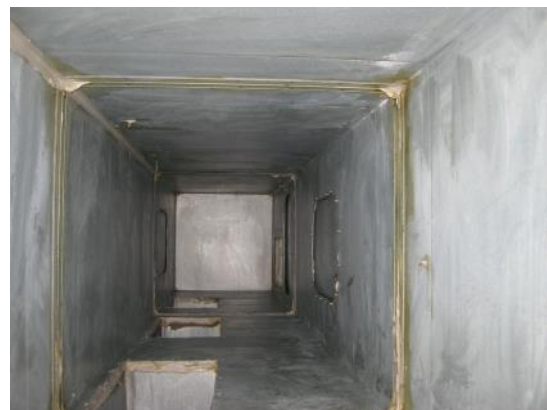
39. LOOKING BACK TO HEADER DUCT FROM BASE OF RISE PRE CLEAN

40. POST CLEAN

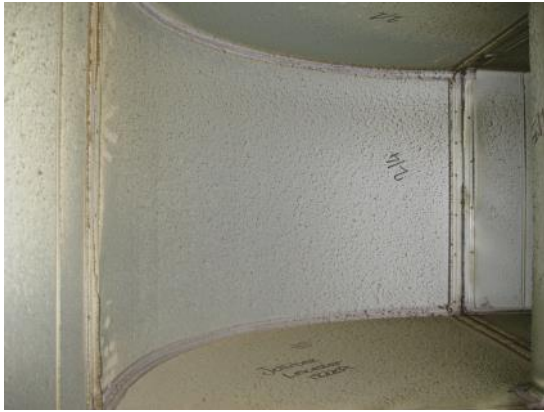
41. TURN TO BASE OF RISER TO ROOF  
PLANT SPACE PRE CLEAN

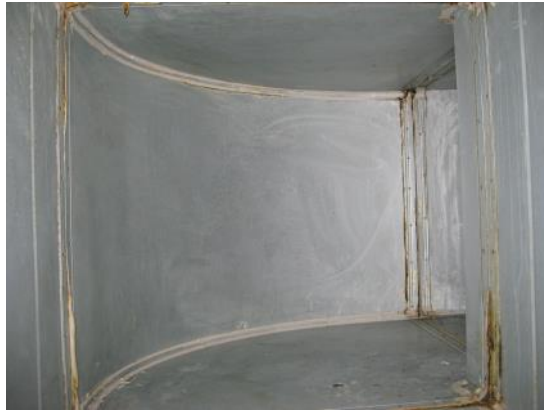
42. POST CLEAN

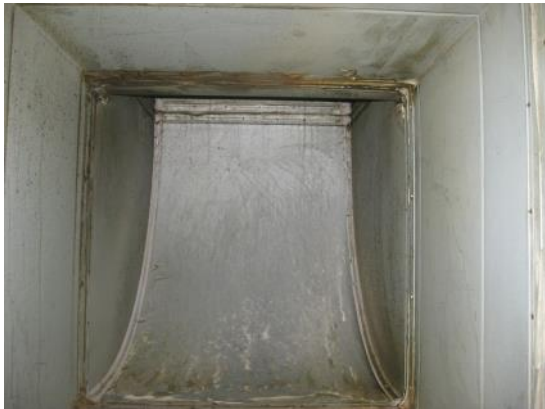
43. BASE OF RISER TO ROOF PLANT SPACE  
PRE CLEAN

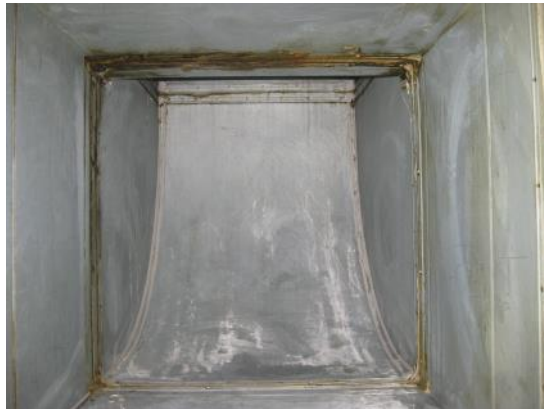
44. POST CLEAN

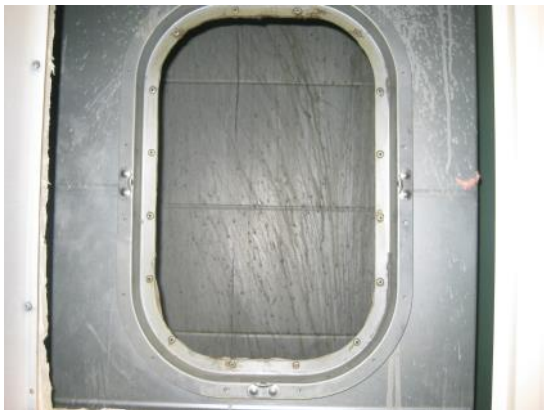
45. ACCESS TO RISER ON 1ST FLOOR PRE  
CLEAN

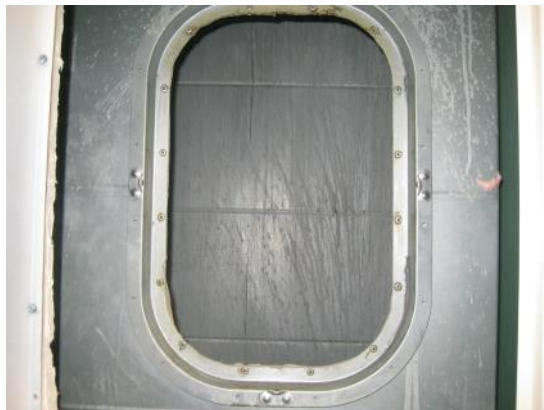
46. POST CLEAN

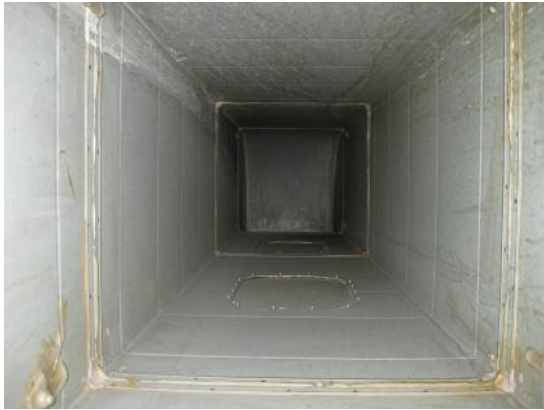
47. LOOKING DOWN THE RISER FROM 1ST FLOOR ACCESS PRE CLEAN

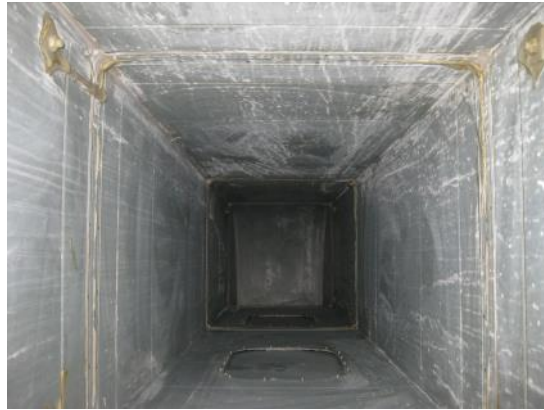
48. POST CLEAN

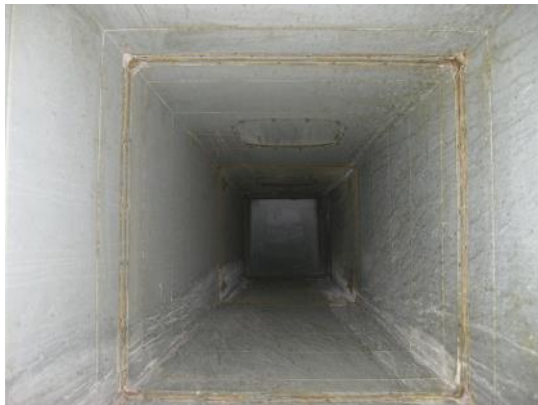
49. LOOKING UP THE RISER FROM 1ST FLOOR ACCESS PRE CLEAN

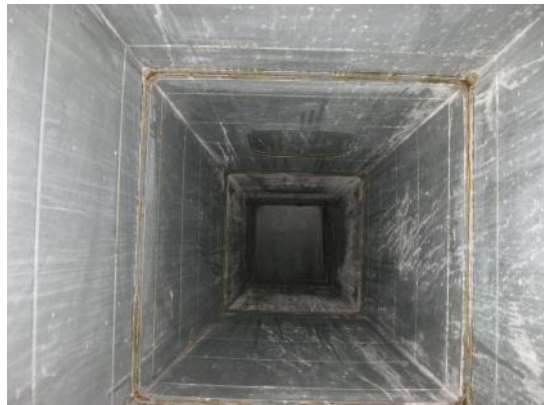
50. POST CLEAN

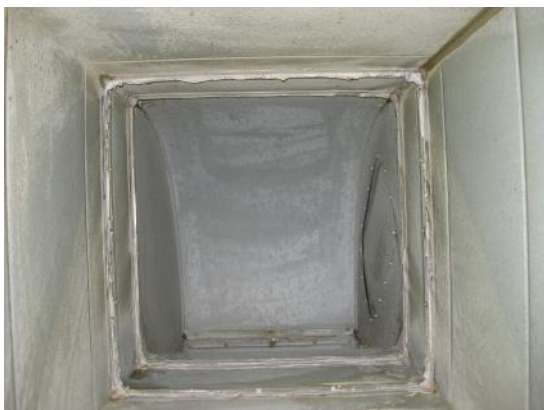
51. TOP OF THE RISER AT ROOF PLANT SPACE LEVEL PRE CLEAN

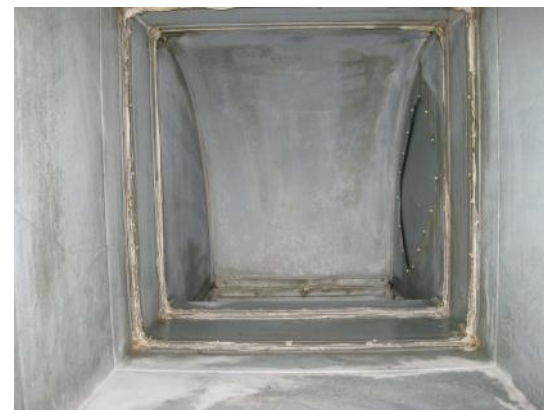
52. POST CLEAN

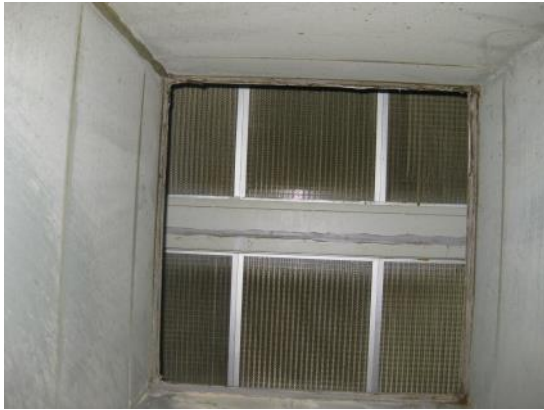
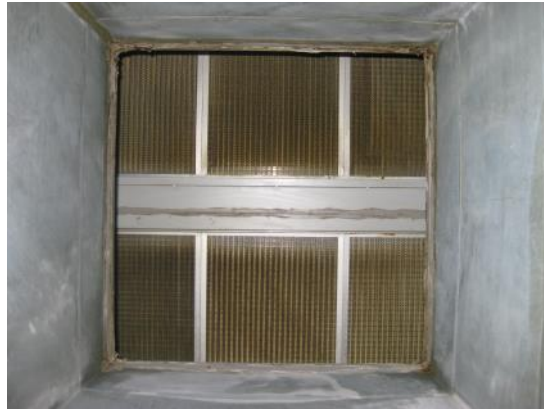
53. INTAKE TO ECOLOGY UNIT PRE CLEAN      54. POST CLEAN

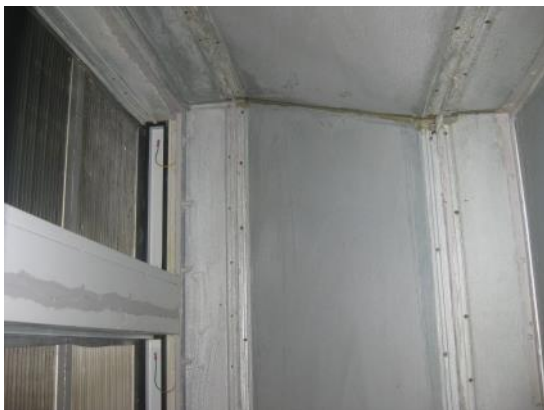
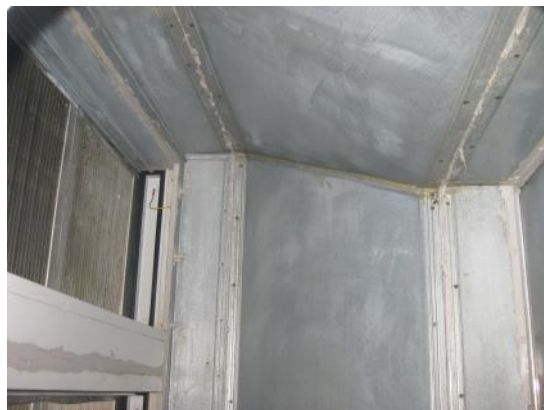
55. DISCHARGE FROM ECOLOGY UNIT PRE CLEAN      56. POST CLEAN

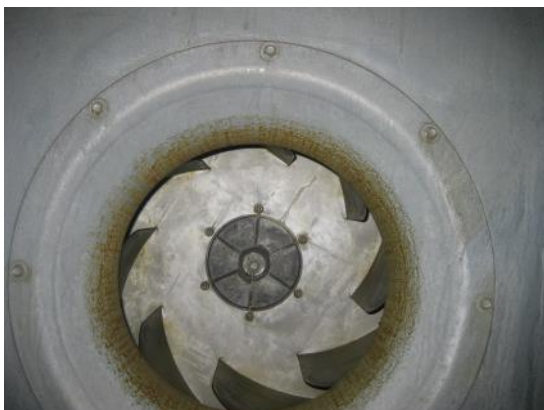
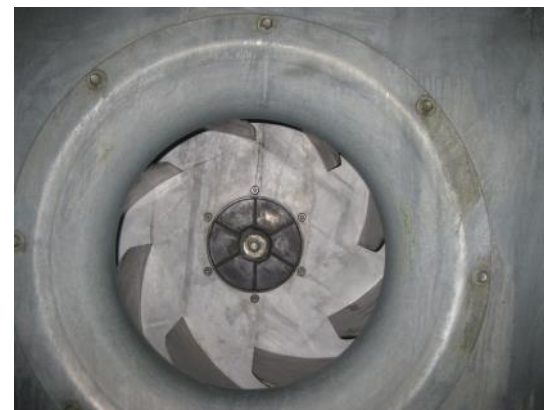
57. INTAKE TO EXTRACT FAN PRE CLEAN      58. POST CLEAN

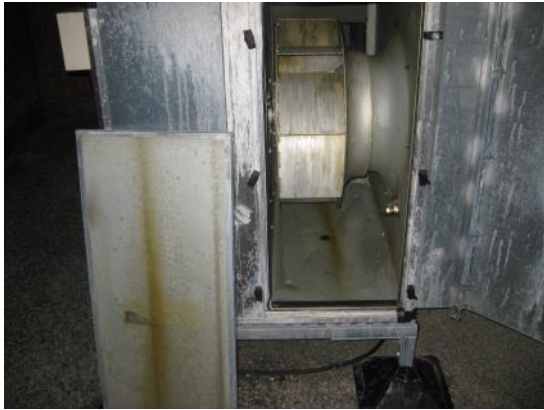
59. EXTRACT FAN AND CASING ON DEAD SIDE PRE CLEAN

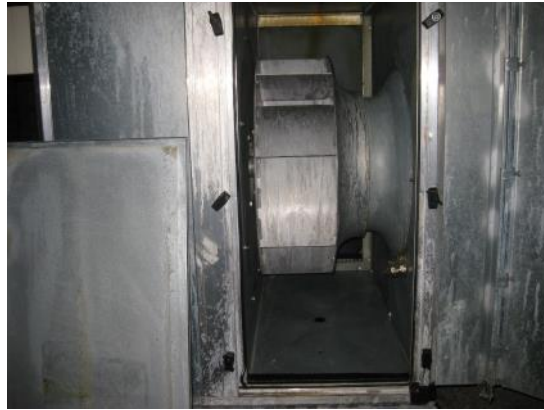
60. POST CLEAN

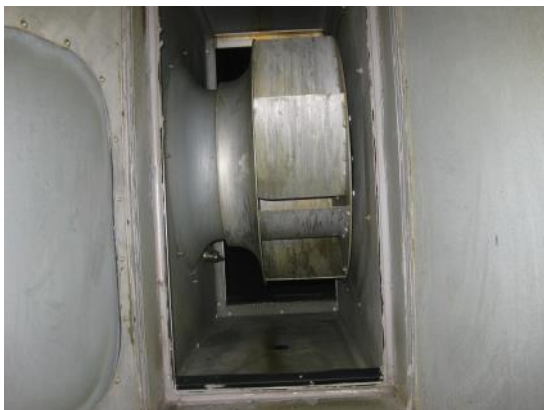
61. DISCHARGE FROM FAN TOWARD TURN TO SOUND ATTENUATOR PRE CLEAN

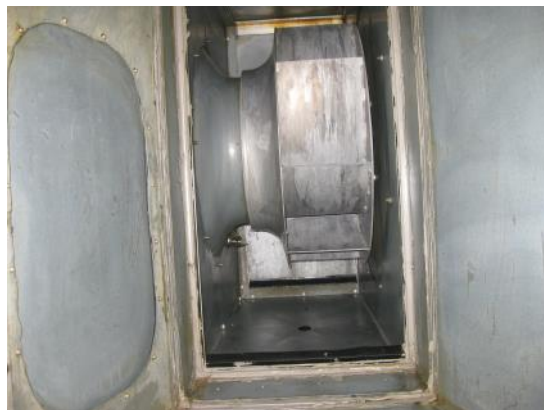
62. POST CLEAN

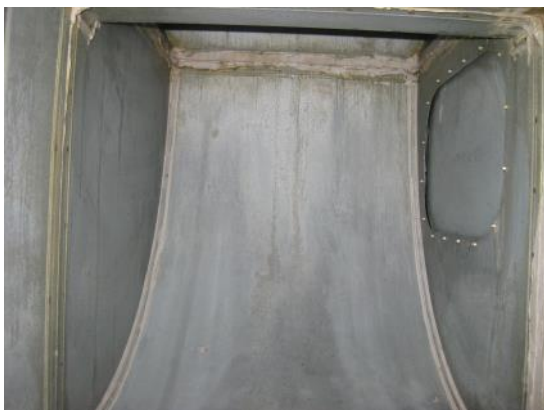
63. TURN TO INTAKE OF SOUND ATTENUATOR PRE CLEAN

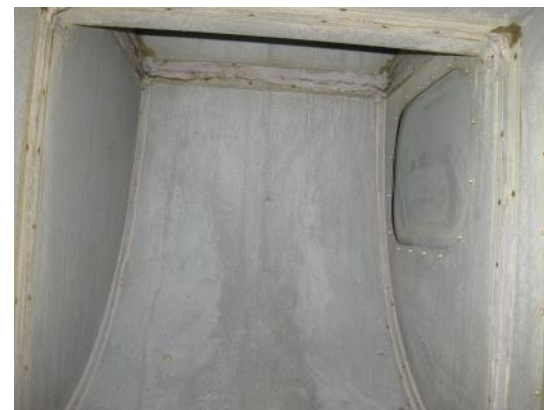
64. POST CLEAN

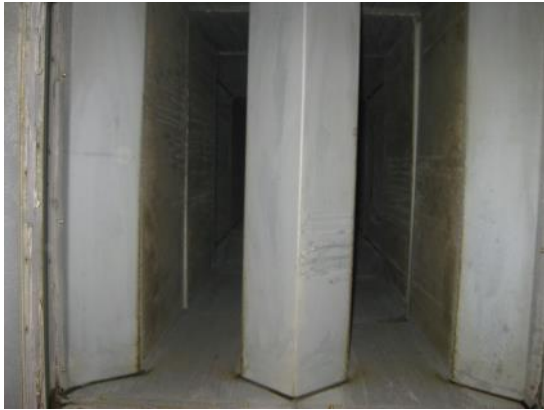
65. INTAKE TO SOUND ATTENUATOR  
PRE CLEAN

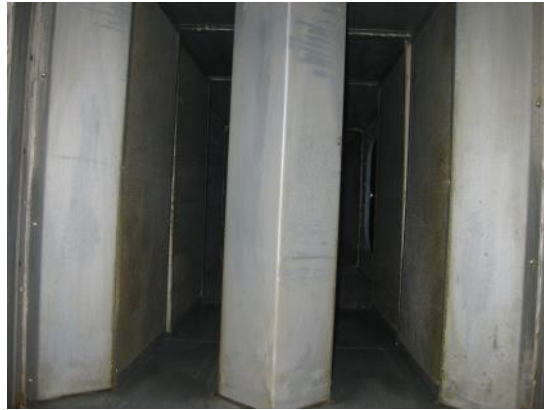
66. POST CLEAN - LIMITED CLEANING ON  
INTERIOR OF PANELS

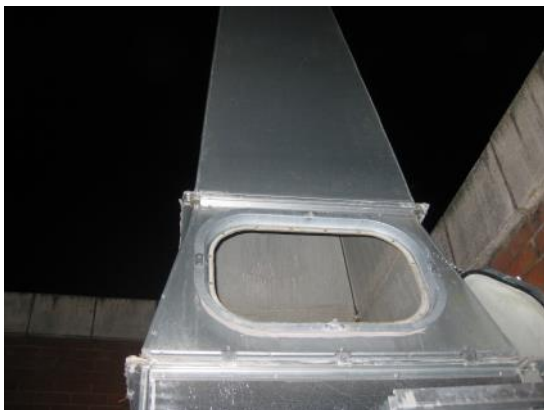
67. ACCESS TO DISCHARGE PRE CLEAN

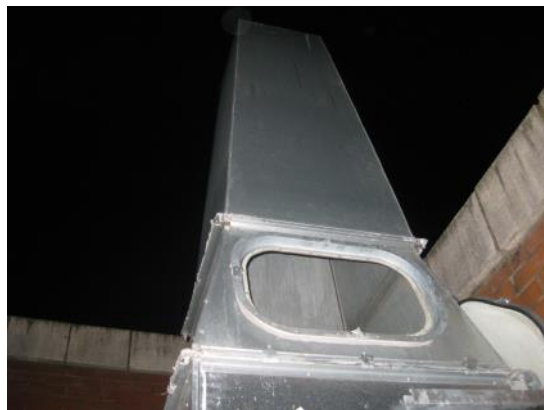
68. POST CLEAN

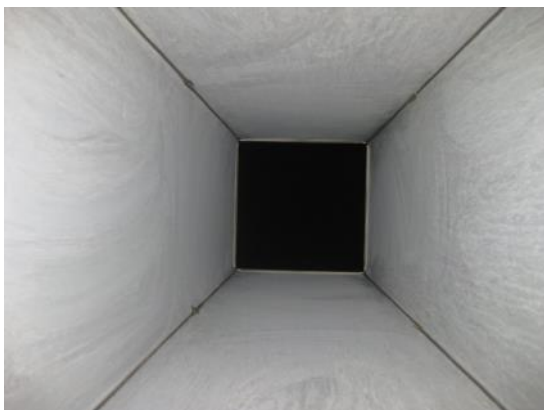
69. DISCHARGE TO ATMOSPHERE  
PRE CLEAN

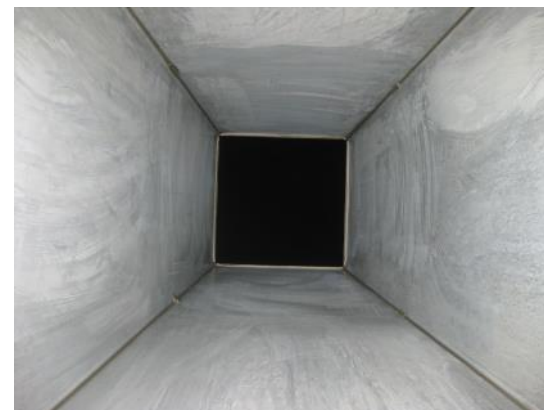
70. POST CLEAN
