Existing Harter Street Elevation extract 1:100  
Timber framed sash windows to be temporarily removed shown hatched

Temporary works - Typical jamb detail 1:2  
Window frames left in-situ and protected with timber boarding on sill, head and jambs

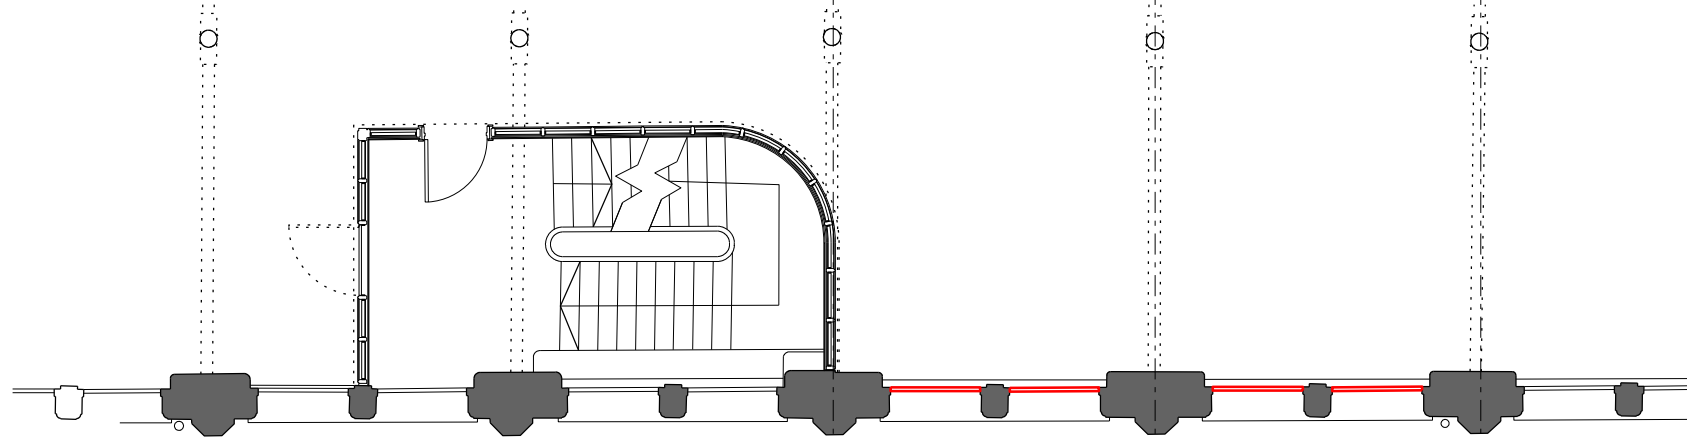
Existing Langley Building plan extract 1:100  
Windows to be removed shown in red

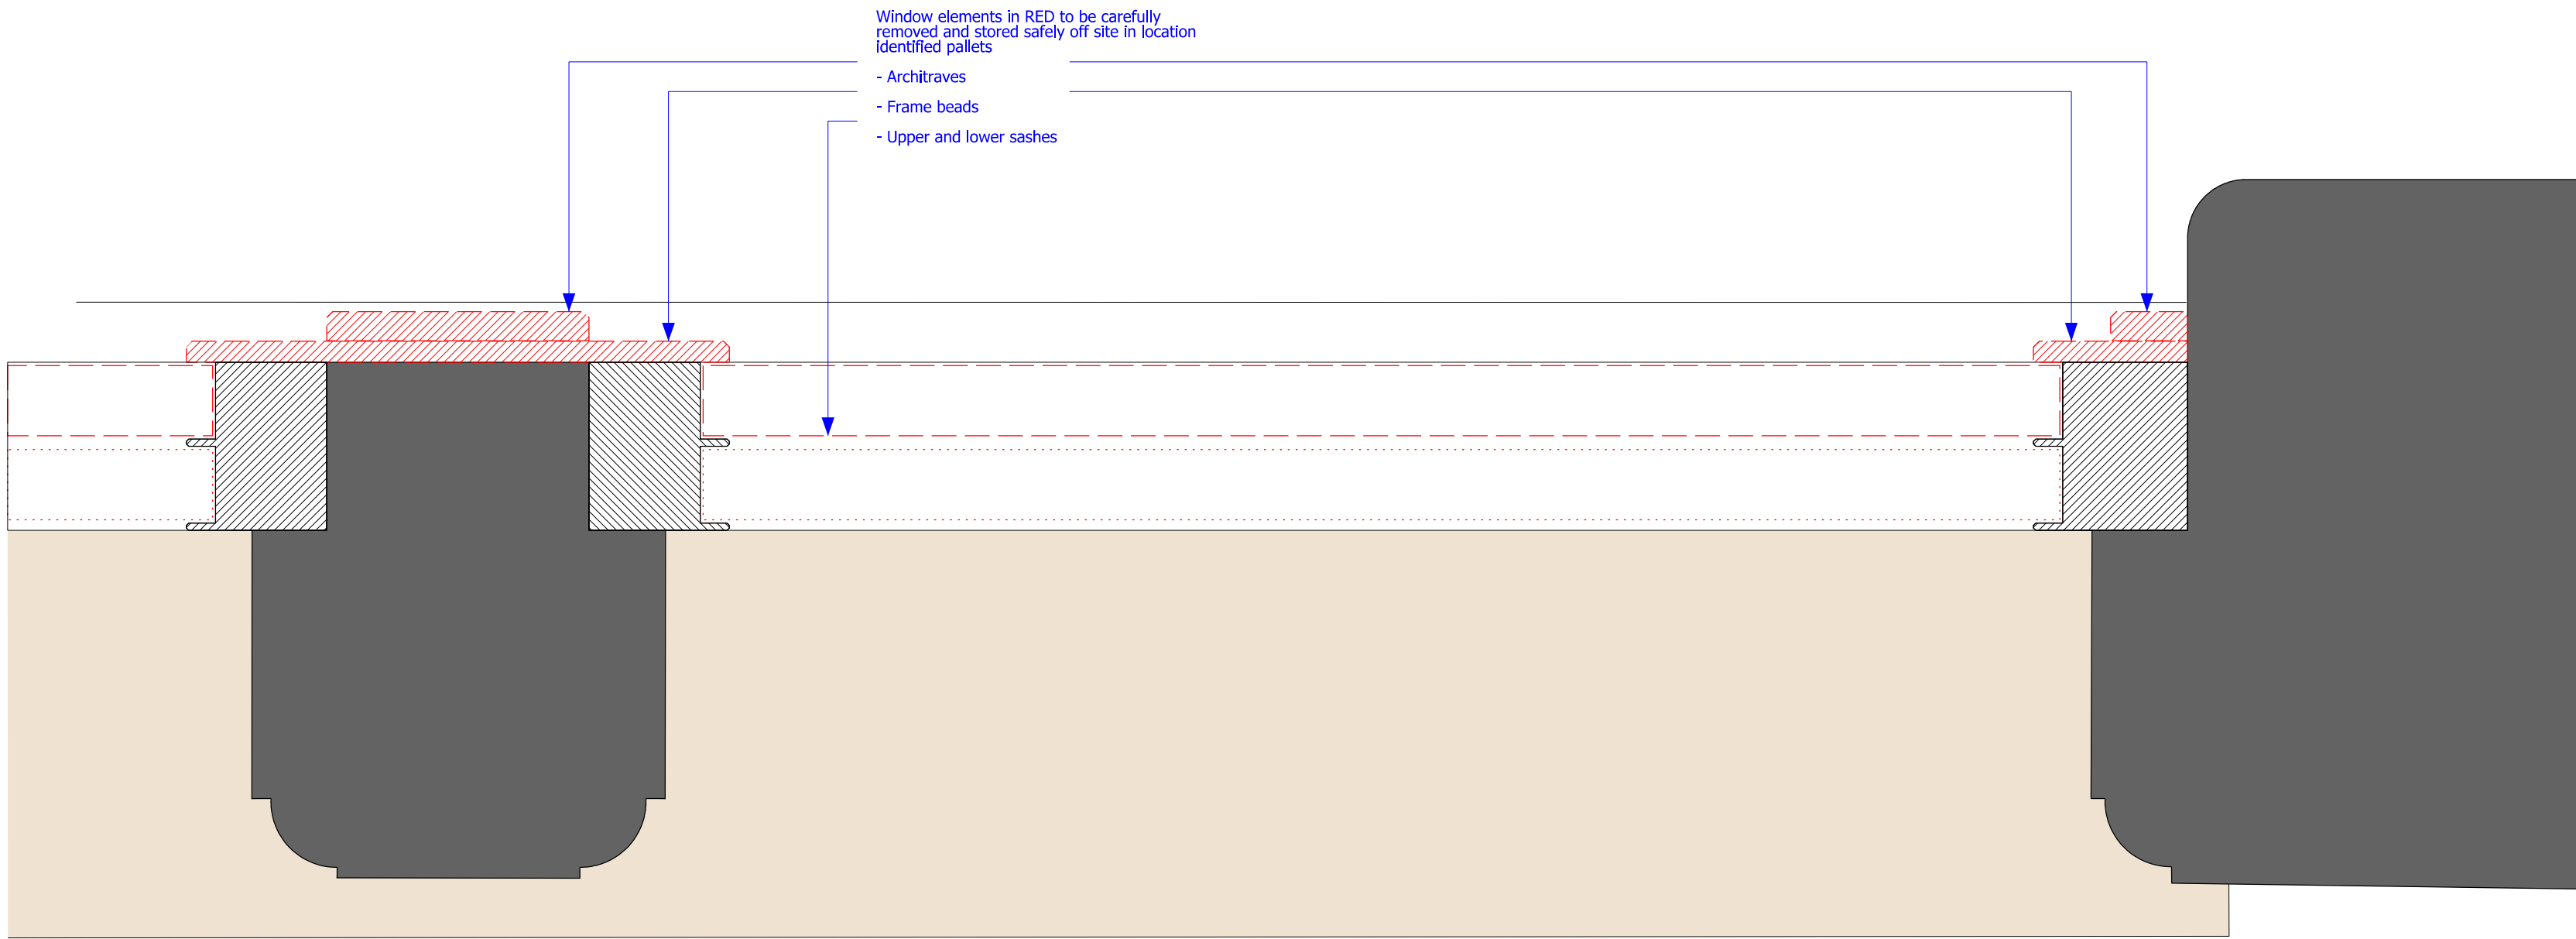
Existing - Typical jamb detail 1:2  
Window sashes, architraves and frame beads carefully removed
