**Marlsbro House, 52-54 Newton Street, Manchester**

Heritage Impact Assessment for Boohoo

December 2021

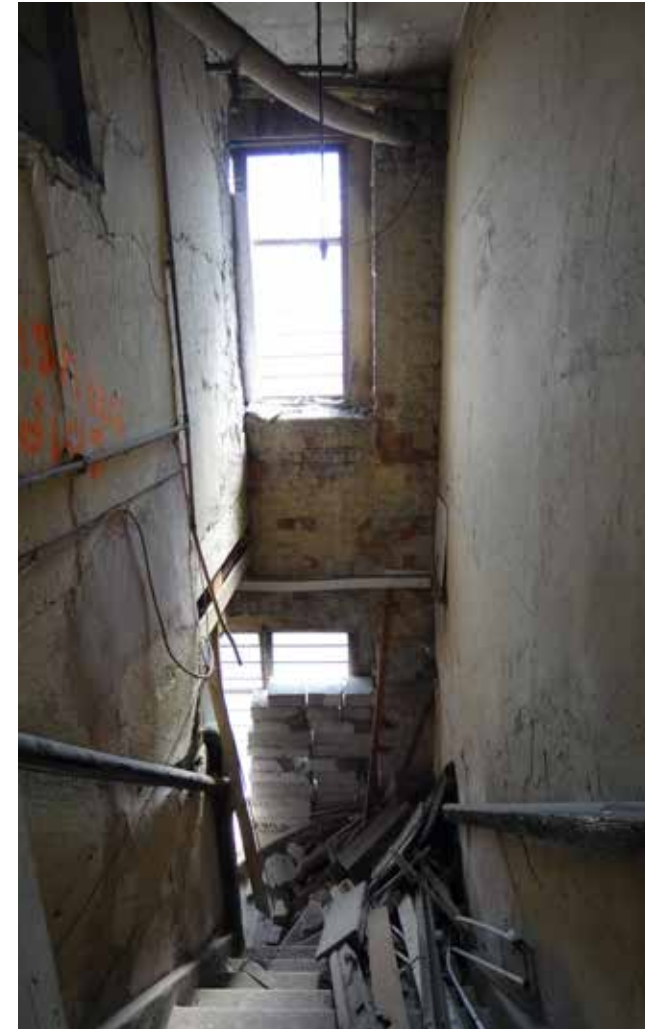
**3.79** T024 (2)

**3.80** T024 (11)

**3.81** T024 (14)

**T024** is a timber half-turn staircase which looks to be early- / mid-Victorian. The stair features timber treads and risers, with bull-nosed ends and timber stringers. The newel is a squared timber post with a depressed / shallow pointed top, and the handrails are also timber – turned to the NE wall (possibly early-20<sup>th</sup> century) and probably late-20<sup>th</sup> century replacement along the SW wall. It is capped at various floors – including to the second floor below with plasterboard. Access from the corridor is via a hefty timber boarded door, which looks to be from the 1960 works, and a plasterboard partition. The NE wall of the stair is made up of timber stud, with plaster over, timber plank, and a high level opening which contains breeze blocks. The NW external wall is brick, partially painted, it contains windows at third and second floor level – metal casements in arched lintels and will bull-nosed cills, bars over the second floor window. The third floor

window is split by an apparent extension of room T022. The SW wall is plastered. Drainage pipes and sprinkler pipes criss-cross the ceiling, plastic conduit is fixed to the walls [Plates 3.79-3.81].
