Ref: 12-757-L4-01  
Date: 15<sup>th</sup> December 2020

**Russell WBHO**  
13 Westpoint Enterprise Park  
Clarence Avenue  
Trafford Park  
Manchester  
M17 1QS

## **SUPPLEMENTARY GROUND INVESTIGATION REPORT (AREA 1) NEW SMITHFIELD MARKET**

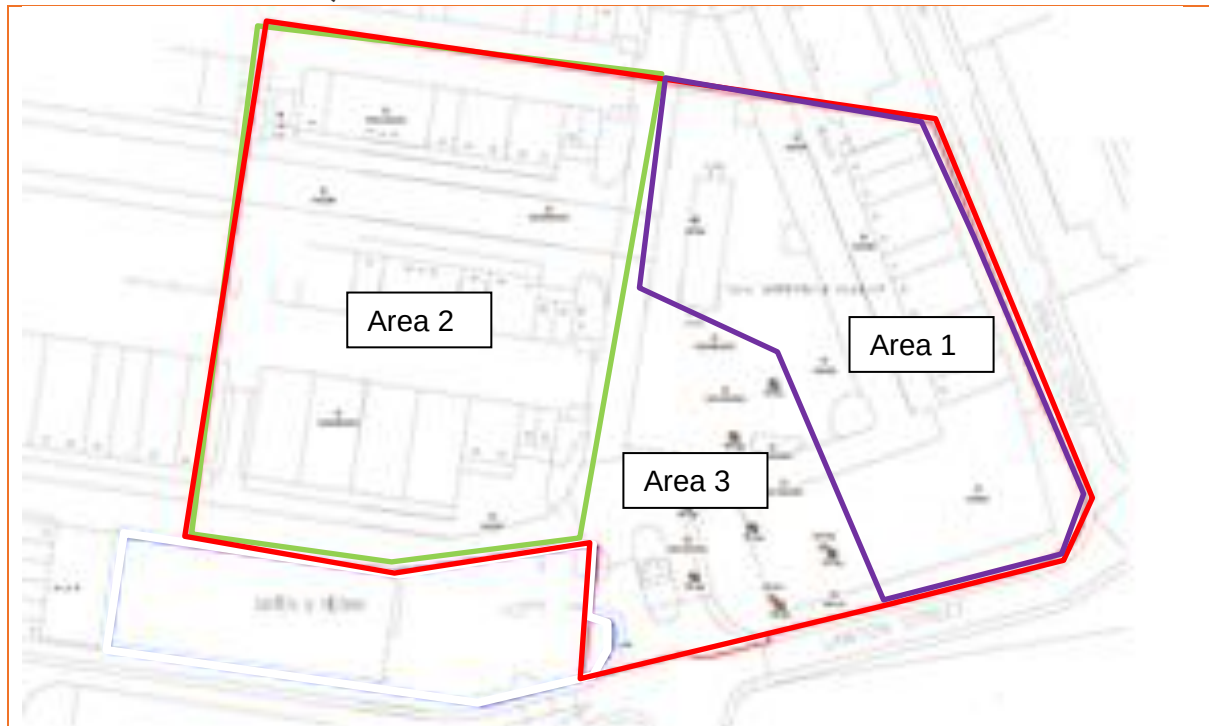
FIGURE 1 AREAS REQUIRING FURTHER INVESTIGATION

As these areas have now become accessible, E3P has completed additional trial pitting. The area shown as Area 1 within Figure 1 is the main discussion of this letter report. Area 2 will be assessed during a separate investigation when access becomes available. Area 3 has sufficiently been investigated at this time.

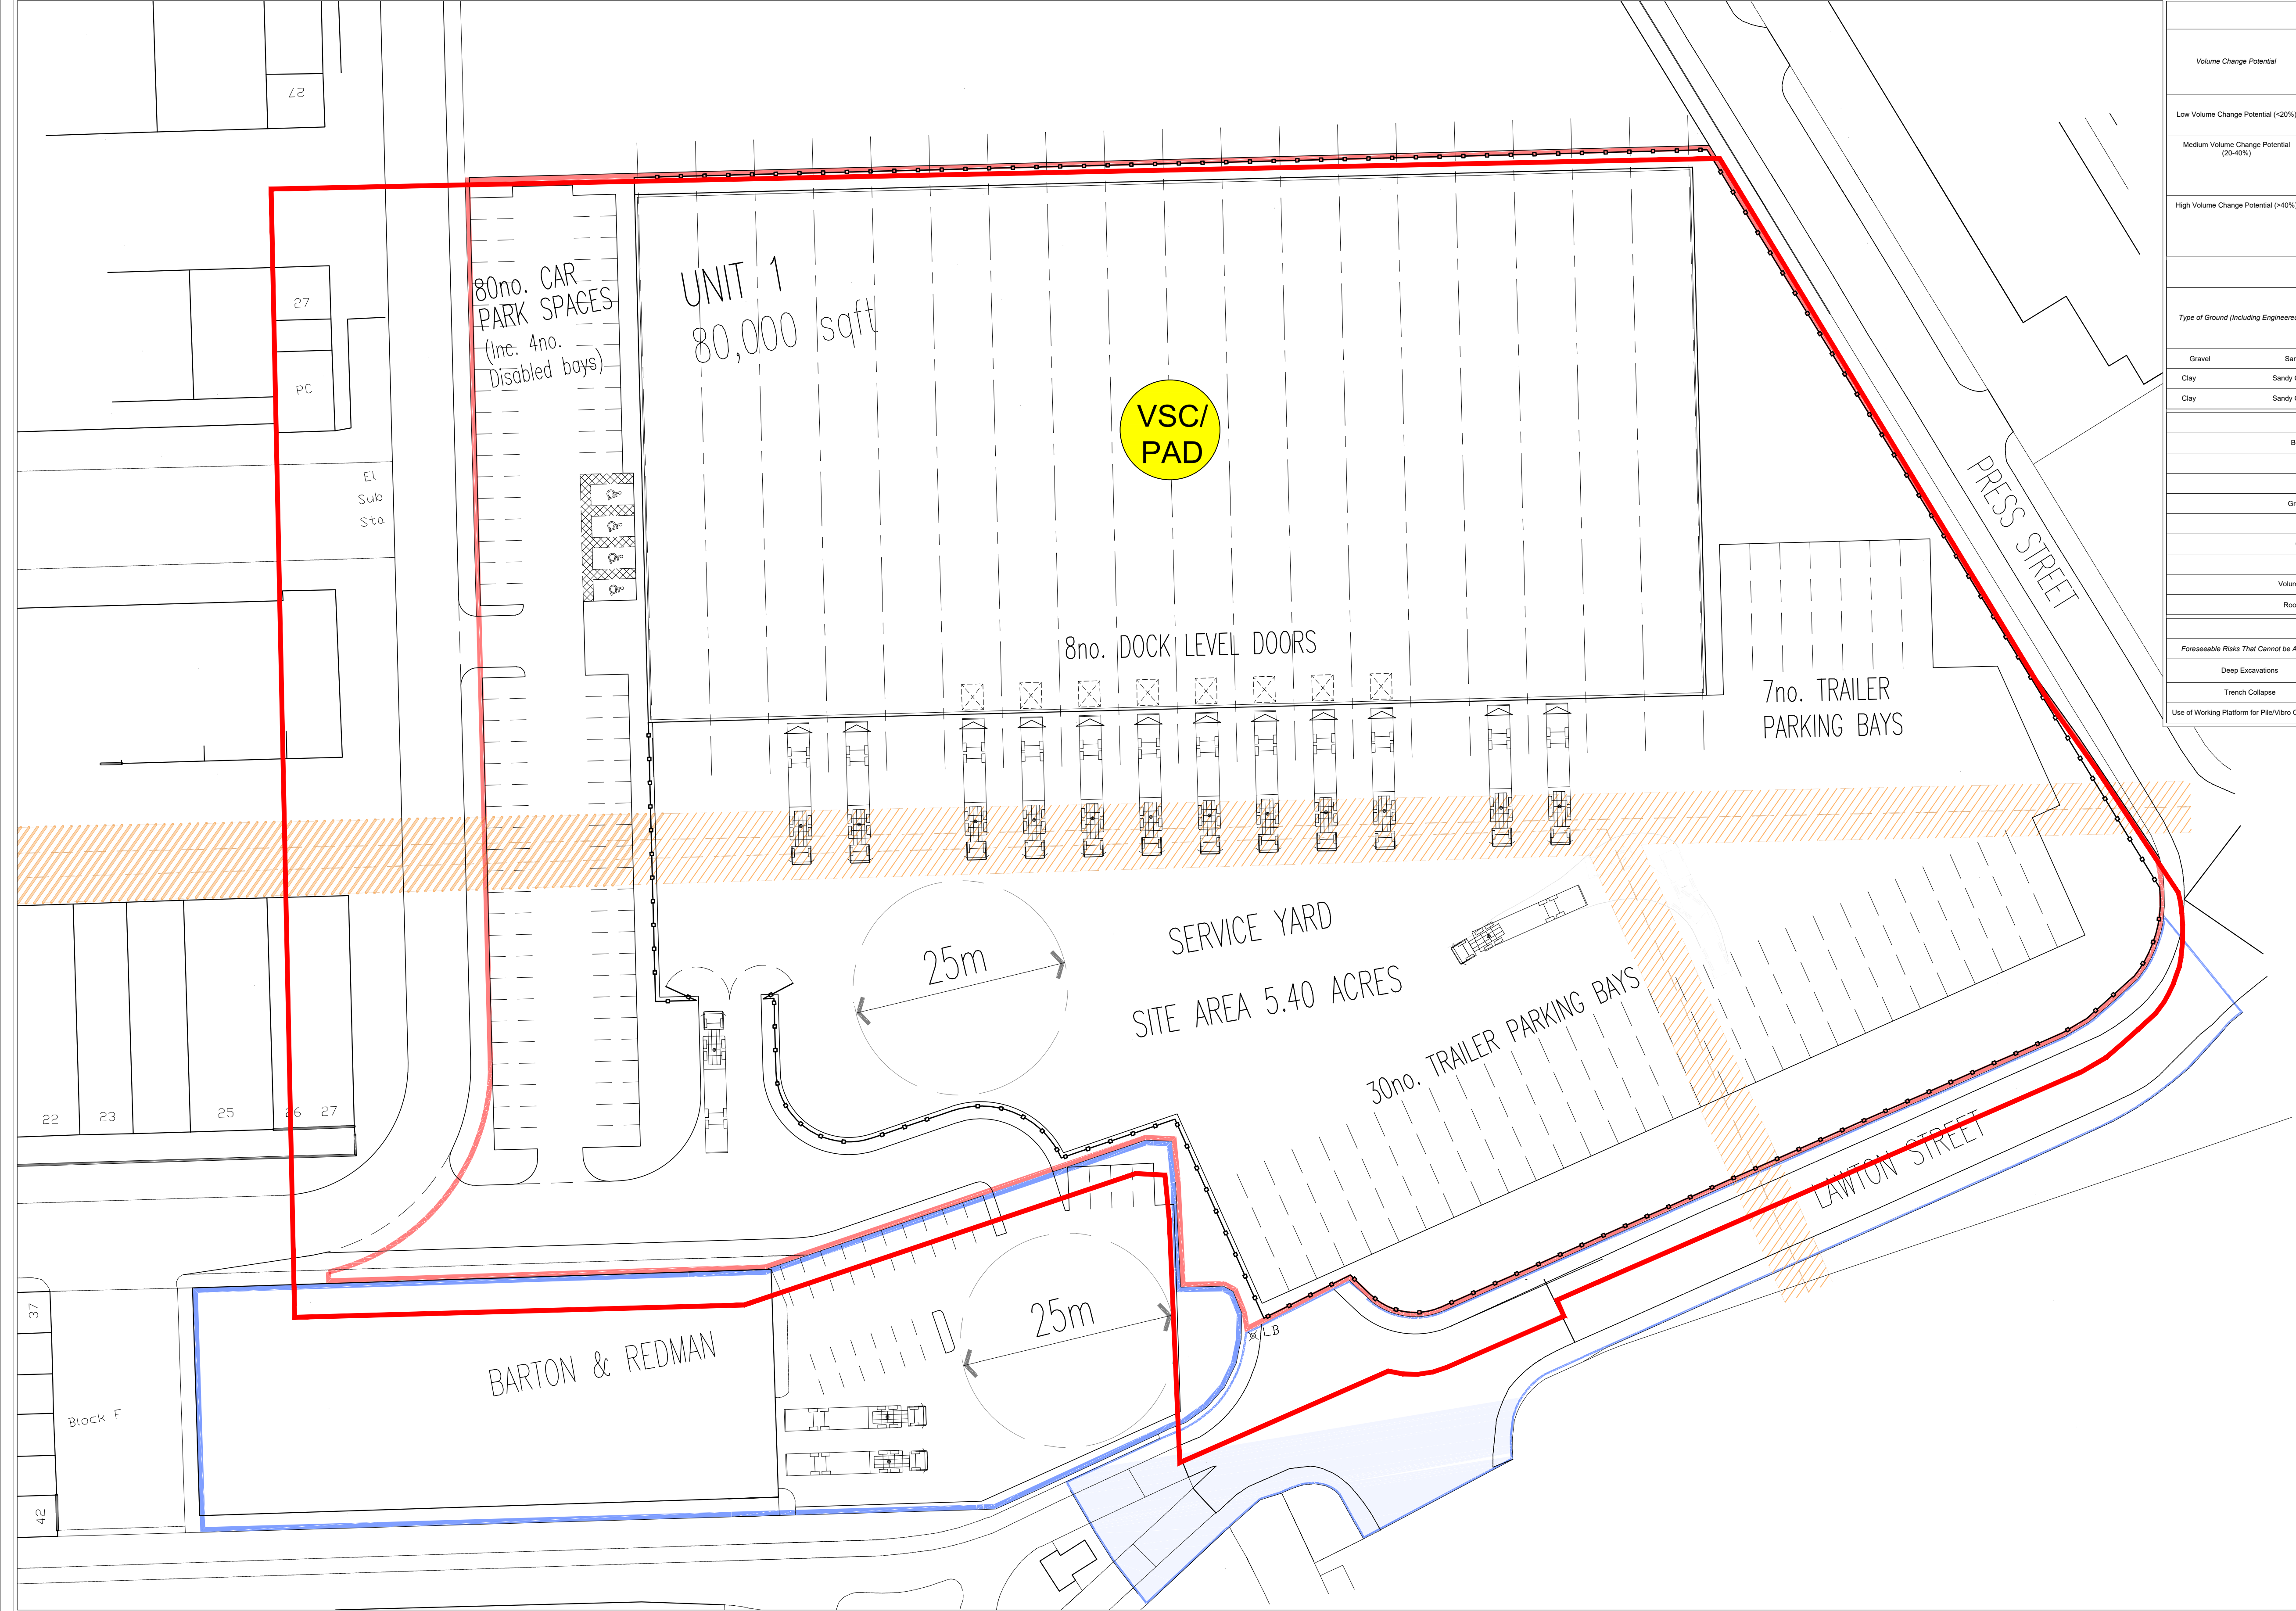
Concept Foundation  
Zoning Plan

- Anticipated Foundation Types**
- TS** Traditional Strip Foundations  
Minimum depth 1200mm below proposed First Floor Level.  
Maximum safe bearing pressure limited to 100kN/m2.

- MT** Mass Trench Fill Foundations  
Minimum depth 1200mm below proposed First Floor Level.  
Maximum safe bearing pressure limited to 100kN/m2.
  - V** Vibro Stone Ground Compaction  
In accordance with NRSBC Chapter 4.2.

- P** Piled Foundations  
Where the proposed foundation depth exceeds 2.50m a piled foundation option rather than a trench fill / deep reinforced strip foundations may be adopted. Columns or tie beams supported by ground beams.

- R** Raft Foundations  
Minimum safe bearing pressure limited to 50kN/m2 or approved engineer's greater. Raft foundations to be designed by a structural engineer in accordance with Chapter 4.5 of BS8100:2019. Raft foundations are considered suitable to mitigate against potential differential clay shrink / expansion in accordance with Section 4.2, sub-section 2(b).

- Depth to Target Founding Strata**
- Footings 0.75 - 0.90m Deep  
From First Floor Level  
In accordance with NRSBC Chapter 4.2
  - Footings 0.90 - 1.25m Deep  
From First Floor Level  
In accordance with NRSBC Chapter 4.2
  - Footings 1.25 - 1.50m Deep  
From First Floor Level  
In accordance with NRSBC Chapter 4.2
  - Footings 1.50 - 1.75m Deep  
From First Floor Level  
In accordance with NRSBC Chapter 4.2
  - Footings 1.75 - 2.00m Deep  
From First Floor Level  
In accordance with NRSBC Chapter 4.2
  - Footings 2.00 - 2.25m Deep  
From First Floor Level  
In accordance with NRSBC Chapter 4.2
  - Footings 2.25 - 2.50m Deep  
From First Floor Level  
In accordance with NRSBC Chapter 4.2

Upon completion of these enabling works, it is likely that the most cost effective option for the majority of the site would be to utilise shallow pad foundations to support the portal frame of the proposed commercial/industrial building bearing at least 500 mm below the stiff to very stiff medium to high strength cohesive soils.

A detailed foundation zoning plan is included as Drawing 12-757-009 in Appendix III.

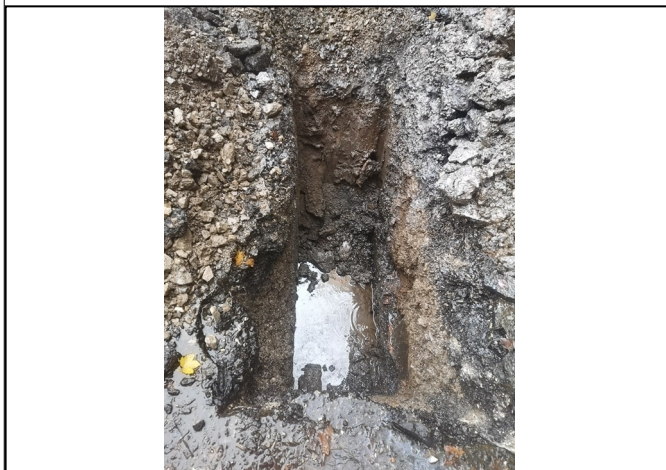
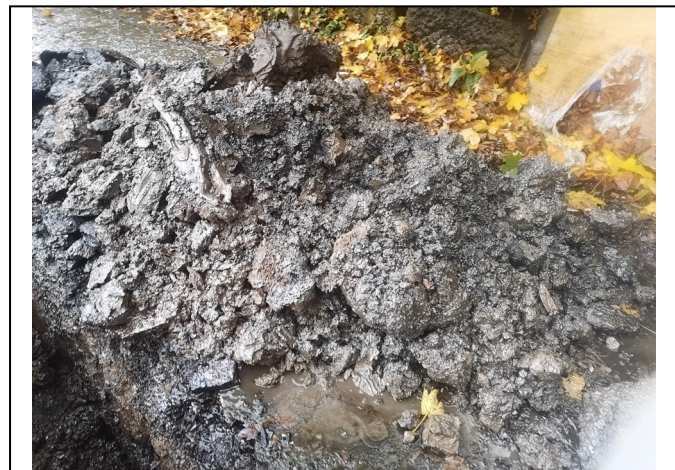
Trial Pit 201

Made Ground typically comprises concrete/asphalt underlain by a grey sandy gravel sub-base. Underlying this a black sandy gravel was encountered between 0.60 m bgl and 1.40 m bgl within TP201 with gravel of brick, asphalt and clinker. A strong hydrocarbon odour and visible sheen were also recorded within this stratum. TP201 was undertaken in a similar area to the previously undertaken WS201 which identified a gravelly reworked clay to 1.90m with a hydrocarbon odour and rare black staining.

Remarks: 1. Terminated at 1.60 m bgl due to water ingress and hydrocarbon impact. 2. Water strike encountered at 1.30 m bgl. 3. Strong hydrocarbon odour and oil substance encountered at 0.60 - 1.40 m bgl.

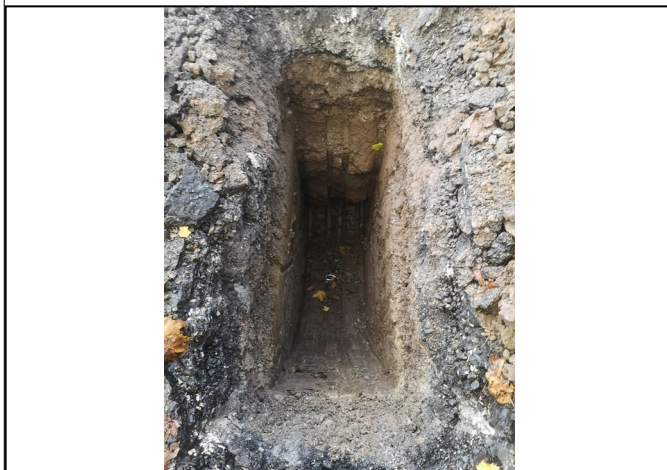
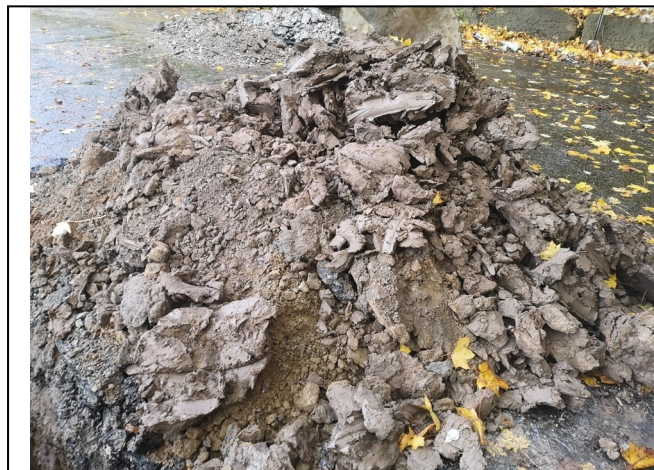
Trial Pit 202

Remarks: 1. Complete. 2. Strong hydrocarbon odour with sand at 0.70 - 1.60 m bgl.

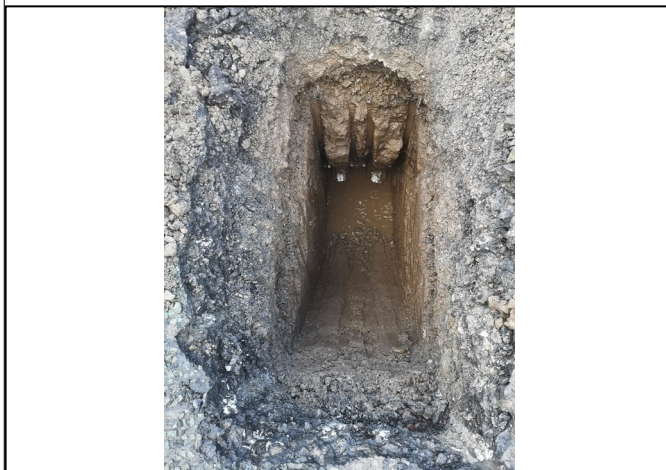
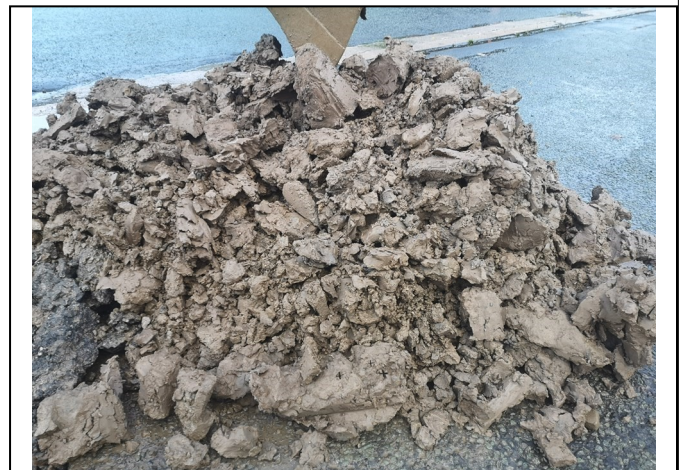
Trial Pit 204

Remarks: 1. Complete. 2. Water strike encountered at 0.60 m bgl as perched water.

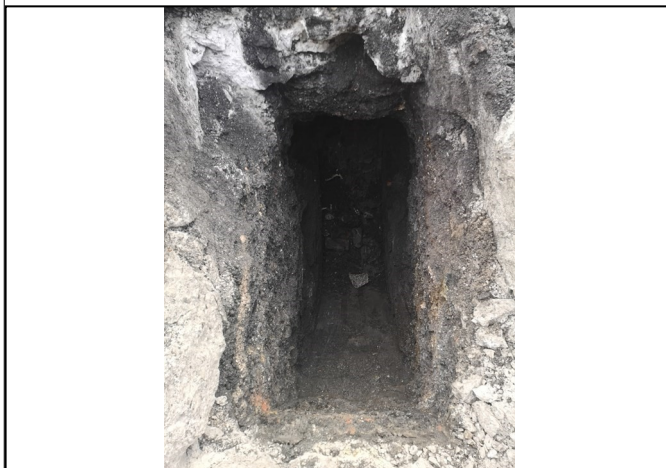
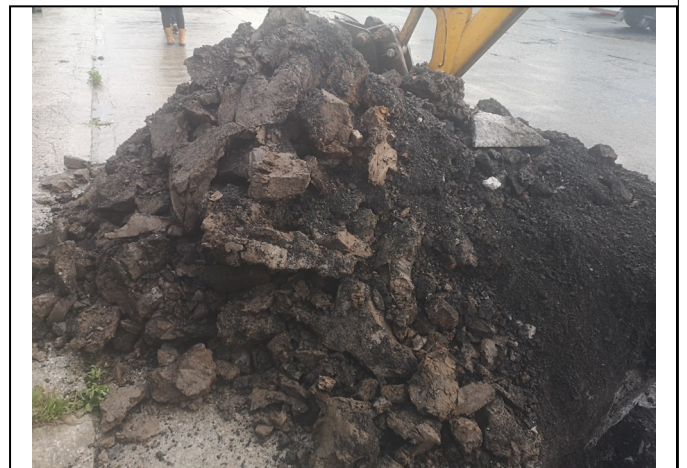
Trial Pit 207

Remarks: 1. Complete. 2. Slightly unstable within loose Made Ground fill between 0.35 m bgl and 1.80 m bgl.
