Our Ref: BEK/19661/211101/CGL/P43

**Residential Development at Ilk Street and Alpine Street, Clayton- PLOT 43**

BEK Enviro (BEK) has been commissioned by The Casey Group (CG) to supervise and validate the remediation works required at the above site.

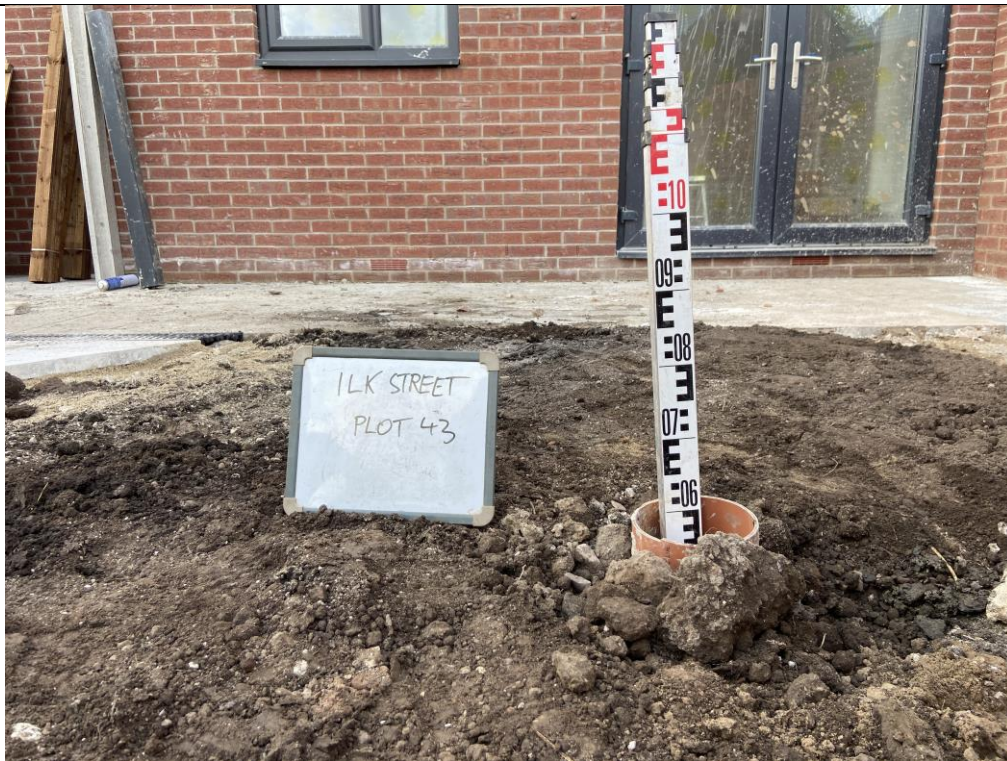
Photograph 1: Validation of Garden Capping Thickness

Following placement of the validated soils by CG, an engineer from BEK carried out spot checks and can confirm that the capping layer for Plot 43 comprises in excess of 600 mm of suitably clean validated soils. The capping soils overly a geotextile membrane at the base. Photographs showing capping thickness are provided within Annex E.

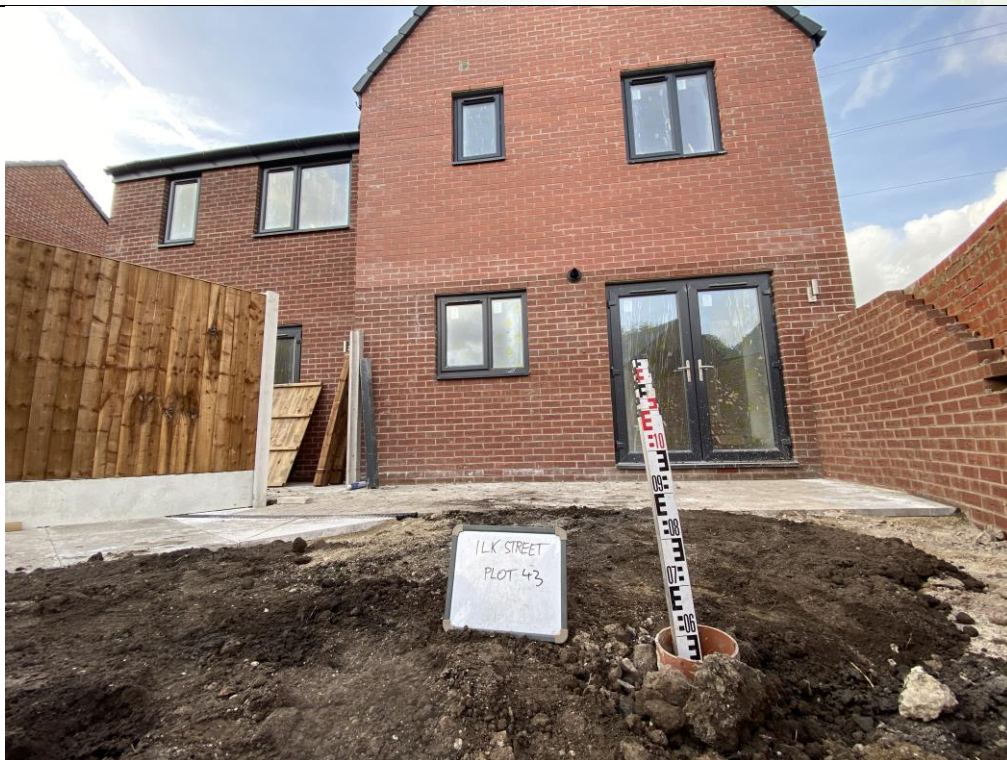
Photograph 2: Validation of Garden Capping Thickness

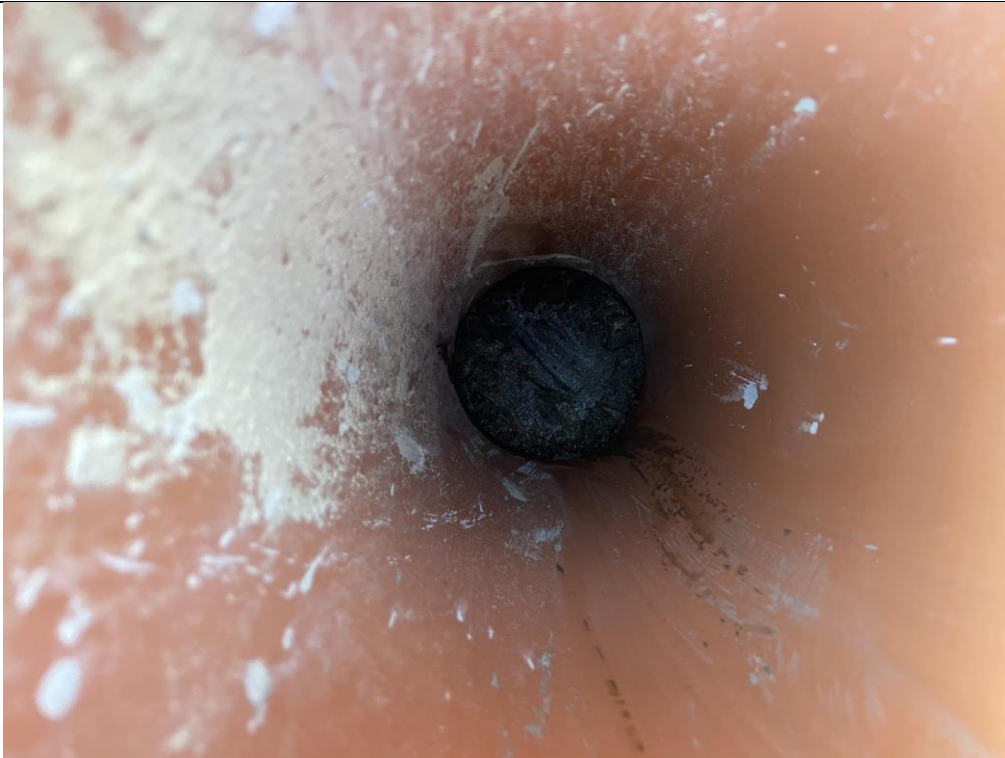
Photograph 3: Validation of Geotextile Membrane

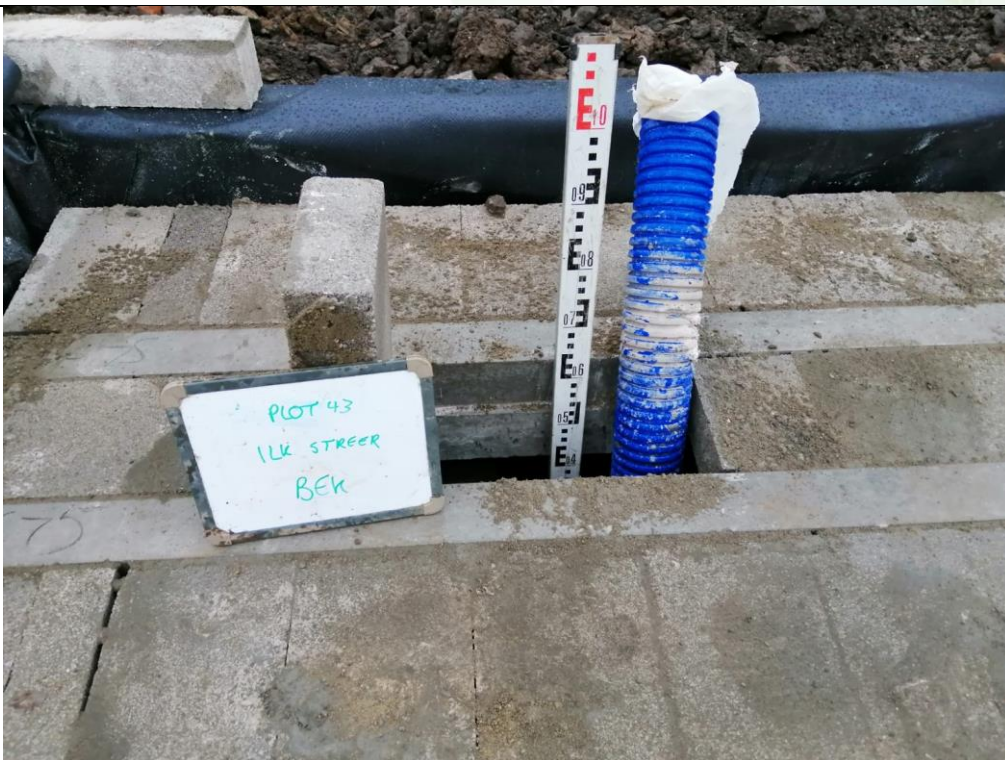
Photograph 4: Validation of Sub-Floor Void Space (min 150 mm)

The sub-floor void and the installation of the membrane has been validated and BEK can confirm the gas measures incorporated into the foundation design of Plot 43 conforms to the specified requirements. The membrane installation was verified by an Engineer from BEK who has attended the Verification of Gas Protection Systems Course delivered by CL:AIRE Training Course.

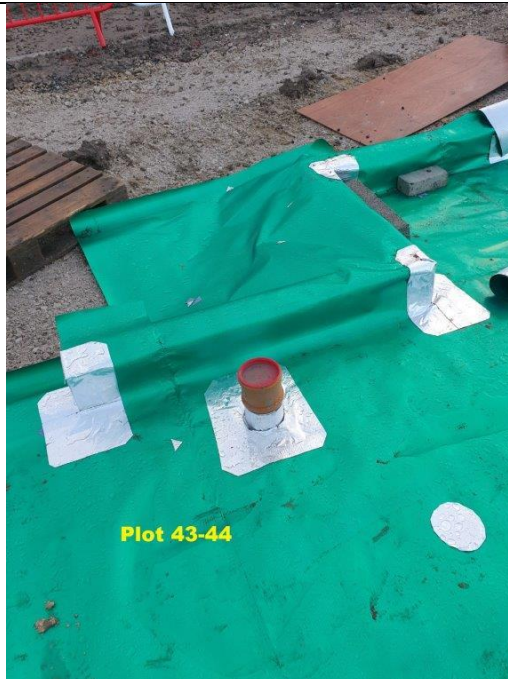
**Photograph 5:** Validation of Gas Membrane Installation (Please note, plots 43 and 44 are semidetached and were validated together. Gas membranes are satisfactory within both plots)

CG commissioned Reeve-Tec Membranes Limited to install the gas membranes at the site, who have used the Protech GM Super gas membrane which is considered suitable for use. A copy of the data sheet for this membrane is presented in Annex C. The completed gas validation proforma for this plot is presented in Annex D and validation photographs are presented in Annex E.

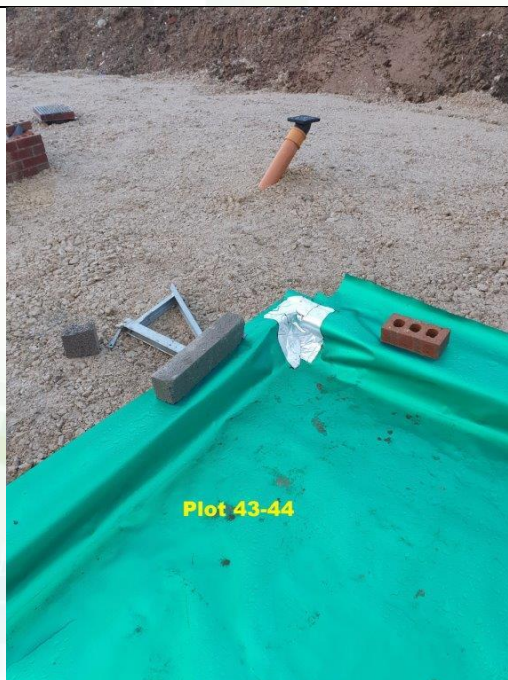
**Photograph 6:** Validation of Gas Membrane Installation (Please note, plots 43 and 44 are semidetached and were validated together. Gas membranes are satisfactory within both plots)

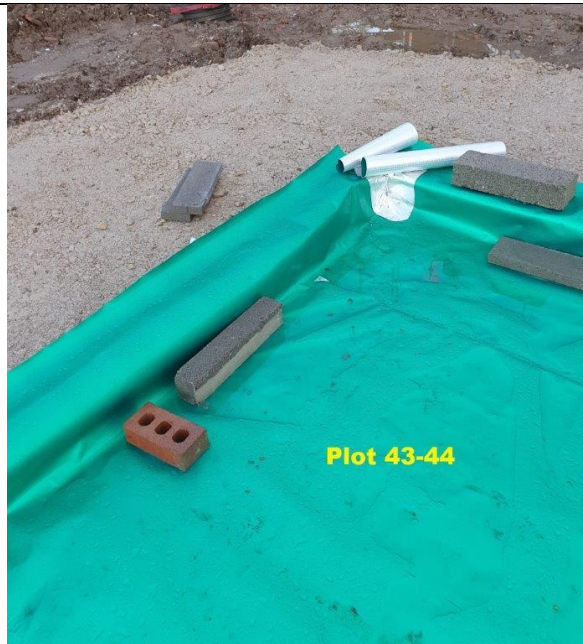
**Photograph 7:** Validation of Gas Membrane Installation (Please note, plots 43 and 44 are semidetached and were validated together. Gas membranes are satisfactory within both plots)

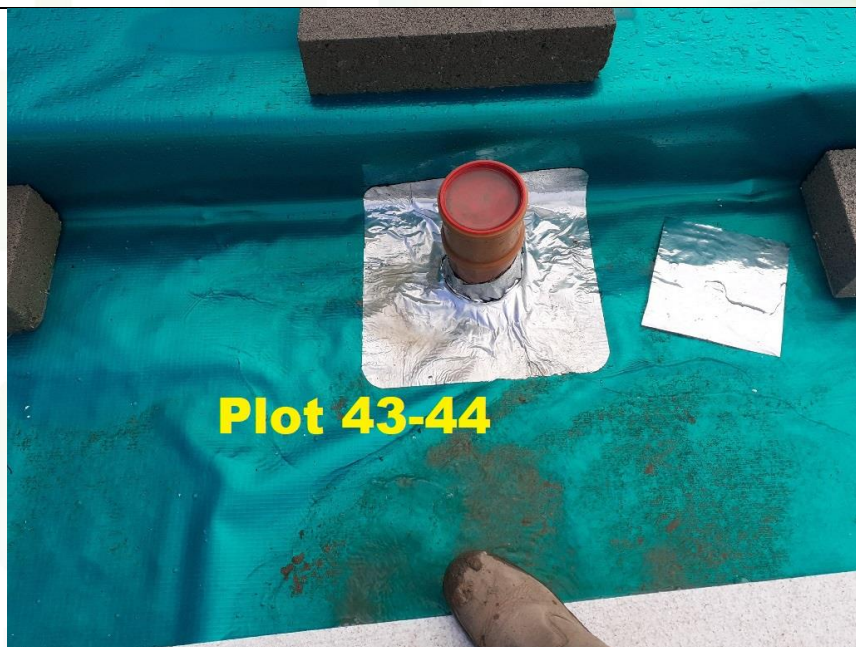
**Photograph 8:** Validation of Gas Membrane Installation (Please note, plots 43 and 44 are semidetached and were validated together. Gas membranes are satisfactory within both plots)
