**HOUGH END HALL  
CHORLTON  
MANCHESTER**

**HERITAGE ASSESSMENT**

## DECEMBER 2021

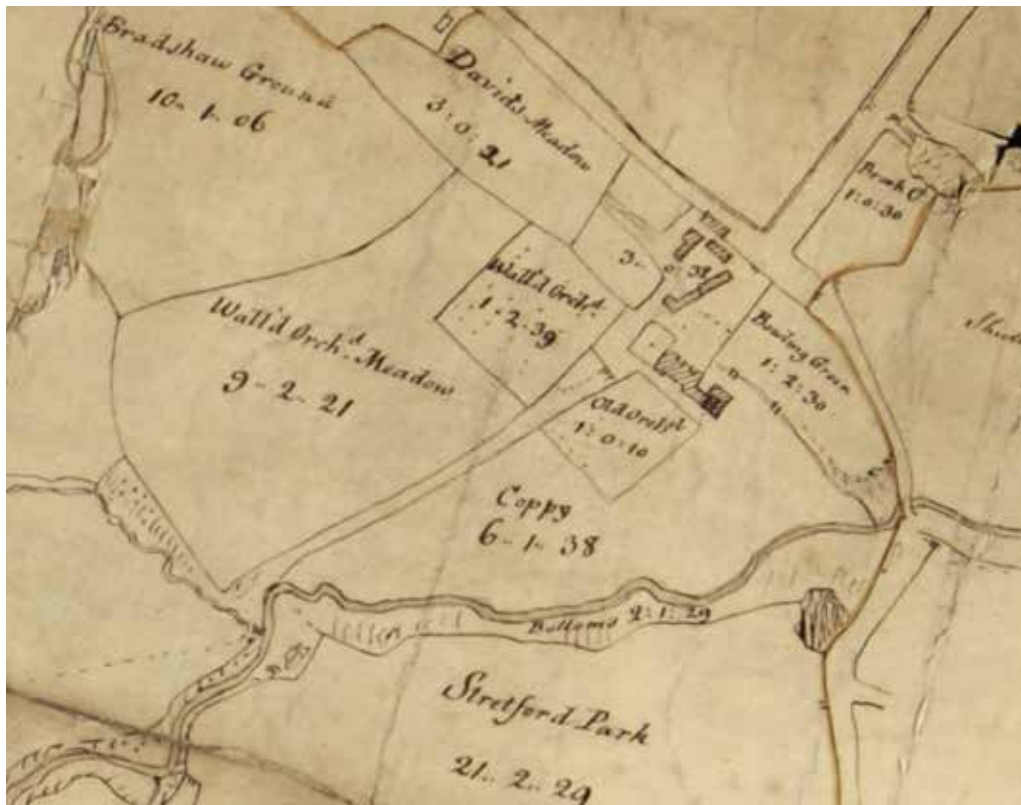
Figure 3- estate map of 1768

- 2.5 The Hall has seen substantial changes both to its fabric and its setting, since it was first built. The earliest map, an estate map of 1768 from the Egerton era, shows the building with its surrounding fields, including orchards, and intriguingly, a bowling green (Figure 3). A series of outbuildings are also shown on the plan, and what appears to be a walled garden. The OS map of 1845 (Figure 4) shows the same outbuildings still located to the south west of the Hall, with an orchard to the rear, and a formal garden fronting the house. At this date, the Hall was still firmly associated with the field systems which surrounded the evolving city of Manchester, with little indication of the growing suburbs.

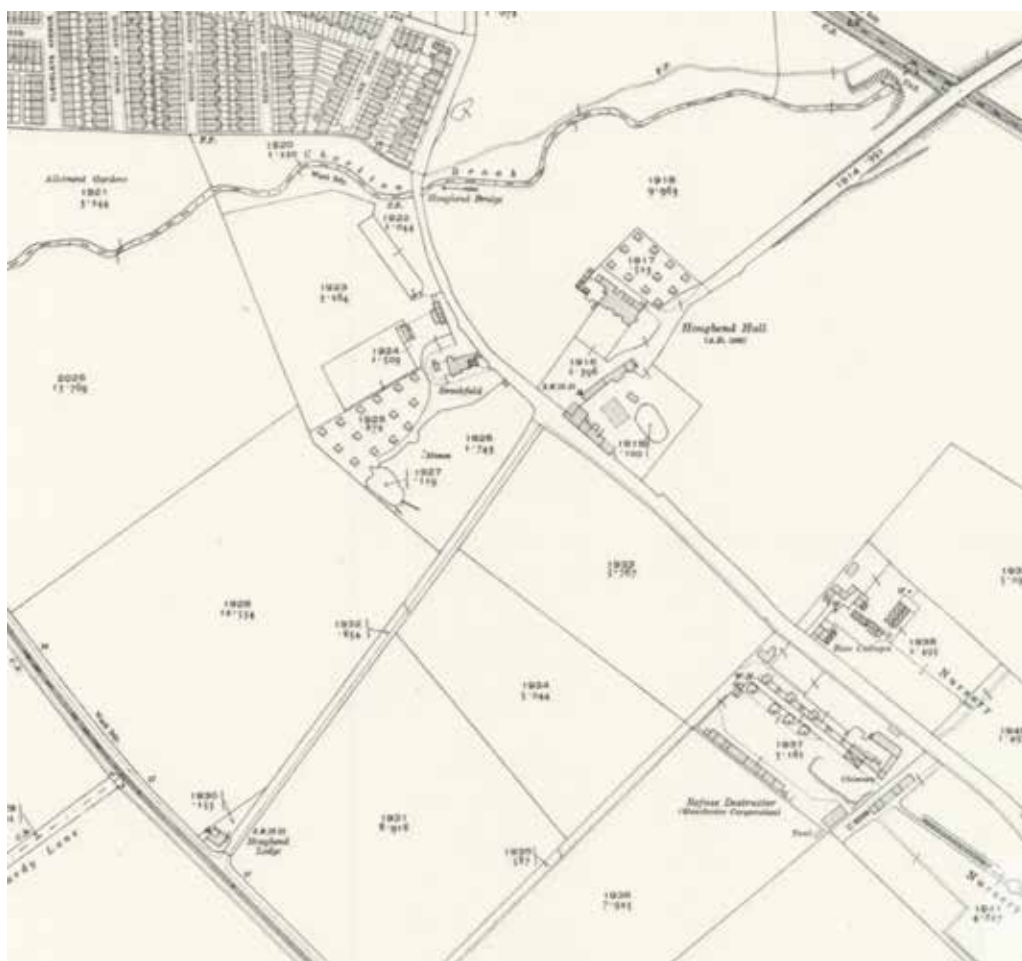
Figure 6- OS map, 1916

- 2.7 Even as late as the 1916 OS map (Figure 6) the Hall retained its essential rural setting, despite the proximity of the terraced streets to the north west, and the municipal waste disposal site located to the south. The 1916 plan shows that the rear of the Hall, and its northern wing to have a series of extensions, and these alterations to the building are noted in a description of Hough End Hall contained in the Victoria County History Series, dating from 1911. The Hall is described as:

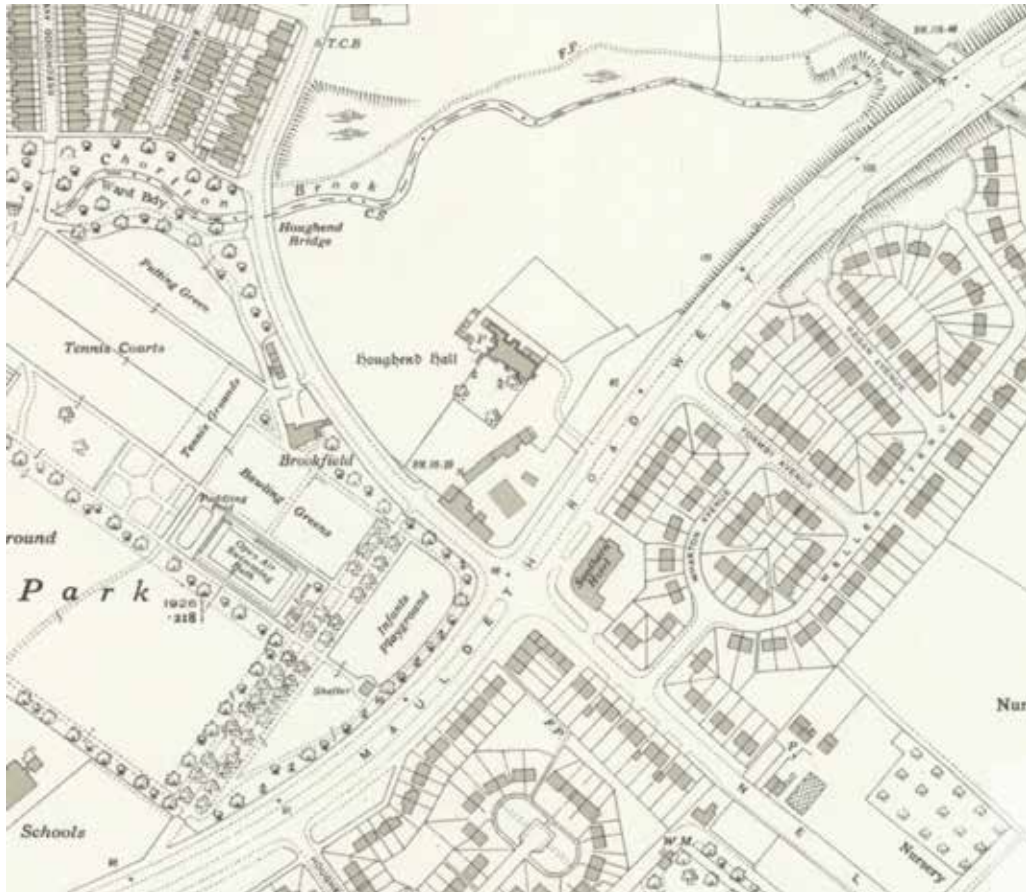
Figure 7- OS map, 1935

- 2.8 By 1935, the Hall was largely engulfed by the encroaching suburbs, although the adjacent Chorlton Park retained at least some semblance of the approach. To the south, Mauldeth Road West had been constructed, and residential suburbs built, whilst to the north west the areas of terraced streets had expanded almost to Chorlton brook (Figure 7). Nevertheless, the Hall retained its series of outbuildings, its rear accretions and the elongated northern wing of the house.

- 2.9 Whilst the setting of the Hall shown in Figure 7 had changed dramatically since the previous OS map of 1916, the late 1960's saw the development of office buildings within the grounds of the Hall, which required the demolition of the ancillary buildings, and which blocked views of the Hall from Nell Lane. This has been exacerbated by the construction of Chorlton High School to the rear of the Hall, and a metal fence now divorces the building from its original curtilage (Figure 8). The Hall is now totally surrounded by modern buildings, with associated security fences and car parking, hard standing and access roads, and nothing remains of the original setting. In terms of the sensitivity required in considering heritage harm to the setting of a grade II\* listed building, which acquired that status in 1952 before the construction of the office blocks which now engulf it, there is little evidence that this was considered in any meaningful way when planning permission was granted.

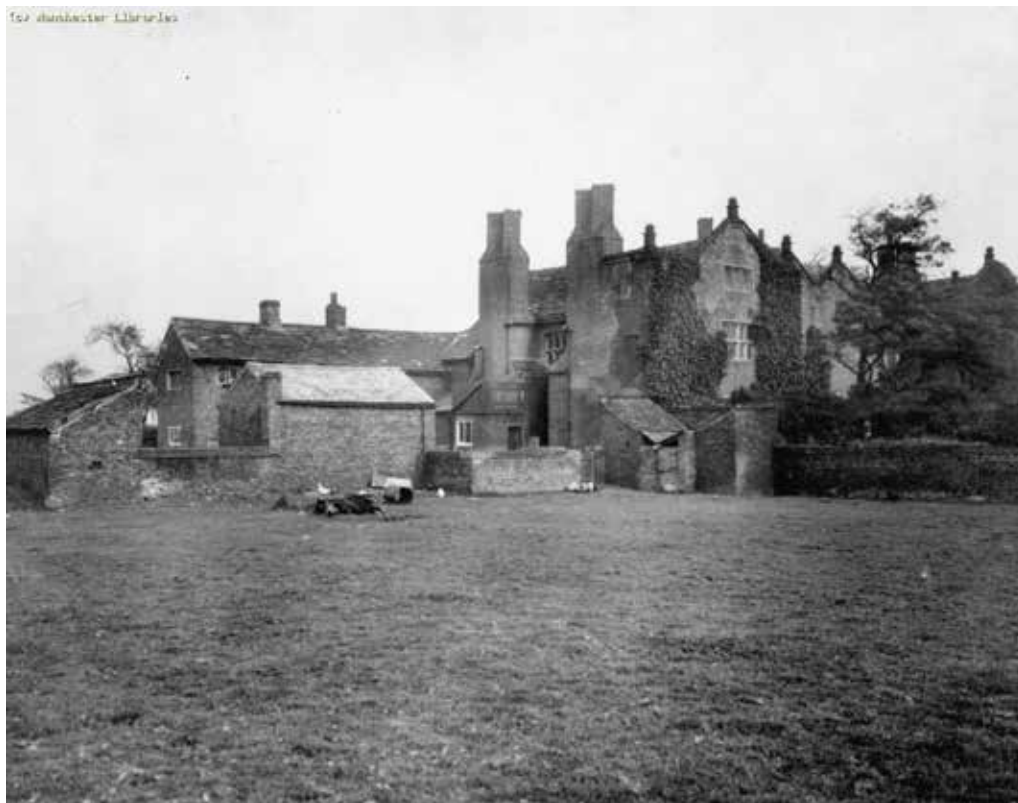
Figure 9- northern wing and linear extension, 1923 (Manchester City Libraries).

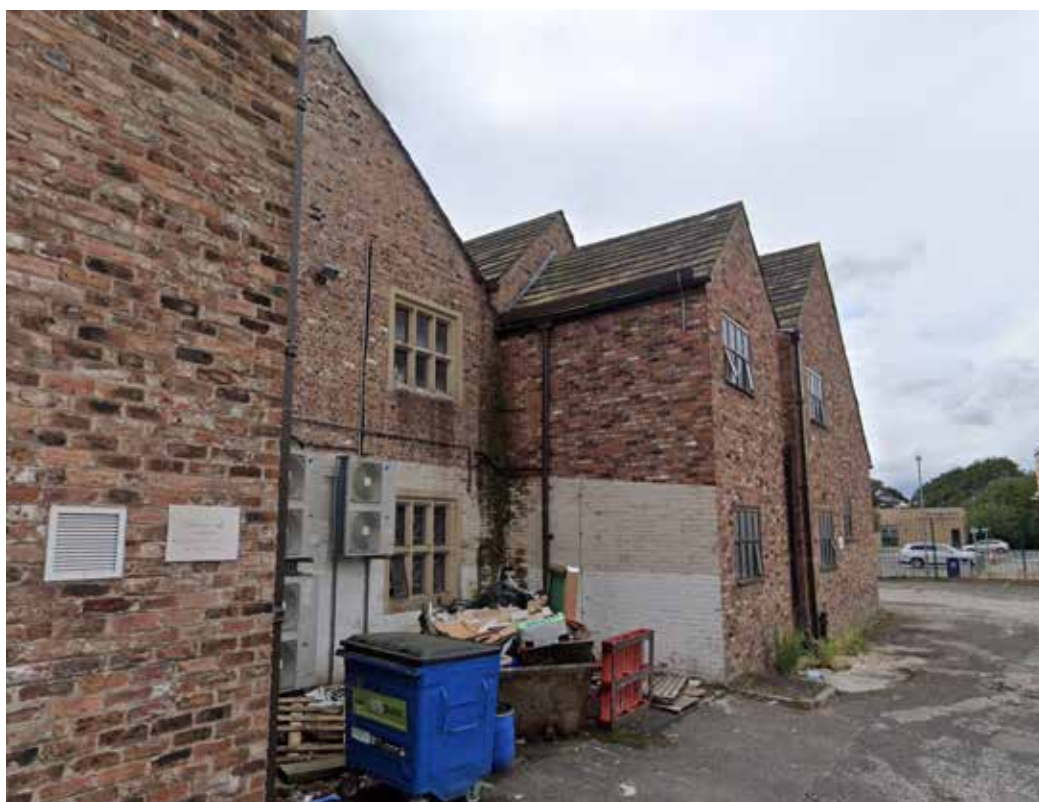
Figure 10- rear of Hough End Hall, 2019 (Google Street View).

- 2.10 As the setting of the building has changed since its construction, so too has the building itself. The interior has been re-modelled, and only two doors and a former bressumer remain as part of the original construction, and the rear door has been moved and is not in its original location. Some features of the house, including the original staircase was moved to Tatton Hall and re-used. The mullioned windows have mostly been renewed in the 20<sup>th</sup> century as part of a poorly executed 'restoration'. The porch is also a 20<sup>th</sup> century addition to the front. The former northern extension to the wing, shown in Figure 9, has been demolished, and the gables shown in Figure 10, before the current works, are of much later date than the original house.

- 2.13 The existing arrangement to the rear, with a series of double pitched extensions which post-date the 1970's refurbishment, has once again re-introduced the principle of accretions to the building, and three of the bays have received extensions (Figure 10), leaving a recess void. The filling of this void with a further extension is considered to be controversial and has been described as constituting heritage harm.

Changes to the house itself illustrate its changing context, from the family home of the Mosleys, through its years as a leased estate for tenanted farmers, and its latter uses as public house, offices and restaurant. All have left their mark on the configuration and arrangement of the Hall, both internally and externally. Not all of these changes have been kind to the Hall, and its setting in particular has been impacted detrimentally. This includes not just the construction of the surrounding office blocks and Chorlton High School, but also the loss of its gardens and orchards, and their replacement with hard standing. As seen in Figures 10 and 12 this pre-dated the acquisition of the Hall by the current owners.

- 5.2 The extension is essentially a free standing volume, with its own structure comprised of steel members (Figure 13). This means that it is not required to tie into the remaining fabric of the building, which, in this location dates from the 1970's. No original fabric of the Hall is impacted by the proposal. The current design does show that the head of the reconstituted stone mullion windows, dating from the 1960's as part of the refurbishment of the building, would be hidden by the extension (Figure 14), but this element can be amended to ensure that the window remains visible, and not impacted, simply by raising the interface. The window is not original to the building, and the evolution of the Hall illustrates that the rear has seen significant changes to the simple 4-bay design. The void has previously been infilled by an earlier structure, as can be seen in Figure 10, with the remains of a painted interior evident on the brickwork.

- 5.4 Figures 10 and 16 also show the degree of hard-standing at the rear of the building, and whilst this has been renewed by the current owners, the relationship of the area of hard standing and its potential impact on the setting of the building, as well as its fabric, remain the same. The new area of hard standing has been laid to falls, and moves water away from the foundations of the structure, rather than towards it. As such it is an improvement to the drainage conditions of the site, and should prevent water damage to the Hall. Figure 17 is an image of the area from 2014, showing the build-up of vegetation both on the structure itself and the hard standing due to inadequate drainage, and illustrates the earlier issue with the potential of water damage to the fabric of the building. The slightly raised level of the hard standing would prevent this re-occurring, and help further protect the building without significant impacts to the setting.

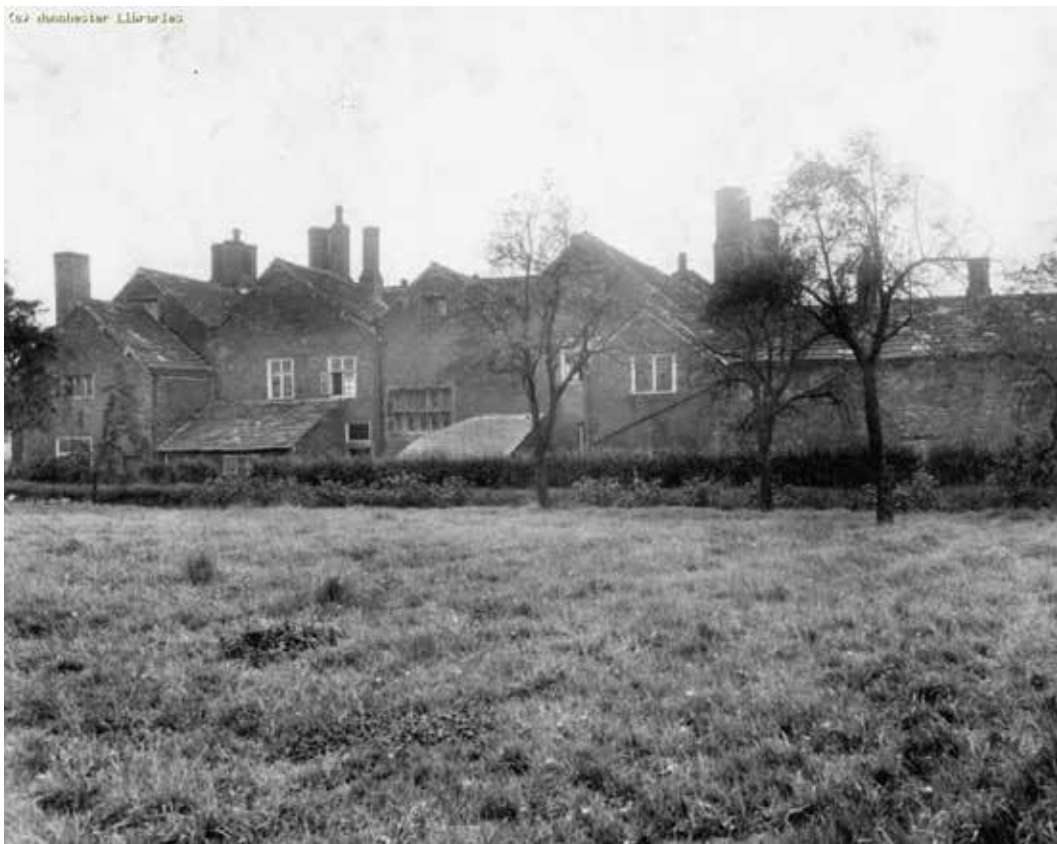
Figure 11- rear of Hough End Hall, 1923 (Manchester City Libraries).

- 2.11 The rear of the building has changed substantially since the original arrangement, and this was noted in the account of the Hall in the Victoria County History of 1911. Figure 11 shows the rear in 1923, illustrating that the original four gabled bays had received a series of accretions, of both double pitch and mono pitch form. The image also shows changes to the fenestration, with a number of the stone mullioned windows replaced by vertical casements, both in the original gables, and the extensions. The image was taken from what is now the car park to the rear of the building, but at the time it formed part of the orchard shown on earlier plans. The change in setting from 1923 to the present day, is striking, and the gentle and verdant pastoral landscape of the Hall now replaced with hard standing, and a thoroughly urban context.

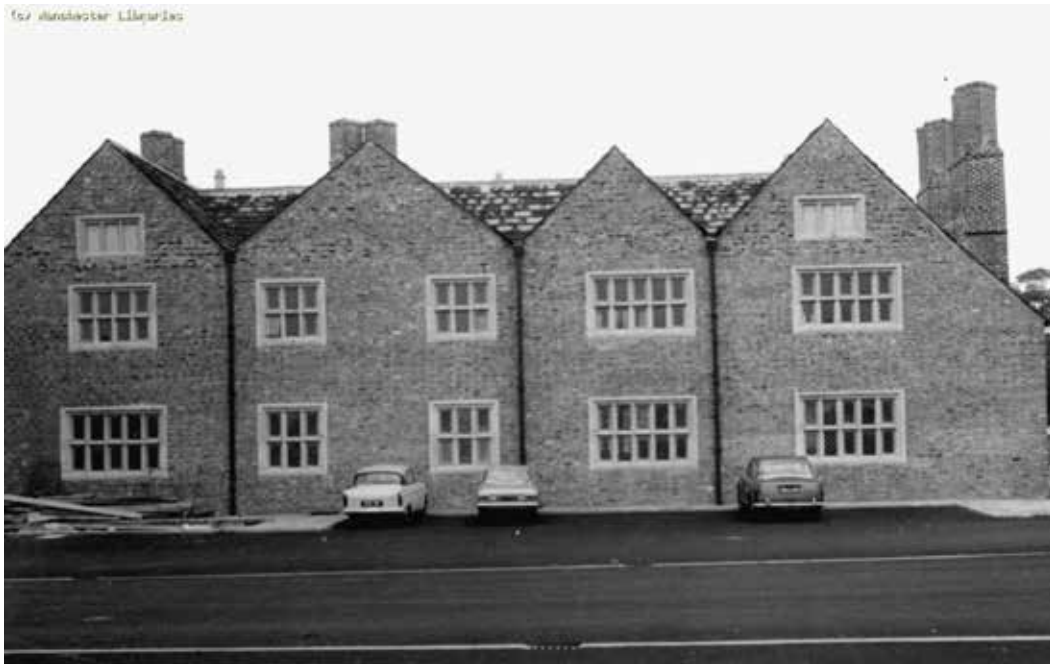
Figure 12- rear of Hough End Hall, 1970 (Manchester City Libraries).

- 2.12 Following a period of abandonment, the Hall was refurbished in the late 1960's. This involved demolishing the rear extensions, and the long, linear wing to the north, as well as a speculative interpretation of the fenestration pattern, with windows replaced with cementitious mullions rather than the original sandstone. At the same time, the front porch was added, and the interior re-modelled, and this included a new structural framework to support the building, with associated new concrete floors. Figure 12 shows the rear of the building in 1970, following the refurbishment. The image shows the building pared back to the original 4-bay form, but with a largely invented fenestration pattern, undertaken in reconstituted stone

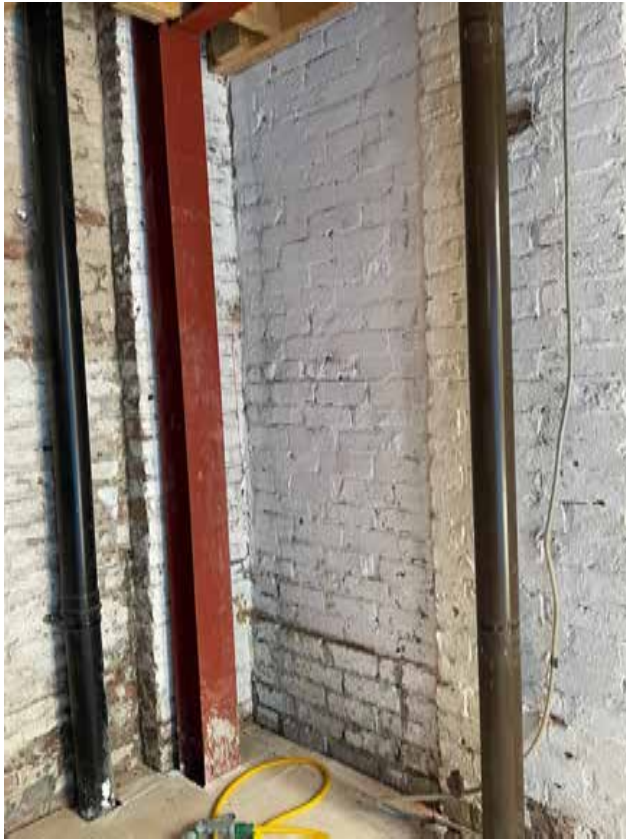
Figure 13- free standing structure of the extension.

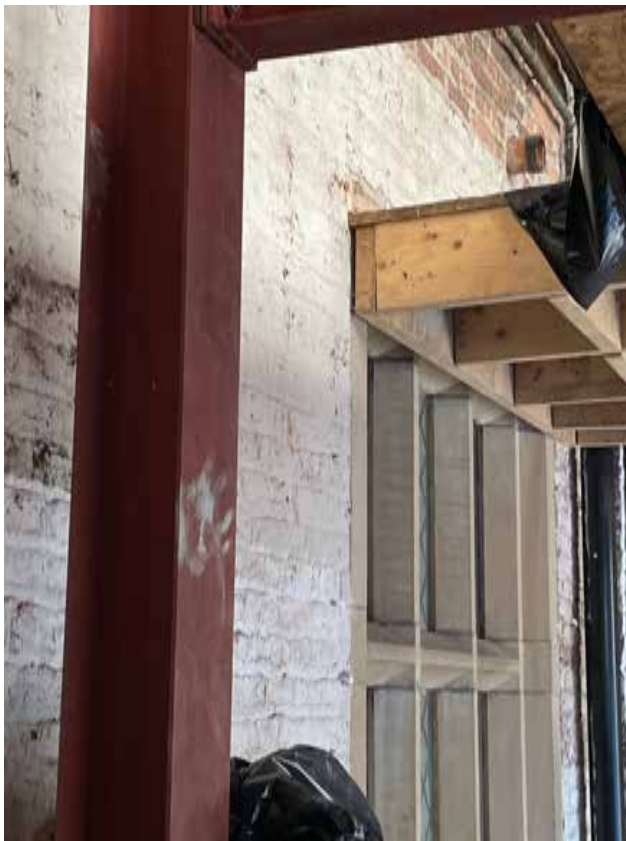
Figure 14- showing free-standing structure, and the interface with the head of the 1960's reconstituted stone mullion window.

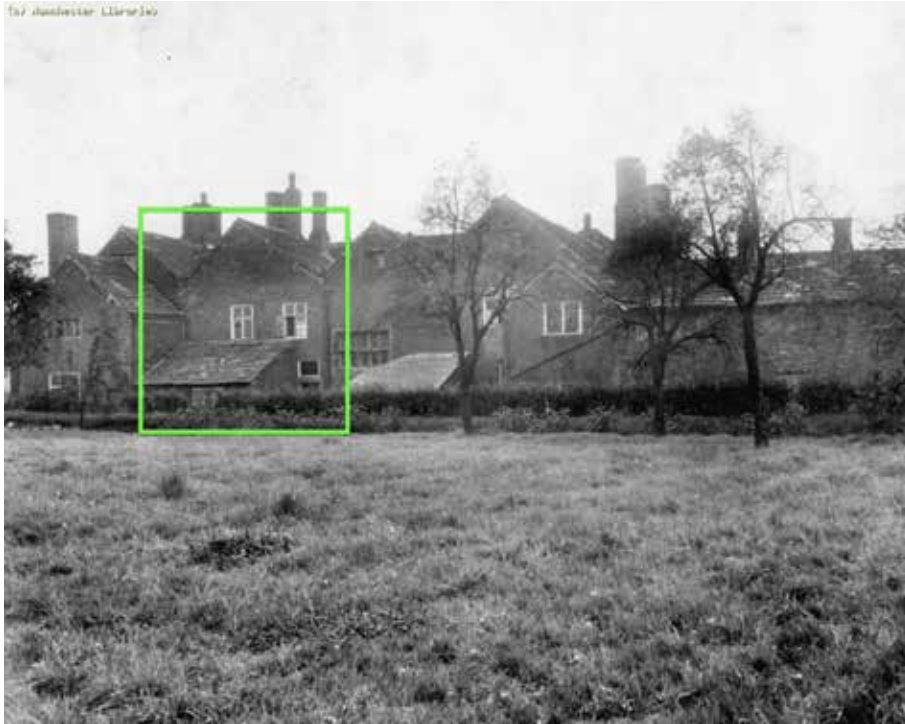
Figure 15- 1923

It can be seen that there are substantial differences between the two images, representing different stages of the lifetime and usage of the Hall. In Figure 15, there is a mono-pitch, single storey extension in the location of the currently proposed extension, whilst the image

- 5.3 The extension is a build out from the second, left hand bay, as indicated on the image from 1923 (Figure 15) and that of 1970 (Figure 16).

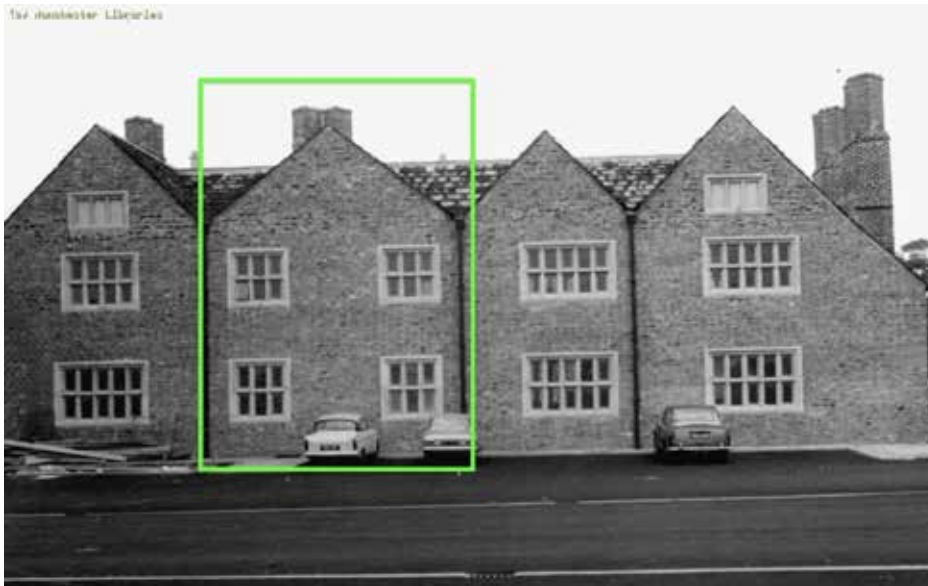
Figure 16- 1970

from 1970 shows that the bay has essentially been rebuilt, and the fenestration pattern is completely different to the earlier arrangement. Following the 1970 image, the other three bays all received extensions, and this is the current arrangement on site.

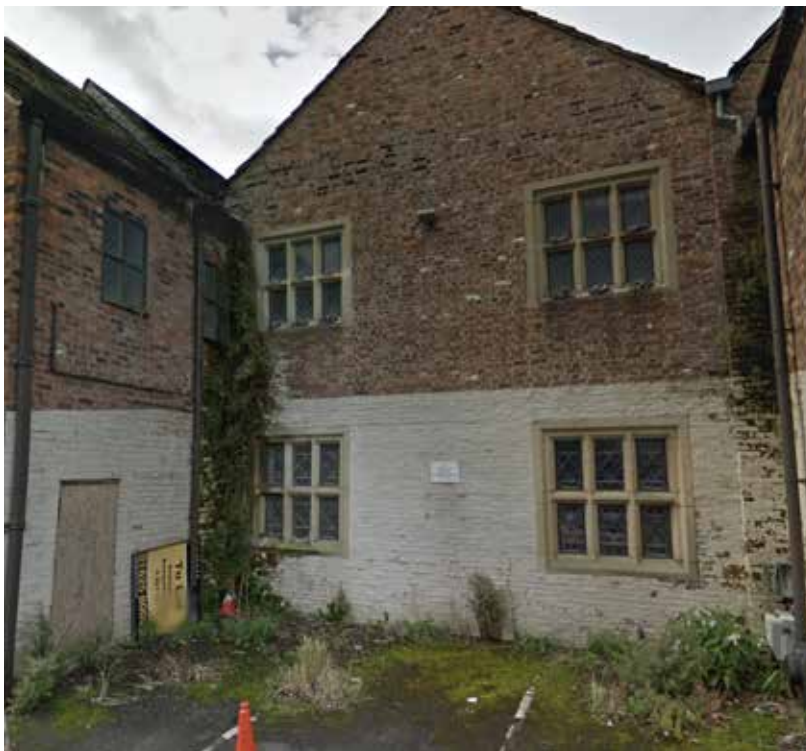
Figure 17- rear extension showing build-up of vegetation and poor drainage (Google Street View, 2014).
