# VICTORIA AVENUE EAST, MANCHESTER

## Preliminary Roost Assessment and Ecological Appraisal Report

*August 2020*

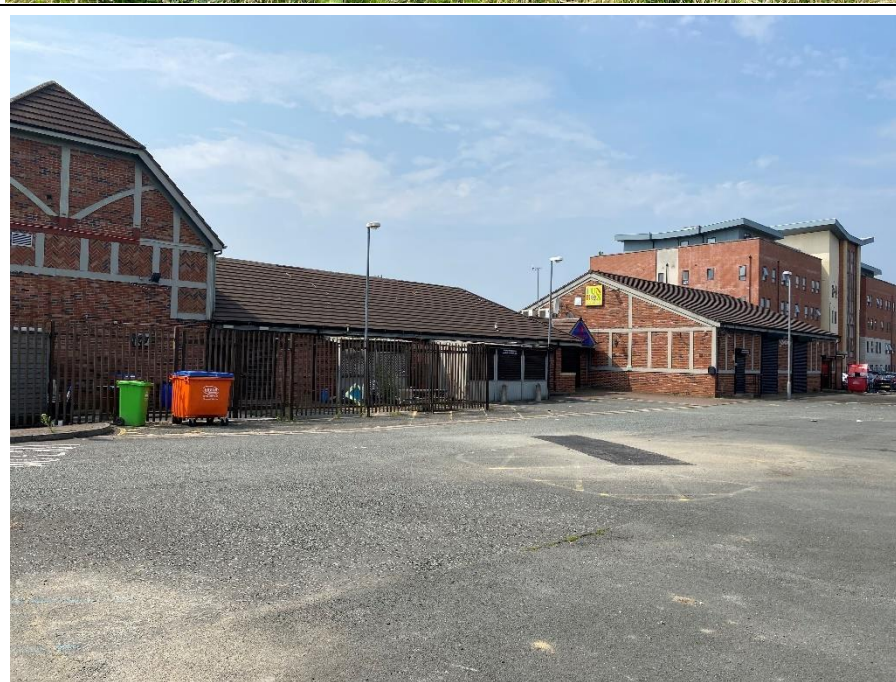
- 3.3.9. Two adjoined buildings were present to the south of the site which comprised restaurants. The buildings were of red brick construction with pitched roofs and were generally well maintained and in a good state of repair. Please refer to Section 3.4 for full description of the buildings.

B1 (left) and B2 (right) located to the south of the site.

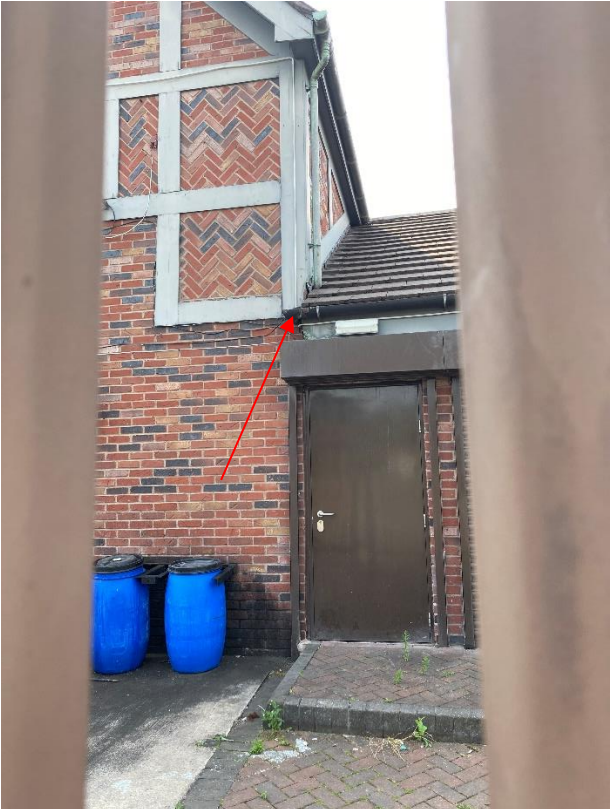
| Feature | Photograph |
|---|---|
| <p>A small area of lifted lead flashing was present on the northern elevation of the building which could provide minor opportunities for crevice dwelling bats on a transitional basis.</p> | <p>A photograph of the northern elevation of a brick building. A red arrow points to a small gap above the dark brown door frame, indicating a potential bat roosting site. Two blue bins are visible to the left of the door.</p> |

- 4.3.4. The buildings were assessed as having low bat roosting potential as per criteria set out in Table 4.1 in Collins (2016). Therefore, in accordance with best practice, it is recommended that one dusk or dawn emergence/ re-entry survey be undertaken to determine presence/ likely absence of roosting bats. The survey should be undertaken between May – October within suitable weather conditions.

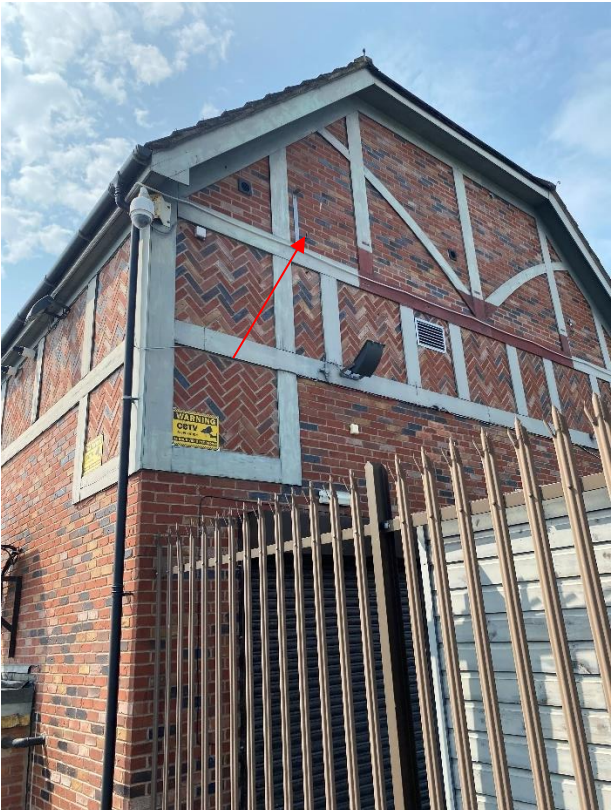
| Feature | Photograph |
|---|---|
| <p>A small crevice was present on the northern elevation where mortar was missing from between two bricks. It is anticipated this would form a small crevice which could support crevice dwelling bats on a transitional basis.</p> | <p>A photograph of the northern elevation of a brick building, showing a gable end. A red arrow points to a small crevice between two bricks, indicating a potential bat roosting site. A yellow warning sign is visible on the wall below the arrow.</p> |

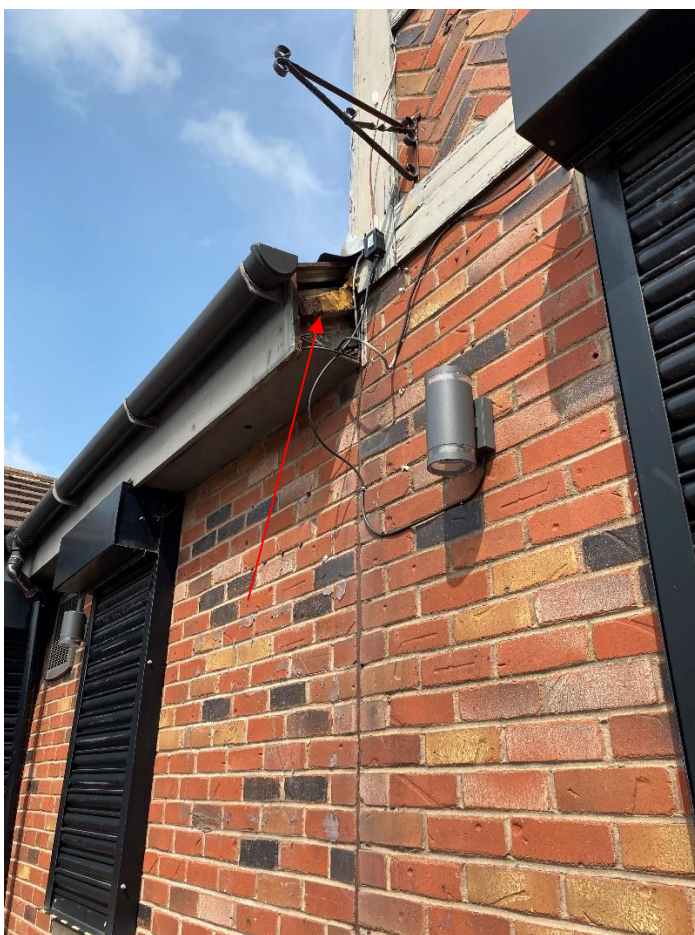
The end of the soffit box on the southern elevation was missing which could provide access or roosting opportunities for crevice dwelling bats.

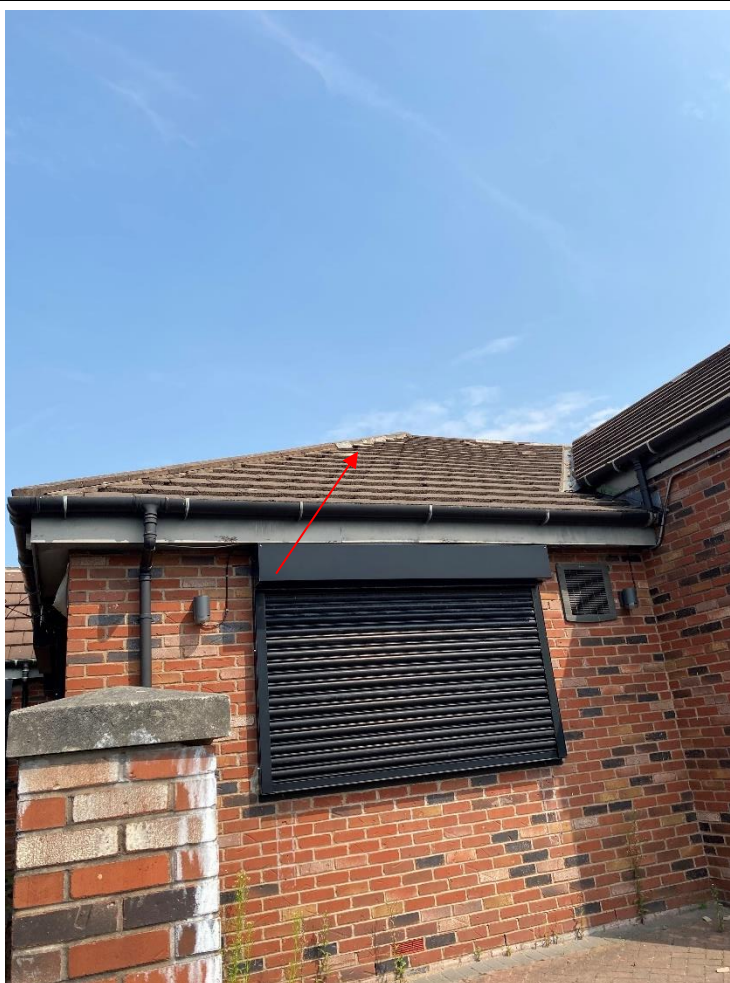
Some ridge tiles were found to be missing on the roof at the south western corner of the building. It is unknown if these provided any access into the building.

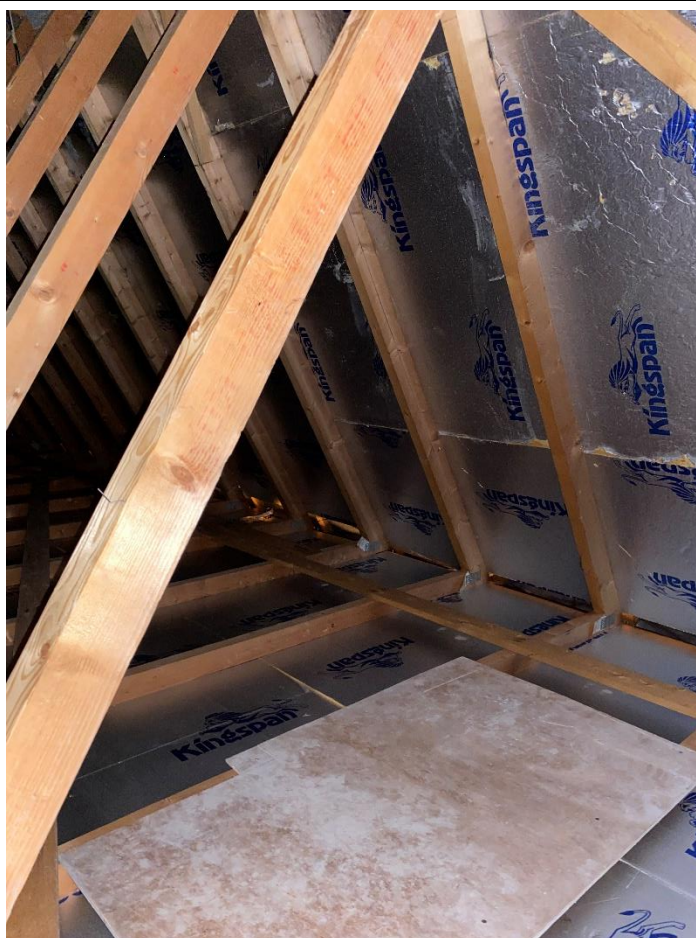
Two loft spaces were checked during the survey. They were too high to climb into and as such an inspection was made from the loft hatch. They were found to be comprised of timber beams with insulated walls. They were clean and well maintained. No signs of bats could be observed, though the lofts were not fully accessed.

Light gaps were present at the ridge of the loft, which could indicate that access is available into the space.

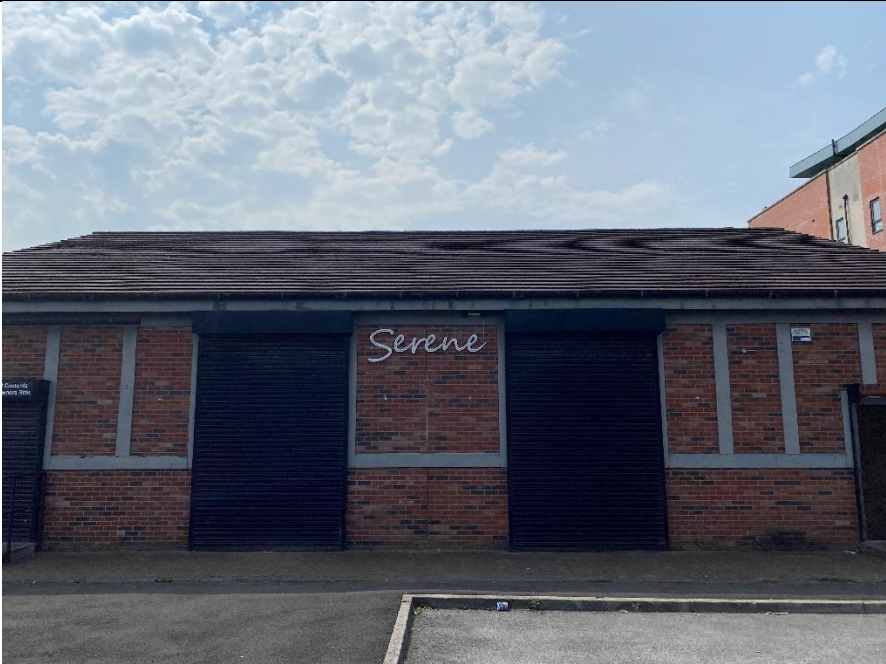
| Feature | Photograph |
|---|---|
| <p>B2 was found to be generally well sealed with roller shutters over doors and windows.</p> | |

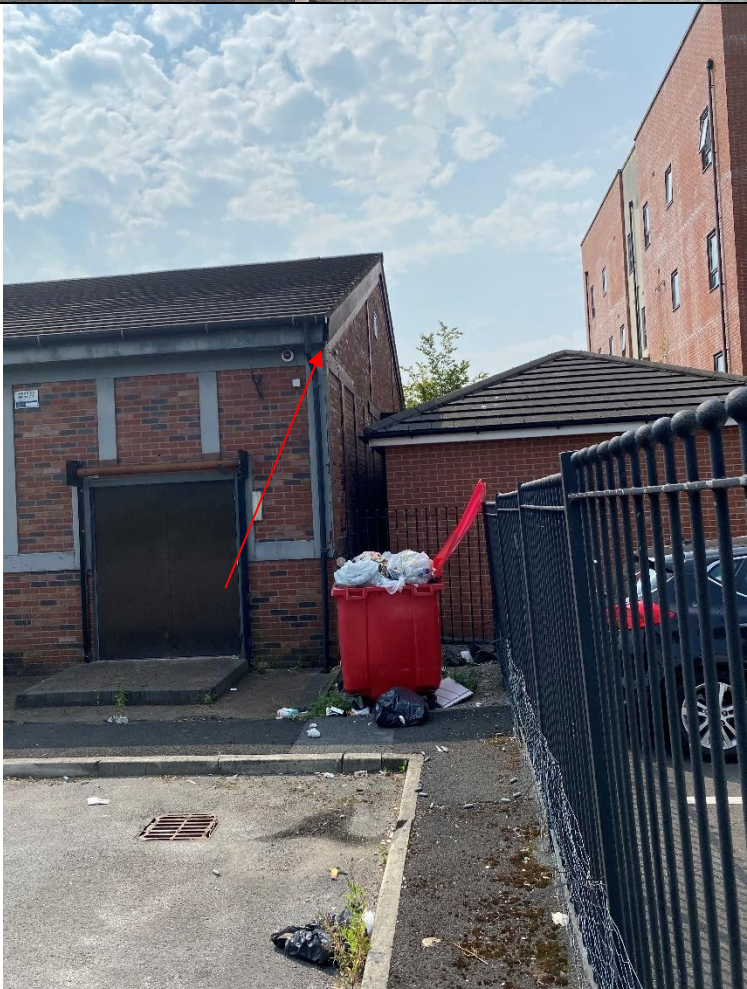
| Feature | Photograph |
|---|---|
| <p>Soffit boards were generally found to be well intact, other than a small section on the north western corner of the building which could provide access or roosting opportunities for crevice dwelling bats.</p> | |

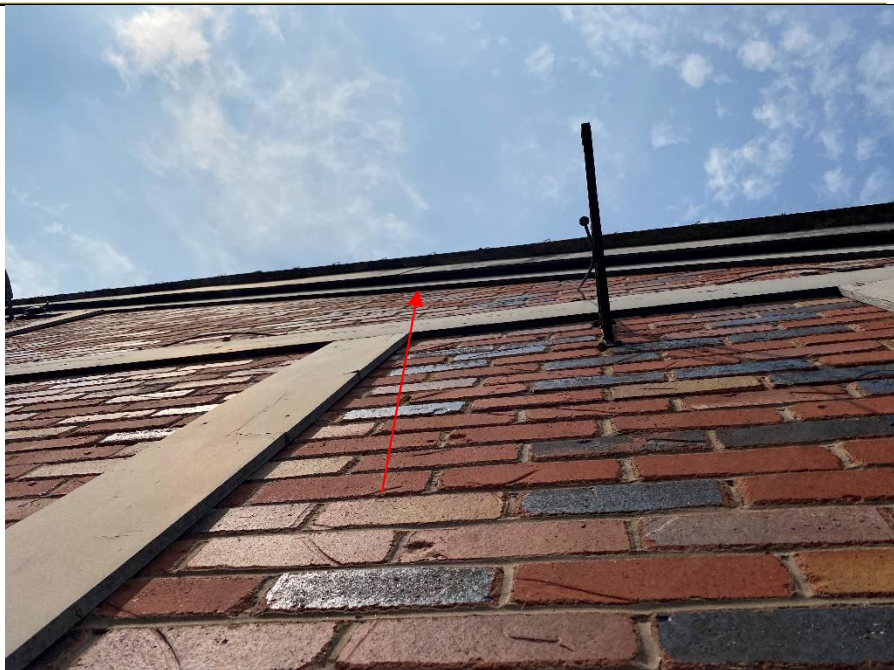
A small area of soffit boarding on the north eastern elevation of the building provided a gap underneath the wood which could provide opportunities for crevice dwelling bats.

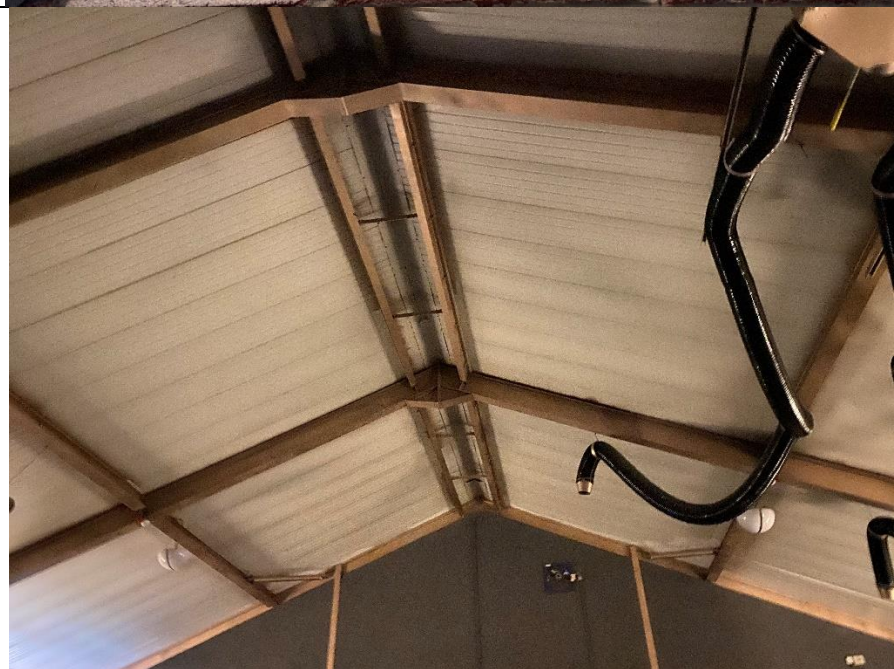
Internally, no loft voids were present, and the corrugated roof was exposed within the restaurant. No opportunities for bats were present internally.
