## **PHASE 2 SITE INVESTIGATION**

**59 UPPER CHORLTON ROAD  
WHALLEY RANGE  
MANCHESTER  
M16 7QR**

**DOCUMENT REFERENCE: 42173R2  
ISSUED REV A  
MARCH 2022**

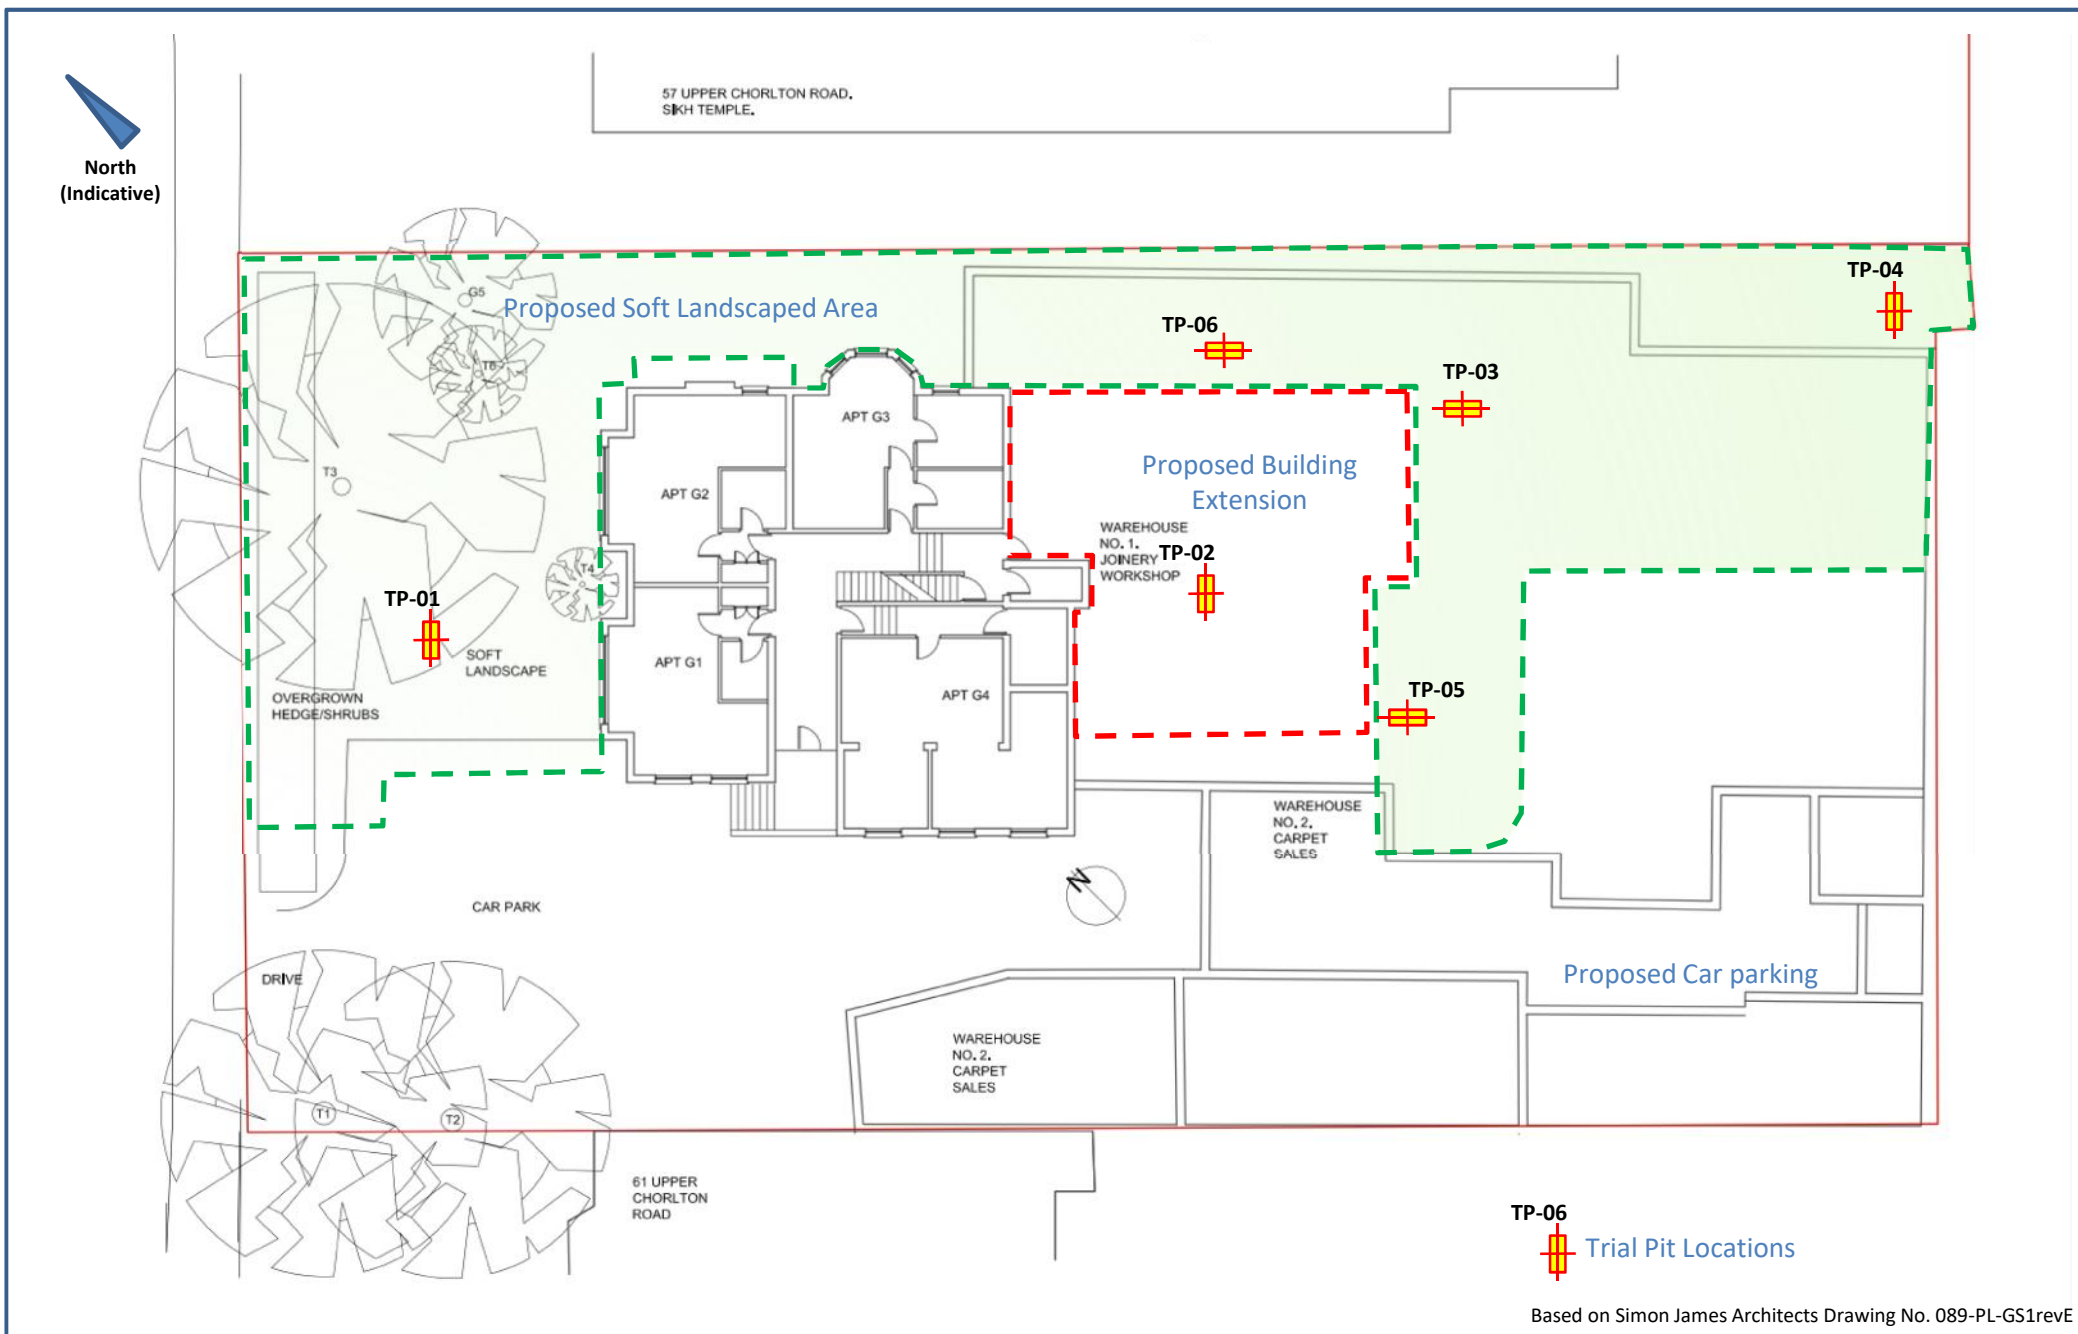
Figure 2 Current and Proposed Development Layout and Trial Pit Locations

Trial pit locations, together with the proposed development layout are shown in Figure 2. Trial pit logs are included in Appendix C and photographs showing the ground conditions in Appendix B.

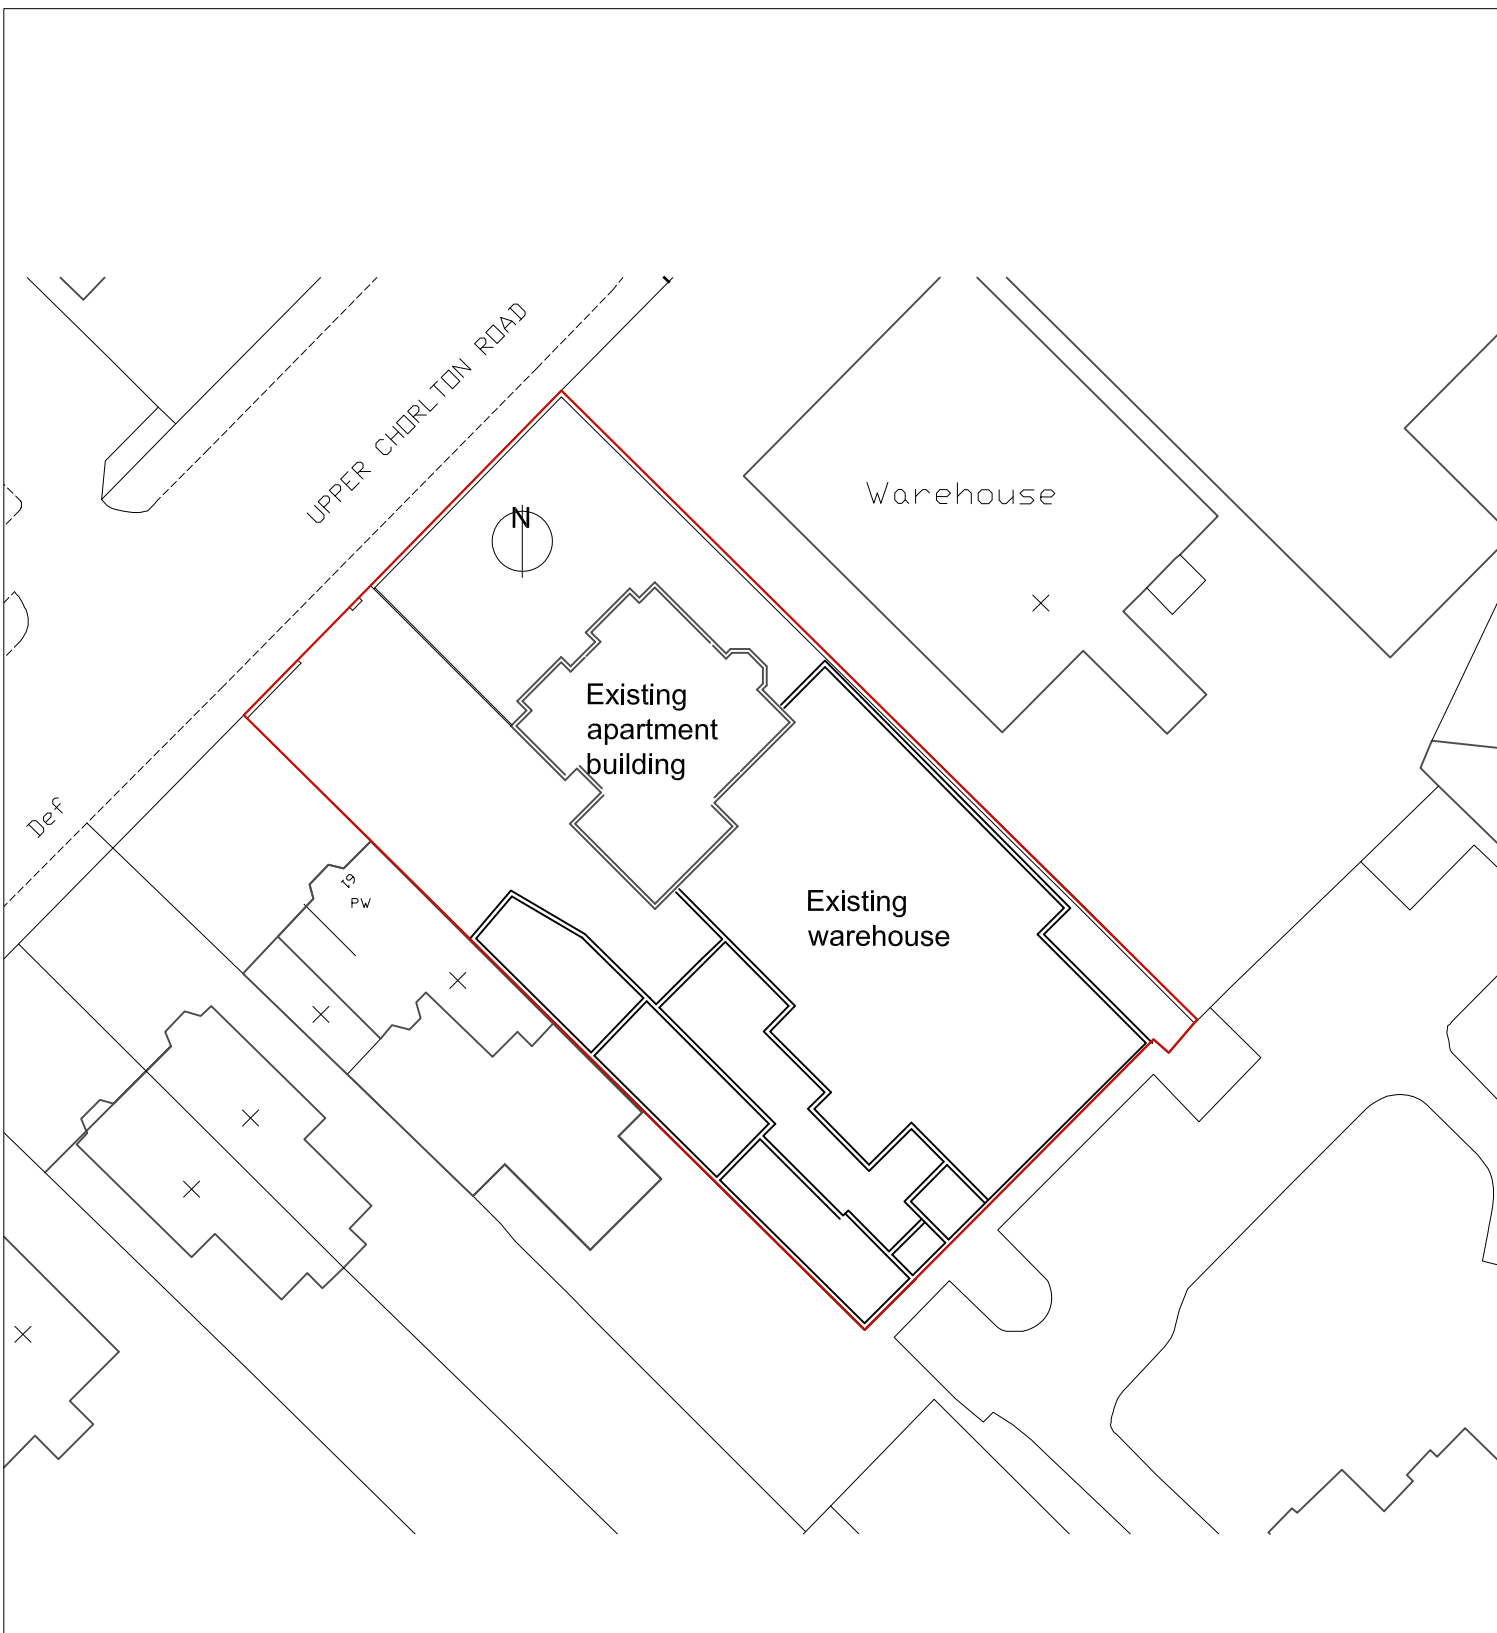
Revision E. 30/09/19. Revised scheme submission .

Figure 1 shows the site location and Figure 2 and Simon James Architects Drawing No. 089-PL-OS1revE, the current site layout. Current site photographs are included in Appendix B.

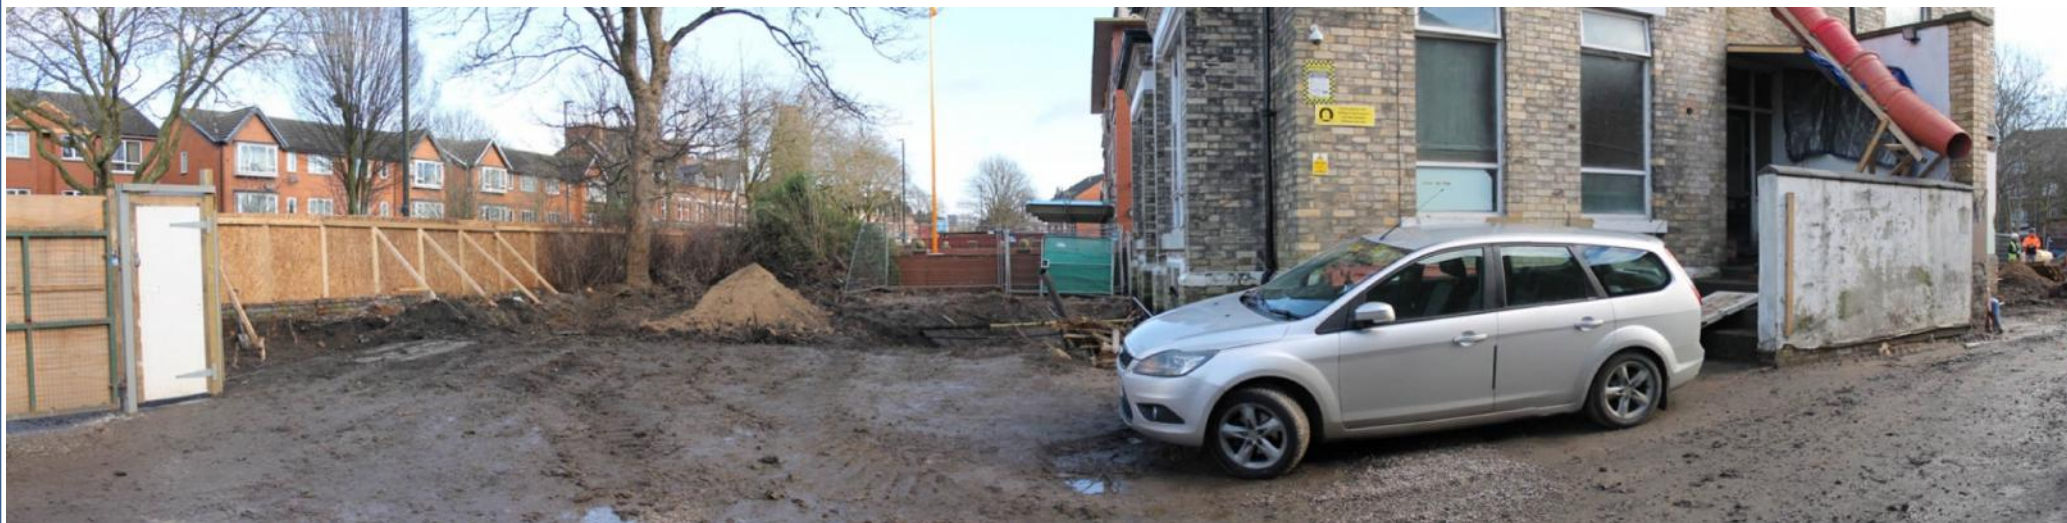
Photo 1: The north-west of the site in February 2022

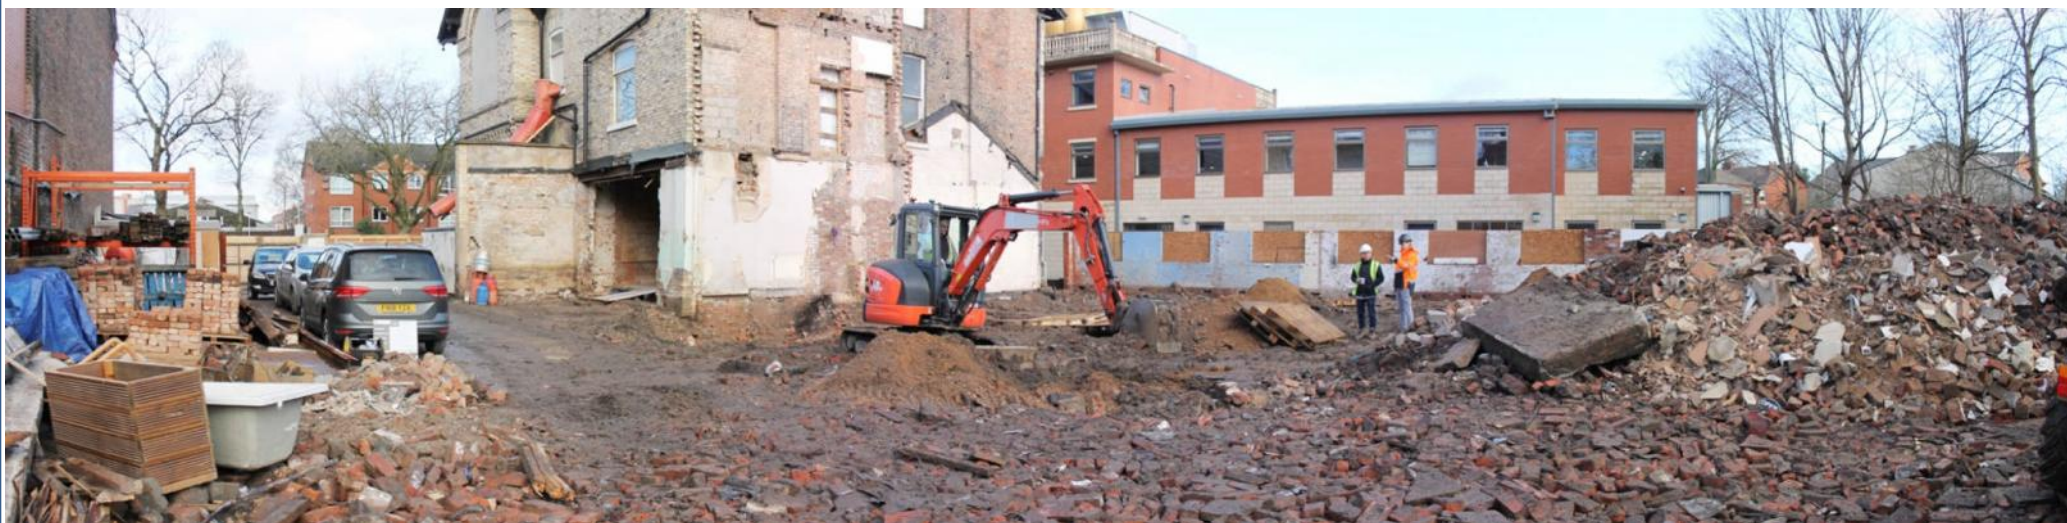
Photo 2: The south of the site in February 2022

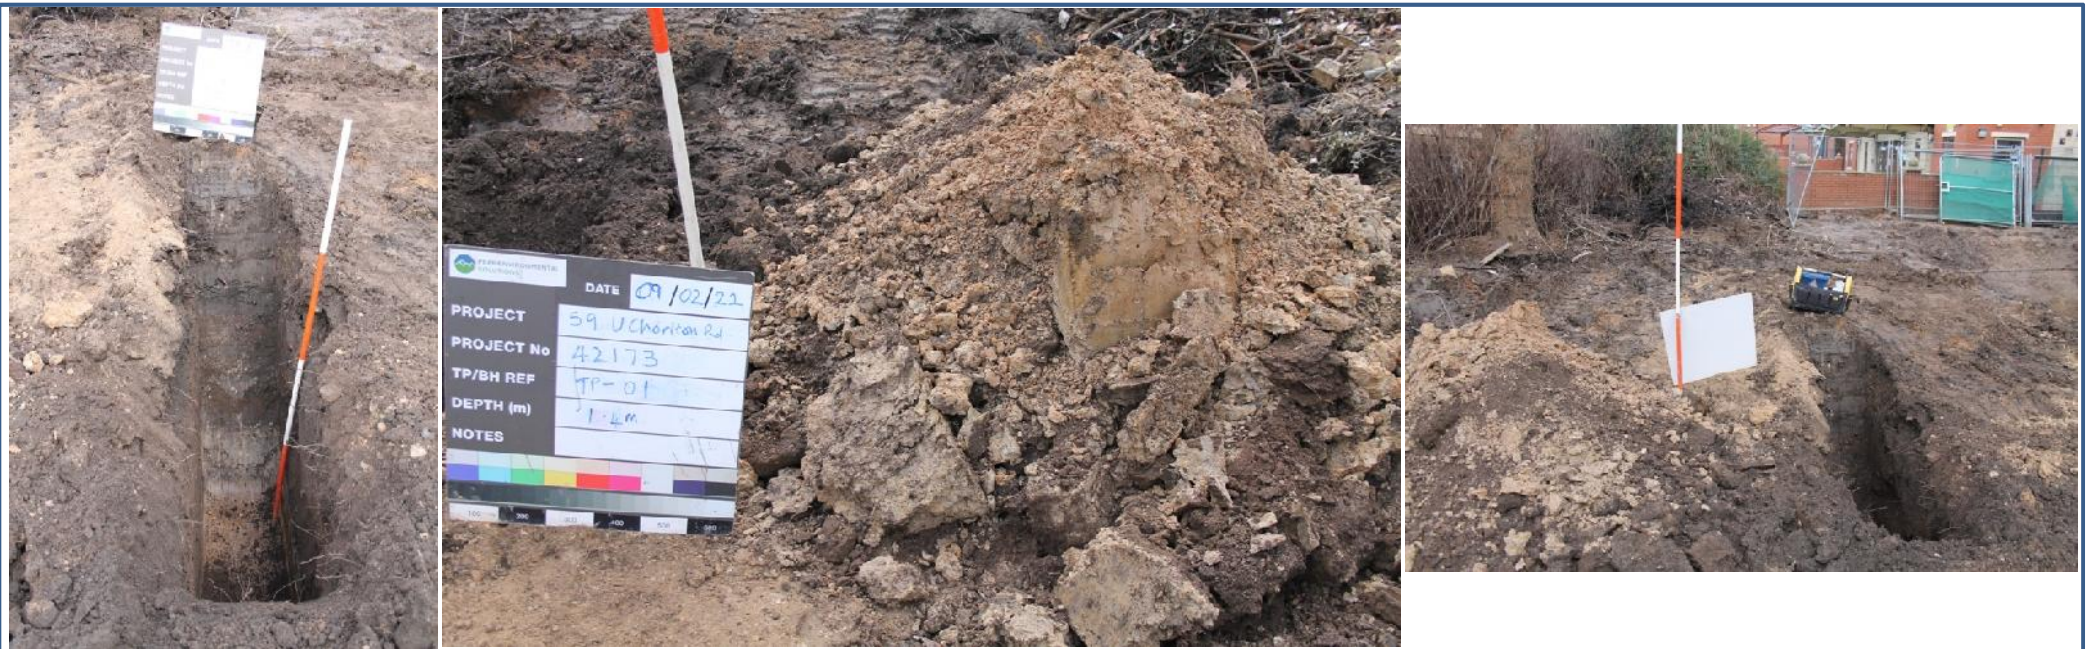
Photos 3-5: TP-01

In TP-01, located in the north-west of the site near to Upper Chorlton Road, 0.5m of made ground comprising dark brown sand and gravel with glass, coal and some ash was identified. This was underlain by light grey/buff very silty sandy clay that extended to the base of the trial pit at 1.4m bgl.

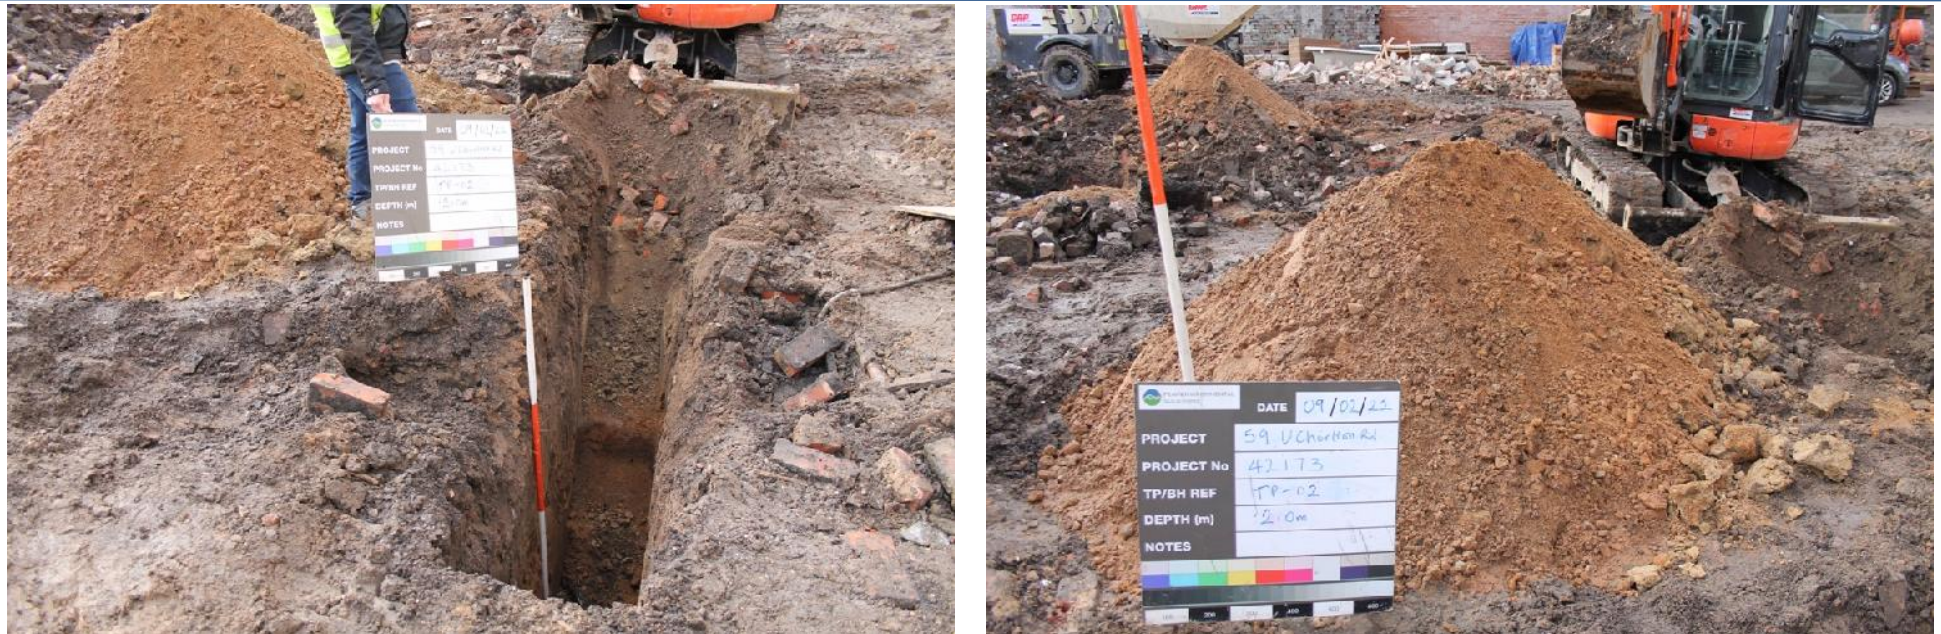
Photos 6-7: TP-02

Consistent ground conditions were identified across the east of the site (TP-02 - TP-06). Made ground comprising dark brown silty sand and gravel with bricks, concrete and some other demolition material was identified at the surface. The made ground extended to a maximum of 1.0m bgl in TP-05 where a brick pillar and wall were observed in the south-west of the trial pit. In general, the made ground extended to between 0.5 and 0.7m bgl.

The sample from TP-02 (0.3m) was found to contain 320 mg/kg of lead which exceeded the C4SL of 310 mg/kg by 3%.
