# Television Baseline Survey Report

East Didsbury

Dandara

December 2021

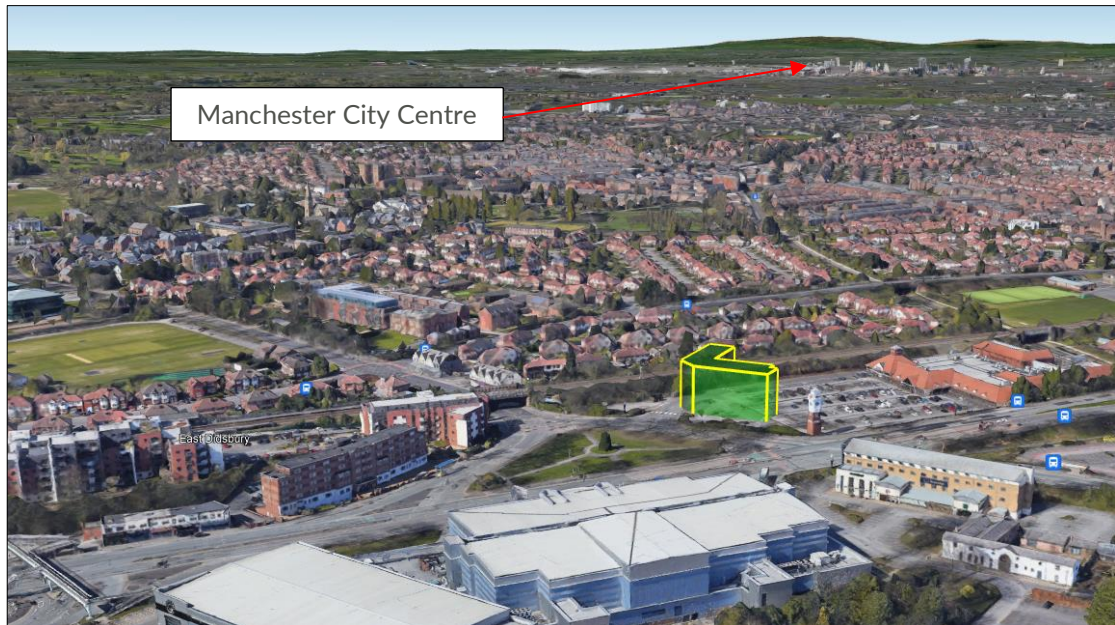
Figure 3 – Proposed development location and nearby environment

Figure 3 below<sup>3</sup> indicates the scale of the proposed development in the context of the neighbouring buildings.

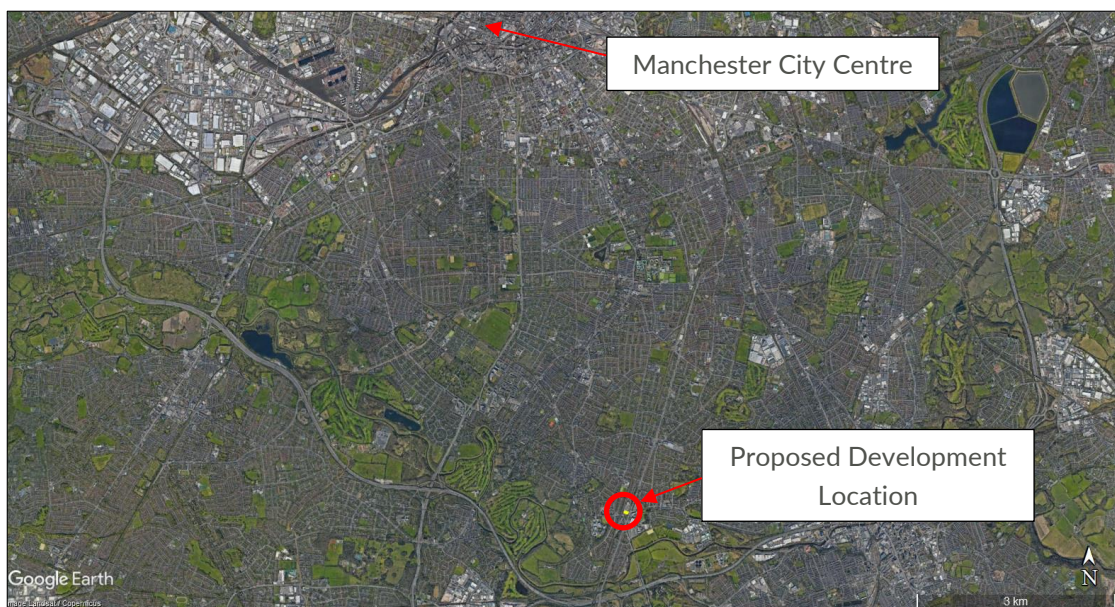
Figure 4 – Map showing location of proposed development

The location of the proposed development relative to Manchester city centre is shown in Figure 4<sup>4</sup> below.

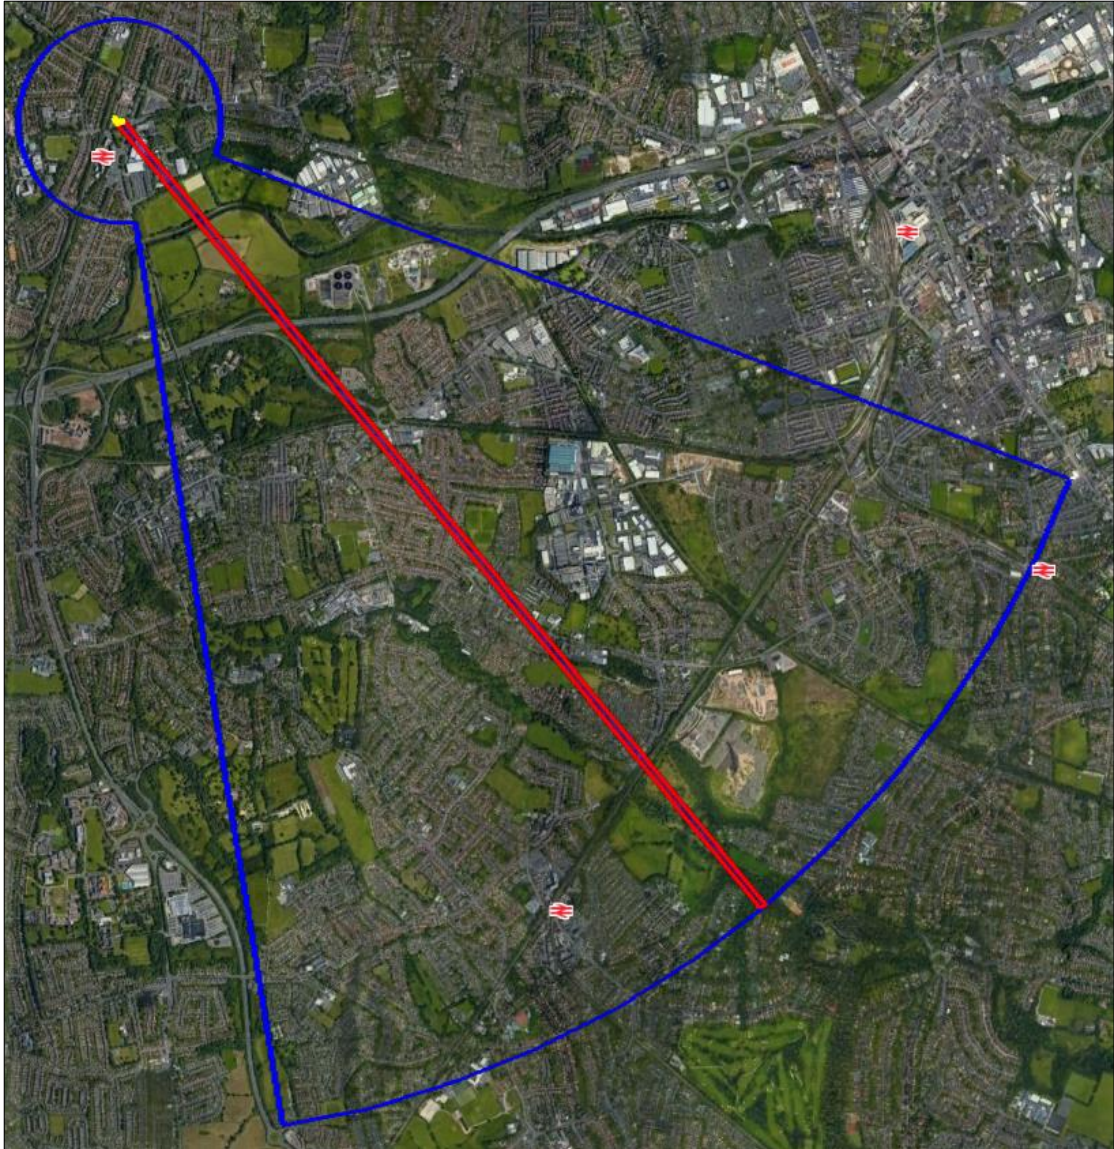
Figure 8 – Interference zones map

Figure 8 below<sup>9</sup> shows the interference zones overlaid onto an aerial image of the area.

It can be seen that the shadow zone passes over sports and grass fields, woods and urban areas that contain dwellings. Areas closest to the proposed development at the highest risk of experiencing television interference. However, fewer buildings are located within the first kilometre from the proposed development. These buildings are mainly commercial buildings or offices. No dwelling is located within the first kilometre. The first urban area within the building shadow is located at circa 1.9km from the proposed development.

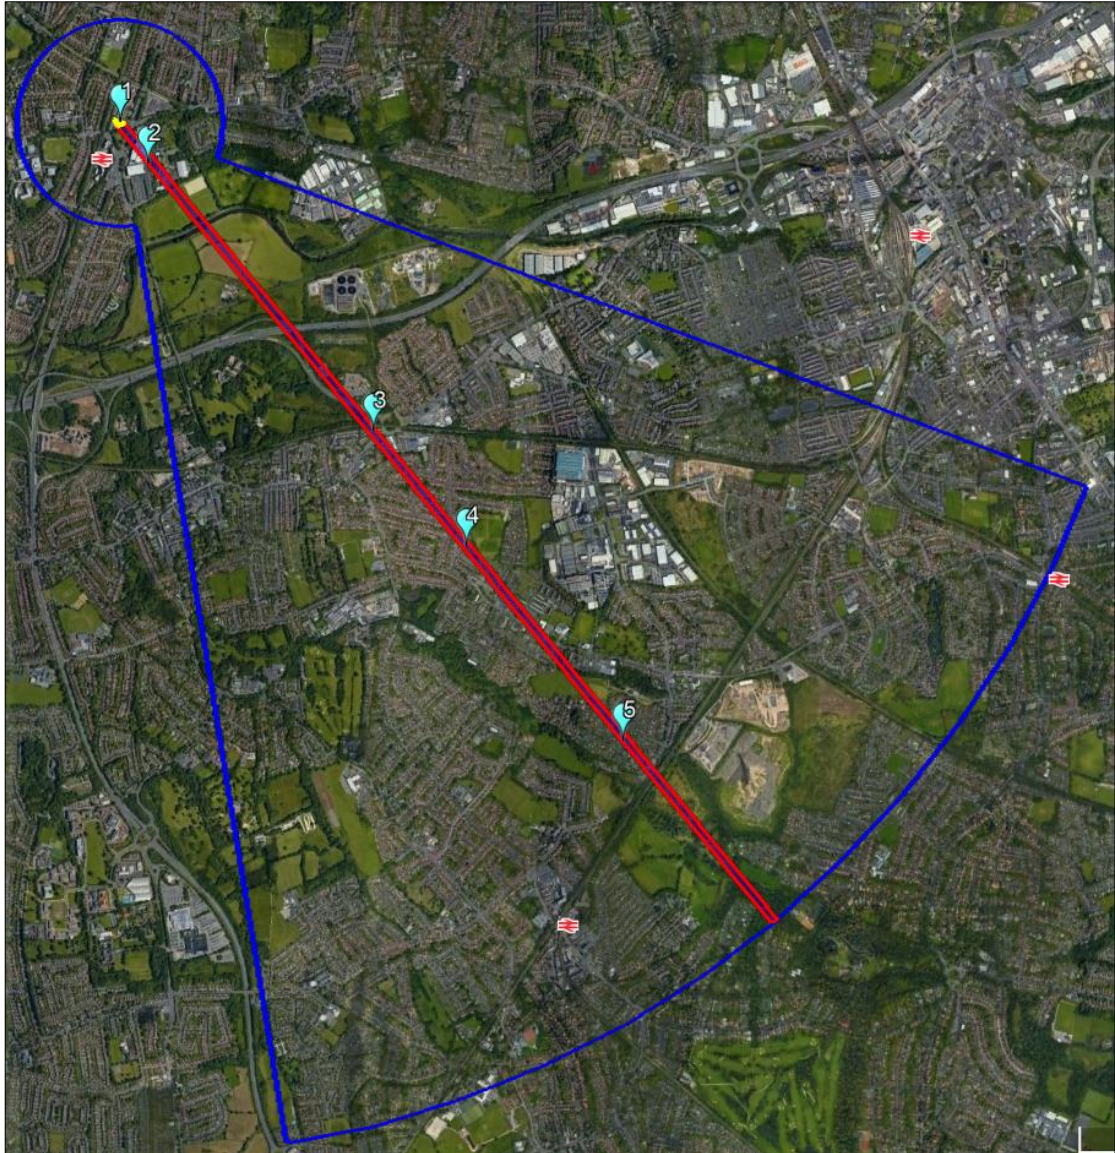
Figure 9 – Survey locations

Figure 9 below<sup>10</sup> shows the survey locations overlaid onto aerial photography. The blue icons show the locations chosen for the pre-construction survey.

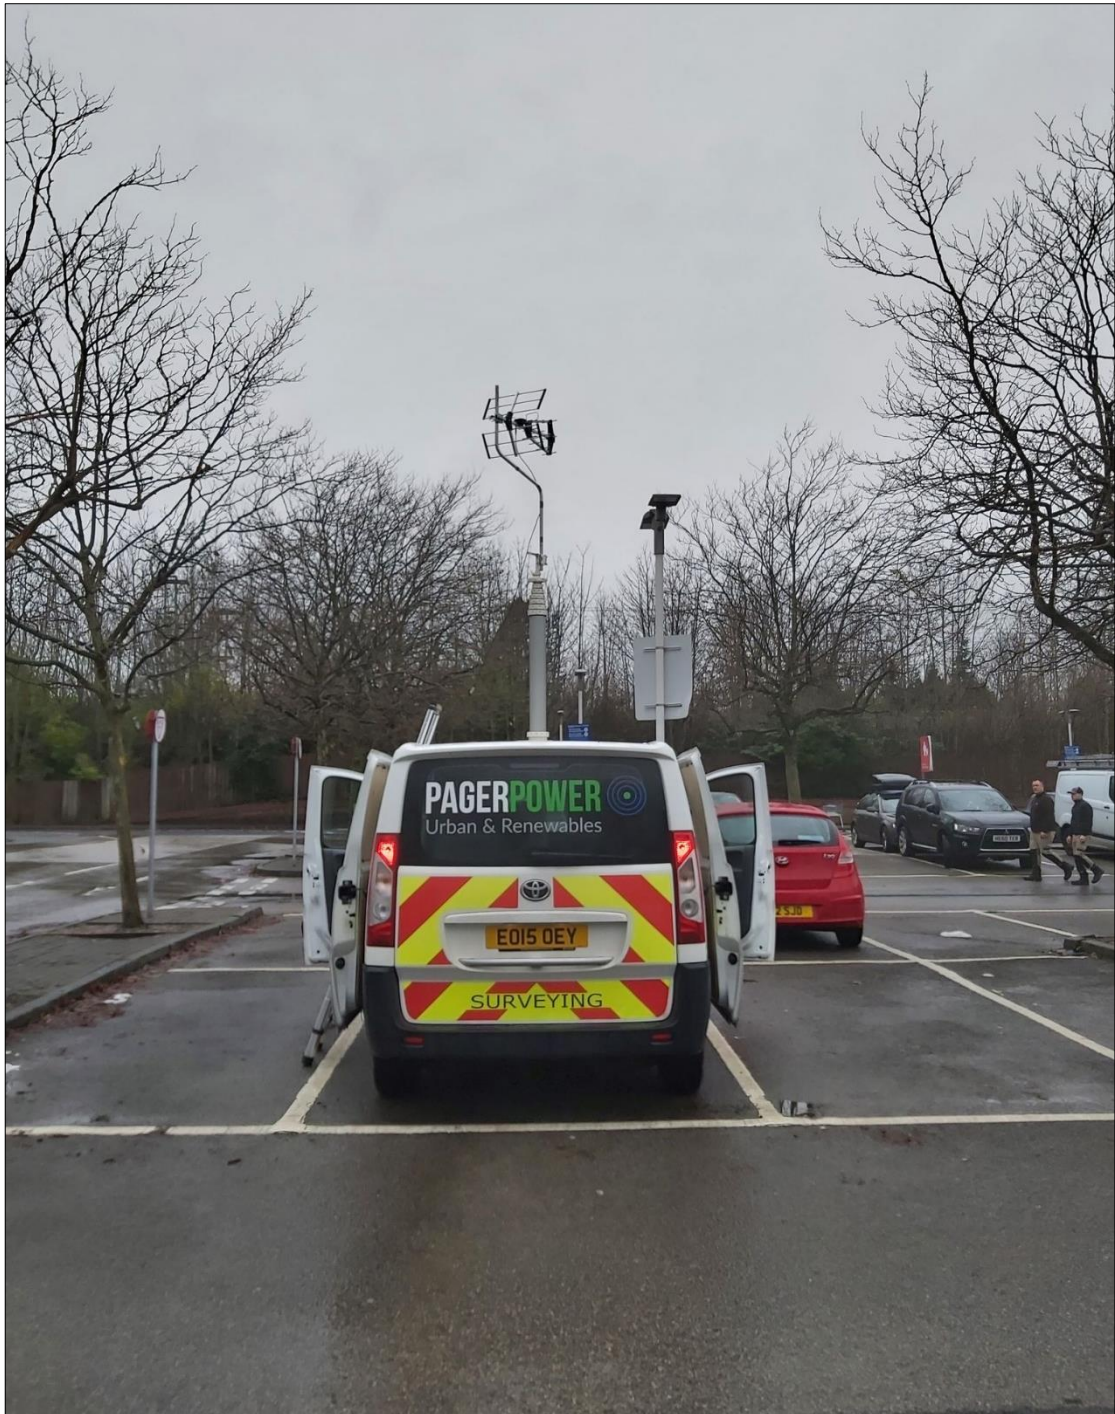
### Location 1

| Location | Average Measured Signal Strength (dB) | Remarks | High Level Conclusion |
|---|---|---|---|
| 1 | Main TV MUX:<br>61.0 (Very Good)<br><br>Local TV MUX:<br>45.2 (Good) | No aerial was visible from this survey location.<br><br>All six main and three local multiplexes had good video and audio.<br><br>This location was not on the shadow <sup>11</sup> ; however, it will be affected by reflections. | This location is within 25 metres of the proposed development. It is highly likely that the signal will be weakened by the proposed development due to reflections. However, no dwellings are in this area.<br><br>No perceivable effects are predicted in practice. |

Notes: No aerials observed

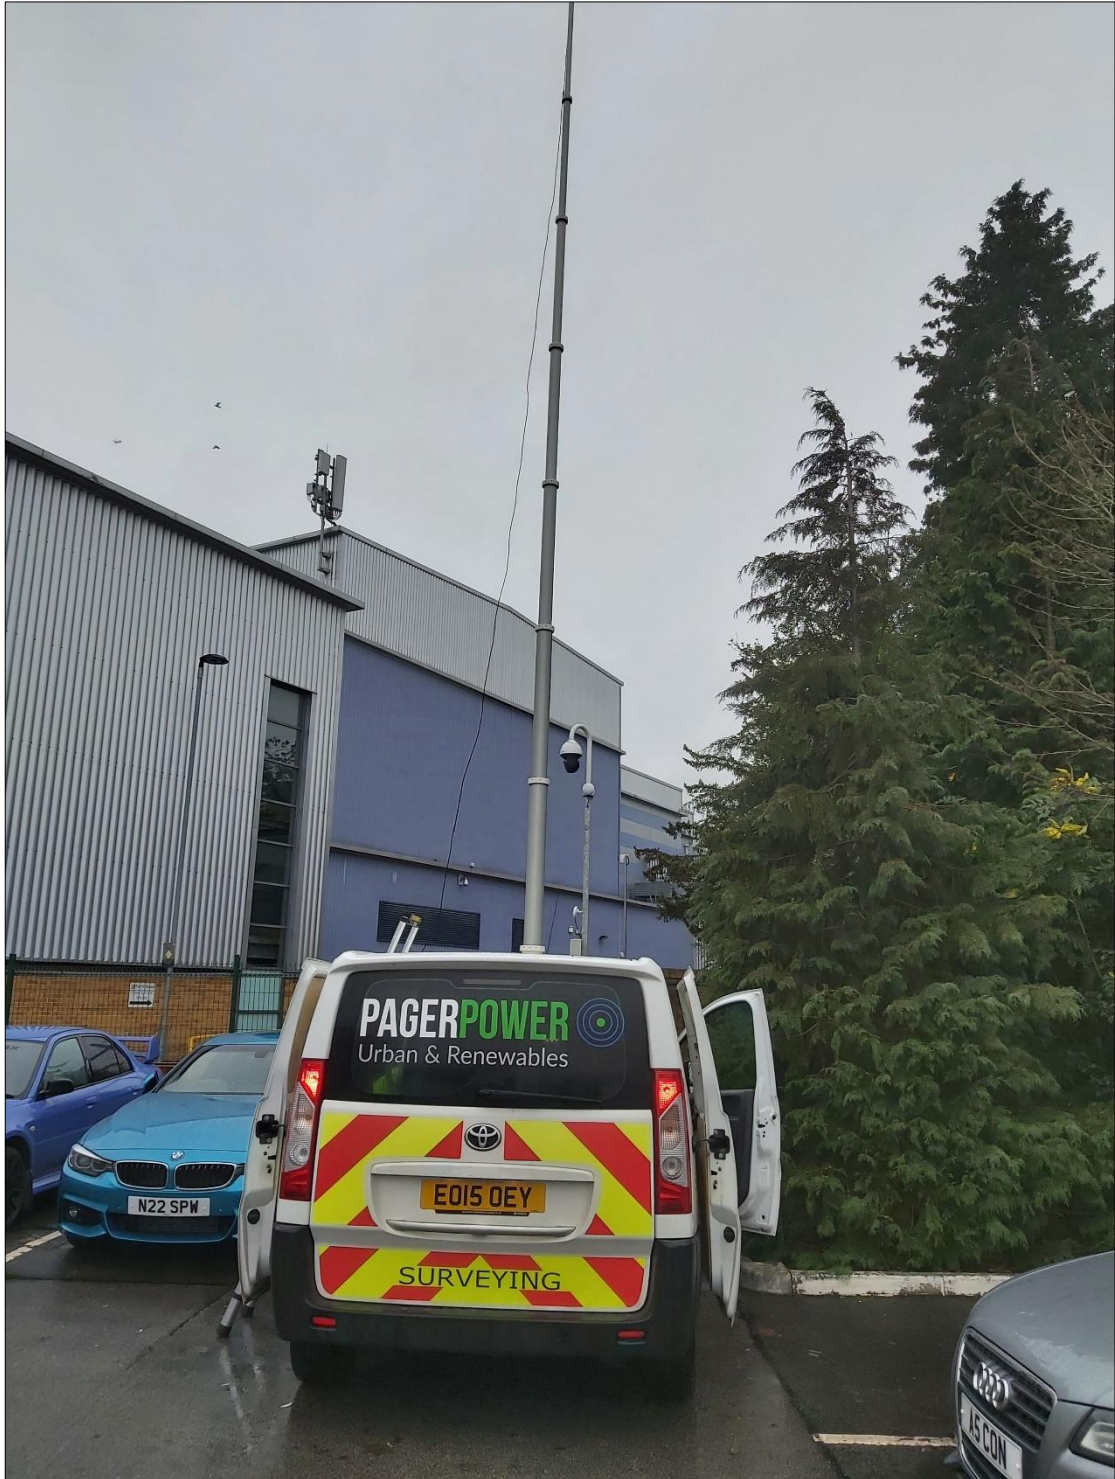
Location 2

| Location | Average Measured Signal Strength (dB) | Remarks | High Level Conclusion |
|---|---|---|---|
| 2 | Main TV MUX:<br>34.0 (Low)<br><br>Local TV MUX:<br>27.3 (Low) | No aerial was visible from this survey location.<br><br>Only three main multiplexes had good video and audio. None of the local multiplexes was received. This was probably due to a building blocking the signal. | This location is within 230 metres of the proposed development boundary. It is highly likely that the signal will be weakened by the proposed development. However, no dwellings are in this area.<br><br>No perceivable effects are predicted in practice. |

Notes: No aerials observed, large building on the way

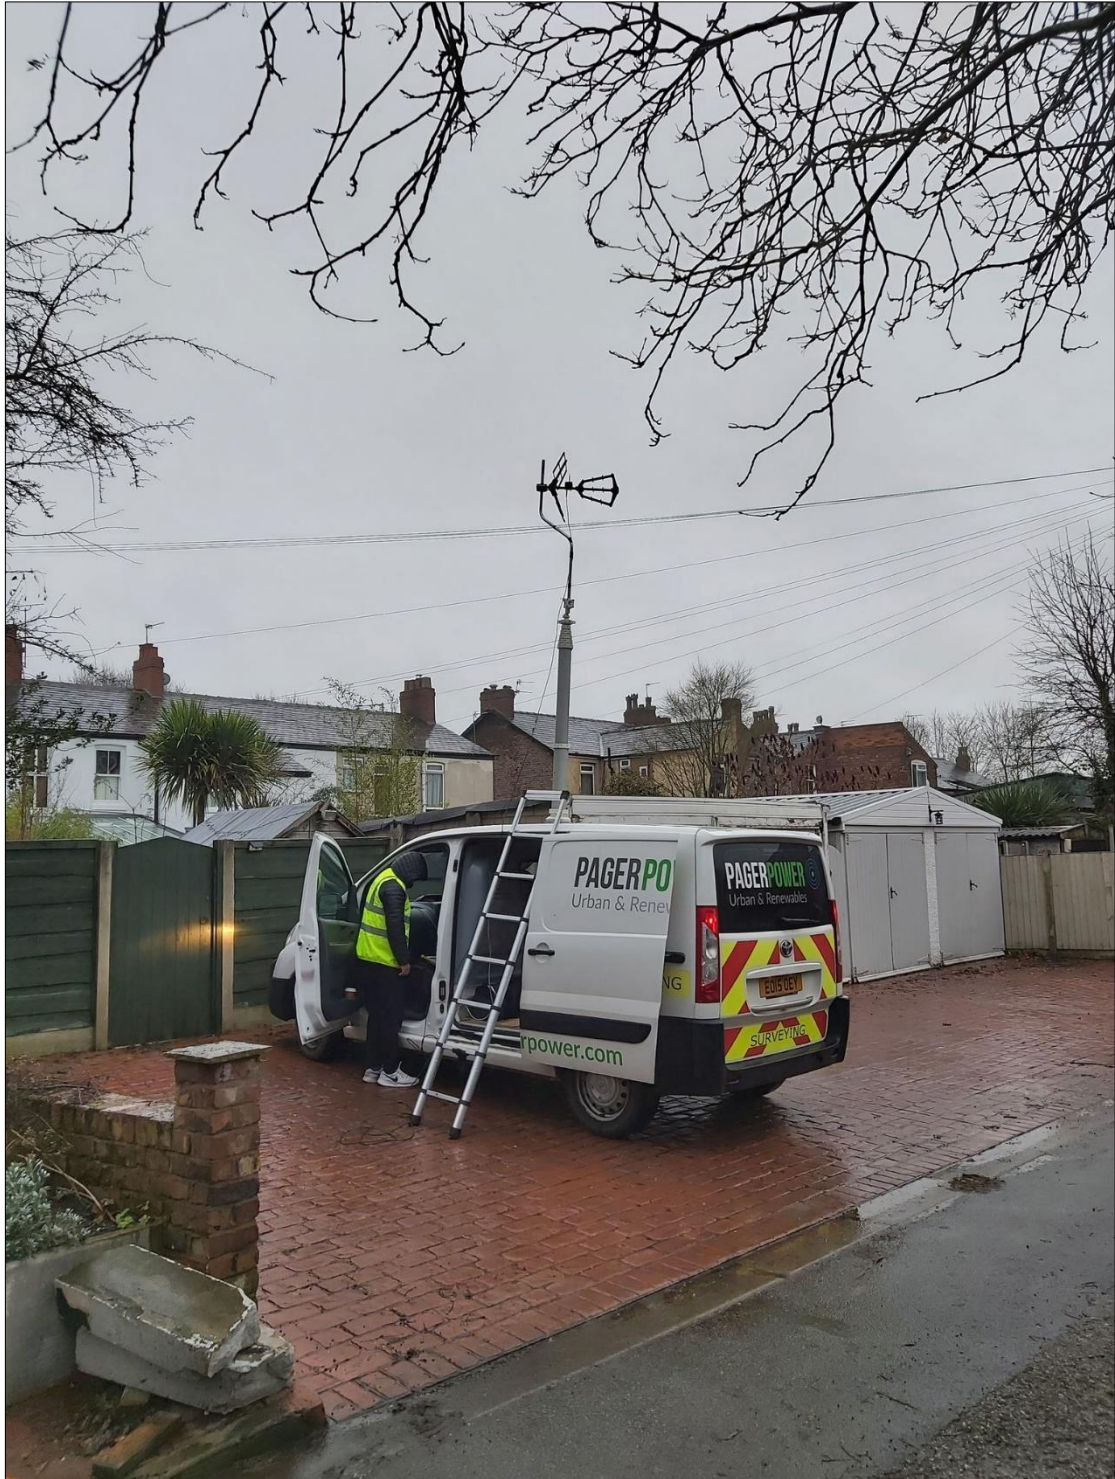
Location 3

| Location | Average Measured Signal Strength (dB) | Remarks | High Level Conclusion |
|---|---|---|---|
| 3 | Baseline:<br><br>Main TV MUX:<br>47.2 (Good)<br><br>Local TV MUX:<br>30.7 (Low) | Multiple aerials observed at this location with the majority pointing towards Winter Hill.<br><br>All six main and all three local multiplexes had good video and audio. | This location is approximately 1,930m from the proposed development boundary. Signal losses at this range are likely to be minimal.<br><br>Interference is unlikely. |

Notes: Multiple HP UHF aerial directed towards the Winter Hill transmitter was observed.  
Multiple satellite dishes were observed.

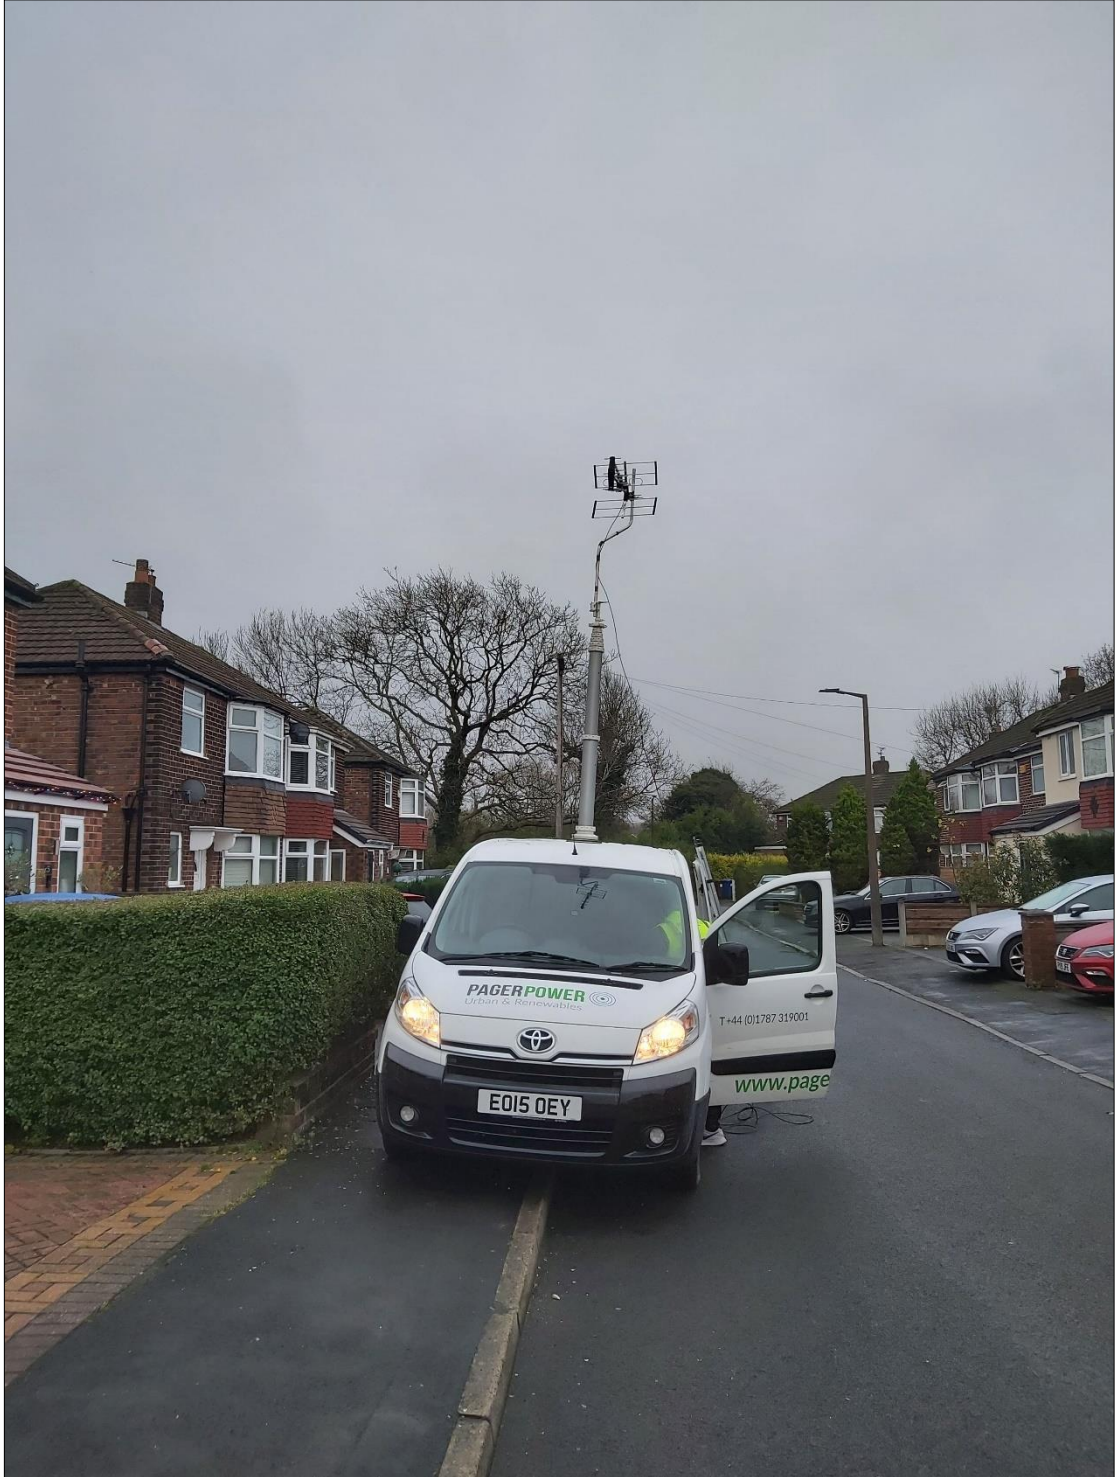
Location 4

| Location | Average Measured Signal Strength (dB) | Remarks | High Level Conclusion |
|---|---|---|---|
| 4 | <p>Baseline:</p> <p>Main TV MUX:<br/>62.8 (Very Good)</p> <p>Local TV MUX:<br/>45.7 (Good)</p> | <p>Multiple aerials observed at this location all pointing towards Winter Hill.</p> <p>All six main and all three local multiplexes had good video and audio.</p> <p>Two in three local multiplexes were not received at this location.</p> | <p>This location is more than 2,650m from the proposed development boundary. Signal losses at this range are likely to be minimal.</p> <p>Interference is unlikely.</p> |

Notes: Multiple HP UHF aerial directed towards the Winter Hill transmitter was observed.  
Multiple satellite dishes were observed.

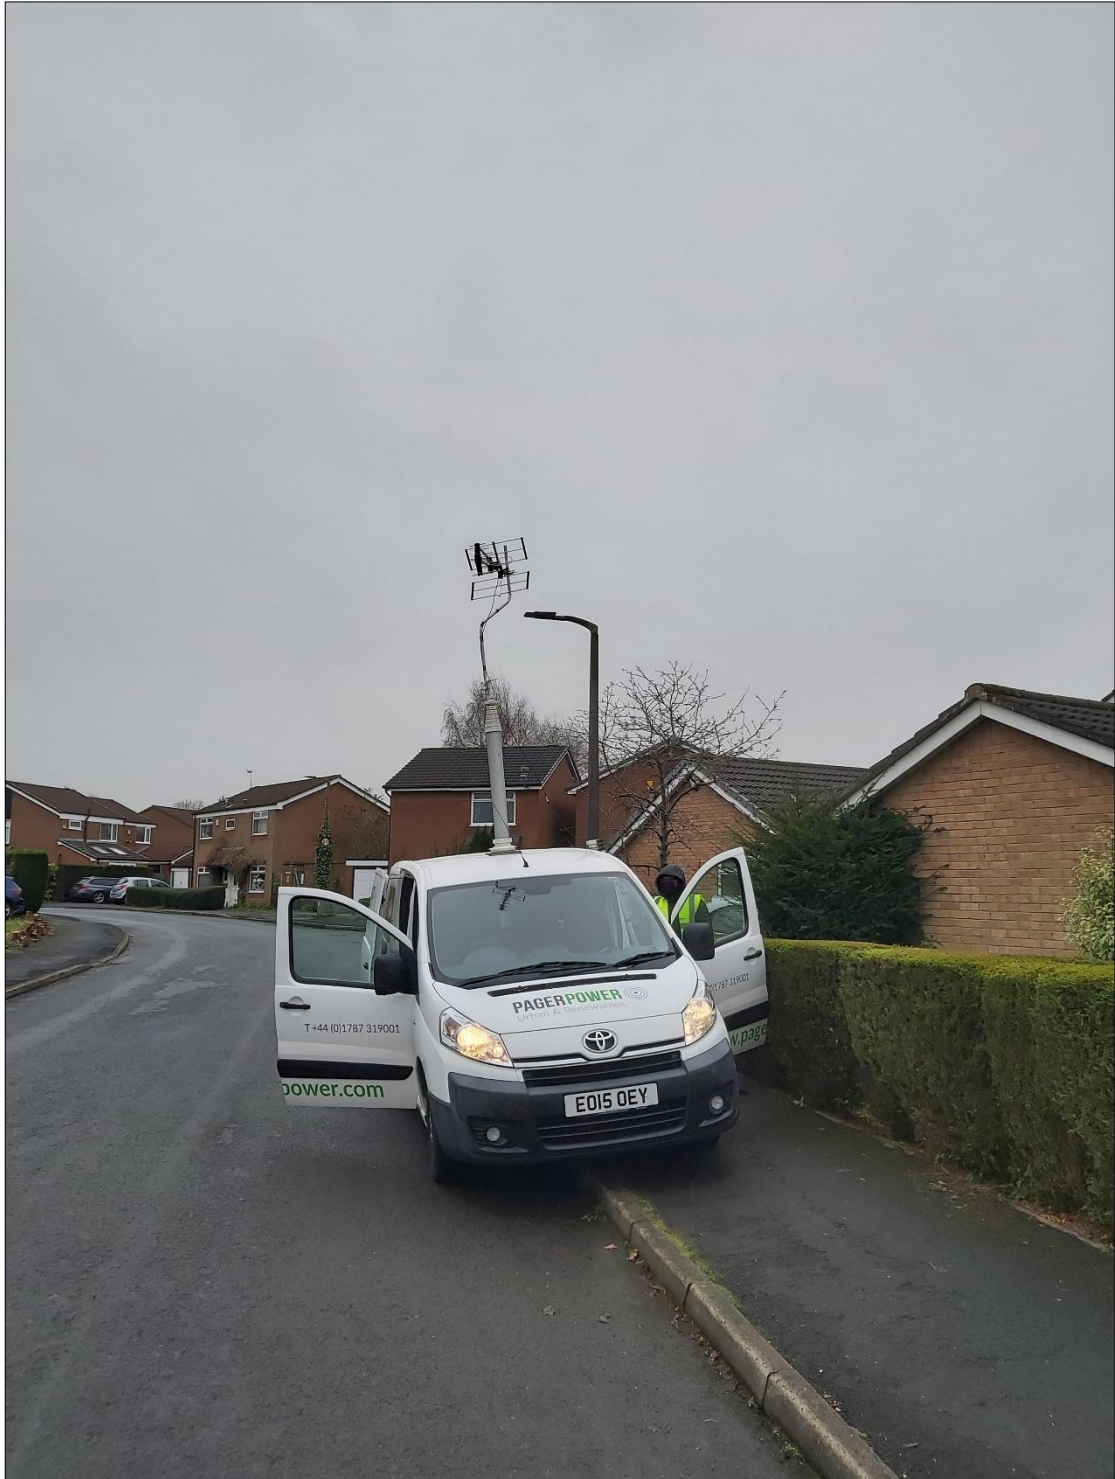
Location 5

| Location | Average Measured Signal Strength (dB) | Remarks | High Level Conclusion |
|---|---|---|---|
| 5 | <p>Baseline:</p> <p>Main TV MUX:<br/>64.7 (Very Good)</p> <p>Local TV MUX:<br/>47.8 (Good)</p> | <p>Multiple aerials observed at this location all pointing towards Winter Hill.</p> <p>All six main and all three local multiplexes had good video and audio.</p> <p>Two in three local multiplexes were not received at this location.</p> | <p>This location is more than 3,850m from the proposed development boundary. Signal losses at this range are likely to be minimal.</p> <p>Interference is unlikely.</p> |

Notes: Multiple HP UHF aerial directed towards the Winter Hill transmitter was observed.  
Multiple satellite dishes were observed.
