**Project Name: Architectural Paint Research**

Piccadilly Warehouses, Manchester

**Client: Manchester Design & Build**

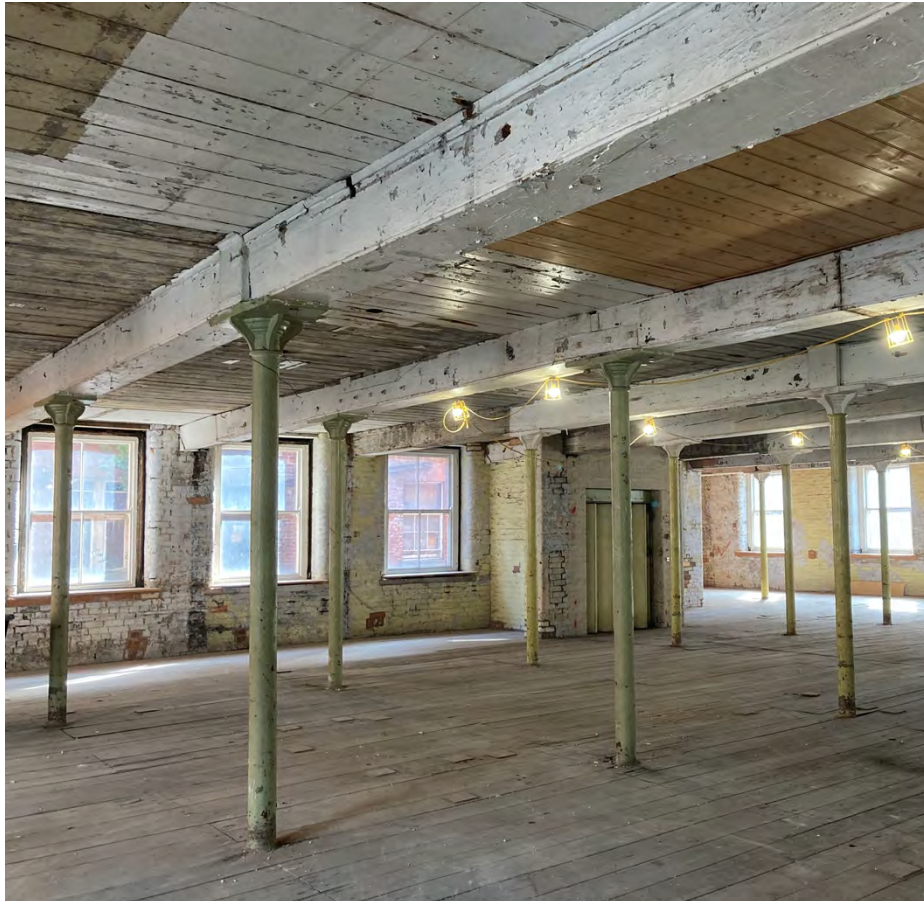
Figure 1: 2<sup>nd</sup> Floor 11 Bloom Street

The interiors across all floors have been stripped out, leaving behind open spaces revealing the perimeter brick walls, with traces of earlier paint schemes still clinging to the surfaces (see fig.1).

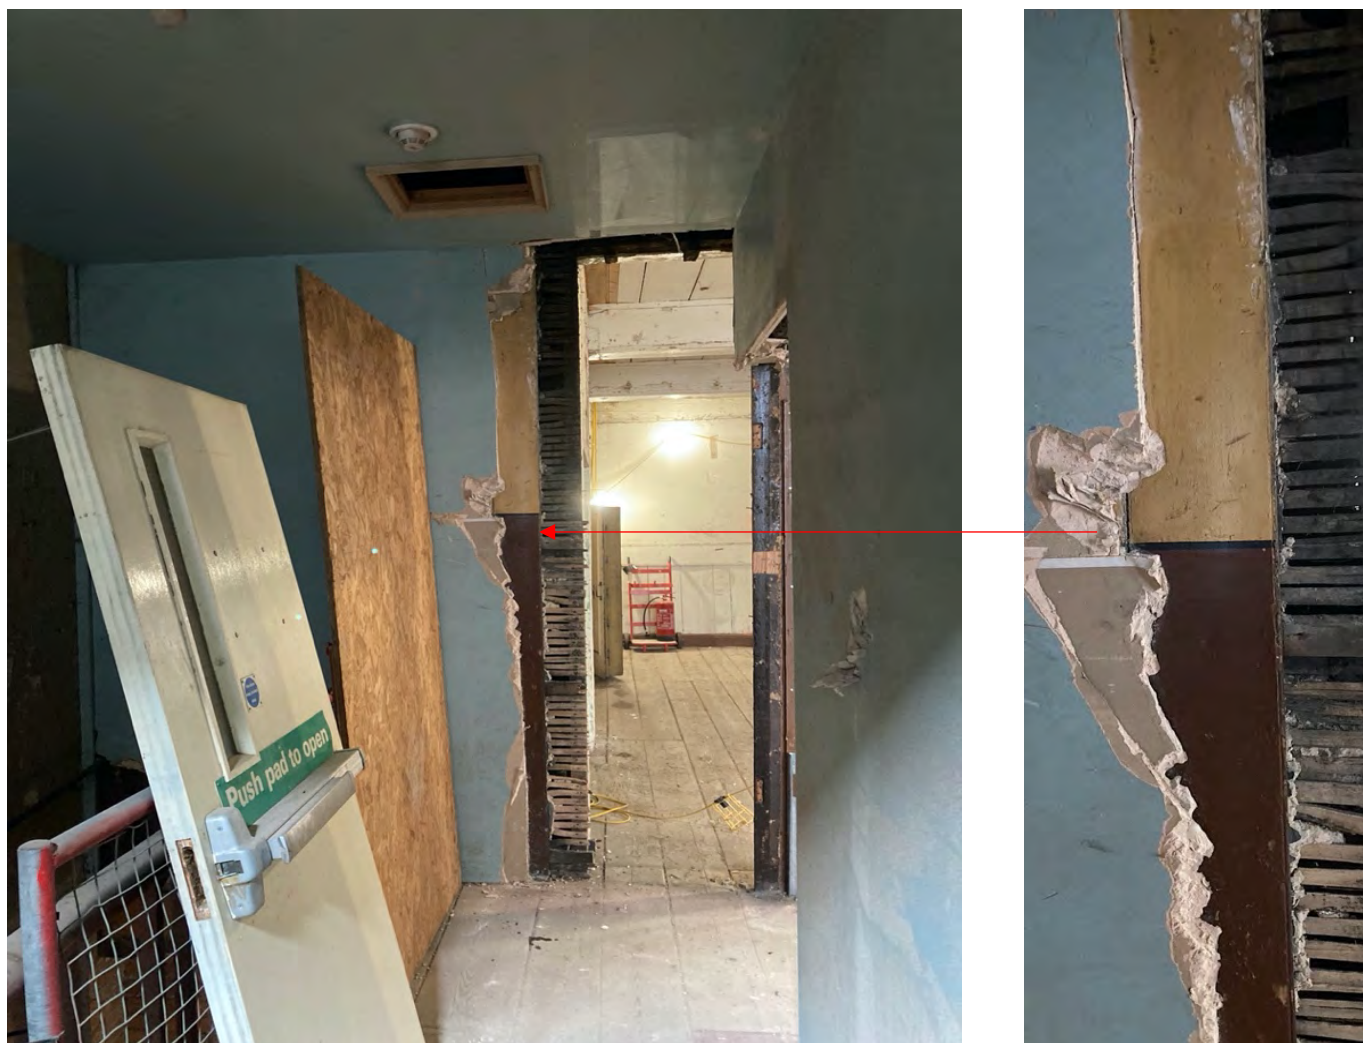
*Figure 2: Revealed phase II stud wall on the 1<sup>st</sup> Floor*

Horseshoe stair and stairwell: painted brown at lower (dado) level with cream above, separated by a thin black band. This brown and cream theme of decoration is common across many surfaces during the phase II period (including internal stud walls and supporting iron columns). This is revealed behind a later plaster board wall on the 1<sup>st</sup> floor (see fig 2)

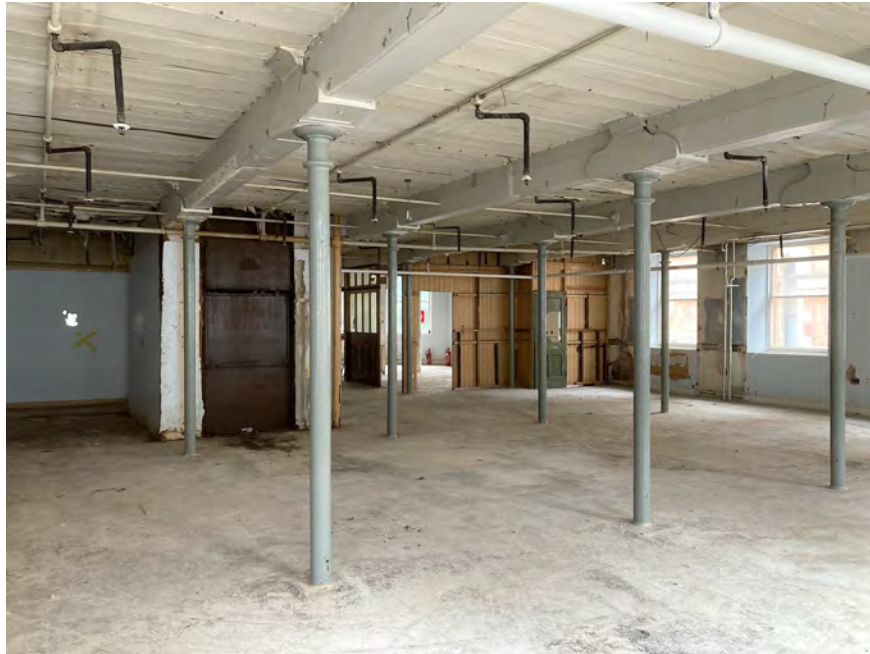
Figure 3: view of the 2nd floor

The interiors across all floors have been stripped out, leaving behind open spaces revealing the perimeter walls, a central lift shaft and historic tongue & groove partitioning on some floors. (see fig.3). The partitioning dates to the phase II period.

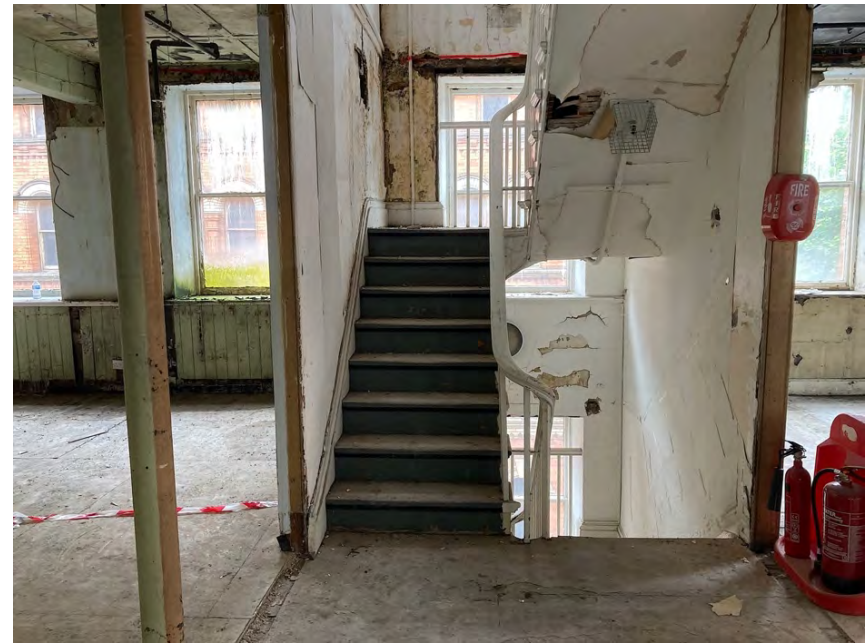
Figure 4: The Stairs &amp; Stairwell

The main entrance to the building is accessed on the canted corner at the junction of Bloom Street and Minshull Street, with a stair leading off to access all floors. This (main) stair retains its original lime plastered stairwell wall and wooden staircase, with newels, balusters and handrail all intact (see fig.4). There is a further service stair in the corner of the building, with exposed brick walls that were originally lime washed blue and later white.

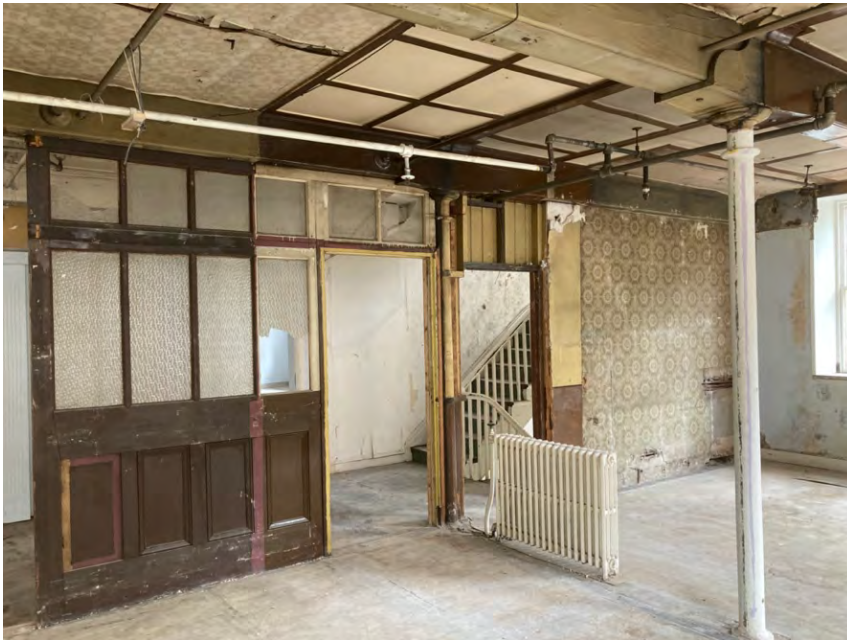
Figure 5: Early enclosed office area on the 2<sup>nd</sup> floor

Some wall papers remain. One of particular note is a section of 19<sup>th</sup> century wall paper surviving largely intact in an area on the canted corner of the building on the 2<sup>nd</sup> floor; enclosed by phase II timber panelling and glazed screens (see fig.5). The wall paper here sits beneath the brown and cream oil paints and is clearly of the phase I period (possibly late 19<sup>th</sup> century).

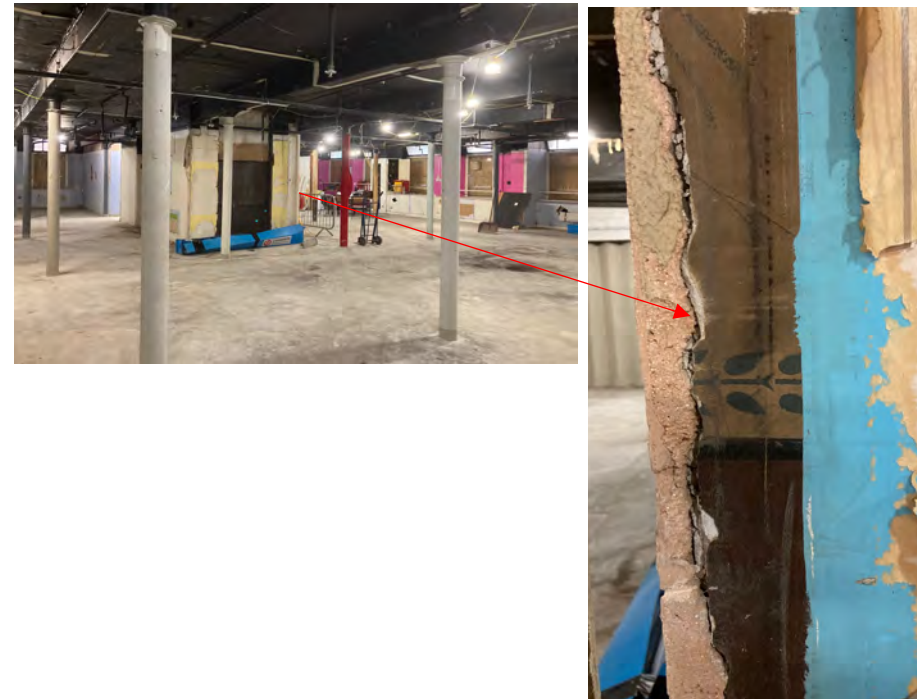
Figure 6: Evidence for phase II stencilling on the Upper Ground Floor

A variation on the brown and cream theme exists on the Upper Ground Floor, where there are traces of stencilling to the plaster wall surrounding the lift shaft (see fig. 6). This is a simple leaf design painted in green, immediately above the thin black line separating the lower and upper walls and provides further evidence for the extensive use of this colour scheme during the phase II period throughout the entire building.

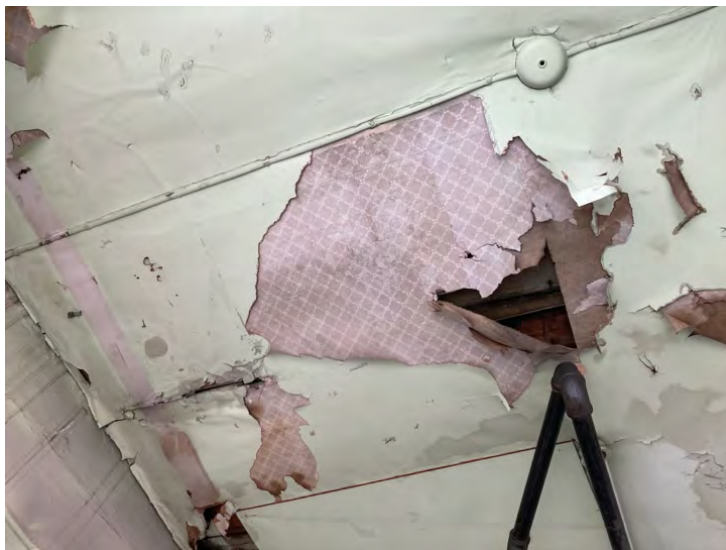
Figure 7: Evidence for patterned ceiling paper (3<sup>rd</sup> Floor)

Into the phase II period the ceilings were painted cream and white with evidence the ceilings on the 2<sup>nd</sup> and 3<sup>rd</sup> floors were lined with linen fabric and papered during the phase II or phase III period (see fig.7)

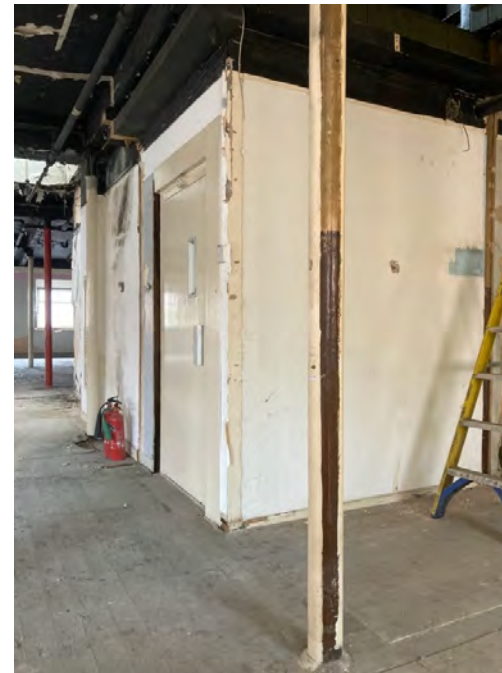
Figure 8: Phase II decoration revealed on iron column on 4<sup>th</sup> Floor

The removal of a later stud wall on the 4<sup>th</sup> floor has revealed the phase II painted decoration on one of the supporting columns, echoing the familiar scheme of brown and cream dating to the phase II period already identified at Bloom Street (see fig.8)

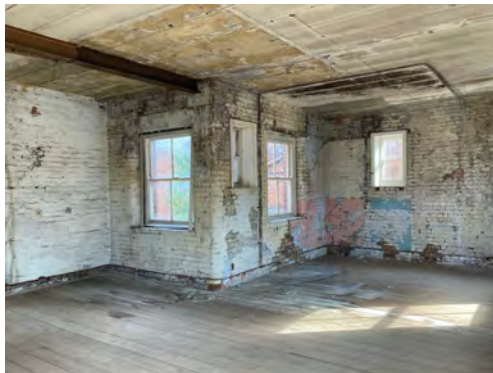
4<sup>th</sup> floor sample location (1)

4<sup>th</sup> floor white painted wall

Brick substrate at the base of the sample with the earliest 19<sup>th</sup> century phases of decoration above.

Initially, white lime wash followed by further lime washes tinted with blue pigment

The later paints are modern alkyd masonry paints in cream and latterly white

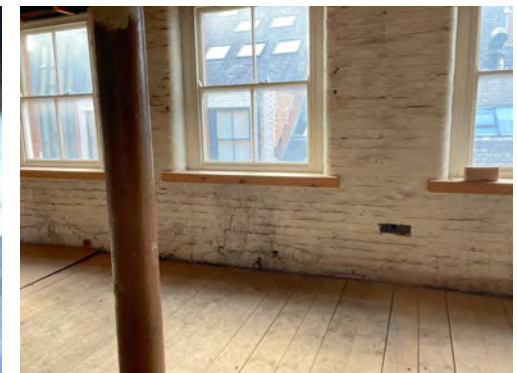
3<sup>rd</sup> floor sample location (3)

3<sup>rd</sup> floor white painted wall

Earliest 19<sup>th</sup> century phases identical to the 4<sup>th</sup> floor above, in blue lime wash

The later paints are modern white alkyls.

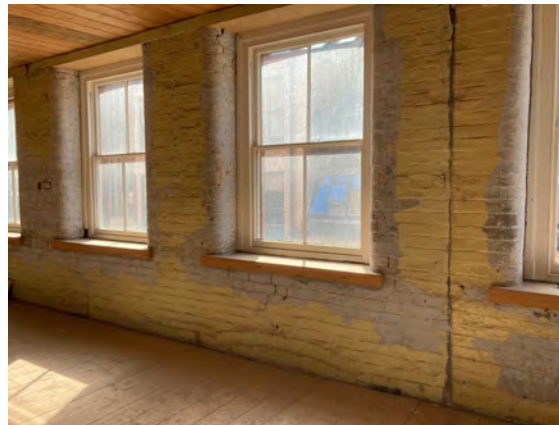
2<sup>nd</sup> floor sample location (7)

2<sup>nd</sup> floor yellow painted wall

Further blue tinted lime washes during the early phases, providing evidence for a consistent theme across all floors.

Later alkyd paints in creams and latterly white.

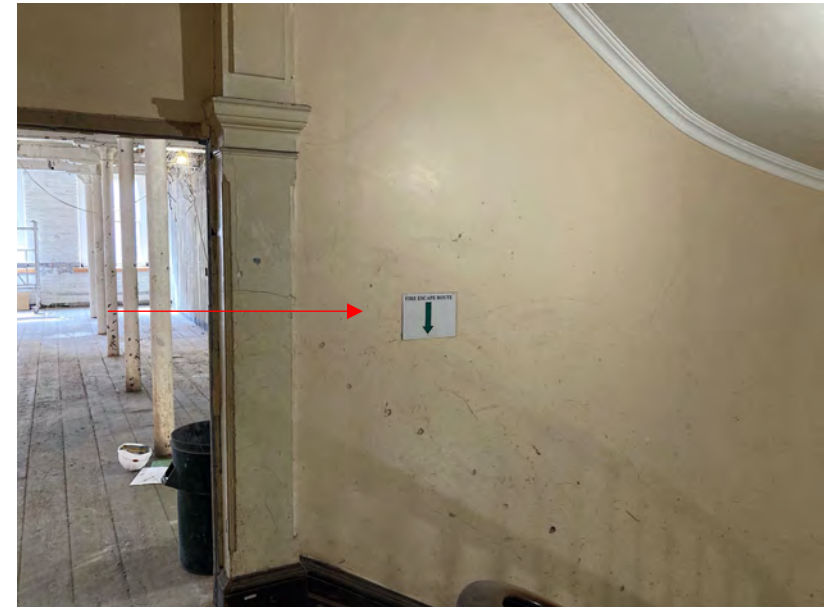
**Sample location (13)**

Phase 3: post war paint schemes in blues and creams

Phase 2: browns and creams

Phase 1: 19<sup>th</sup> century schemes, initially in pale blue/green, followed by cream coloured lead oil paints

The sample displayed (left) was removed from a location on the stairwell wall as indicated. This is original plaster and displays a full chronology of decorative schemes applied throughout the 19<sup>th</sup> century and beyond.

During the 19<sup>th</sup> century, the wall was painted uniformly in pale blue green followed by creams.

The later phase 2 schemes were applied as brown to the lower wall with creams above the dado level, separated by a thin black band

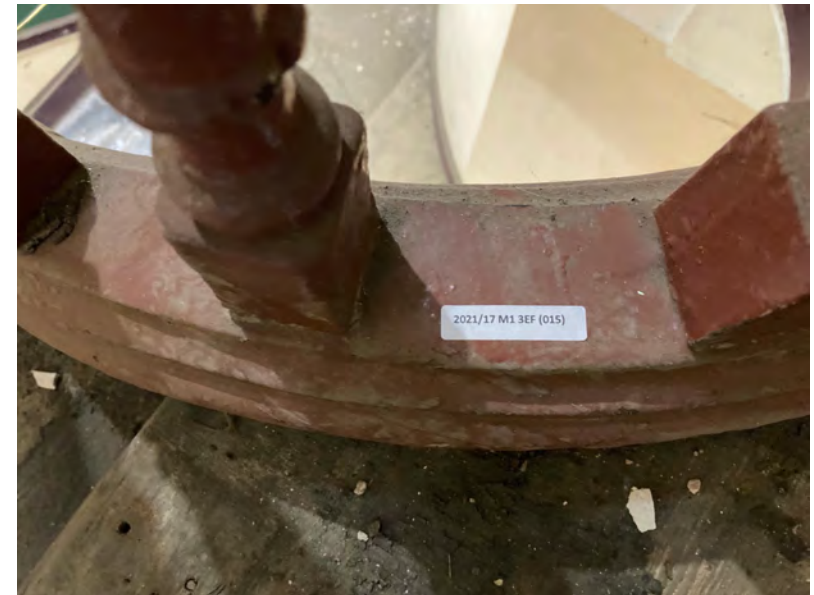
### Sample location (15)

Phase 3: post war paint schemes in maroon, black & brown

Phase 2: browns and creams

This sample is representative of all the stair joinery within the historic horseshoe stairwell.

The joinery was originally wood grained and varnished; a typical decorative effect for joinery of the period. This was left in place for some considerable time before being overpainted in reddish brown. Further brown oil paints were applied during the phase 2 period, prior to the modern finishes post war.

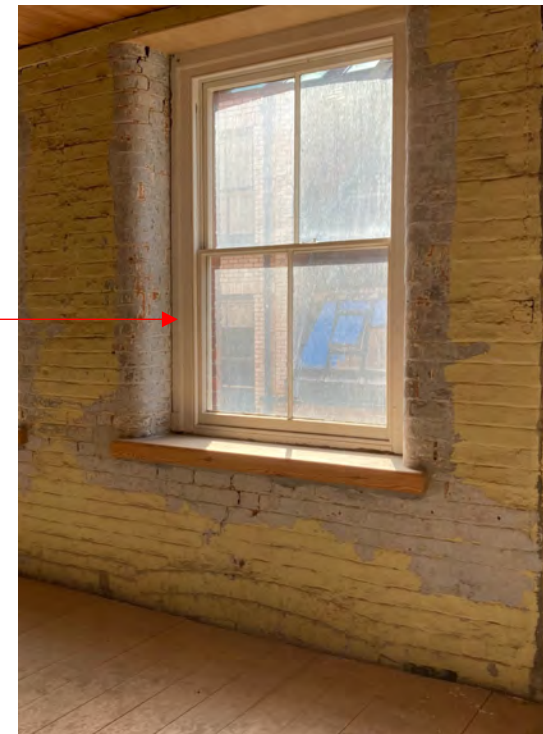
Box frame (8)

Phase III: post war paint schemes in white, blue & yellow

Phase II: cream & pale blue

Sample removed from the 19<sup>th</sup> century box frame. The sashes are relatively recent replacements.

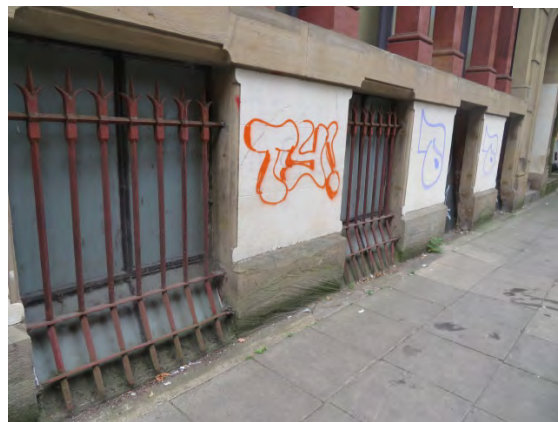
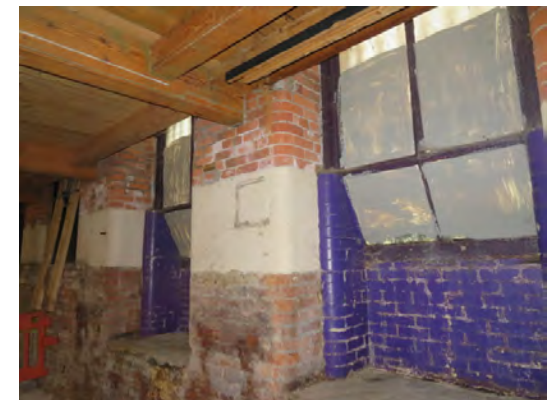
Sample locations

**Note: the early paints on both internal and external faces of the Crittall windows have a high lead content, measured at approx. 100,000 ppm (or 10% concentration).**

#### EXTERNAL

Phase II: green lead oil paints

Phase I/II: deep red lead oil paints

#### INTERNAL

Predominantly cream lead oil paints throughout the phase I and phase II periods.

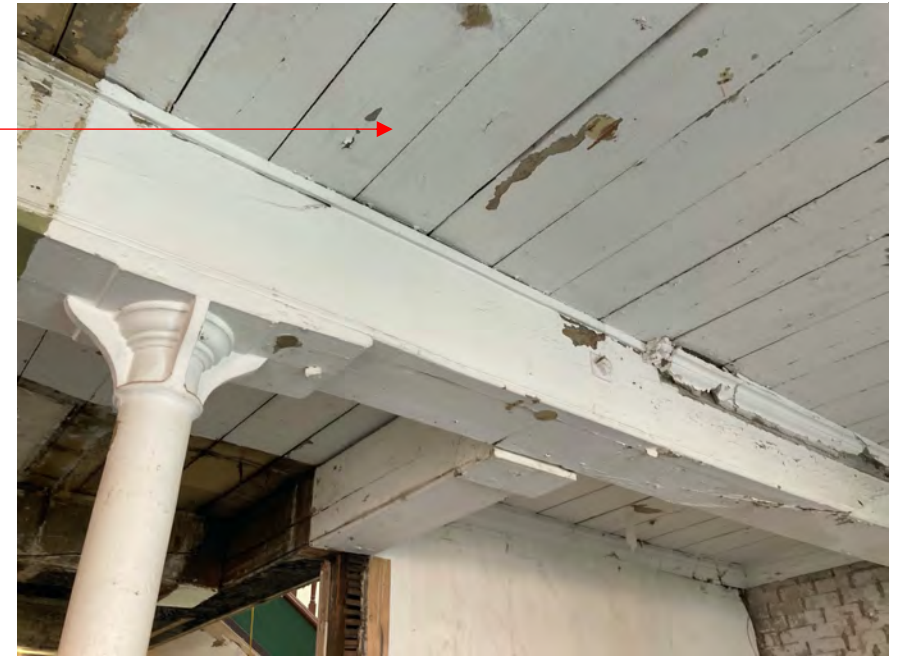
sample location (5)

Phase III: post war paint schemes in white

Phase II: dark cream/stone colour

Phase I: 19<sup>th</sup> century schemes, initially lead white with later pale blue

The earliest paints applied here, in lead white and later pale blue match those on the window frames and may be considered representative of the phase I joinery colours.

The phase II paints are dark cream or stone coloured.

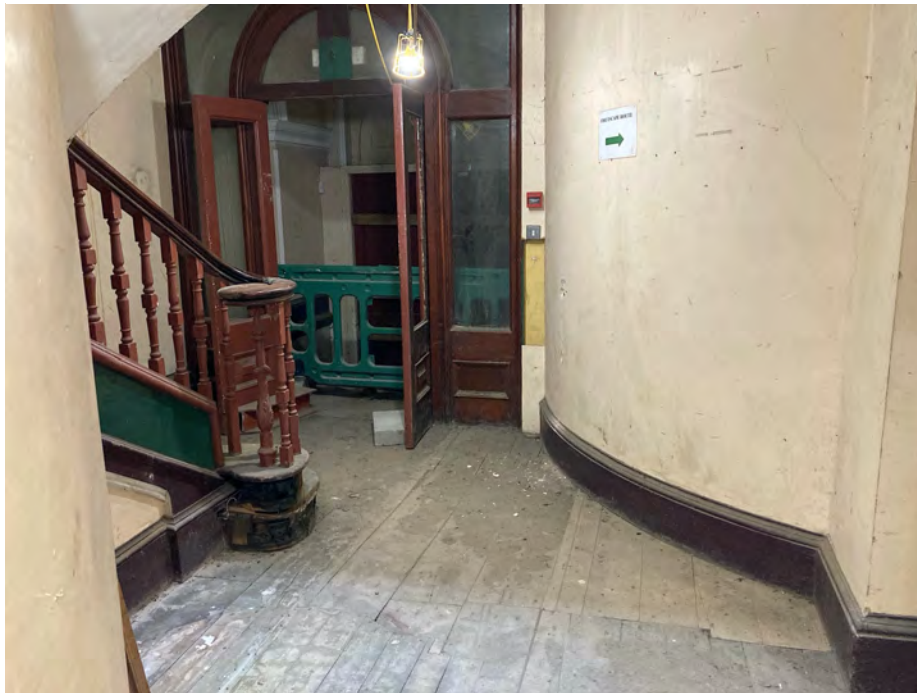
**View of the entrance at the foot of the main stair**

The Entrance Vestibule faces into Bloom Street, and was the main entrance to the building. Upon arrival, visitors went up a short flight of steps, through a glazed door and into the entrance hall at the foot of the stairs.

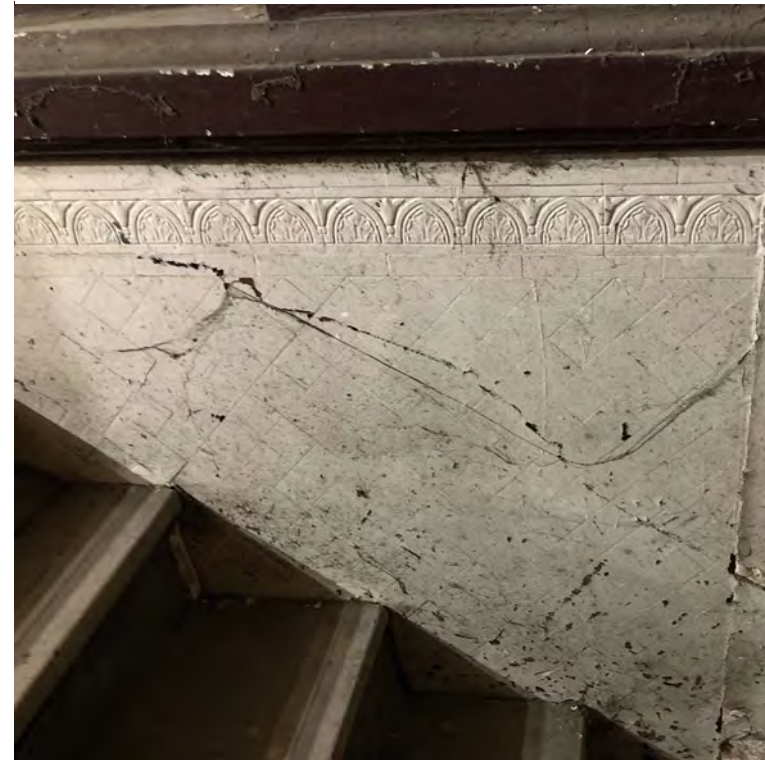
**Tiled walls**

The stair walls within the entrance vestibule still have their original 19<sup>th</sup> century tiles in situ, although now covered in white paint.

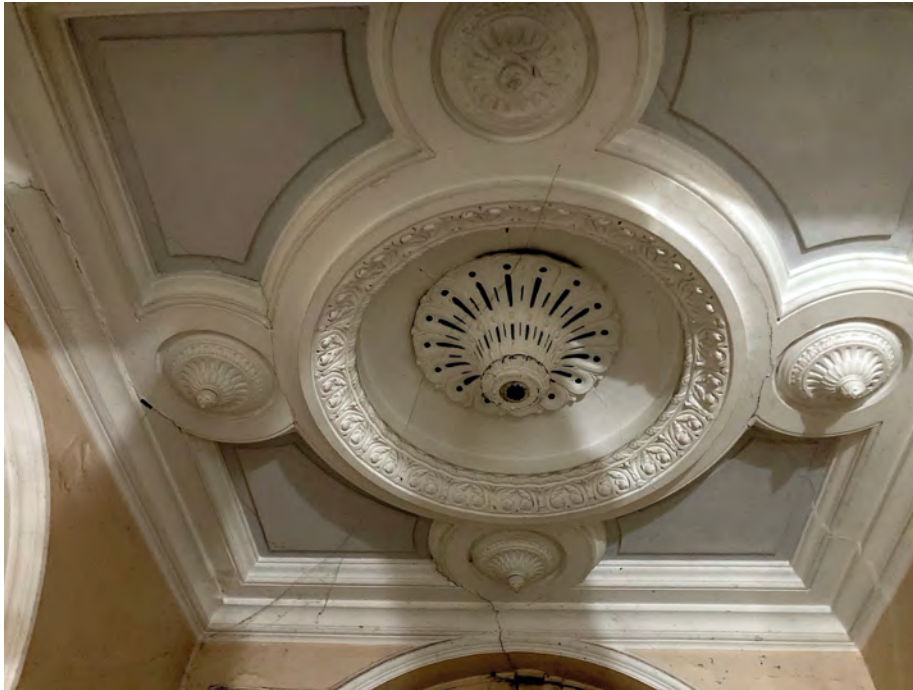
**Vestibule ceiling**

The heavy plaster ceiling mouldings in the vestibule with central rose, possibly used as a fixing for a hanging gas light (Gasolier). There are two wall niches (one each side) with framing plaster mouldings.

The niches and walls were sampled and examined, but no samples were removed from the ceiling due to safe access restrictions.

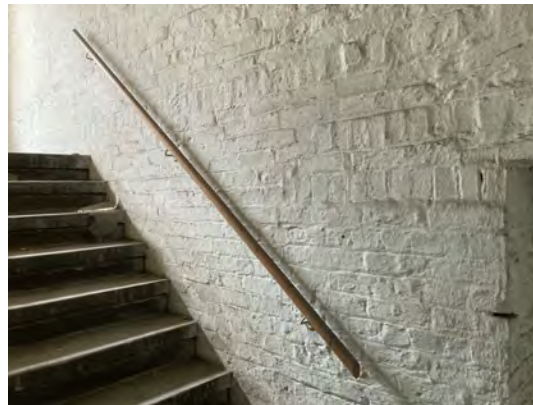
sample location (50)

Phase I: several applications of lime wash tinted with blue pigment. Later white lime wash into the phase II period.

Latterly white alkyl masonry paints

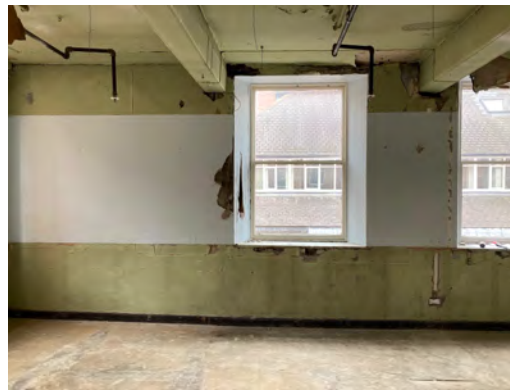
Sample location (28)

Phase I: Lime wash tinted with blue pigment.  
Latterly white and rust alkyd masonry paints (phase III)

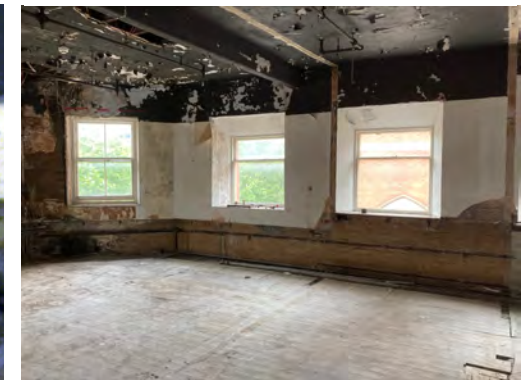
Sample location (20)

Phase I: several applications of lime wash tinted with black & blue pigment.  
Latterly white alkyd masonry paints (phase III)

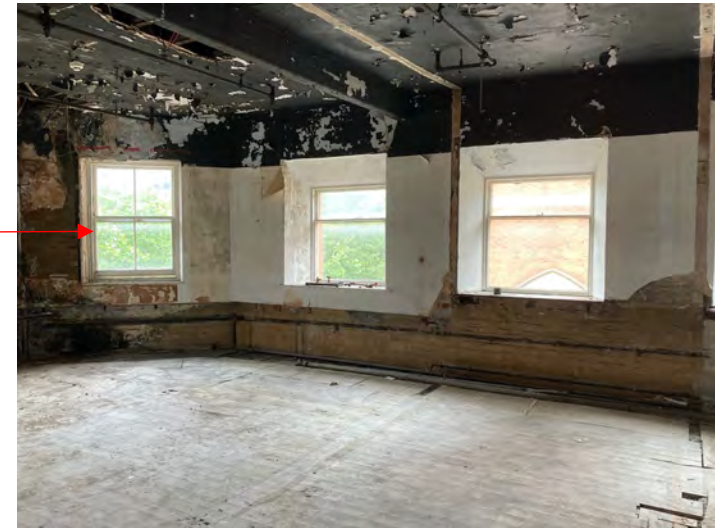
Sample location (22)

Phase III: post war paint schemes in white and green.

Phase I & II: approx 13 applications of predominantly cream and stone coloured lead and zinc oil paints.

Sample removed from two light sash of the window as indicated. This is typical of the windows throughout Mindel House and may be considered representative of all.

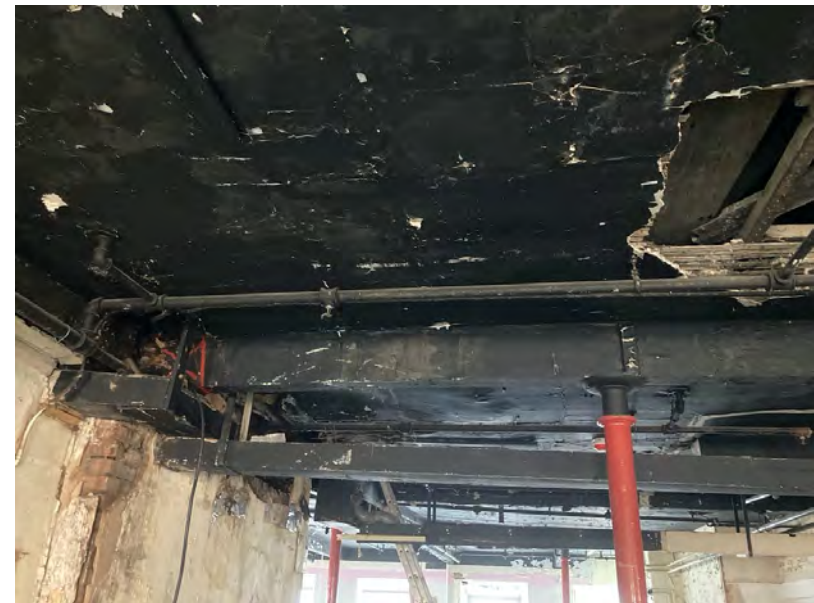
sample location (23)

Phase III: post war paint schemes in cream, white and black.

Phase I & II: several applications of blue tinted lime wash

The lath and plaster ceiling on the 4<sup>th</sup> floor is 19<sup>th</sup> century and with evidence for several coatings of the blue tinted lime washes detected on the walls.

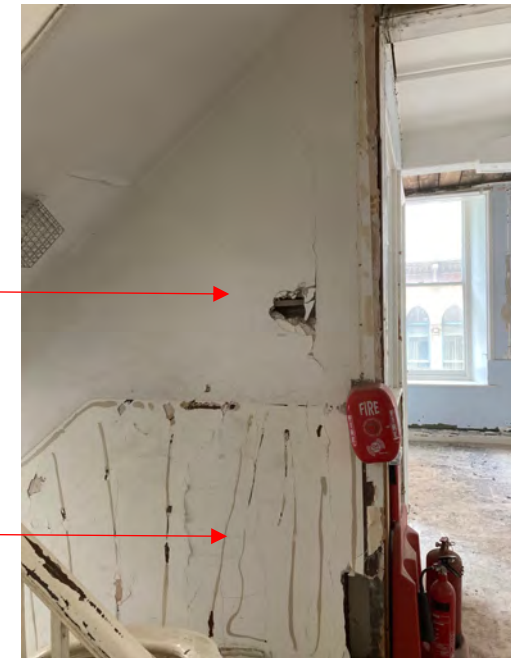
Sample location (45)

Phase III: post war paint schemes in white and pale cream

Phase II: cream water paints (upper wall) with brown at dado level (lower wall)

Phase I: cream and stone coloured water paints

Throughout the phase I period the stairwell was painted uniformly in stone coloured water paint. Into phase II two colour theme was introduced with brown water paints at dado (lower) level with cream above.

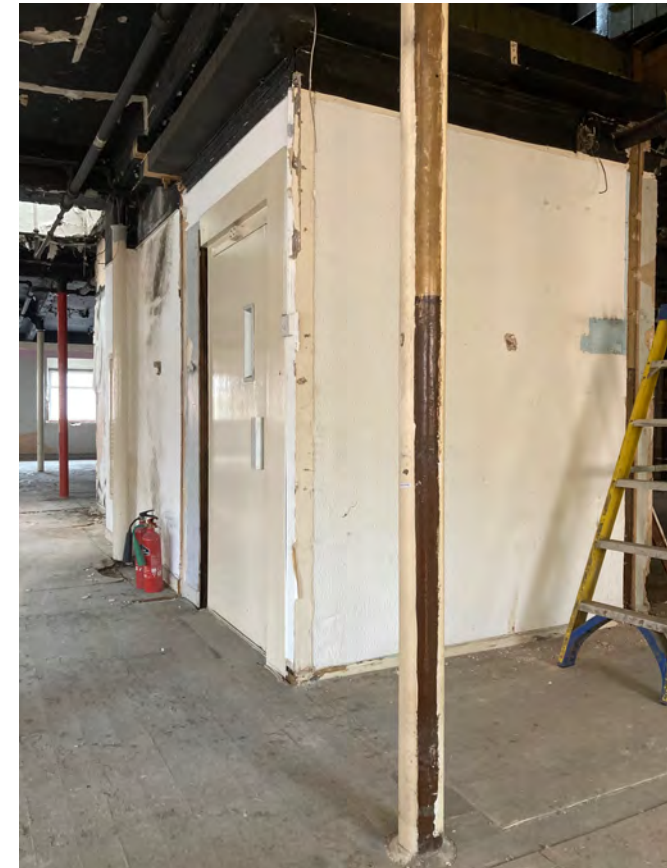
Sample location (21)

Phase III: post war paint schemes

Phase II: red and later brown at lower level with cream above

Phase I: pale blues and greens applied uniformly across the length of the column shaft

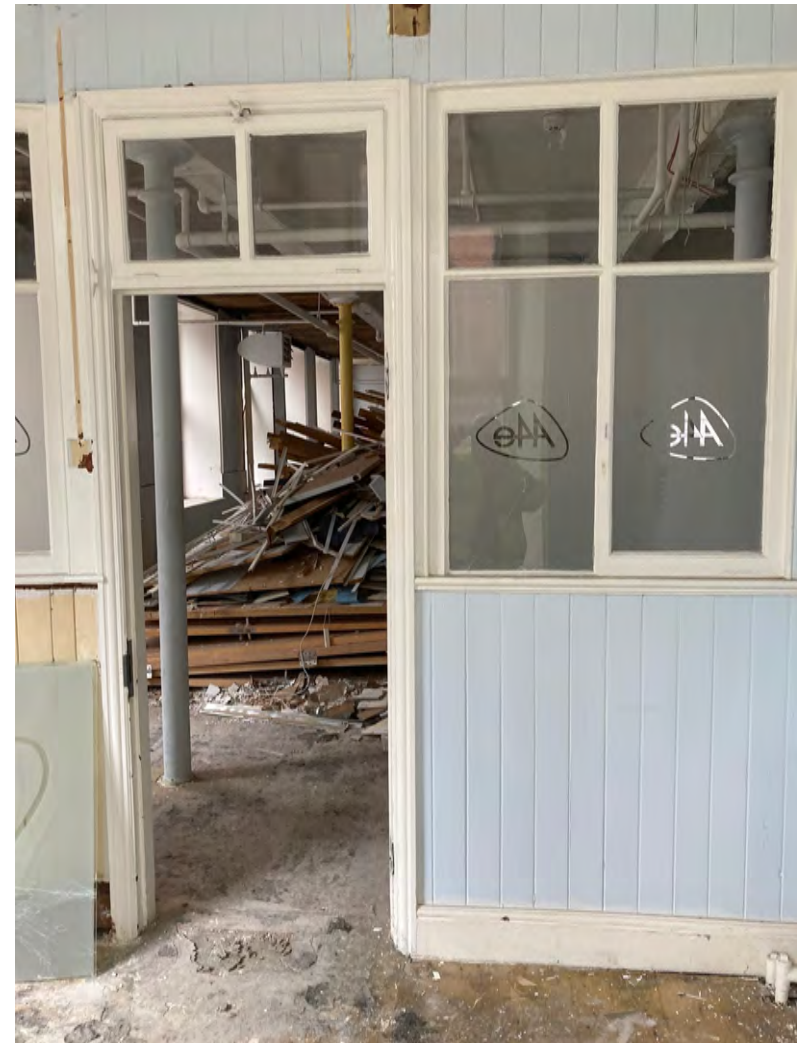
Glazed partition on the 1<sup>st</sup> floor

Phase III: pale blue,  
latterly white

Later Phase II:  
initially brown then  
green.

Dating to the phase II period. Traces  
of varnish on the surface of the  
softwood substrate, with later  
brown and green lead oil paints
