Phase II Geoenvironmental Site Assessment  
Laystall Street, Manchester

Reference: 15-140-R1-1  
Date: March 2022

## PHASE II GEOENVIRONMENTAL SITE ASSESSMENT

**Great Places Housing Group**

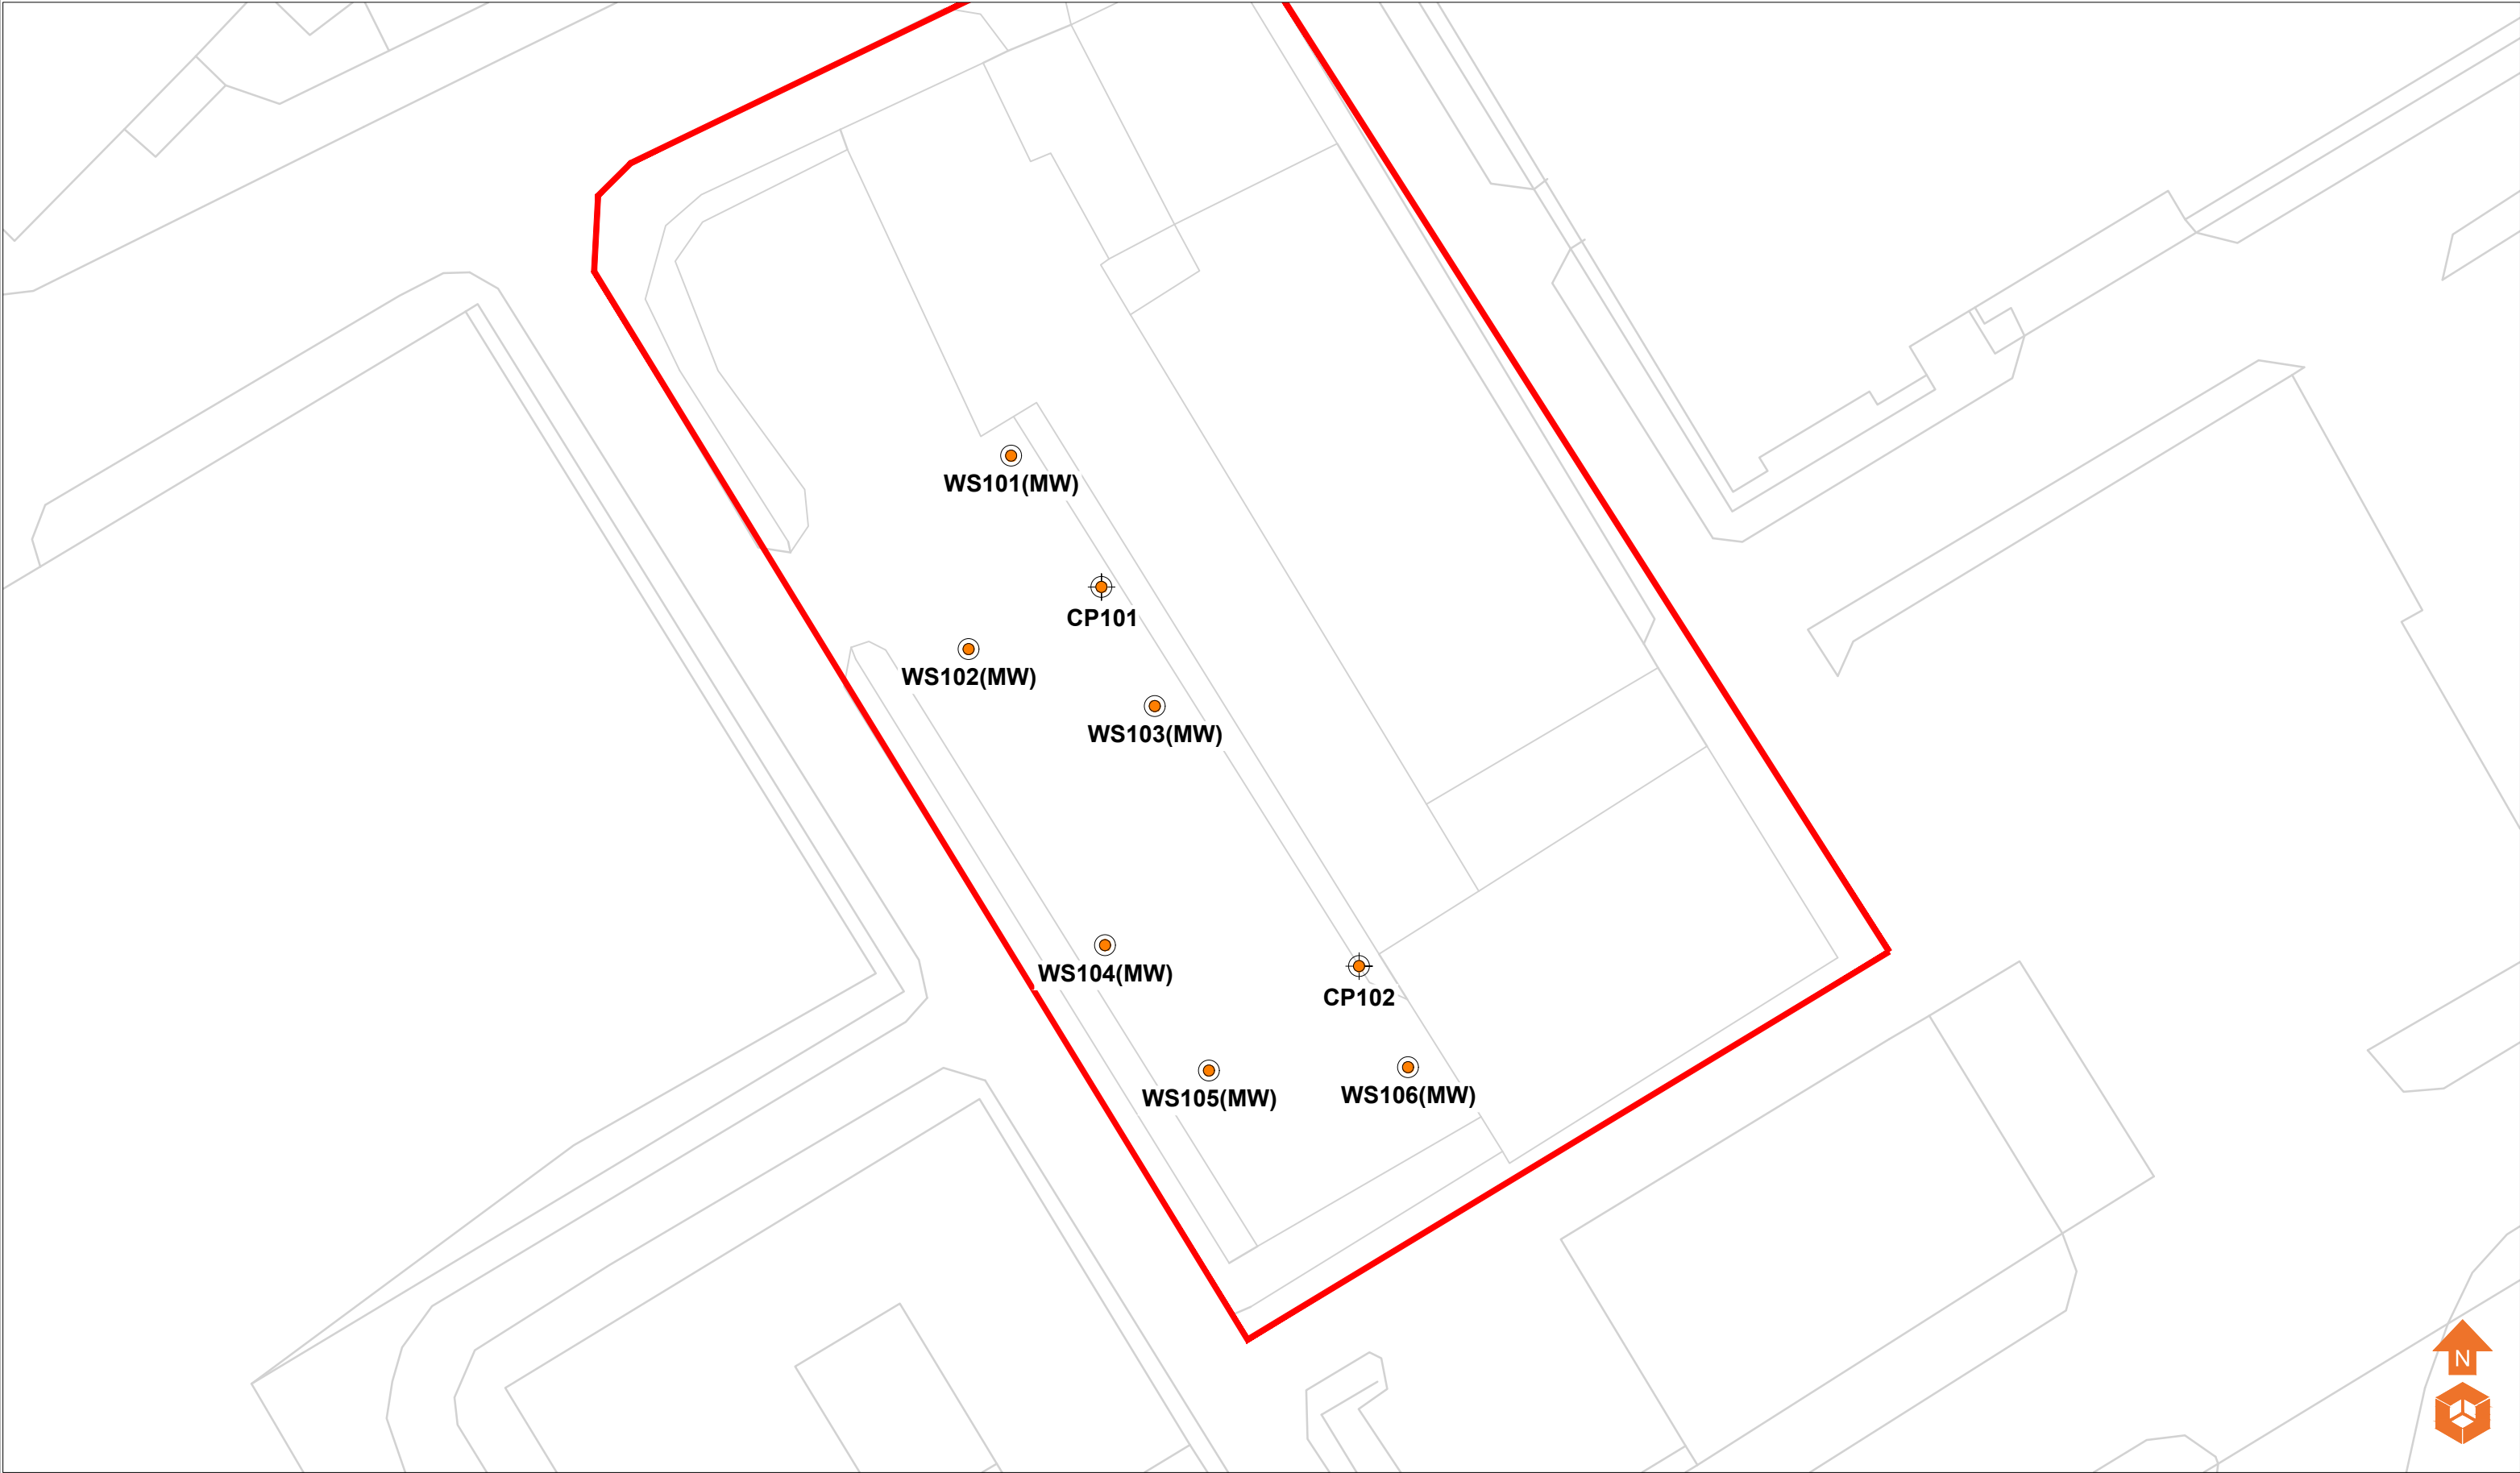
The sampling locations are illustrated in Drawing 15-140-005 (Appendix III). The ground conditions encountered are indicated on the logs, which are provided in Appendix V.

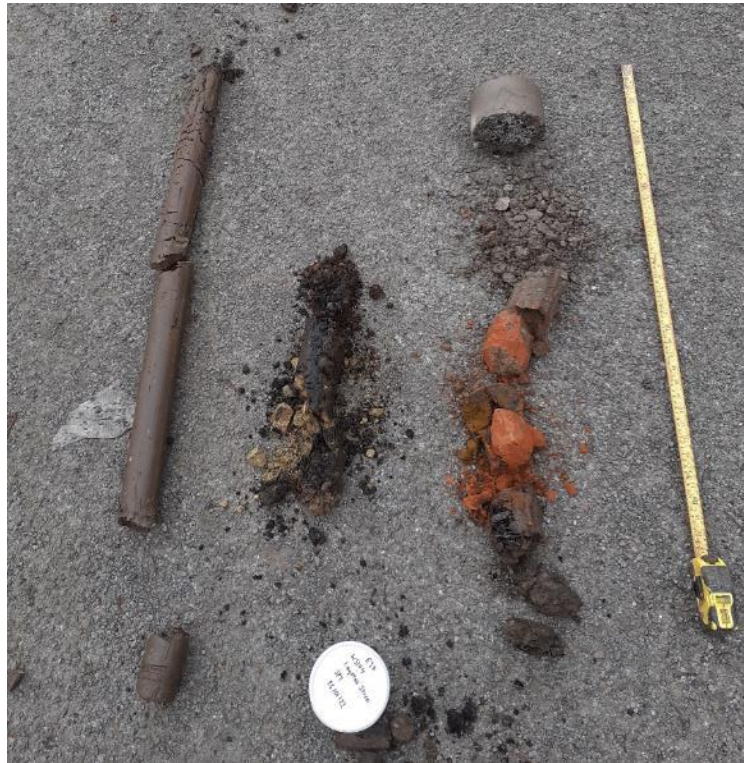
PLATE 5      WS105 ARISINGS

Asbestos in the form of loose amosite fibres (<0.001 %) has been identified in the Made Ground in WS105 at 0.85 m bgl.

| POLLUTANT LINKAGE | CONTAMINANT (SOURCE) | PATHWAY | RECEPTOR | PROBABILITY | CURRENT RISK | RESIDUAL RISK AFTER MITIGATION |
|---|---|---|---|---|---|---|
| <p><b>Assessment:</b><br/>Asbestos in the form of loose amosite fibres (&lt;0.001 %) has been identified in the Made Ground in WS105 at 0.85 m bgl.</p> <p><b>Recommendation:</b><br/>The soils will require placement in accordance with the asbestos CSM. Construction works completed with PPE and provision of welfare. A pre demolition survey will be required for the existing buildings.</p> | | | | | | |
