Phase II Geoenvironmental Site Assessment  
New Smithfield Market, Barton and Redman

Reference: 12-757-R2-1  
Date: July 2020

## **PHASE II GEOENVIRONMENTAL SITE ASSESSMENT**

New Smithfield Market  
Whitworth Street East  
Openshaw  
Manchester  
M11 2WJ

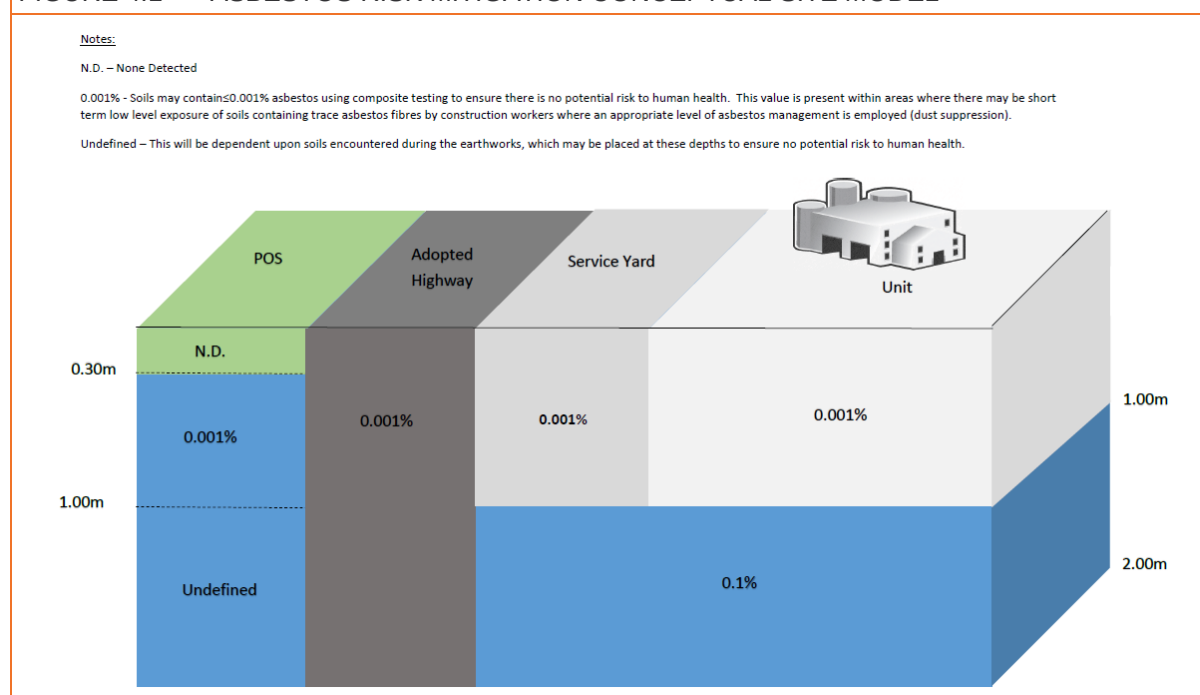
**FIGURE 4.1 ASBESTOS RISK MITIGATION CONCEPTUAL SITE MODEL**

Asbestos in the form of amosite has also been identified within localised areas in shallow Made Ground deposits (WS206, 0.40 m). Asbestos quantification records a concentration of <0.001%. No visual signs of ACM were encountered during the ground investigation; it is therefore likely that only trace fibres are present. Impacted soils should be managed according to the asbestos risk mitigation conceptual site model shown in Figure 4.1.

| POLLUTANT LINKAGE | CONTAMINANT (SOURCE) | PATHWAY | RECEPTOR | PROBABILITY | CURRENT RISK | RESIDUAL RISK AFTER MITIGATION |
|---|---|---|---|---|---|---|
| <b>Recommendation:</b><br><p>No further works unless a change in development is planned. With reference to the E3P Asbestos Conceptual Site Model, Made Ground deposits will require placement below hardstanding or buildings or a cover system in order to mitigate the risks to future commercial end users. Where asbestos has been identified &gt;0.1% the impacted Made Ground will require removal from site by a licensed waste handler or placement at depth in POS, with subsequent validation sampling to determine if asbestos remains at this location. Construction works completed with PPE and provision of welfare.</p> | | | | | | |

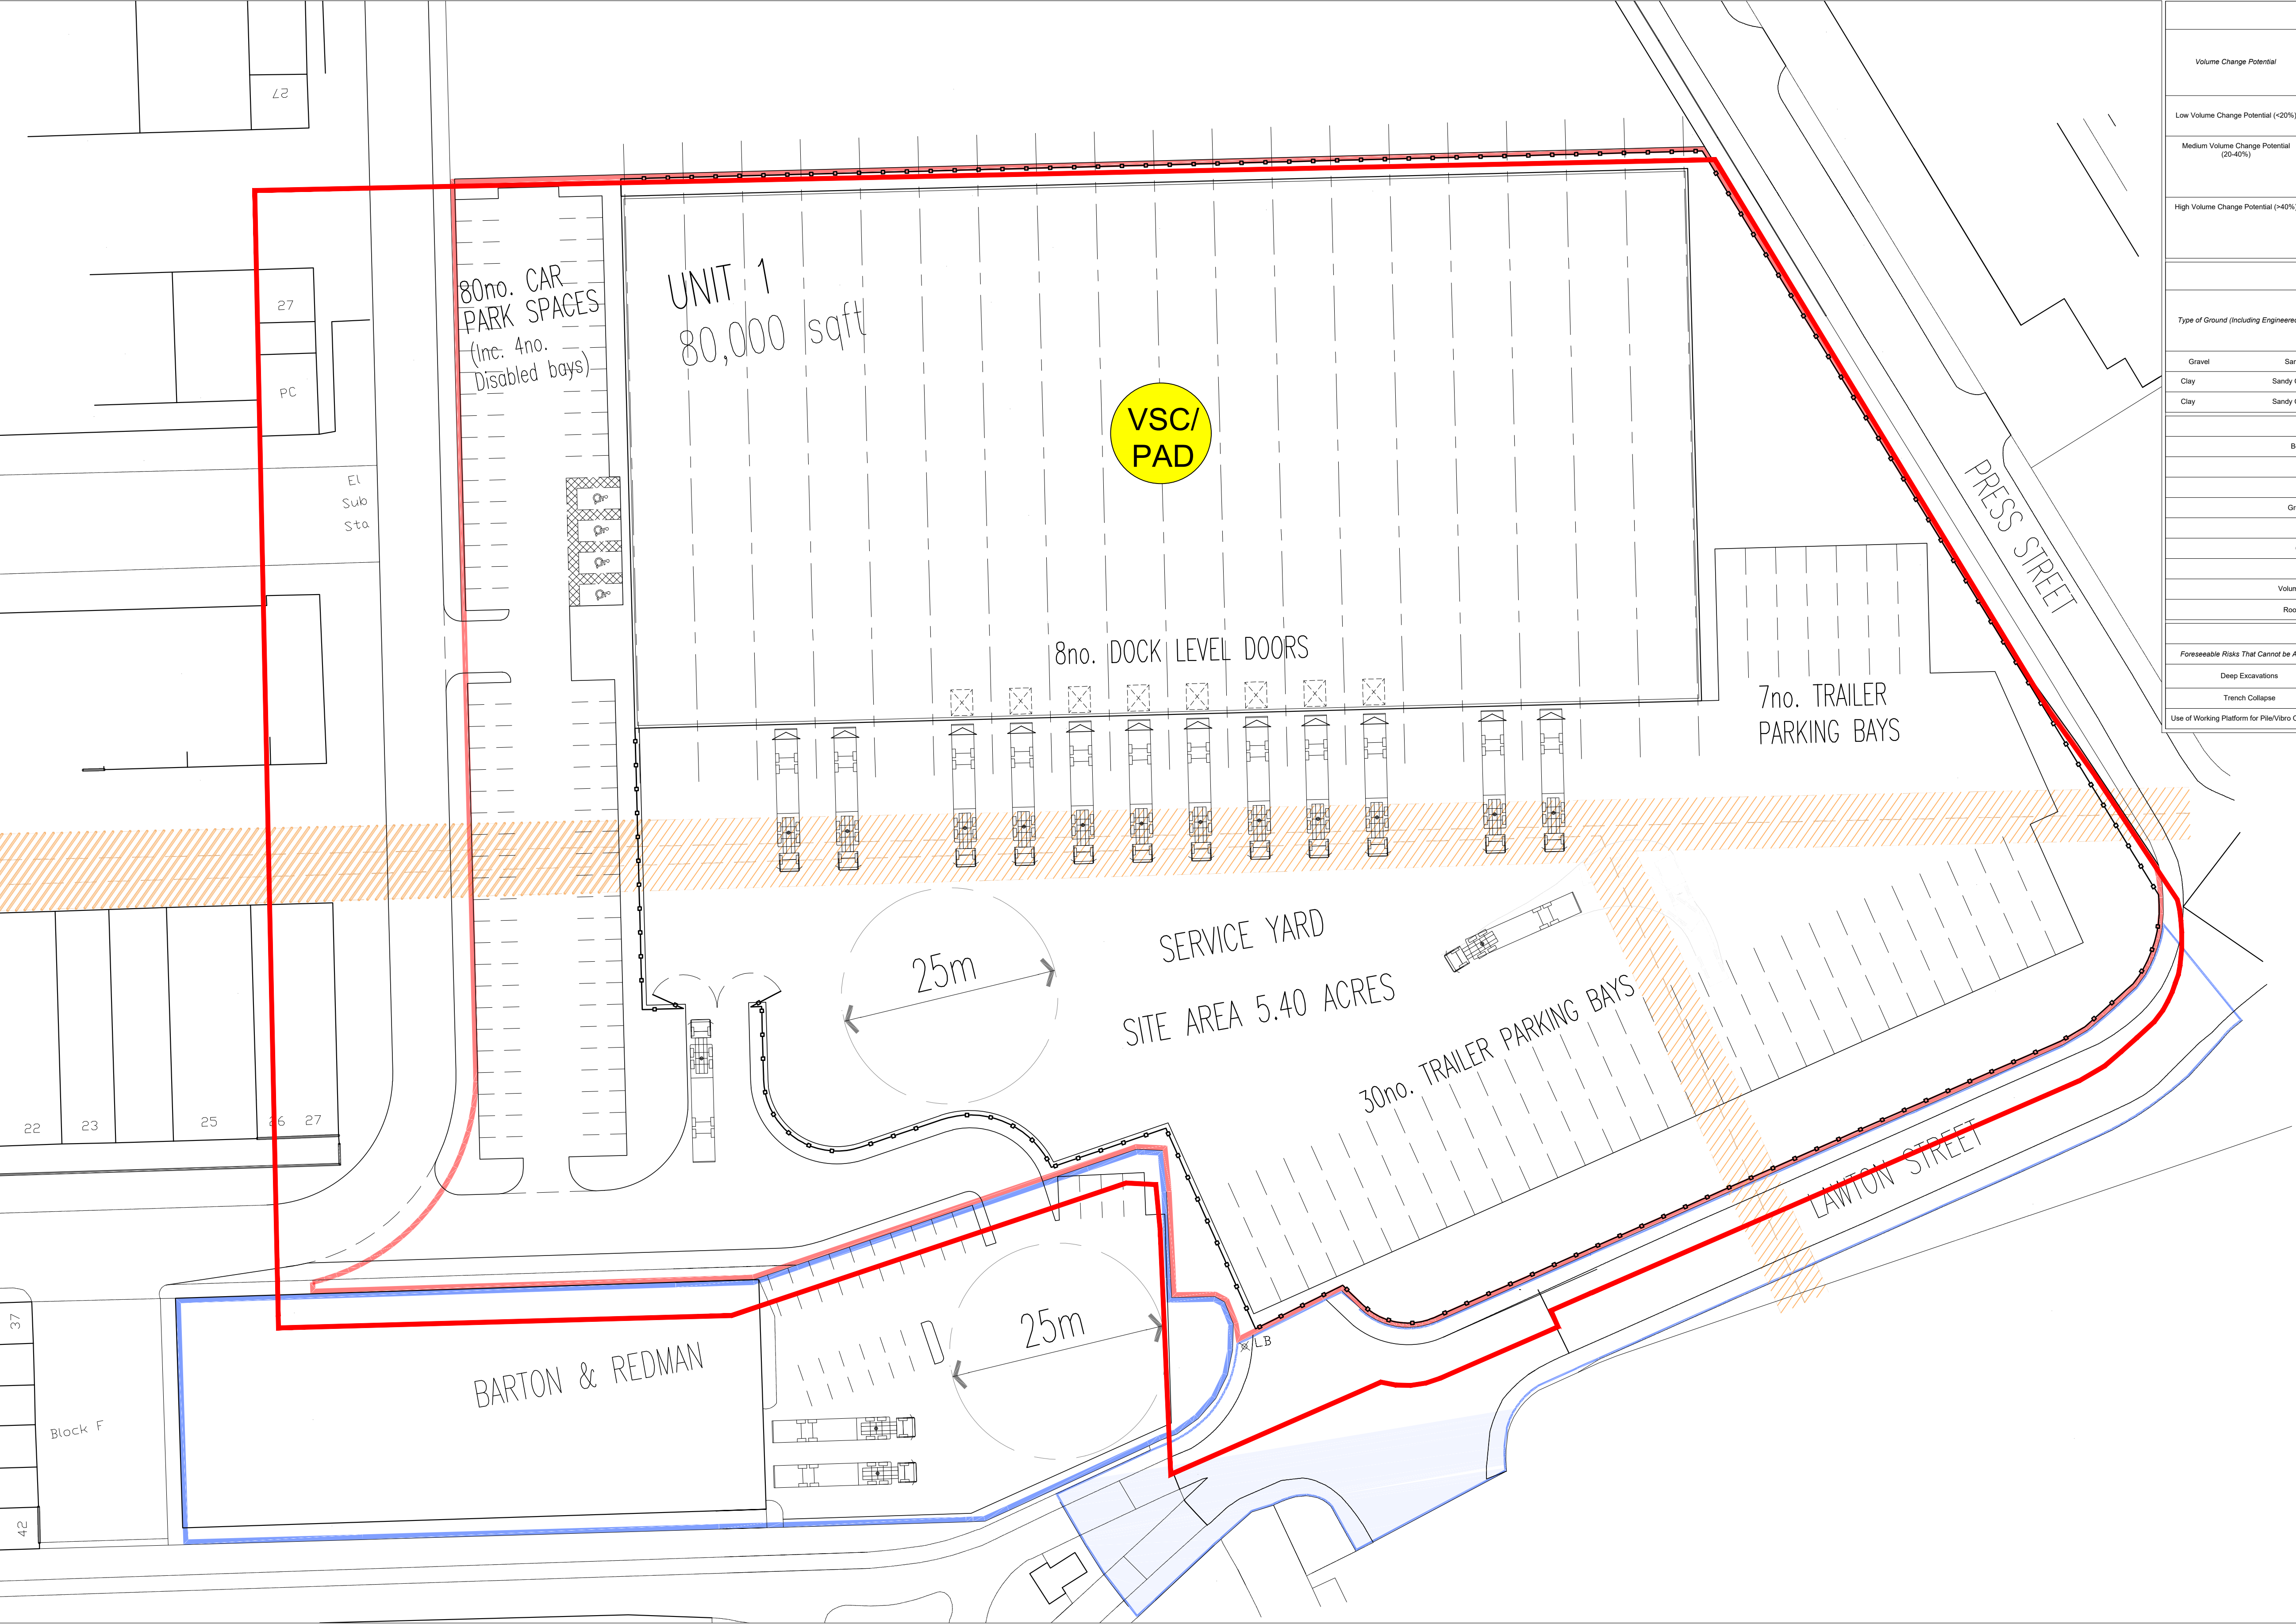
| Barton & Redman, Manchester | | Concept Foundation Zoning Plan | |

- Anticipated Foundation Types**
- TS** Traditional Strip Foundations  
Minimum depth 1200mm below proposed First Floor Level.  
Maximum safe bearing pressure limited to 100kN/m2.

- MT** Mass Trench Fill Foundations  
Minimum depth 1200mm below proposed First Floor Level.  
Maximum safe bearing pressure limited to 100kN/m2.
  - V** Vibro Stone Ground Compaction  
In accordance with NRSBC Chapter 4.2.

- ✳ E3P consider it feasible to construct the commercial unit with pad foundations supported by VSC on an engineered sub-grade set at least 500 mm into the clay soils to support the associated ground bearing slab and infrastructure. The requirement for the vibro stone columns is due to the presence of the deep Made Ground on the site.

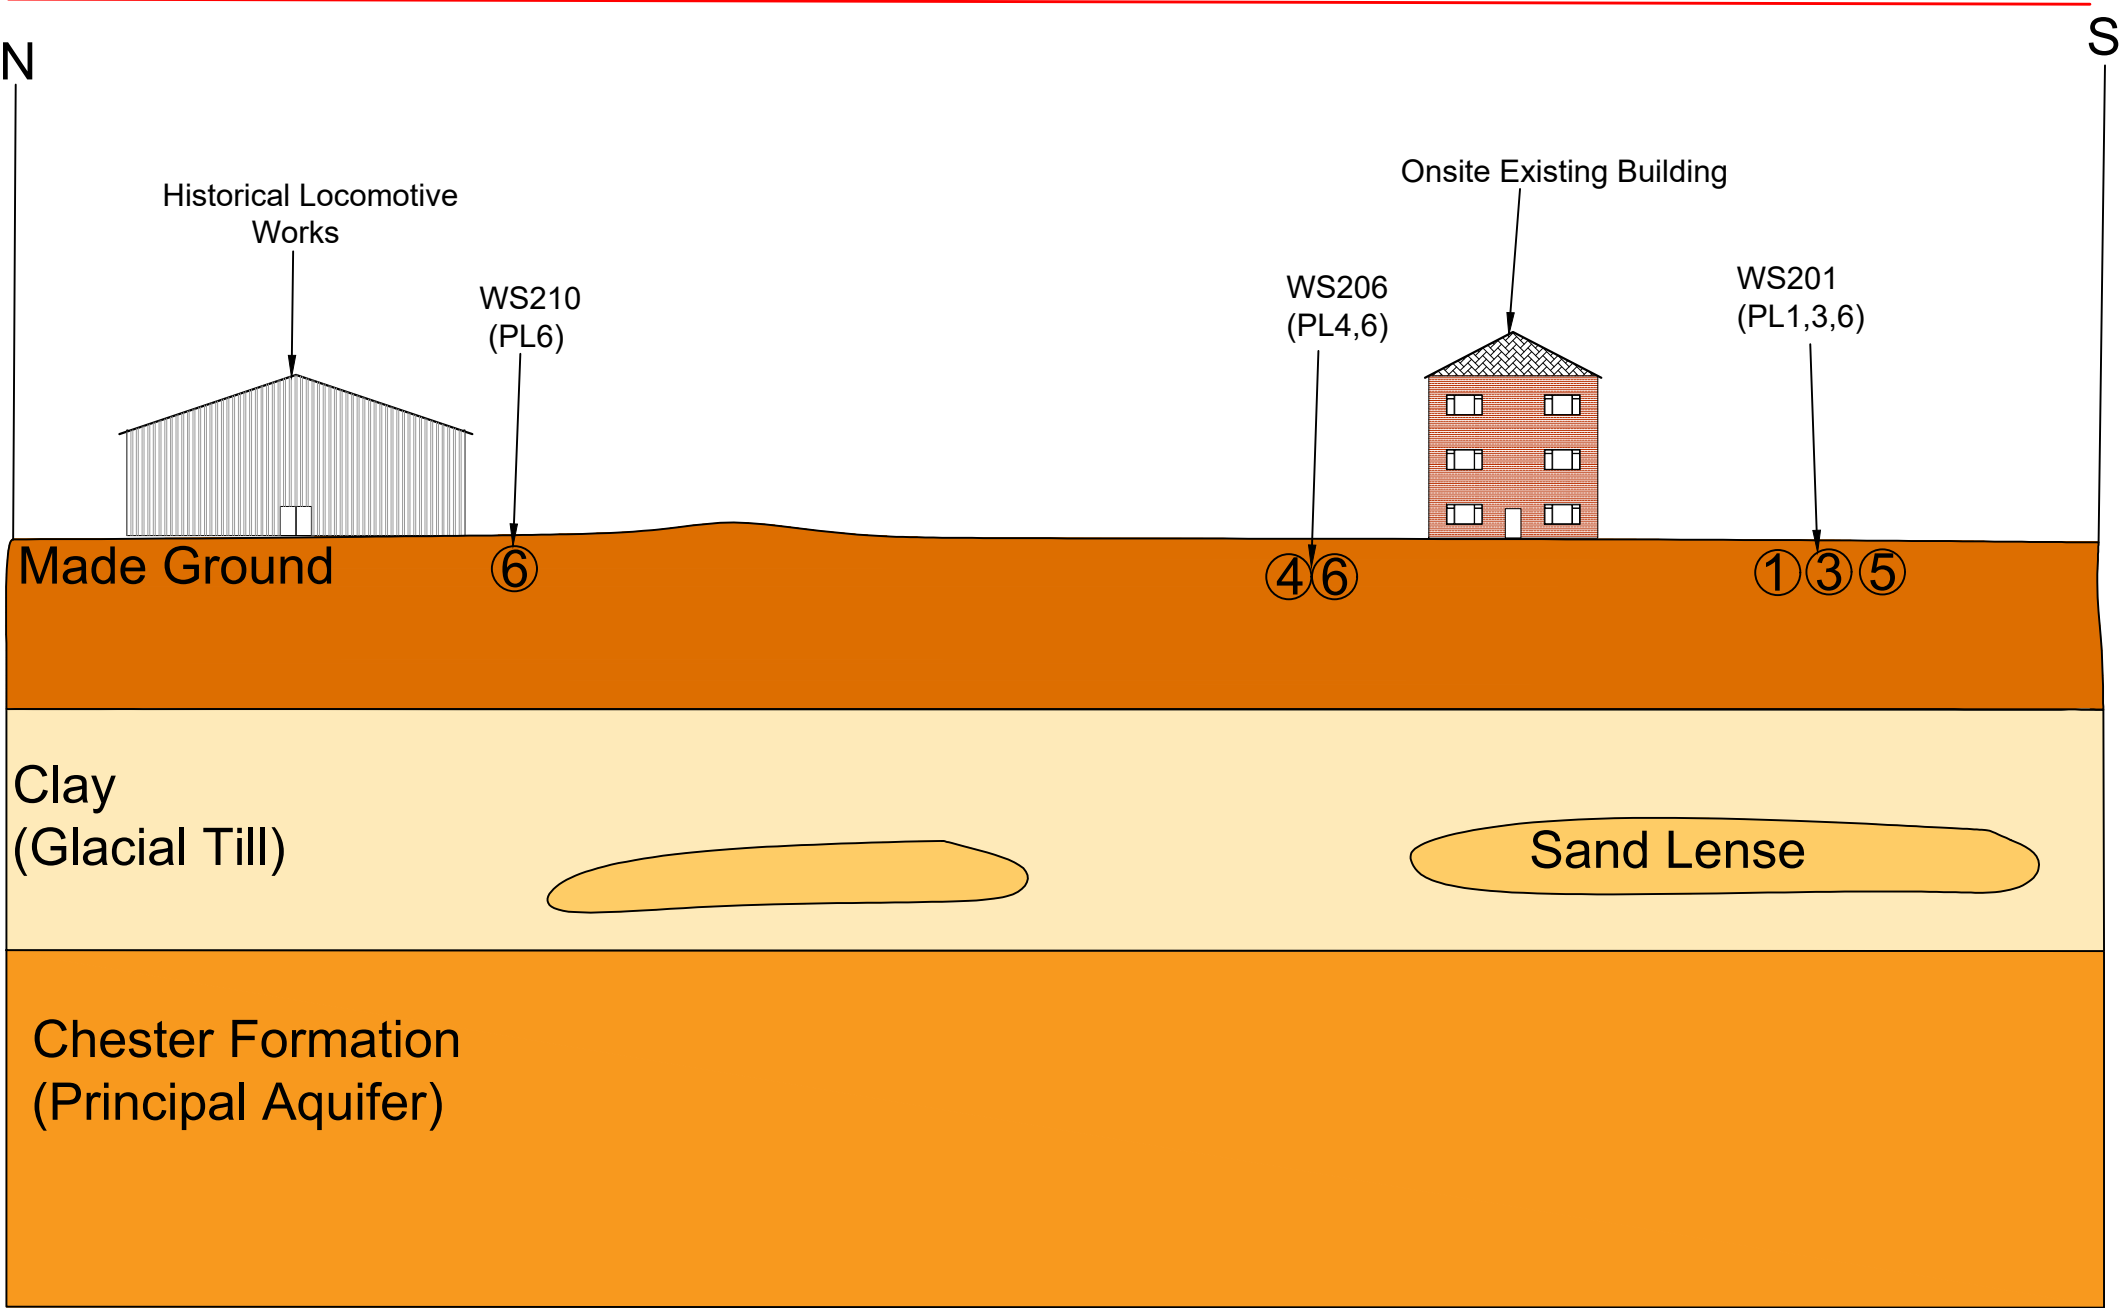
- Made Ground
- Clay (Glacial Till)
- Sand Lense
- Chester Formation (Principal Aquifer)

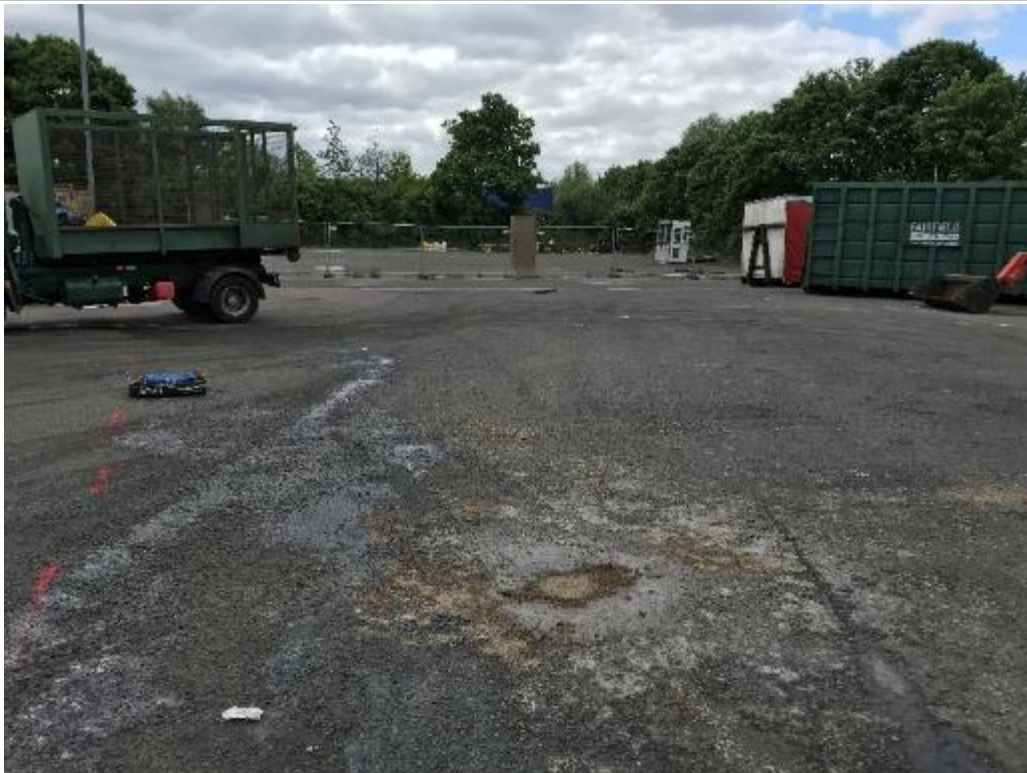
PLATE 4 VIEW OF ASPHALT AREA IN SOUTH EAST OF SITE

Made Ground depths and composition was relatively consistent across the site. Concrete was found to be circa 0.30 m thick and asphalt was 0.08 m thick, with the exception of WS201, where asphalt was thicker at 0.25 m in the existing storage area. WS201 and WS205 identified a reworked brown gravelly clay with gravel of concrete, asphalt and brick. At WS202, WS204 and WS207 asphalt was found to be underlain by concrete, followed by a subbase.

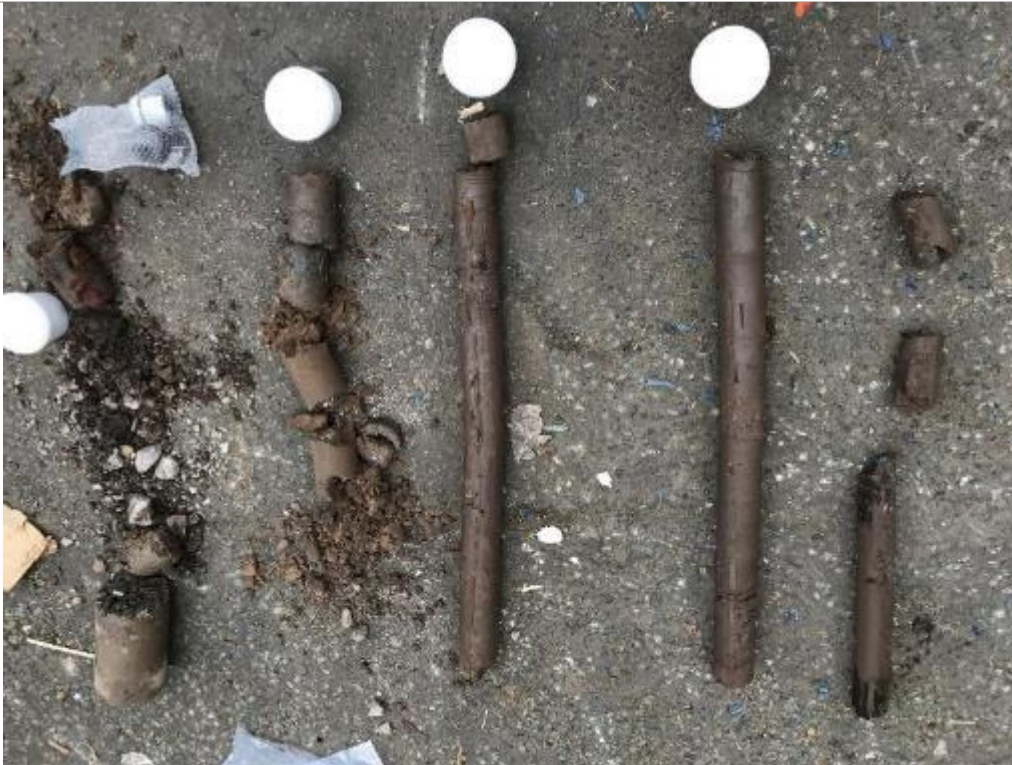
PLATE 5 WS201 ARISINGS FROM LEFT TO RIGHT

| LOCATION | DEPTH (m) | STRATUM | NOTES |
|---|---|---|---|
| WS201 | 0.50 | Made Ground | hydrocarbon odour and black staining |

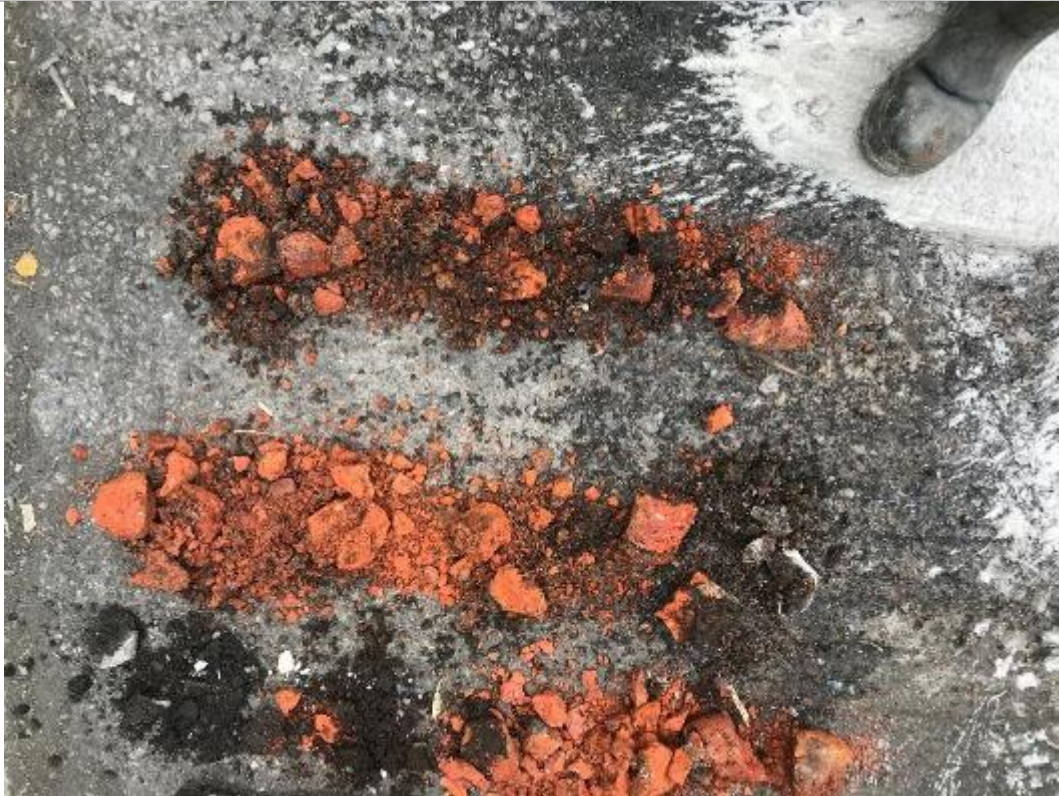
PLATE 7 WS203 ARISINGS

| LOCATION | DEPTH (m) | STRATUM | NOTES |
|---|---|---|---|
| WS203 | 0.30 | Made Ground | Black staining |

Concrete and brick obstructions have been encountered within the Made Ground across the site at the surface and more extensively in WS203, indicative of relict foundations from the former buildings and railway tracks.

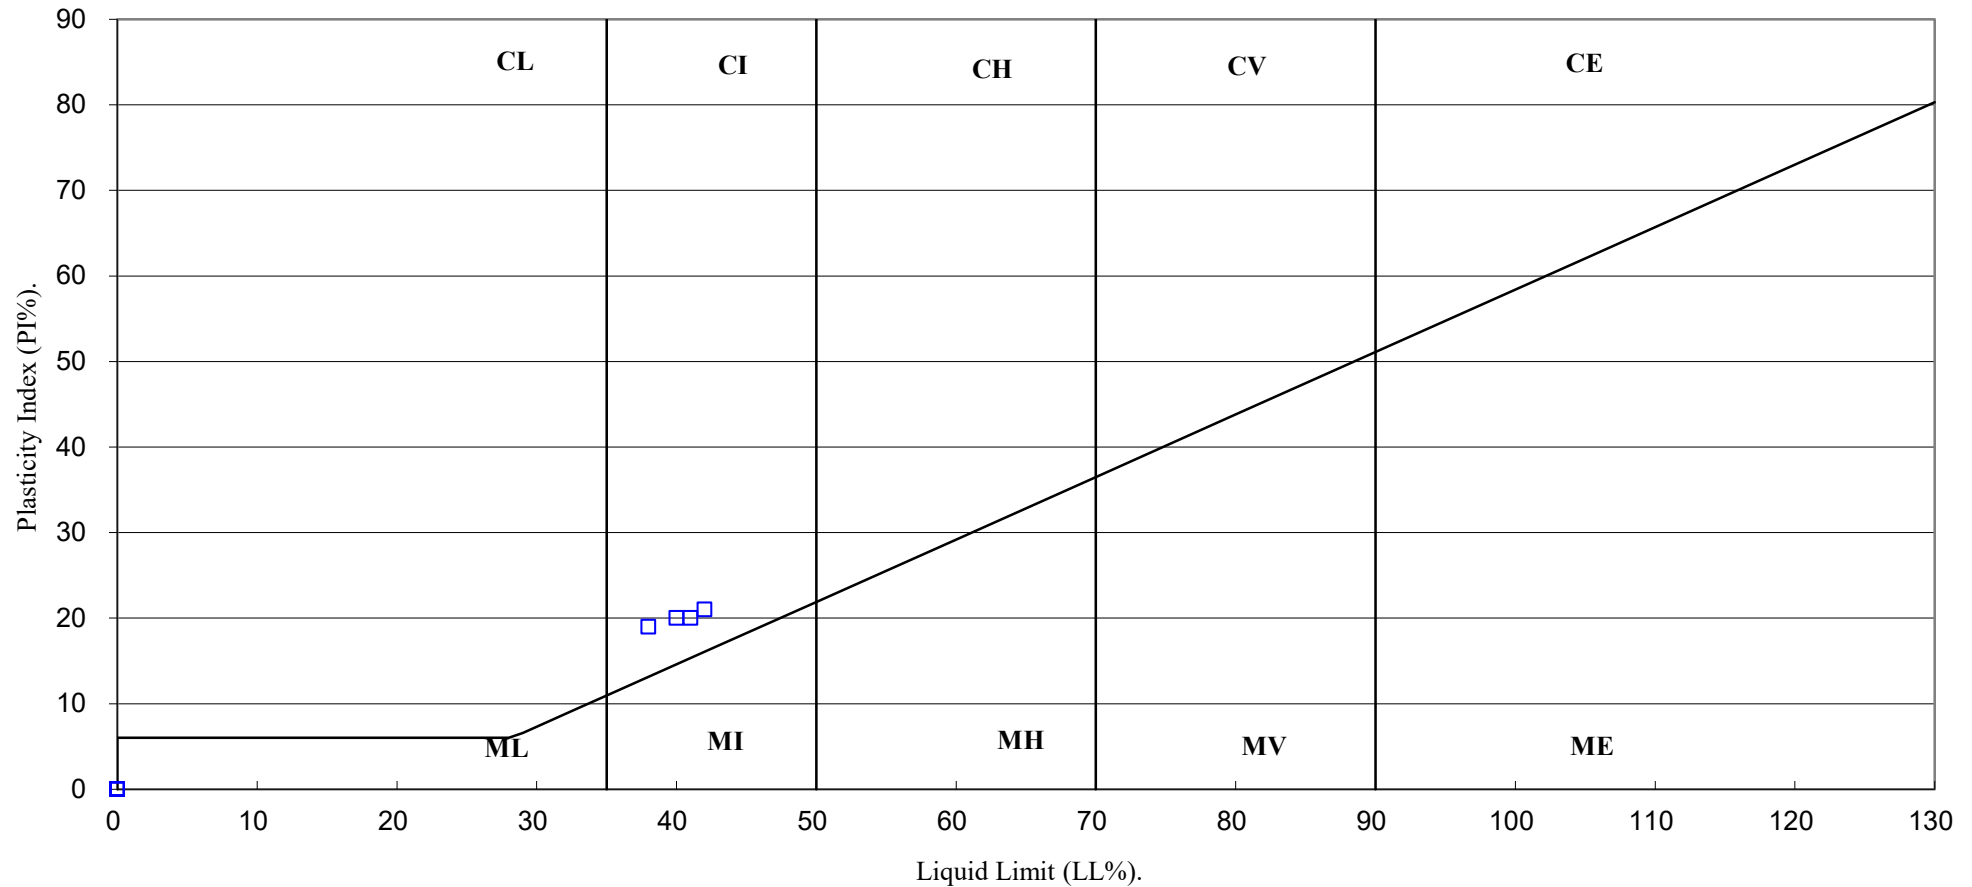
# PLASTICITY CHART FOR CASAGRANDE CLASSIFICATION.

PI can be related to shrinkability (low, medium or high) and then to minimum founding depth.

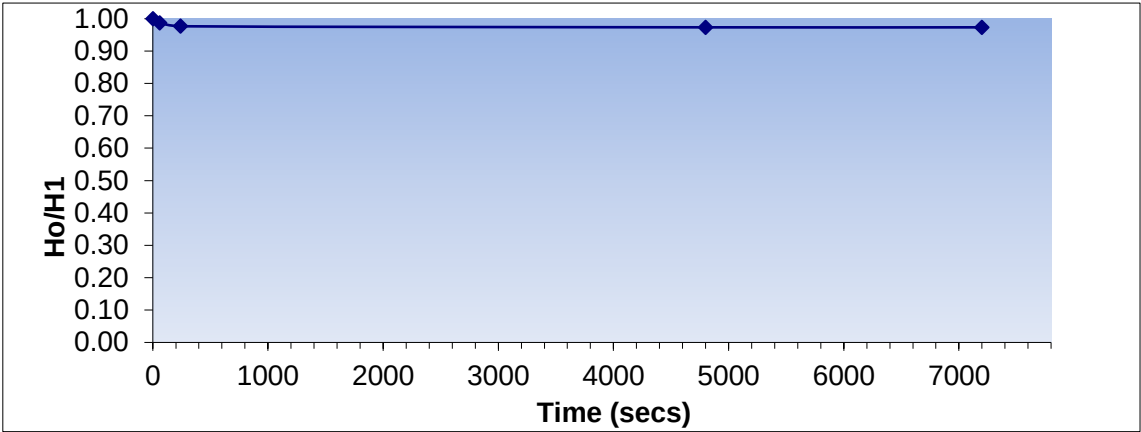
$$k = \frac{A}{F(t_2 - t_1)} \log_e \frac{H_1}{H_2}$$

In-situ falling head permeability tests were undertaken within the monitoring well installations located in four probeholes, WS204, WS205, W206 and WS210. All of the installations were noted to be dry prior to the test being undertaken, therefore the tests were undertaken in the unsaturated zone. Tests were undertaken within monitoring wells with response zones located in the natural cohesive drift stratum.

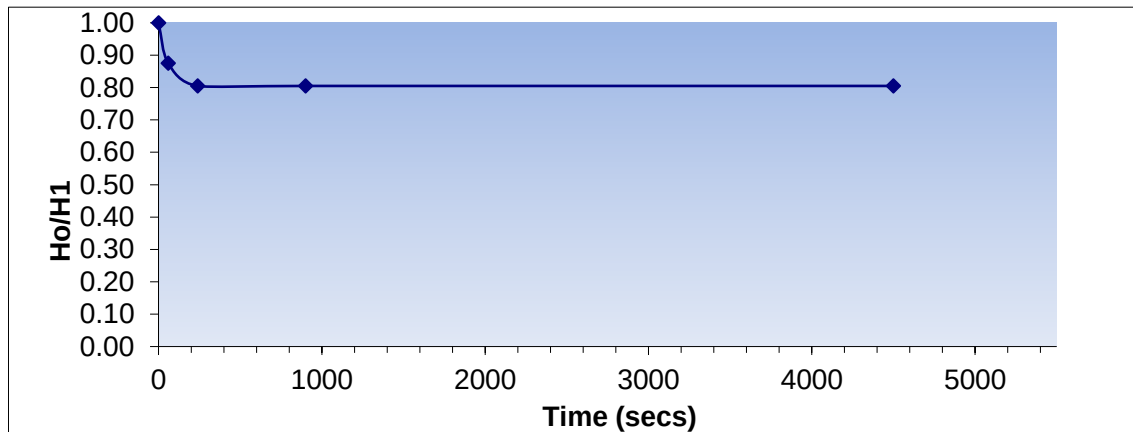
General Approach

$$k = \frac{A}{F(t_2 - t_1)} \log_e \frac{H_1}{H_2}$$

Soil infiltration was taken over the wetted area from between 75% and 25% of the effective depth. All tests showed that soakage potential was significantly reduced due to the cohesive drift deposits.

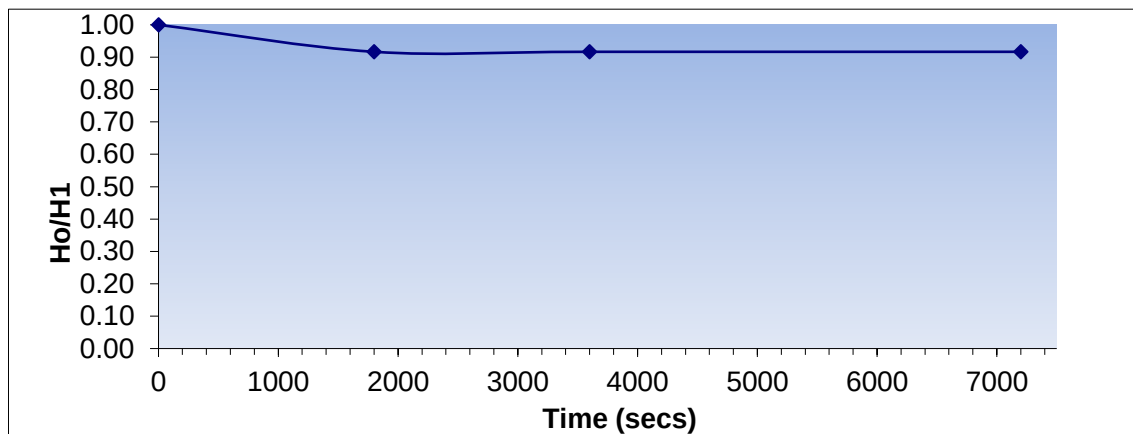
General Approach

k = permeability of soil

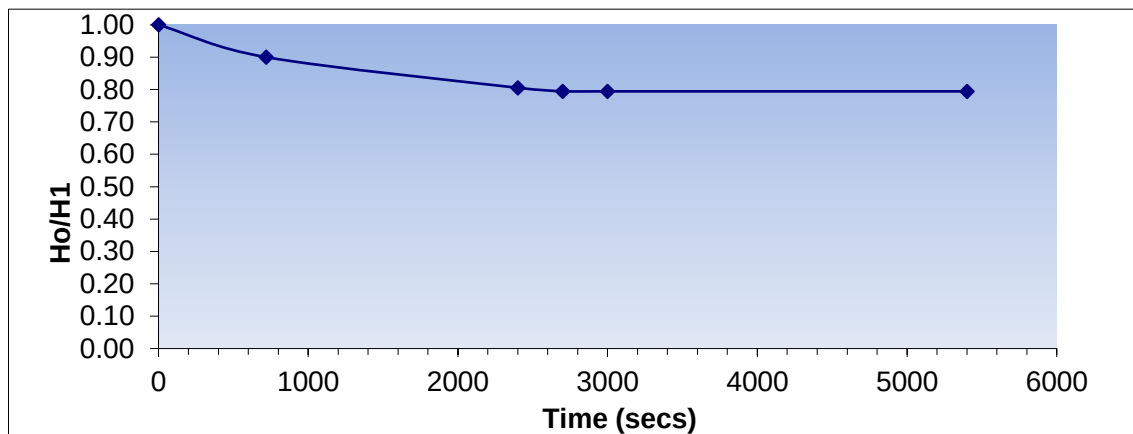
General Approach

k = permeability of soil
