Phase I Geoenvironmental Site Assessment  
Smithfield Market  
Manchester

Reference:12-757-R3-1  
Date: July 2020

## PHASE I GEOENVIRONMENTAL SITE ASSESSMENT

New Smithfield Market  
Whitworth Street East  
Openshaw  
Manchester  
M11 2WJ

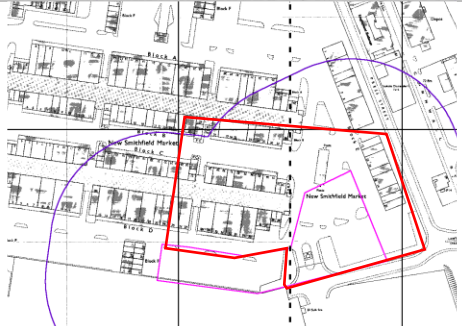
| MAP EDITION | HISTORICAL LAND USE | HISTORICAL MAP EXCERPT |
|---|---|---|
| 1978-1987<br>1:1,250 | No significant changes | |

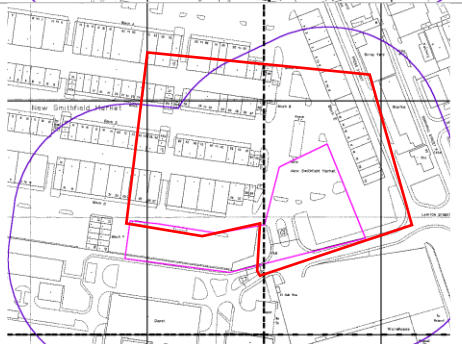
| MAP EDITION | HISTORICAL LAND USE | HISTORICAL MAP EXCERPT |
|---|---|---|
| 1992<br>1:1,250 | No significant changes | |

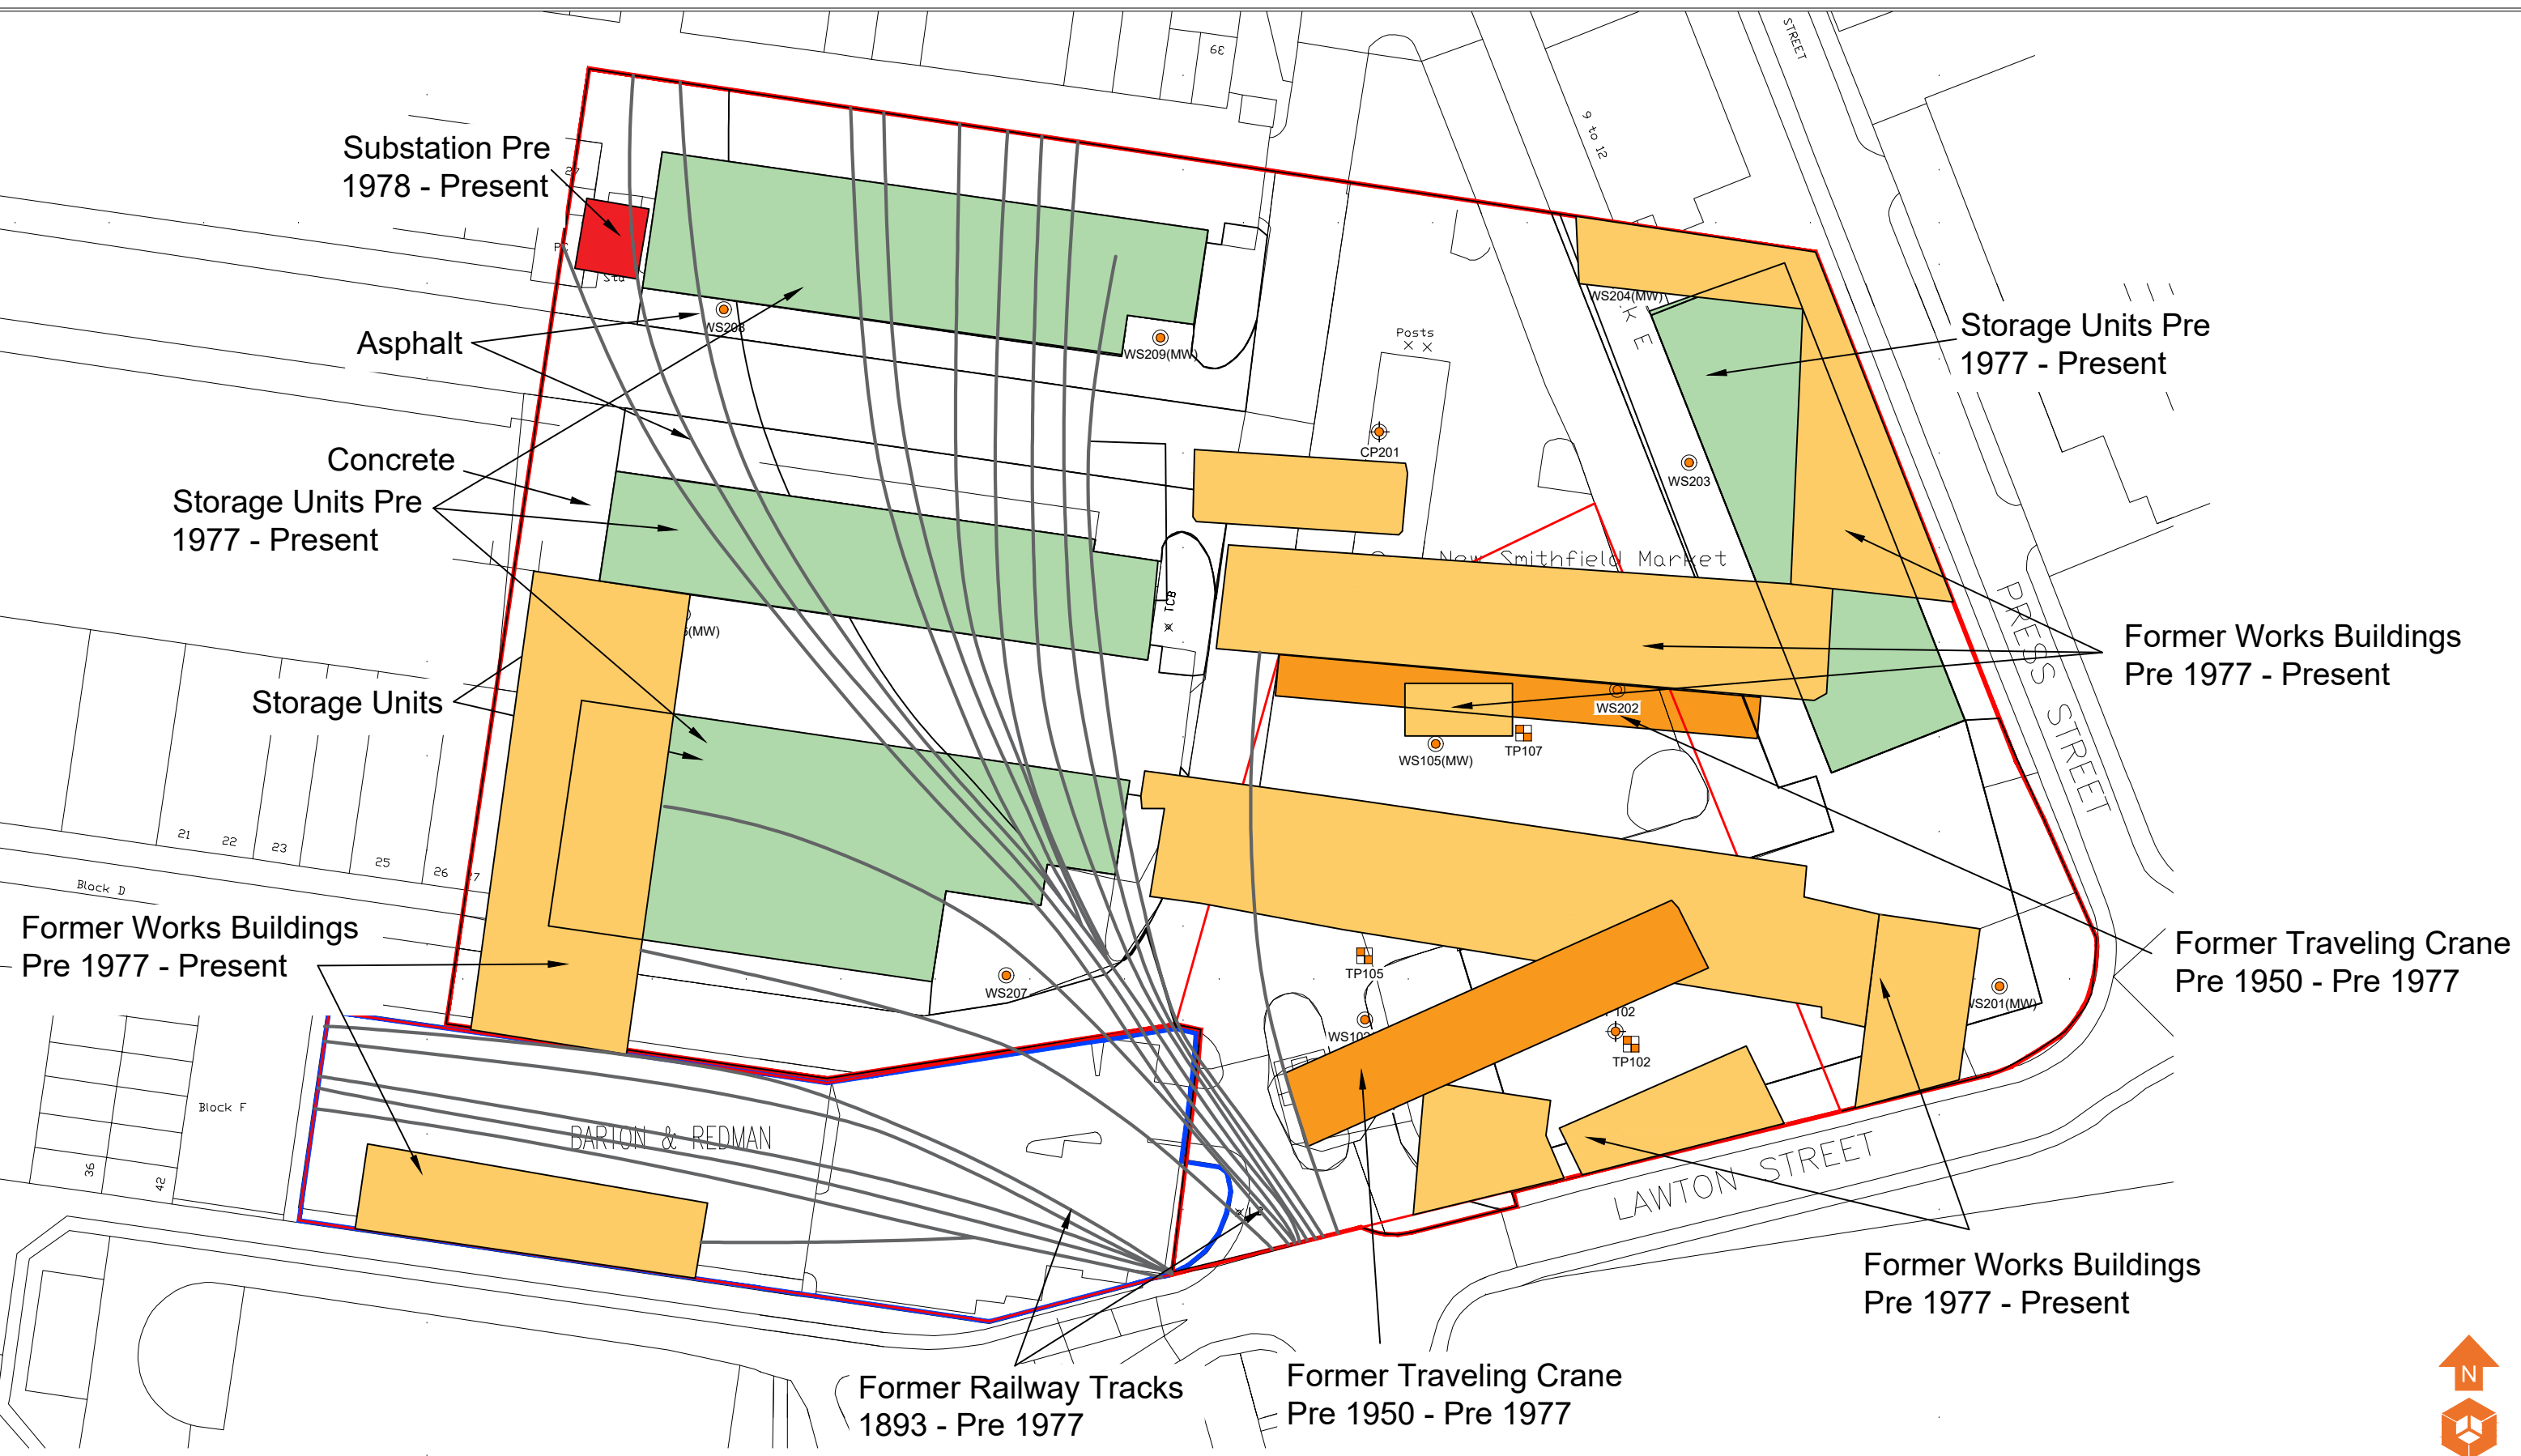
| <div>Historical Features</div> <div><div></div>Storage Units</div> <div><div></div>Former Works Buildings</div> <div><div></div>Former Traveling Crane</div> <div><div></div>Substation</div> <div><div></div>Former Railway Tracks</div> |

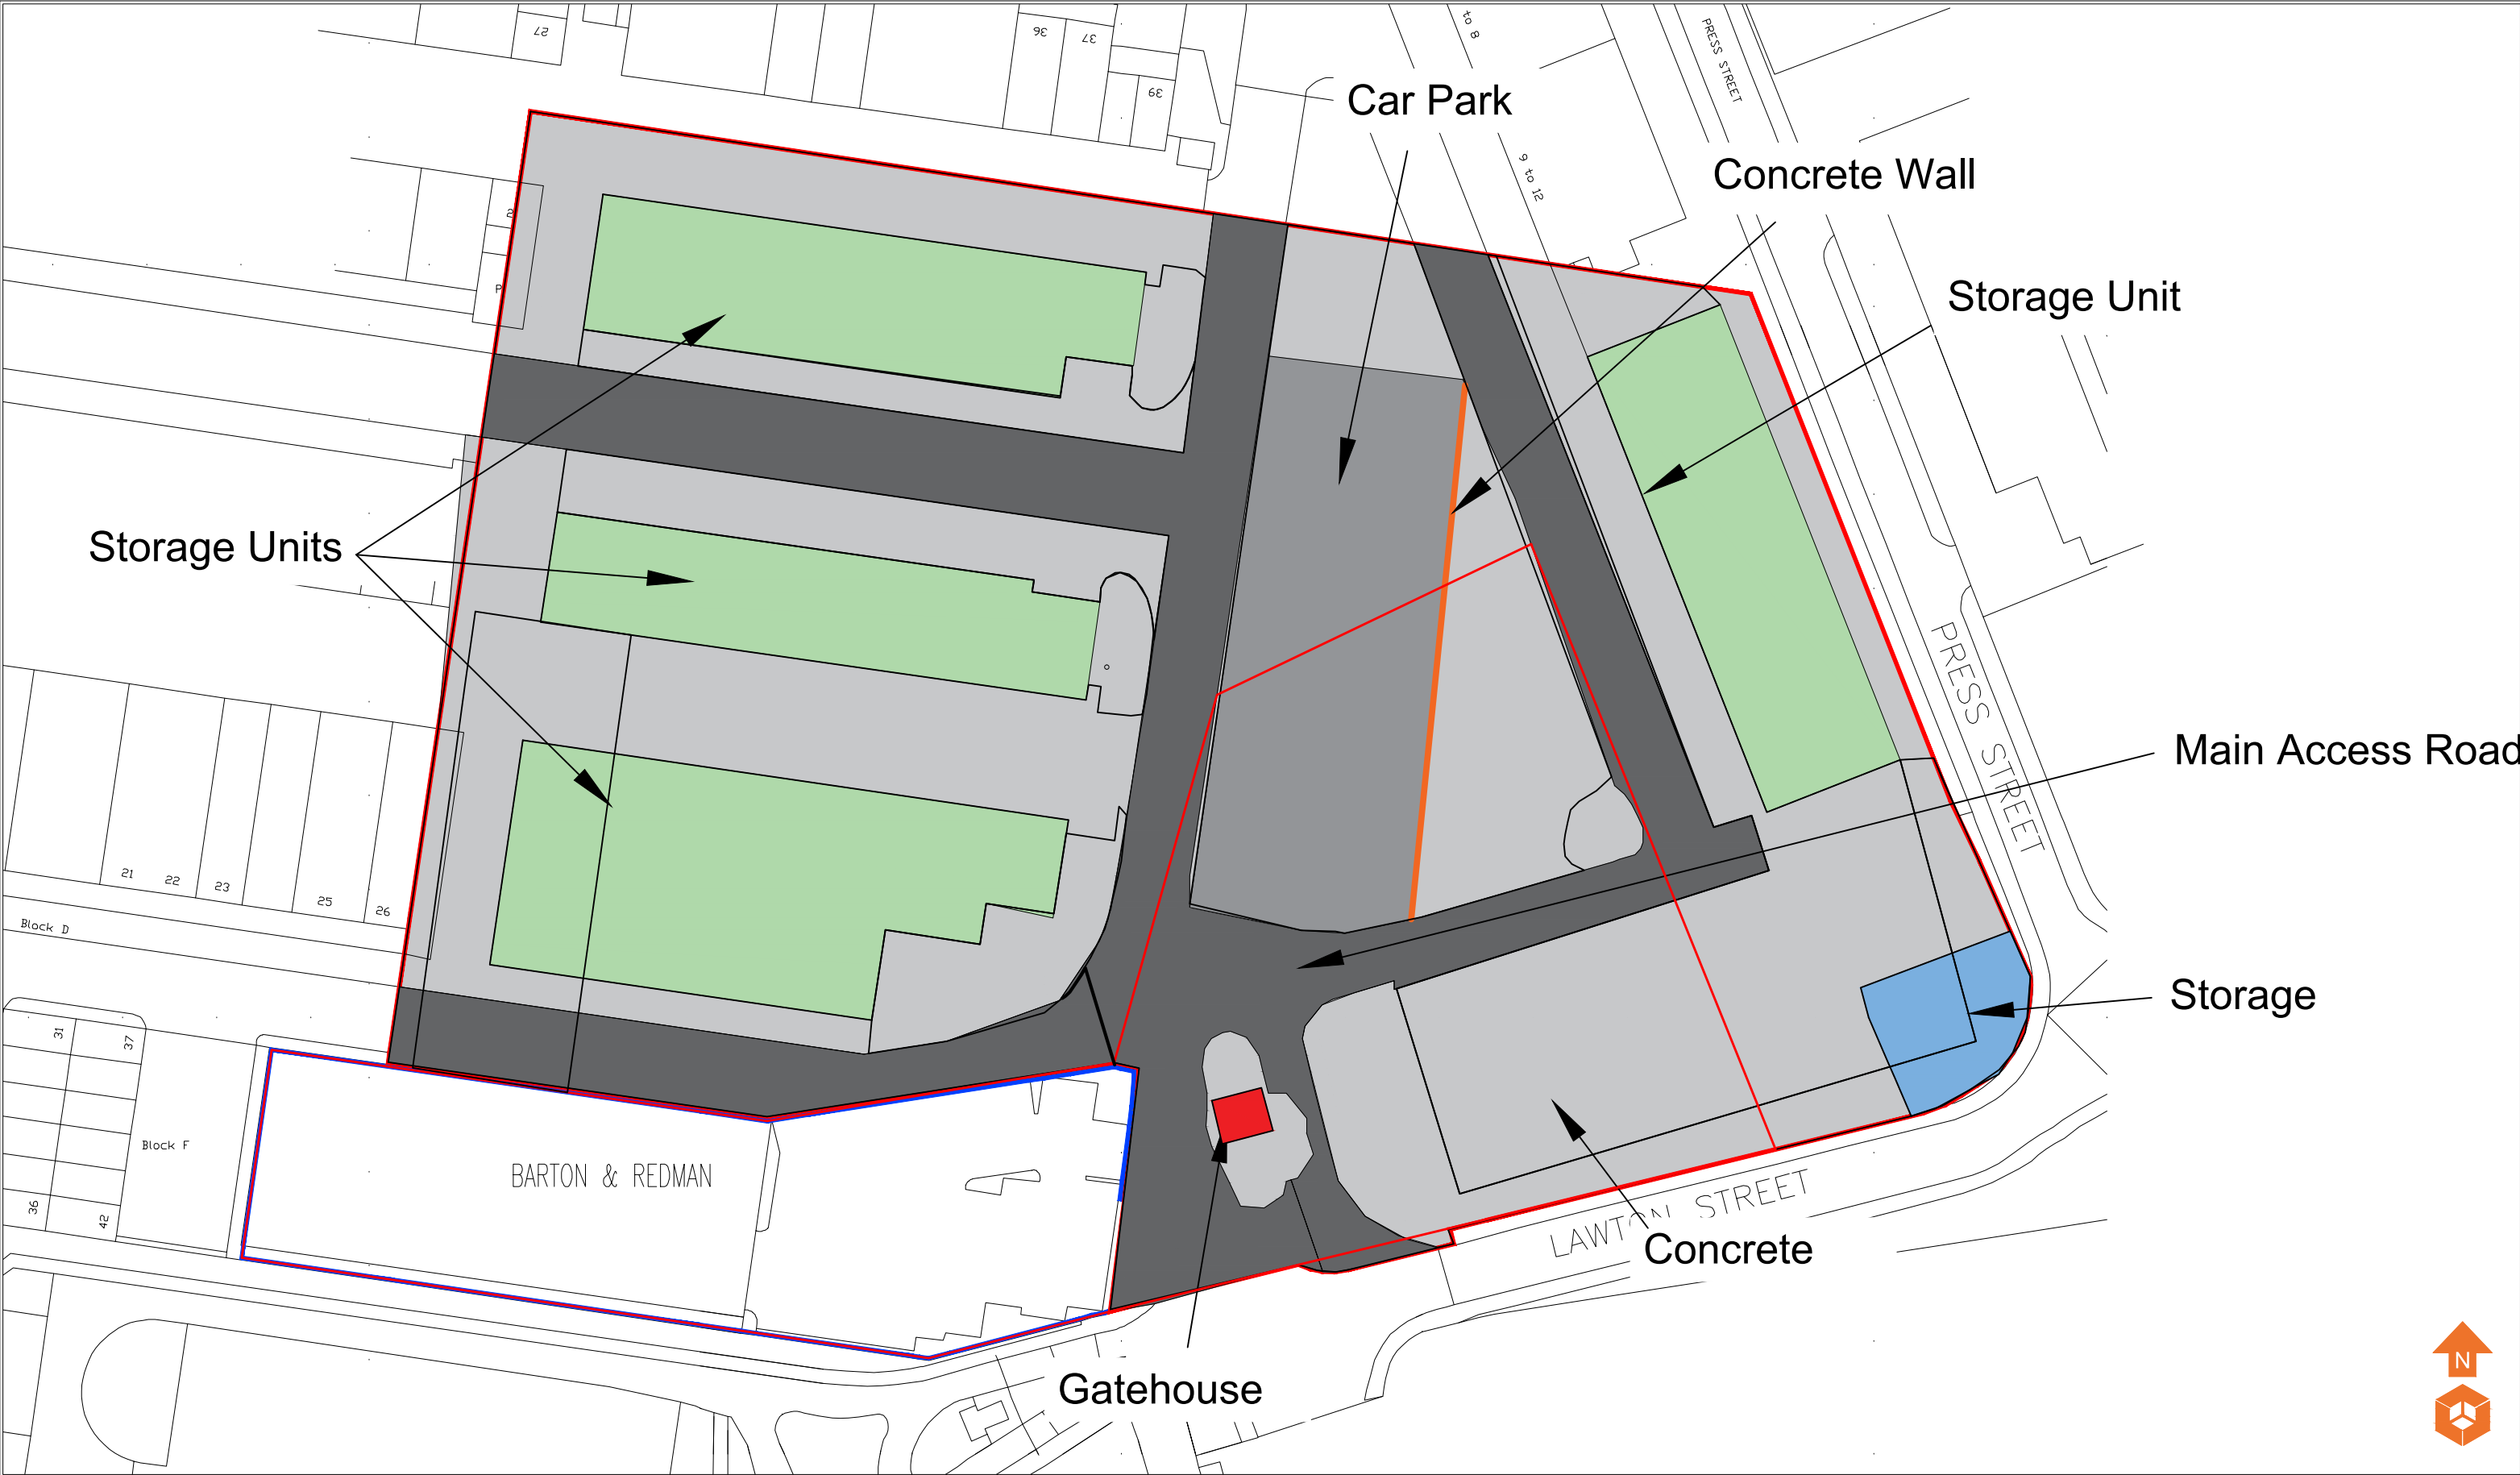
| <div>Site Features</div> <div><div>Concrete</div><div>Car Park</div><div>Main Access Road</div><div>Storage Units</div><div>Storage</div><div>Gatehouse</div><div>Concrete Wall</div></div> | <div>Notes:</div> | | | | | <div>Client:</div> <div>Russells Construction</div> | <div>Job No:</div> <div>12-757</div> | <div>Date:</div> <div>25.06.2020</div> | <div><div><div></div></div><div>e3p</div><div>Environmental Engineering Partnership Ltd<br/>Taylor Road, Trafford Park<br/>Urmston, Manchester, M41 7JQ<br/>Tel: 0161 707 9612<br/>E-mail: info@e3p.co.uk<br/>Website: www.e3p.co.uk</div></div> | | | |

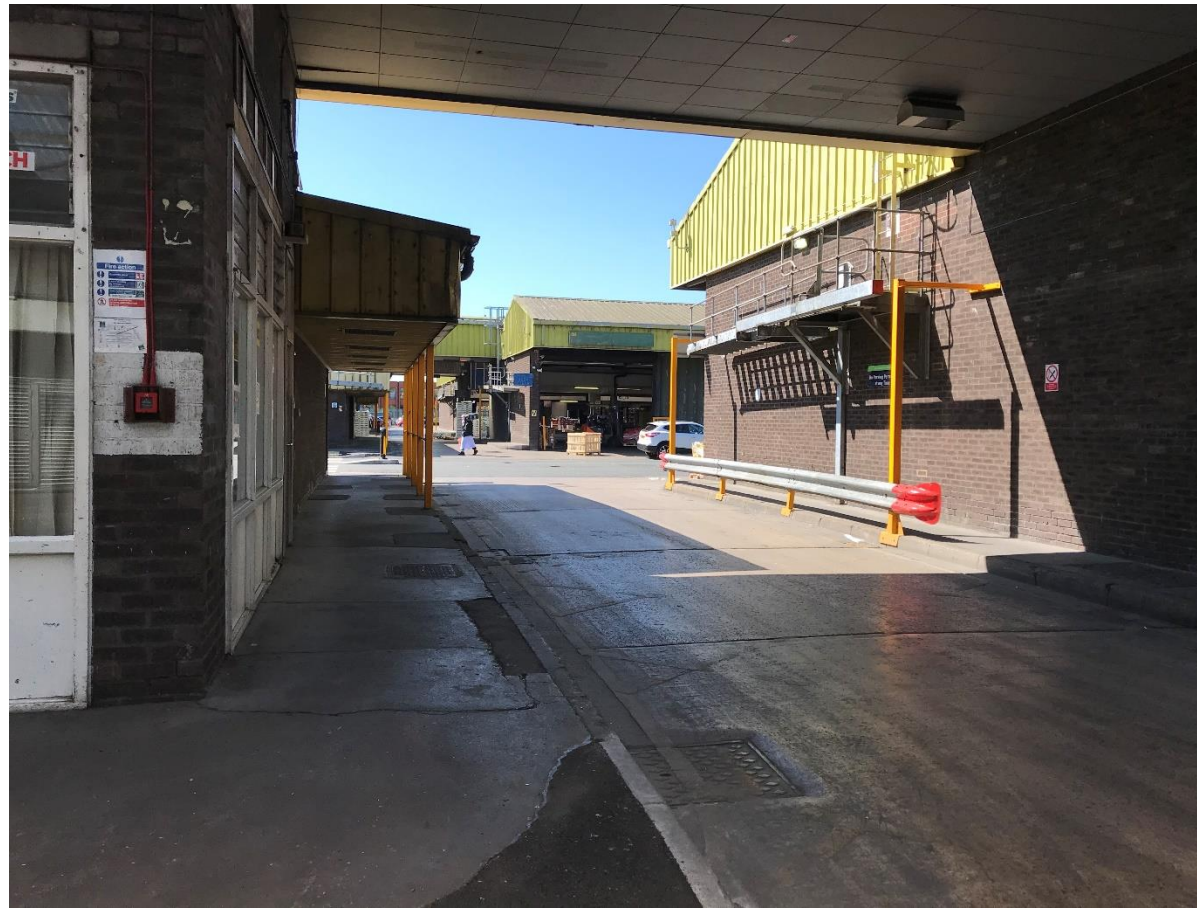
PLATE 2

A VIEW OF ACCESS AREAS FOR SMITHFIELD MARKET

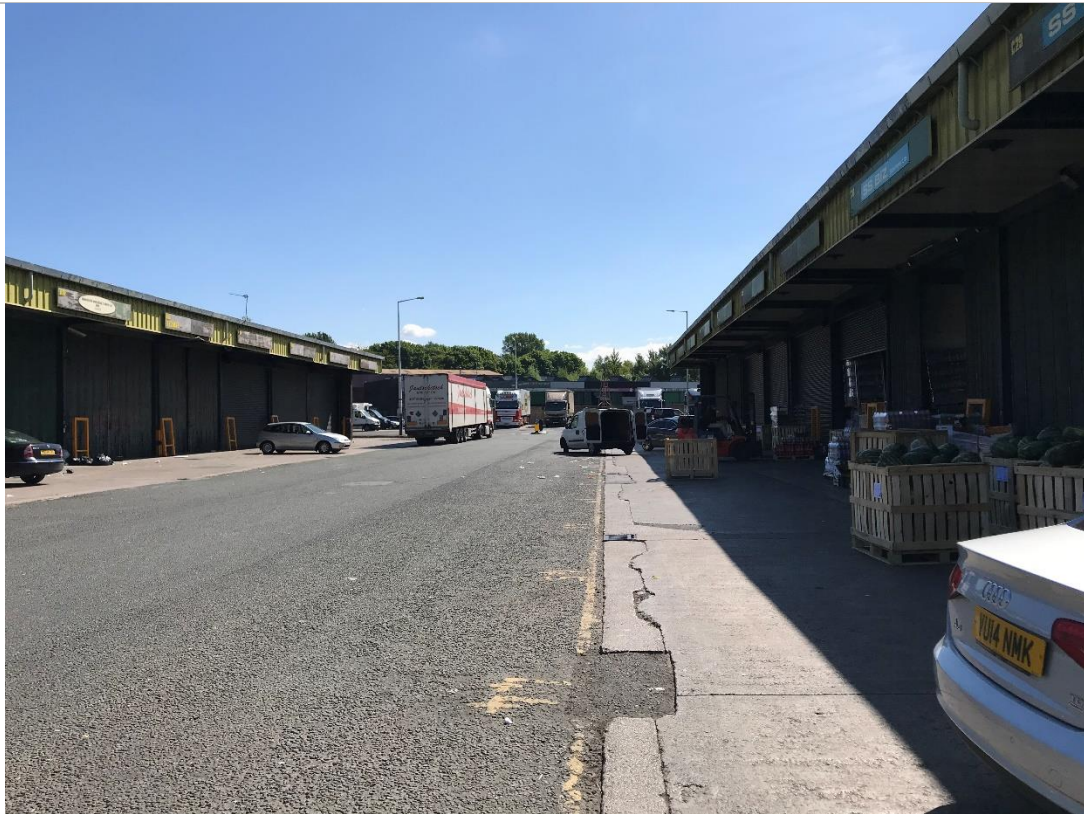
PLATE 4      LOOKING EAST ACROSS THE SITE

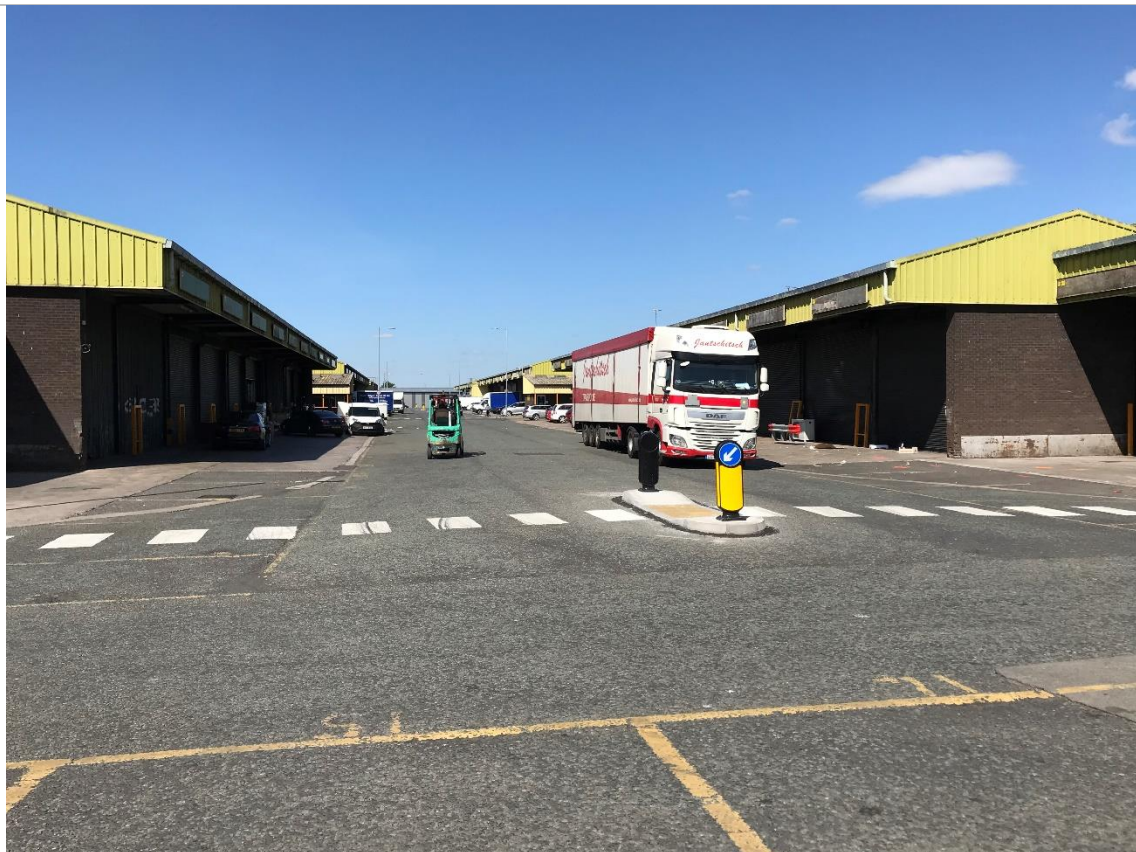
PLATE 5      LOOKING WEST ACROSS THE SITE

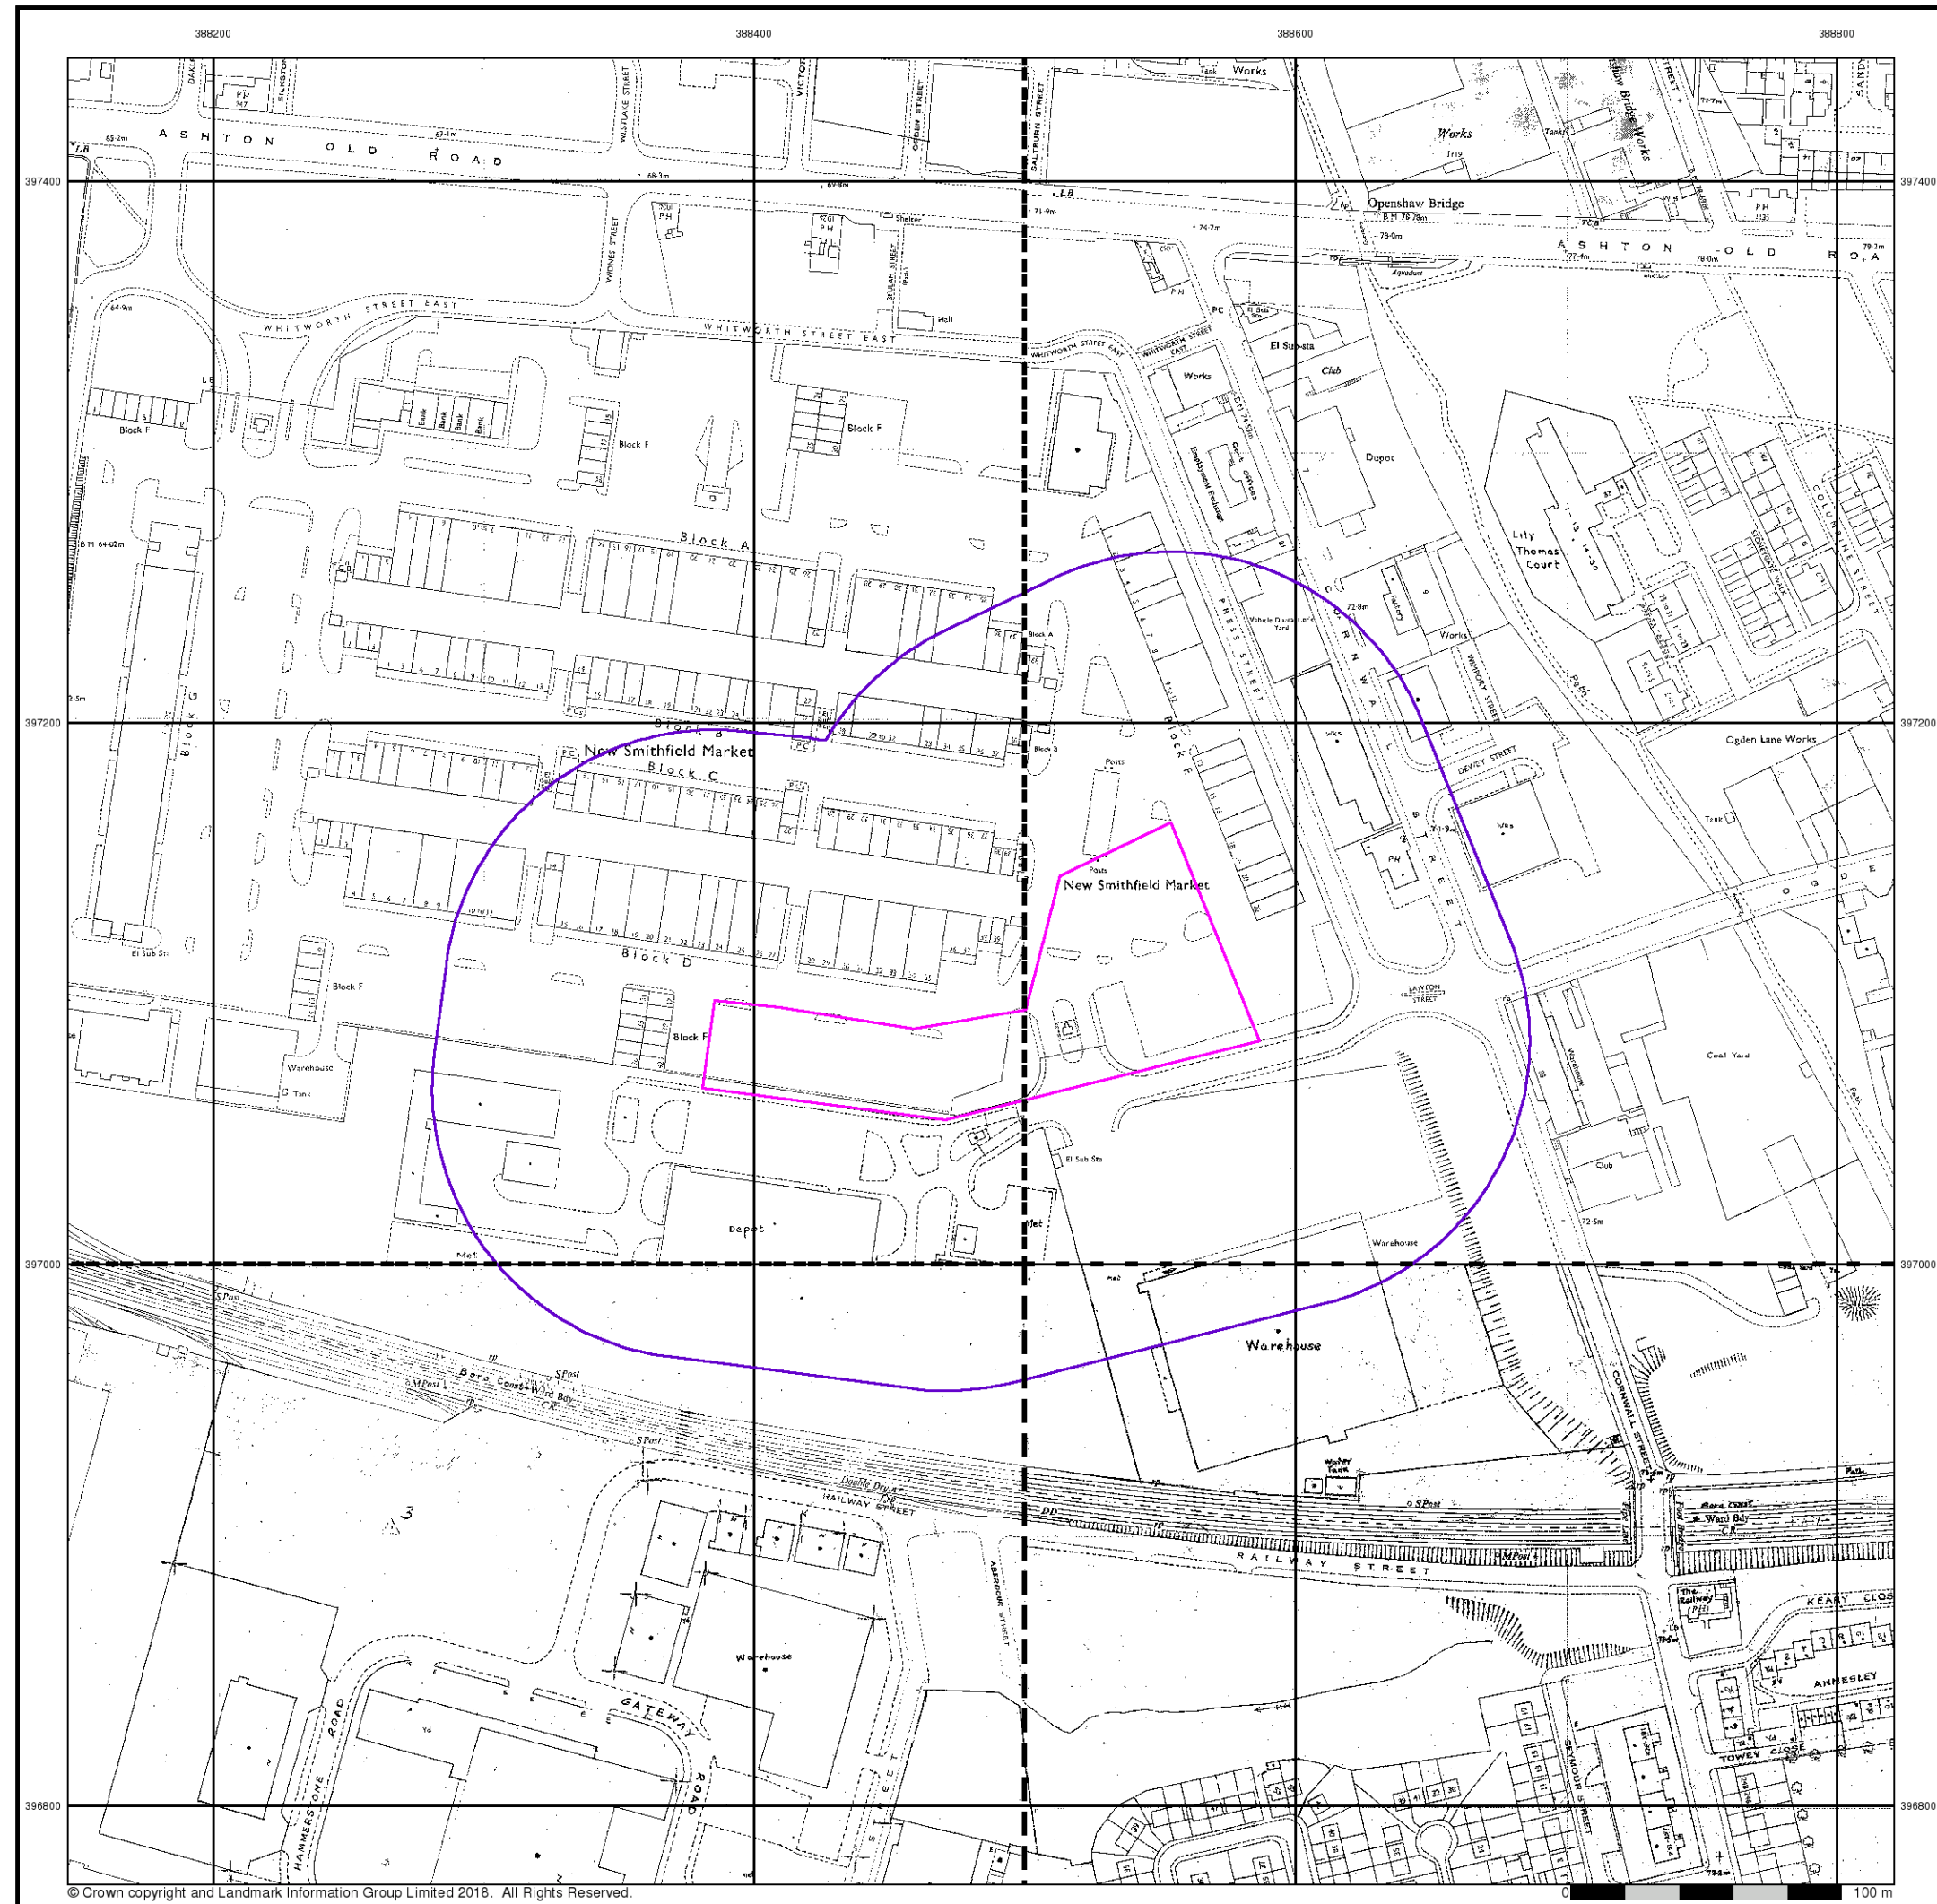
**Additional SIMs**  
**Published 1977 - 1980**  
**Source map scale - 1:1,250**

The SIM cards (Ordnance Survey's 'Survey of Information on Microfilm') are further, minor editions of mapping which were produced and published in between the main editions as an area was updated. They date from 1947 to 1994, and contain detailed information on buildings, roads and land-use. These maps were produced at both 1:2,500 and 1:1,250 scales.

| MAP EDITION | HISTORICAL LAND USE | HISTORICAL MAP EXCERPT |
|---|---|---|
| 1977-1980<br>1:1,250 | <p>The former locomotive works have been replaced by New Smithfield Market, indicating demolition and construction work.</p> <p>An electricity substation is shown in the north west of the site.</p> | |
