# Phase 2 Geoenvironmental Investigation & Assessment

Oakwood Lodge, Wythenshawe

Garden City Design and Build Ltd

| <b>Report Reference:</b> | <b>8928G-WML-00-XX RP-G-0002</b> |

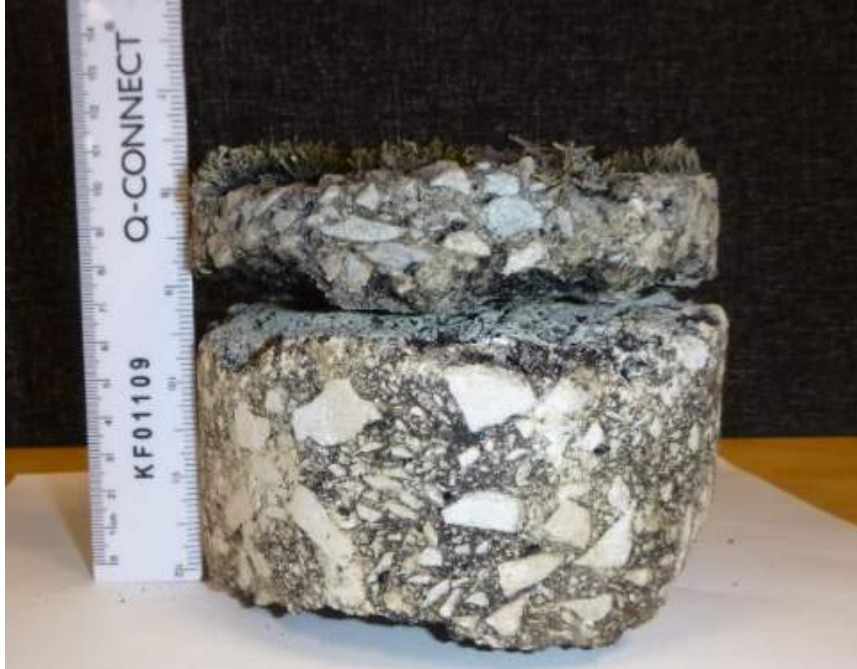
| Depth (m) | Type | Test Result | Level | Legend | Depth (m) | Description | Water |
|---|---|---|---|---|---|---|---|
| | | | | | 0.08 | Dark grey, medium to coarse, angular, bituminous bound gravel of granite - HRA (SURFACE COURSE) | |

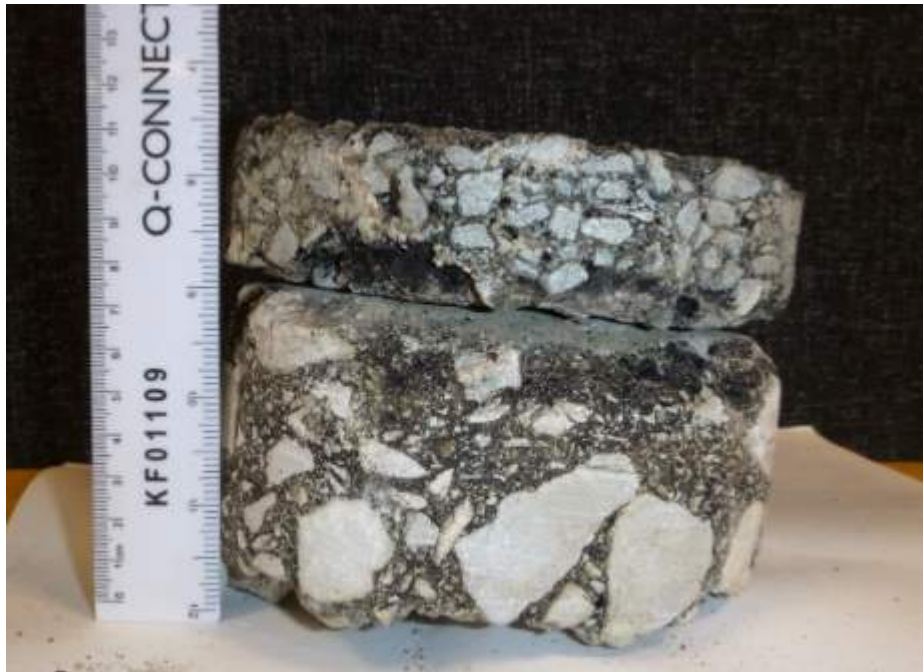
| Depth (m) | Type | Test Result | Level | Legend | Depth (m) | Description | Water |
|---|---|---|---|---|---|---|---|
| | | | | | 0.09 | Dark grey, medium to coarse, angular, bituminous bound gravel of granite - HRA (SURFACE COURSE)<br>0.02 ...Surface Course debonded from Binder Course<br>Dark grey, fine to coarse, angular, bituminous bound gravel of granite - DBM (BINDER COURSE)<br>Light brownish grey, slightly sandy, subangular, medium to coarse GRAVEL of limestone. (SUBBASE) | |
