**REPORT 71256/G**

**PETROGRAPHIC EXAMINATION AND  
CHEMICAL ANALYSIS**

**OF MORTAR SAMPLES**

**PICCADILLY WAREHOUSE  
11 BLOOM STREET  
MANCHESTER, M1 3EF**

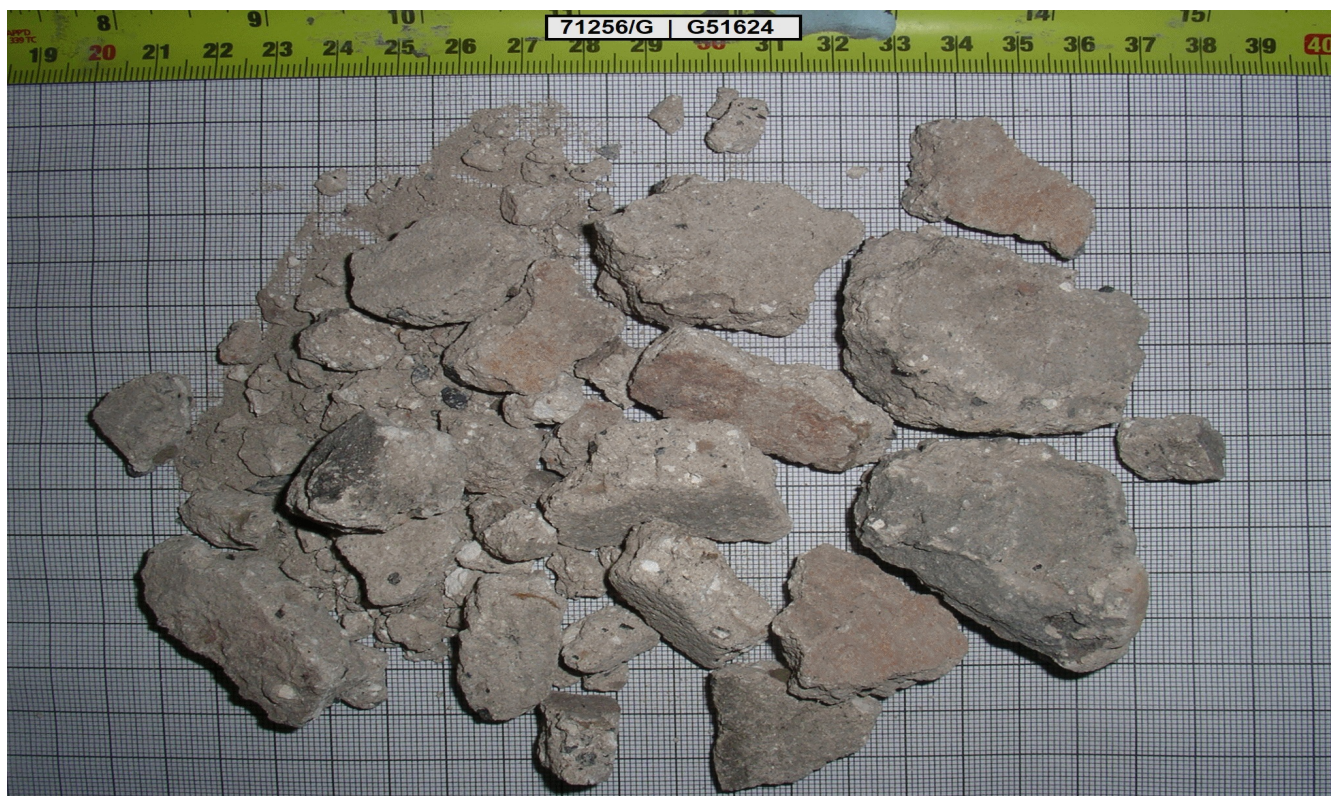
### SHEET 1a - SAMPLE DETAILS AND RECORD PHOTOGRAPH

| <b>Sample Description:</b><br>(compaction, voidage, cracking, honeycombing, sweaty patches, deposits, other features): | Pieces of mortar exhibiting greyish cream to greyish buff colour. The mortar was generally hard to moderately hard and moderately robust, as it is expected for a lime mortar (subjective assessment). The mortar appeared to exhibit a generally normal compaction with occasional irregular to elongate voids up to 2mm and commonly less than 1mm across. |
| <b>Position of Specimen:</b><br>(size, relationship to sample) | The thin section was taken along the length and through the thickness of mortar pieces. Thin section approximate dimensions (mm): 4No. pieces covering an area 67 x 45 approx. |

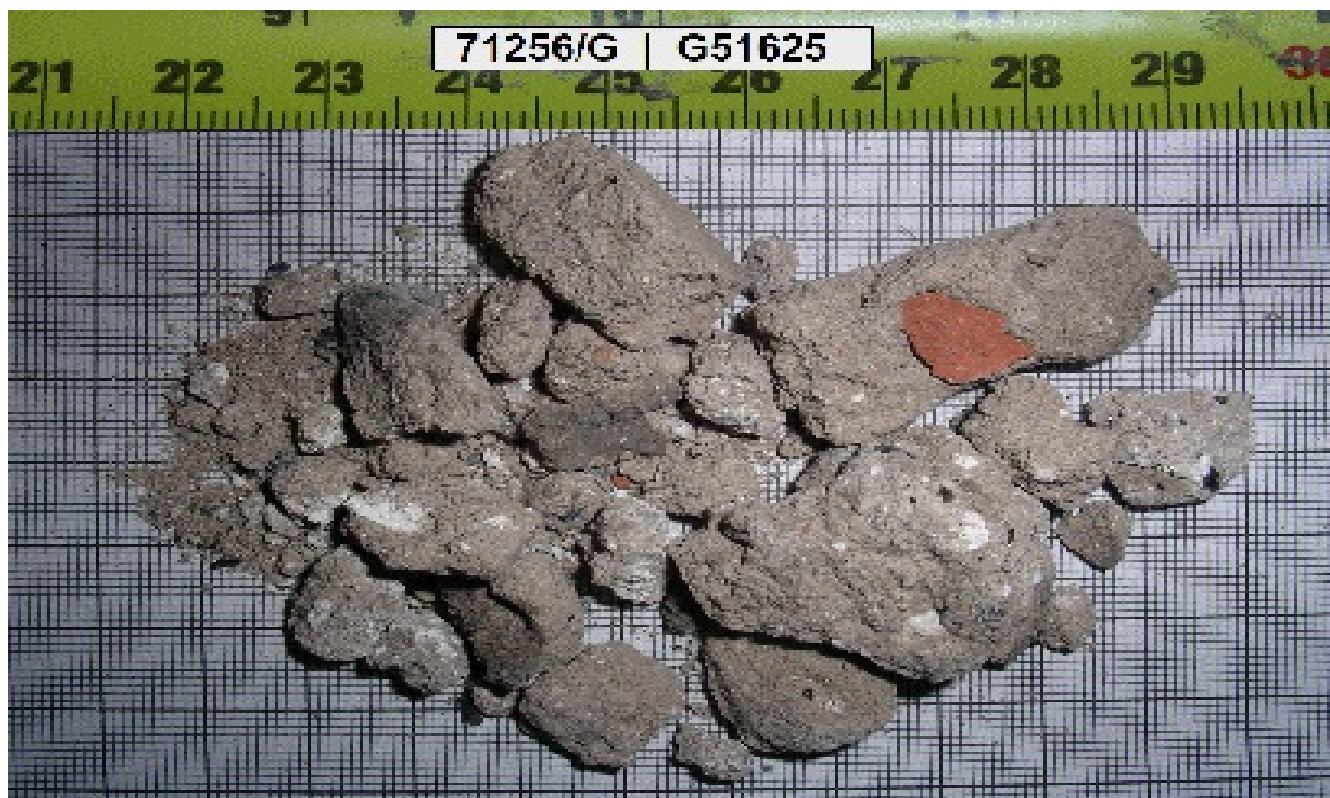
### SHEET 1a - SAMPLE DETAILS AND RECORD PHOTOGRAPH

| <b>Sample Description:</b><br>(compaction, voidage, cracking, honeycombing, sweaty patches, deposits, other features): | Pieces of mortar exhibiting greyish cream to greyish buff colour. The mortar was generally hard to moderately hard and moderately robust, as it is expected for a lime mortar (subjective assessment). The mortar appeared to exhibit a generally normal compaction with occasional irregular to elongate voids up to 2mm and commonly less than 1mm across. |
| <b>Position of Specimen:</b><br>(size, relationship to sample) | The thin section was taken along the length and through the thickness of mortar pieces. Thin section approximate dimensions (mm): 4No. pieces covering an area 67 x 45 approx. |
