# ARCHAEOLOGICAL INVESTIGATIONS

Land at Oldham Road, Newton Heath, Greater  
Manchester

ARS Report N°: 2022/33  
OASIS ID: archaeol5-421363

# Archaeological Investigations on Land at Oldham Road, Newton Heath, Greater Manchester

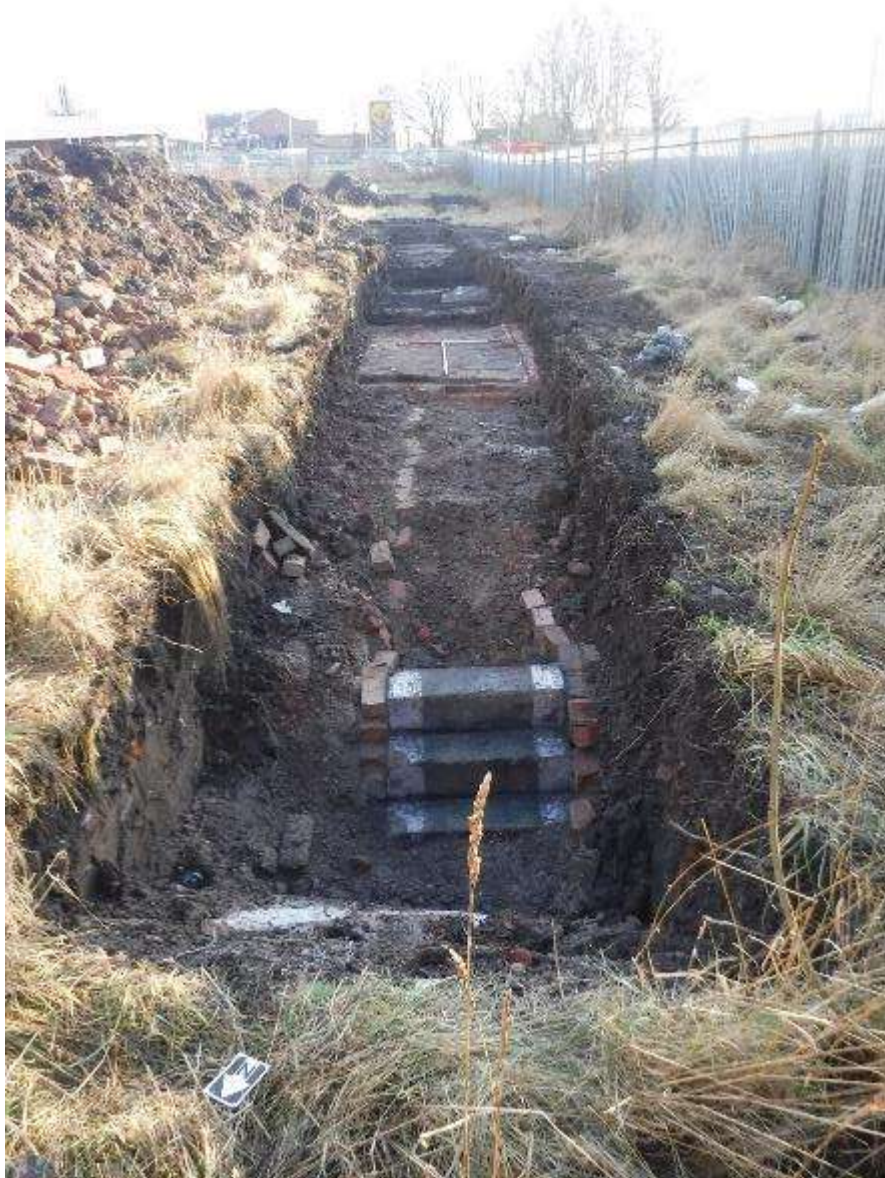
Figure 3: A south-east facing photograph showing Trench 1 with steps {122} in the foreground. Scale 2x 1m in 0.5m graduations.

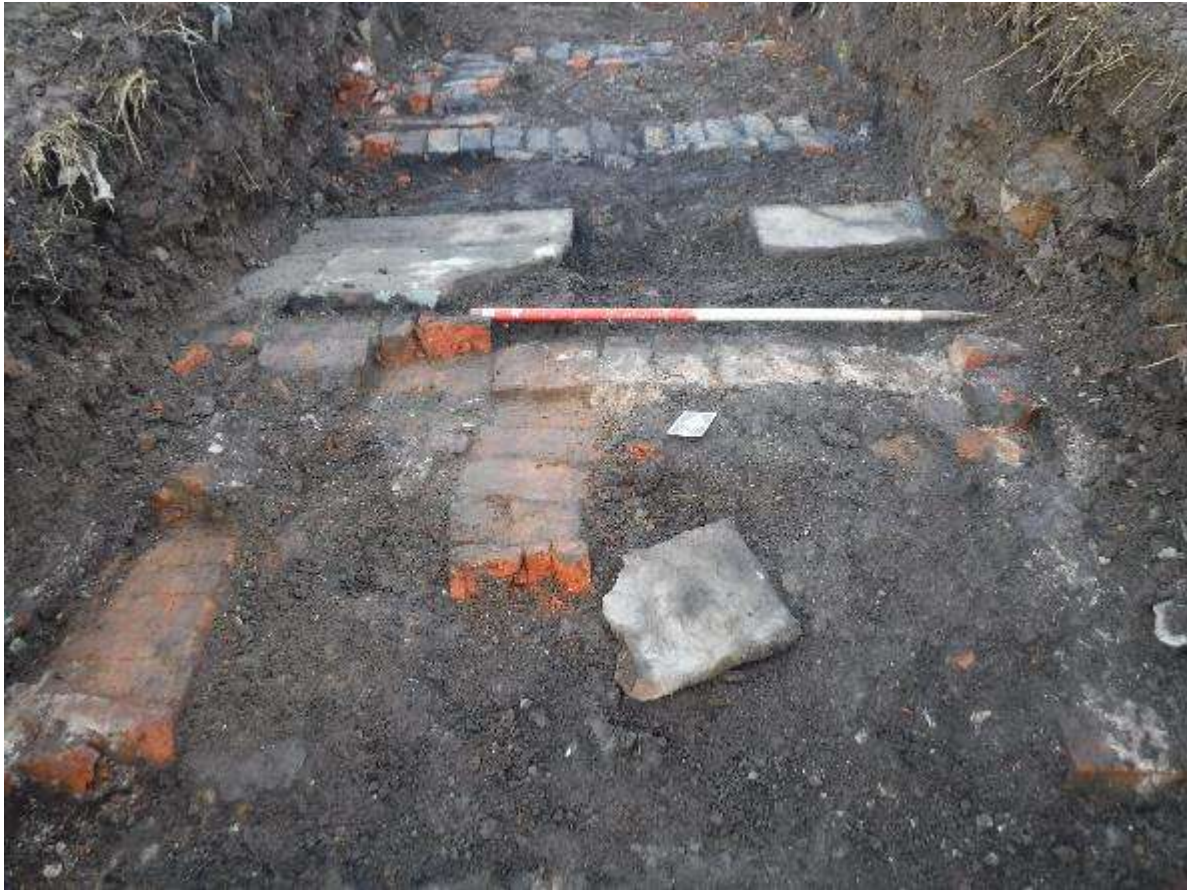
4.2.13 Wall {115} was south-west to north-east aligned and comprised two skins of machine-made unfrogged red bricks bonded by a black ash mortar. It survived to four courses in height and is of uncertain function as it does not appear to line up with any of the walls shown on either the 1846 Tithe Plan or the 1893 OS map.

Figure 4: A north-west facing photograph showing walls {109}, {110} and {111} abutting wall {124} in the foreground and walls {113}, {114} and {115} in the background. Surface {112} can be seen separating the areas of walls. Scale 1x1m in 0.5m graduations.

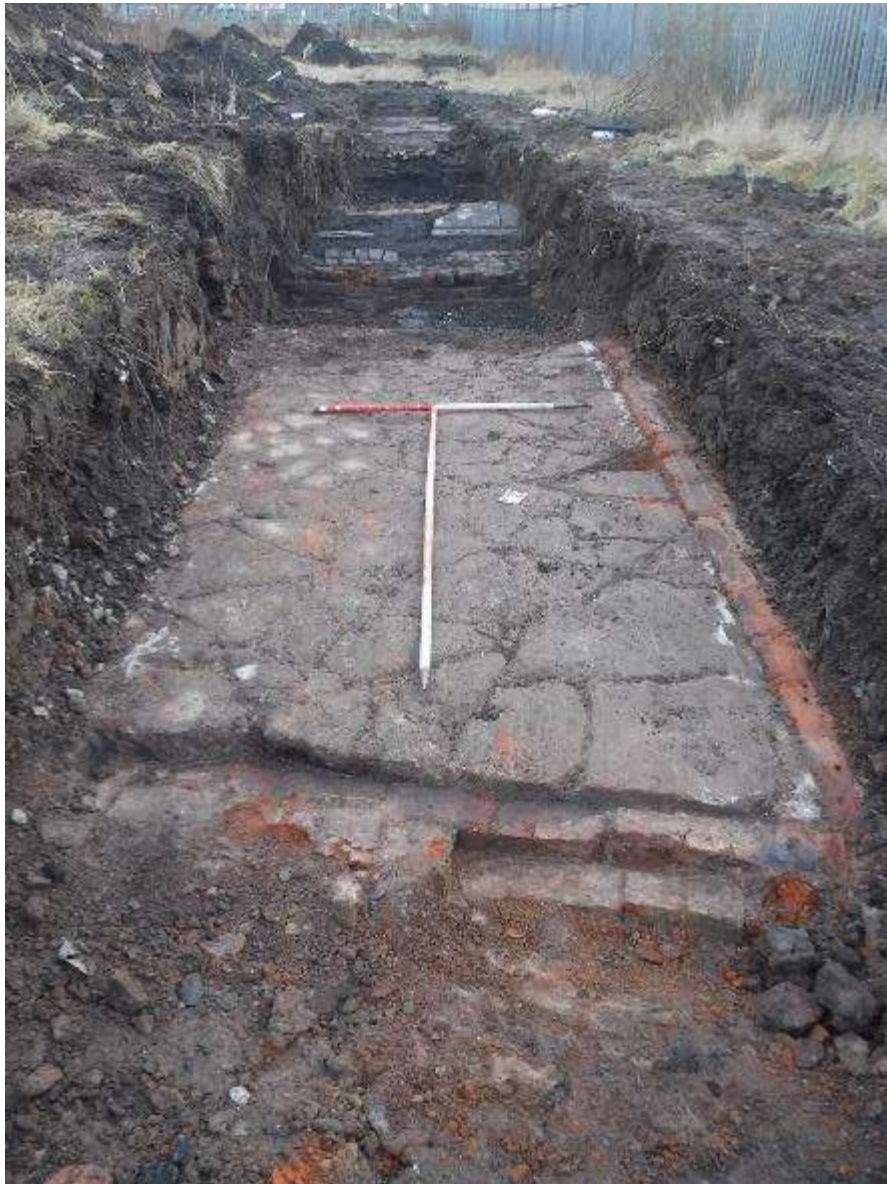
4.2.16 Surface {118} consists of poured concrete which likely formed an exterior yard surface to the rear of one of the elongated properties which front on to Oldham Road as shown on the 1893 OS map. Surface {118} abuts walls {117} and {119}. It likely dates to the early 20<sup>th</sup> century.

Figure 5: A south-east facing photograph showing exterior yard surface {118}. Scale 1x1m and 1x2m in 0.5m graduations.

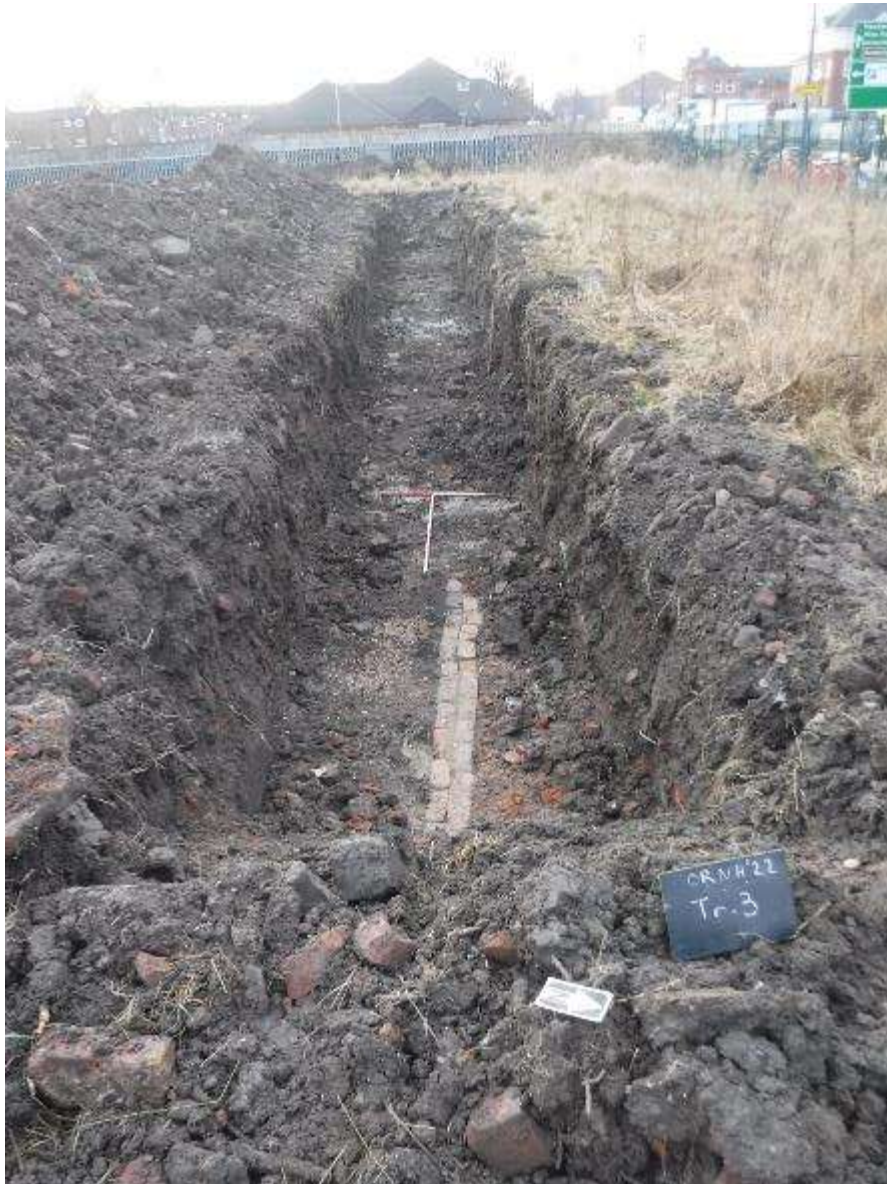
4.2.24 Trench 3 (see Figure 37) was aligned broadly east to west and targeted two buildings showing on the 1846 Tithe Plan which fronted onto the southern side of Oldham Road but. By the 1893 OS map these buildings appear to have been replaced with a row of elongated buildings including the Woodman Inn pub. Topsoil (301) was removed on to a deposit of clay made ground (302) which capped made ground deposit (303) consisting of demolition rubble likely associated with the 1970s demolition of the buildings. Exposed within deposit (303) was the remains of a single wall {304}.

Figure 6: A south-west facing photograph of Trench 3 showing wall {304} in the foreground. Scale 1x1m and 1x2m in 0.5m graduations.

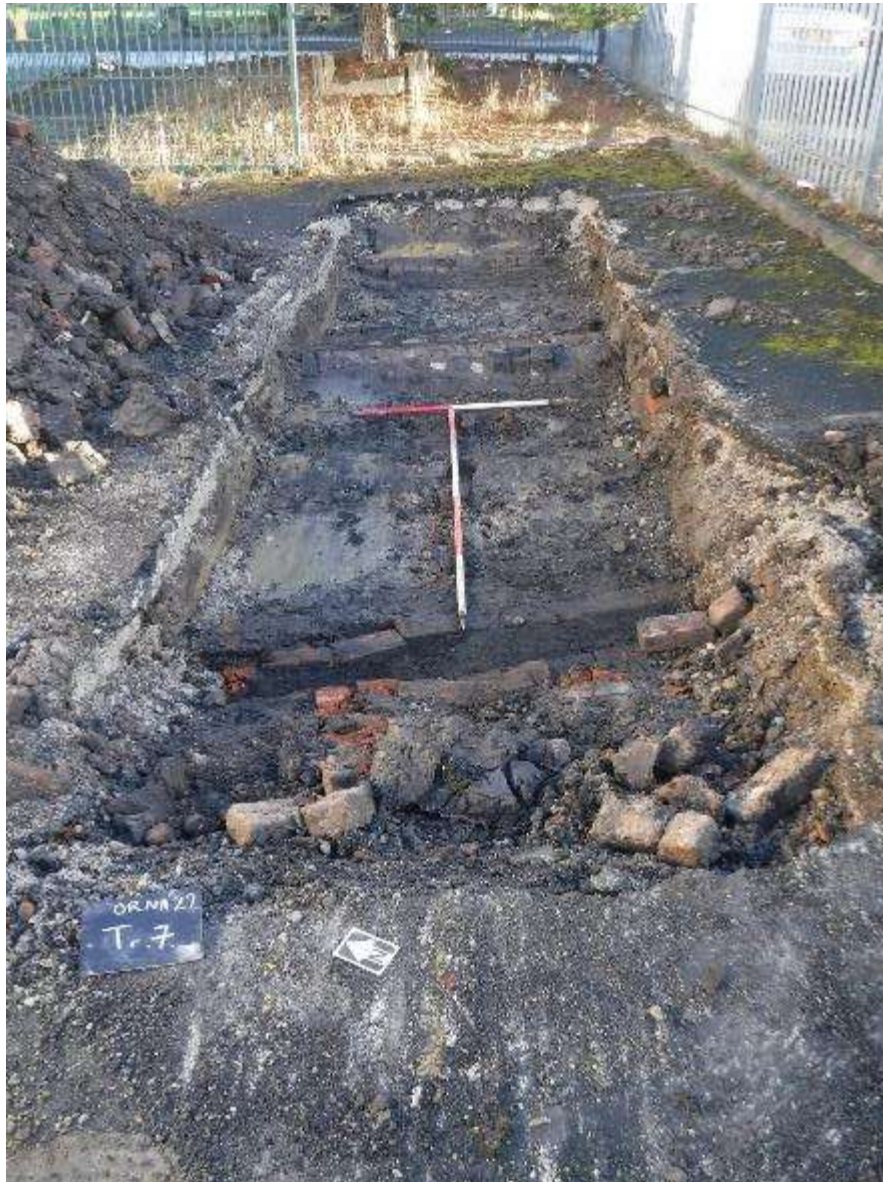
Figure 7: A north-east facing photograph showing Trench 7. Scale 1x1m and 1x2m in 0.5m graduations.

4.2.33 Walls {705}, {706}, {707} were all north-west to south-east aligned and each comprised two skins of machine-made unfrogged red bricks bonded by a lime ash mortar. They survived to two courses in height and possibly represent the foundation courses for a mid/late 19<sup>th</sup> century building located behind a row of terraced houses fronting Newton Street. Wall {708} was south-west to north-east aligned and comprised two skins of machine-made unfrogged red bricks bonded by a lime ash mortar. It survived to two courses in height, abutting wall {707}, and likely represented an internal stub wall probably dating to the mid/late 19<sup>th</sup> century.

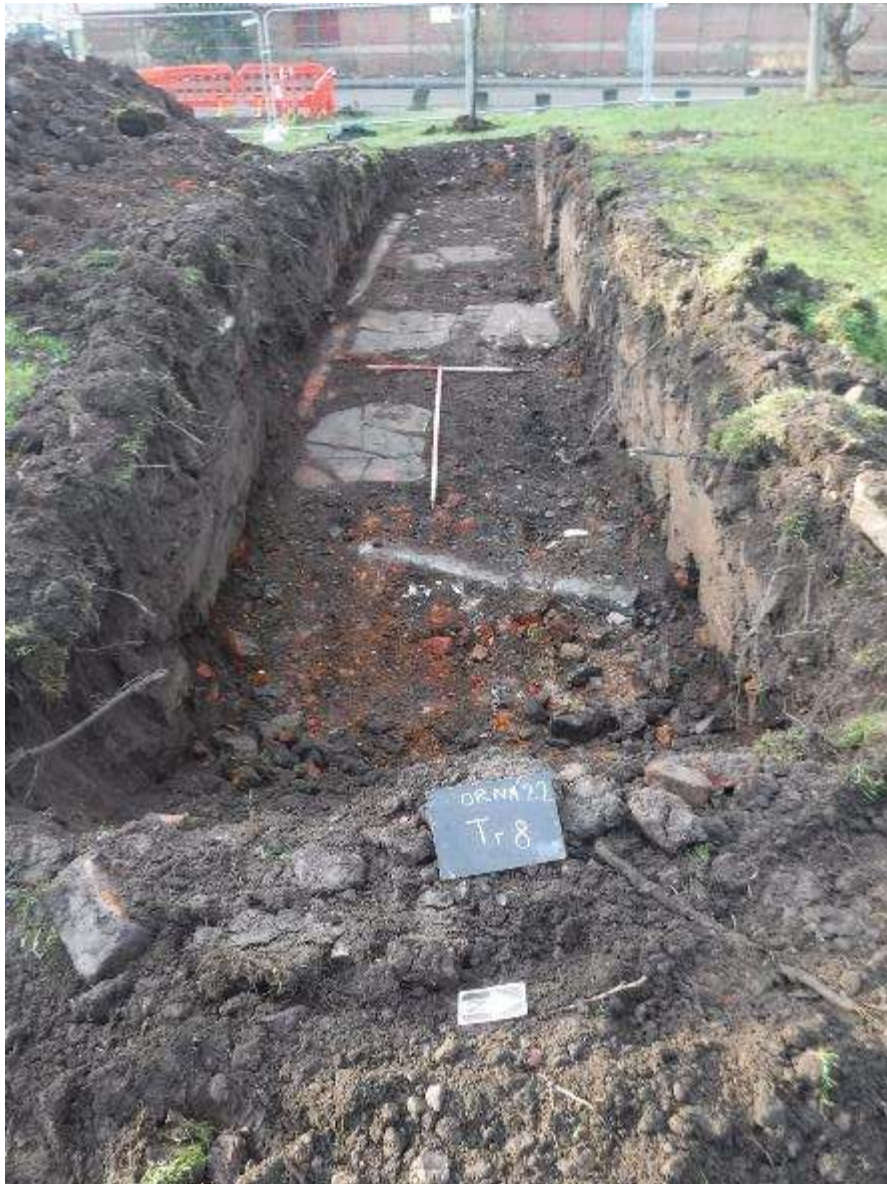
4.2.34 Trench 8 (see Figure 41) was aligned south-west to north-east and targeted a row of terraced houses shown on the 1846 Tithe Plan and still present on the 1893 OS Map. Topsoil (801) was removed onto a deposit of made-ground (802), likely associated with the demolition of the former structures in the 1970s. Deposit (802) was removed onto deposit (803) which consisted of similar material but with a slight change in colour, also likely associated with the 1970s demolition. Beneath deposit (803) were the remains of three walls and three surfaces.

Figure 8: A west-facing photograph showing Trench 8. Scale 1x1m and 1x2m in 0.5m graduations.

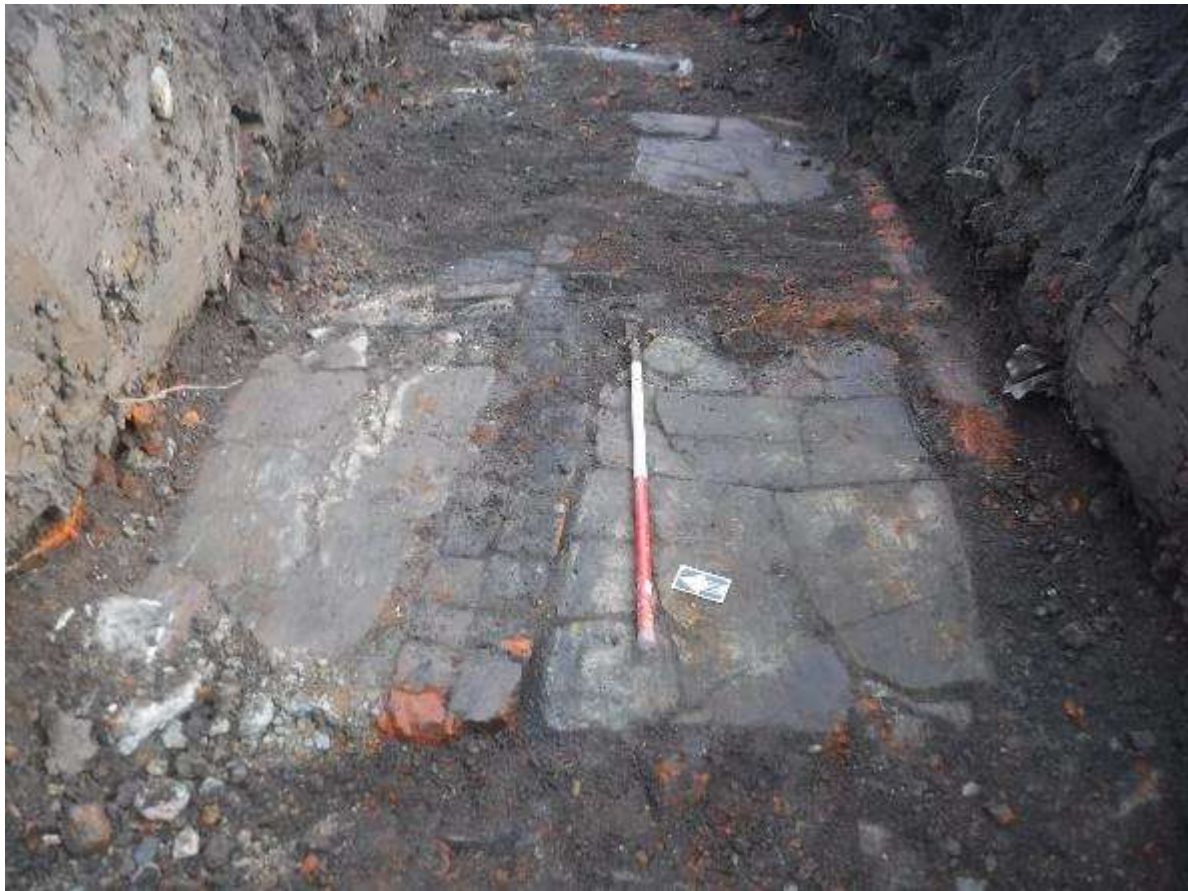
4.2.40 Wall {809} was south-west to north-east aligned and comprised two skins of machine-made unfrogged red bricks bonded by a lime mortar. It survived to one course in height and possibly represented an interior dividing wall between two parts of the outbuilding which is shown on the 1893 OS map. It likely dated to the mid/late 19<sup>th</sup> century.

Figure 9: A north-east facing photograph showing walls {807/808/809} and surfaces {805/806}/ Scale 1x1m in 0.5m graduations.

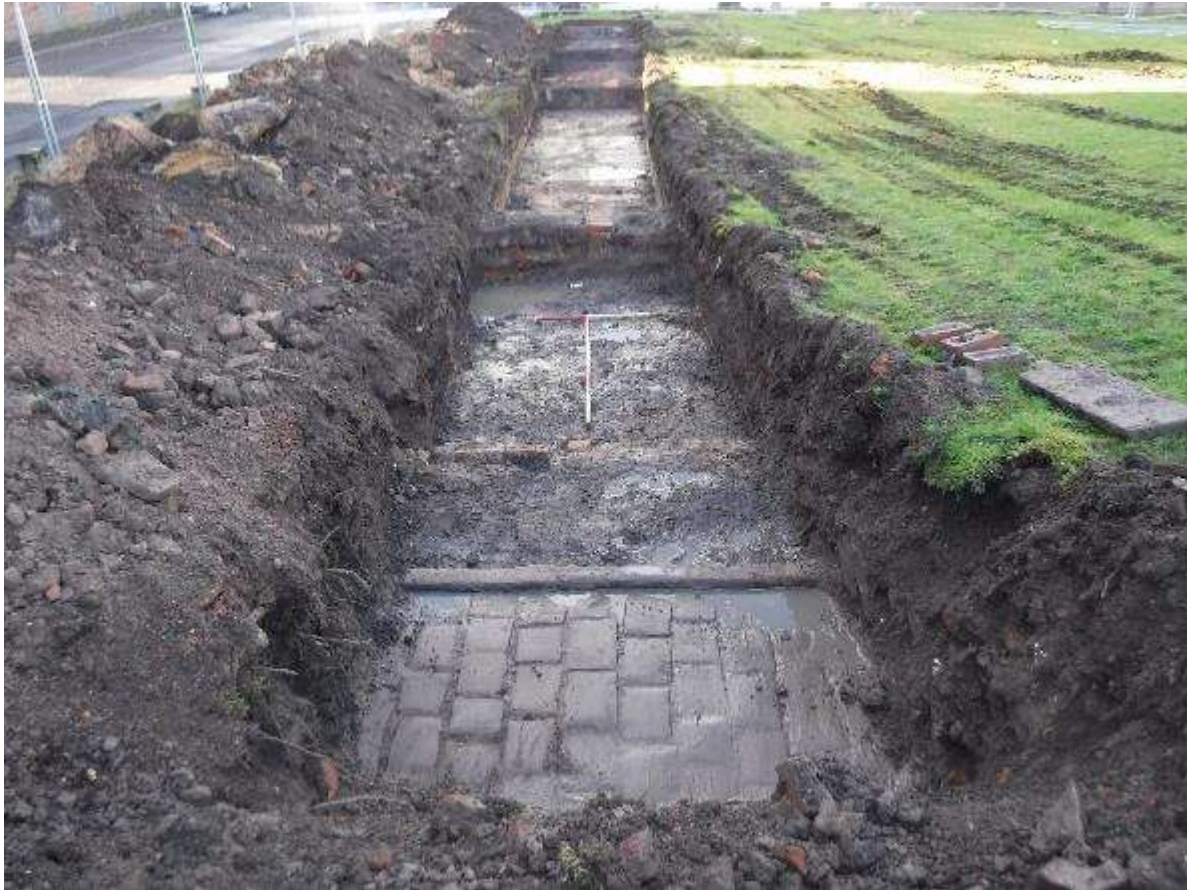
4.2.42 Trench 10 (see Figure 42) was aligned south-west to north-east and targeted a row of terraced houses shown on the 1846 Tithe Plan and which were still present on the 1893 OS Map. Topsoil (1001) was removed onto a deposit of made ground (1002) consisting of demolition rubble associated with the 1970s demolition. Exposed beneath deposit (1002) were the remains of ten walls and one surface which were all founded directly onto the geological substrate (1003).

Figure 10: A south-west facing photograph showing Trench 10 with surface {1014} in the foreground. Scale 1x1m and 1x2m in 0.5m graduations.

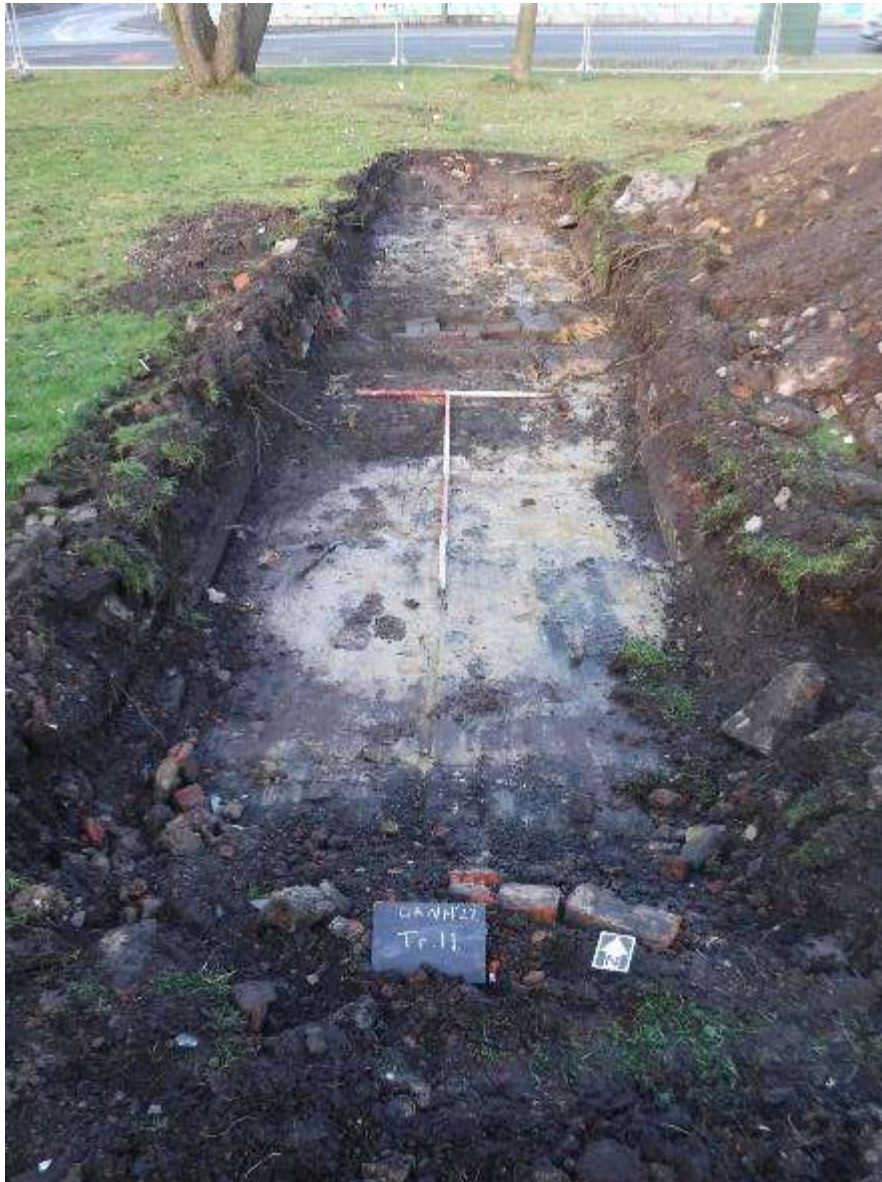
4.2.50 Trench 11 (see Figure 43) was broadly aligned north to south and targeted a building on the corner of Oldham Road and Canal Street (no longer present) and which appears to have undergone some changes by the time of the 1893 OS Map at which point Canal Street has been renamed Allen Street. Topsoil (1101) was removed onto a deposit of made ground (1102) consisting of demolition rubble likely associated with 1970s demolition activity. Exposed beneath deposit (1102) were the remains of seven walls and one surface.

Figure 11: A north-west facing photograph of Trench 11. Scale 1x1m and 1x2m in 0.5m graduations.

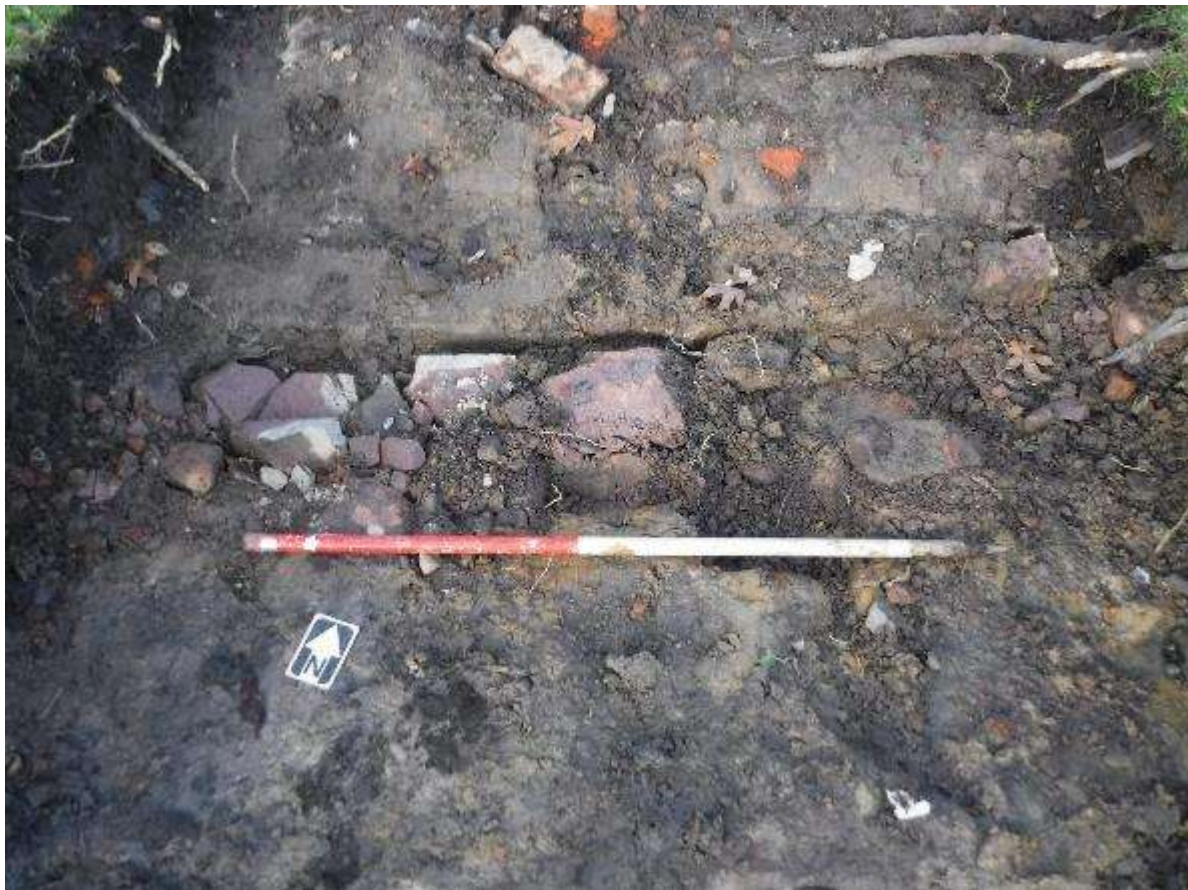
4.2.55 Wall {1108} was south-west to north-east aligned and comprised broken sandstone blocks set within a construction cut but with no discernable bonding material. The wall lines up with one of the party walls as shown on both the 1846 Tithe Plan and the 1893 OS map and is probably a rubble wall foundation. It possibly dates to the early/mid 19<sup>th</sup> century.

Figure 12: A north-west facing photograph showing wall {1108}. Scale 1x1m in 0.5m graduations.

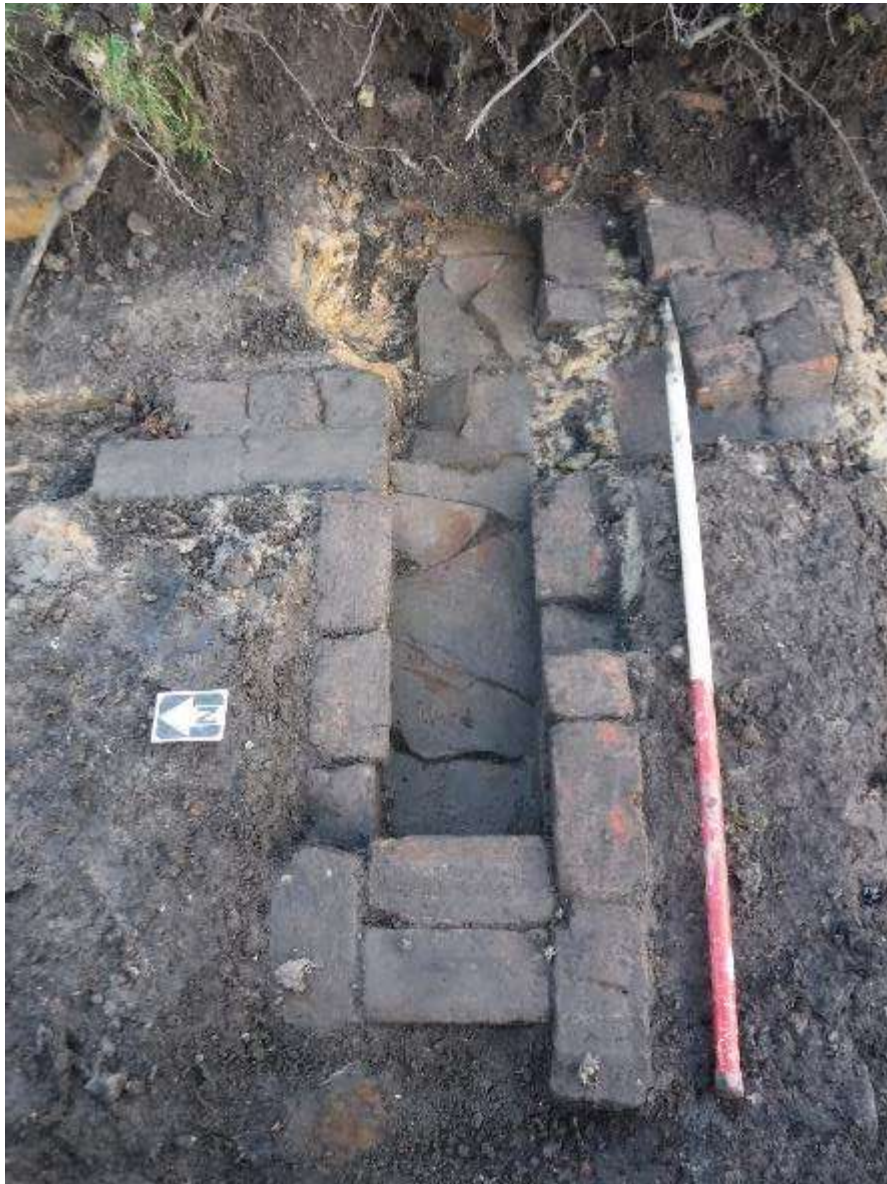
4.2.57 Surface {1110} consisted of flat-laid sandstone flagstone offcuts which constituted the base of the culvert represented by walls {1104}, {1106} and {1109}. It likely dated to the mid/late 19<sup>th</sup> century.

Figure 13: An east-facing photograph showing the drain housing. Scale 1x1m in 0.5m graduations.

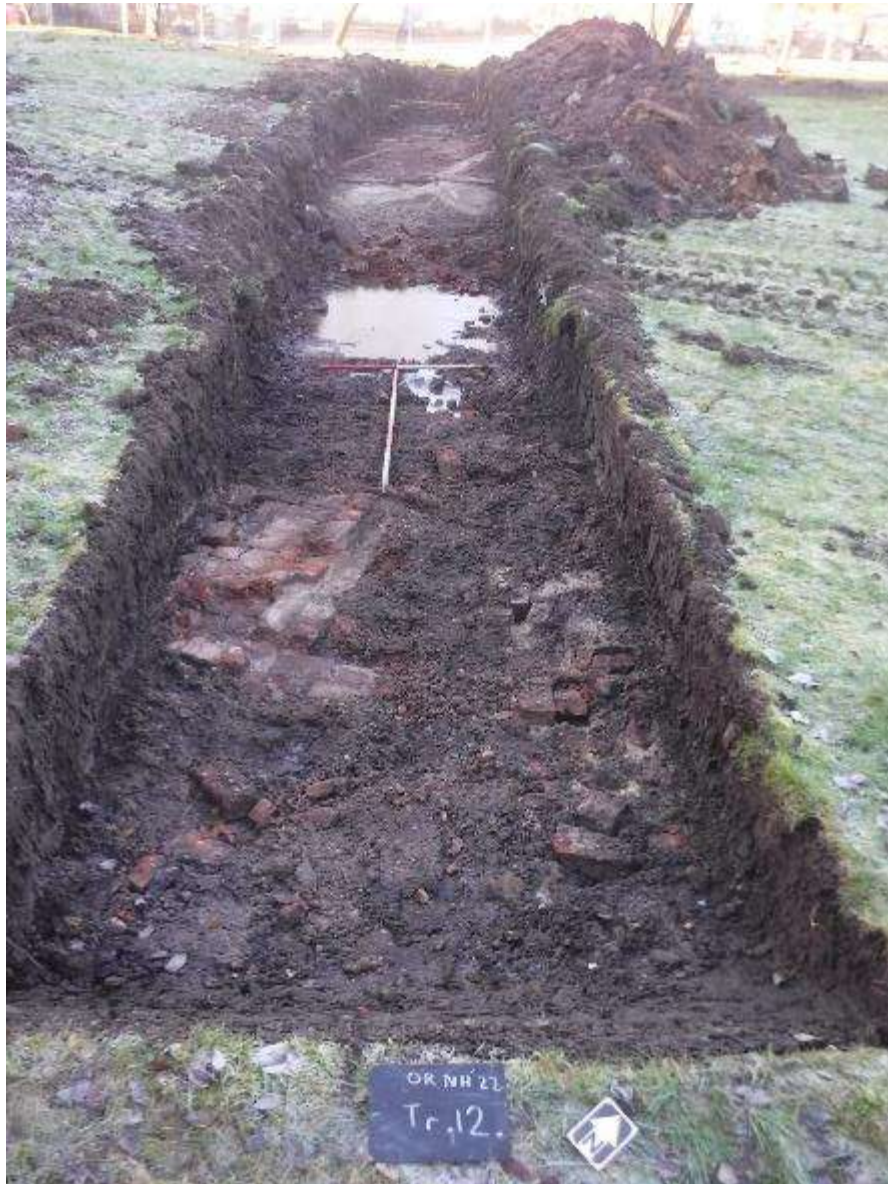
**4.2.59** Trench 12 (see Figure 44) was aligned north-west to south-east and targeted a row of terraced houses which fronted onto the former Canal Street (later Allen Street) and which are shown on the 1846 Tithe Plan. Topsoil (1201) was removed onto a deposit of made ground (1202) associated with 1970s demolition activity. Exposed beneath deposit (1202) were the remains of 11 walls and one surface.

Figure 14: A north-west facing photograph showing Trench 12. Scale 1x1m and 1x2m in 0.5m graduations.

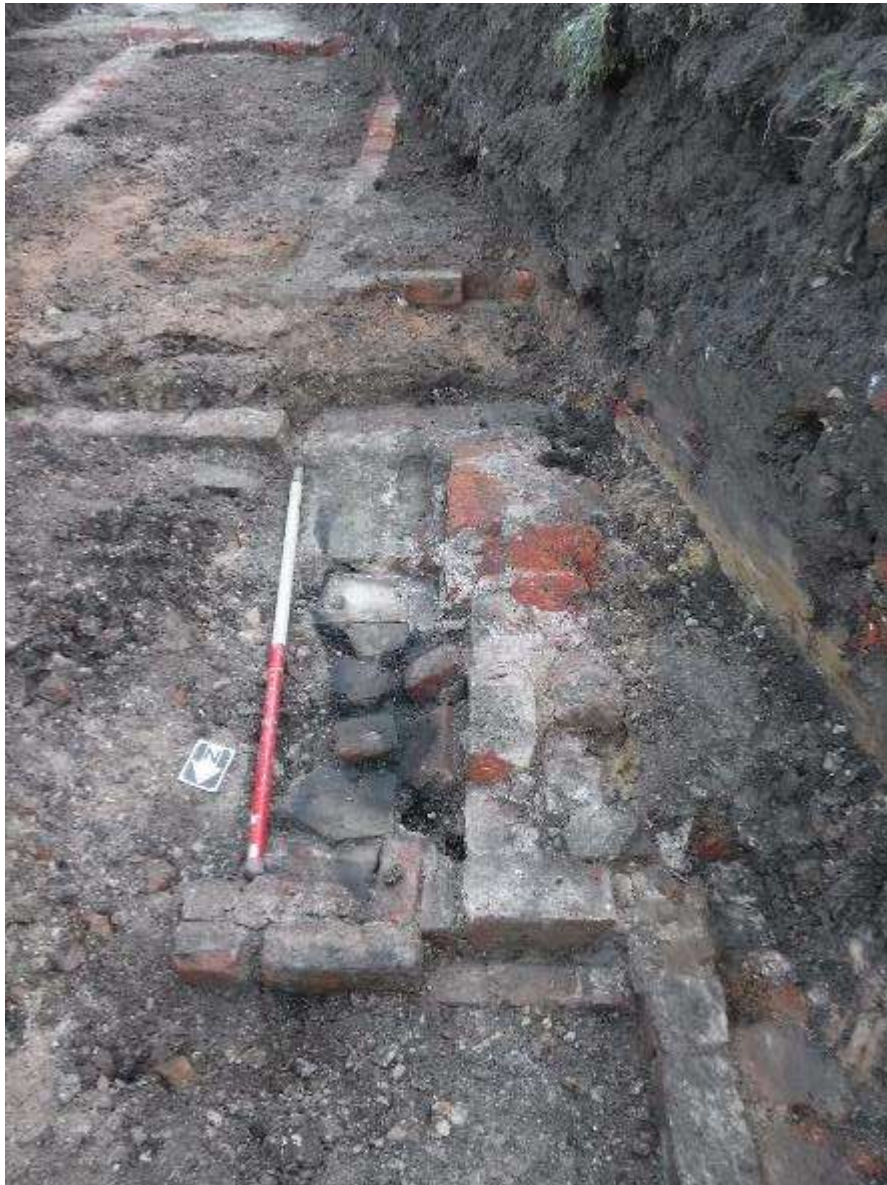
4.2.65 Wall {1209} was south-east to north-west aligned and comprised two skins of handmade unfrogged red bricks bonded by a lime mortar. The wall survived to one course in height and the upper surface had clearly been subject to heat affection which suggests that the wall formed part of a fireplace in conjunction with wall {1207}. It likely dated to the mid/late 19<sup>th</sup> century.

Figure 15: A south-east facing photograph showing possible fireplace {1209}. Scale 1x1m in 0.5m graduations.

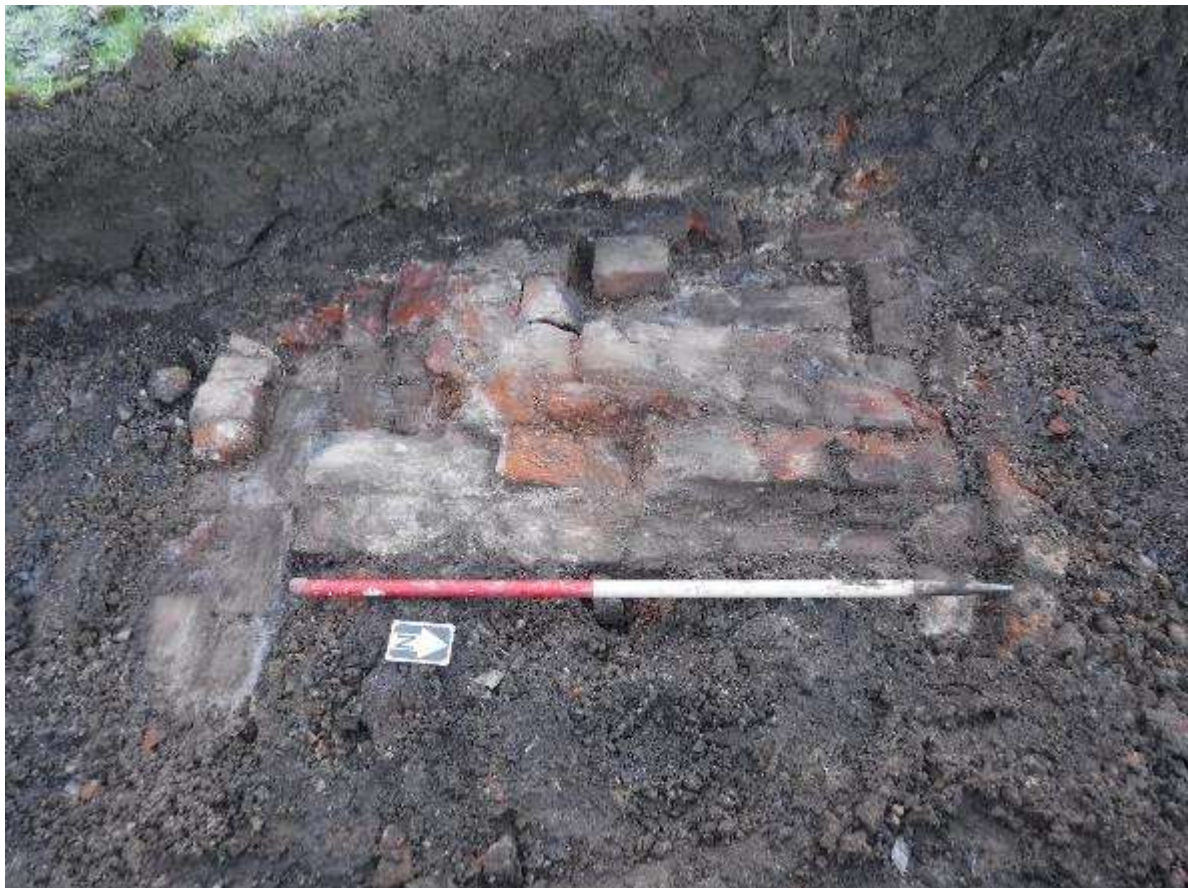
4.2.69 Wall {1214} comprised seven skins of handmade unfrogged red bricks bonded by a lime ash mortar. It formed an apparently square structure of uncertain function but which may have been part of a machine-bed or, perhaps more likely, form the base of a pillar within the larger building fronting on to Heath Street as shown on both the 1846 Tithe Plan and the 1893 OS map. It likely dated to the mid/late 19<sup>th</sup> century.

Figure 16: A west-facing photograph showing the possibly pillar base {1214}. Scale 1x1m in 0.5m graduations.

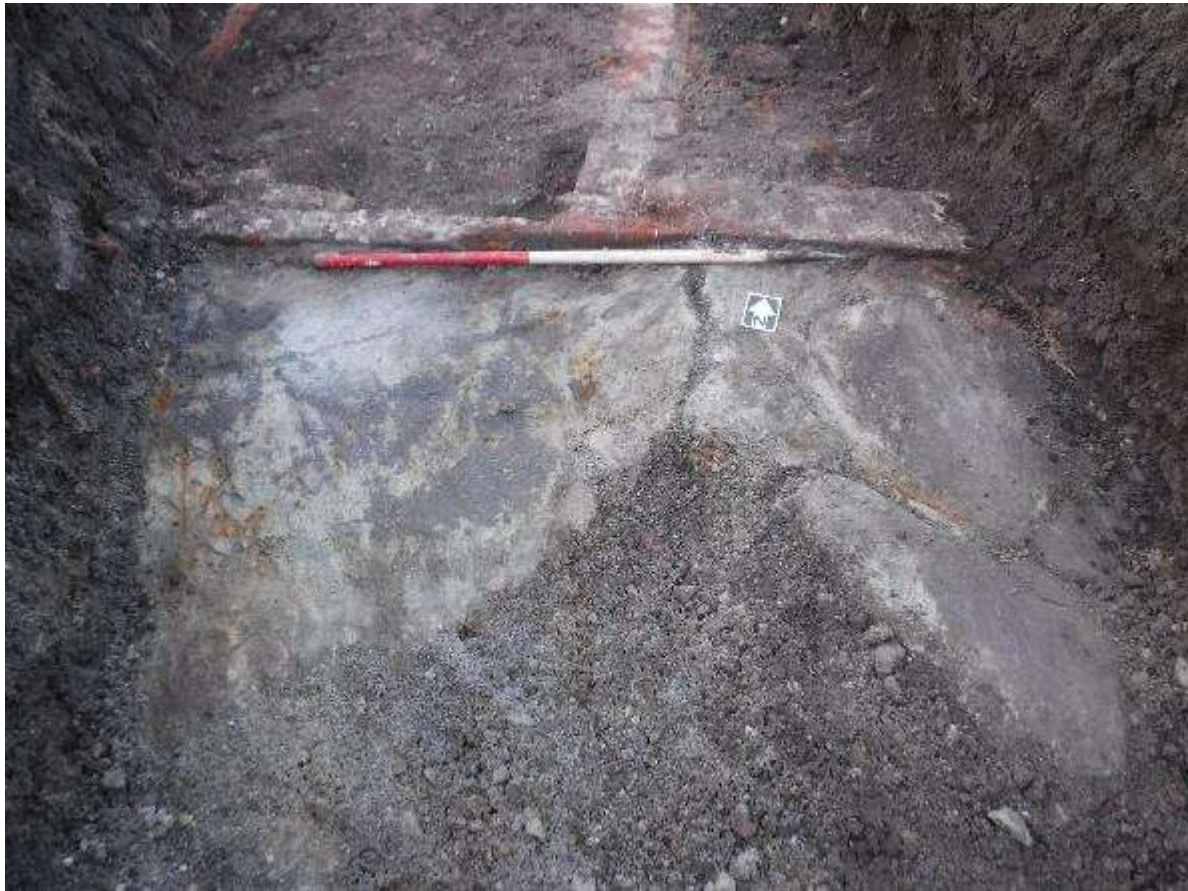
4.2.70 Surface {1215} consists of a coarse grey poured concrete surface which likely acted as a hard-wearing floor as part of the same building as wall {1214} and which may have been a

warehouse or an industrial building. Surface {1215} abutted wall {1213} and possibly dated to the late 19<sup>th</sup>/early 20<sup>th</sup> century.

Figure 17: A north-west facing photograph showing wall {1213} and surface {1215}. Scale 1x1m in 0.5m graduations.

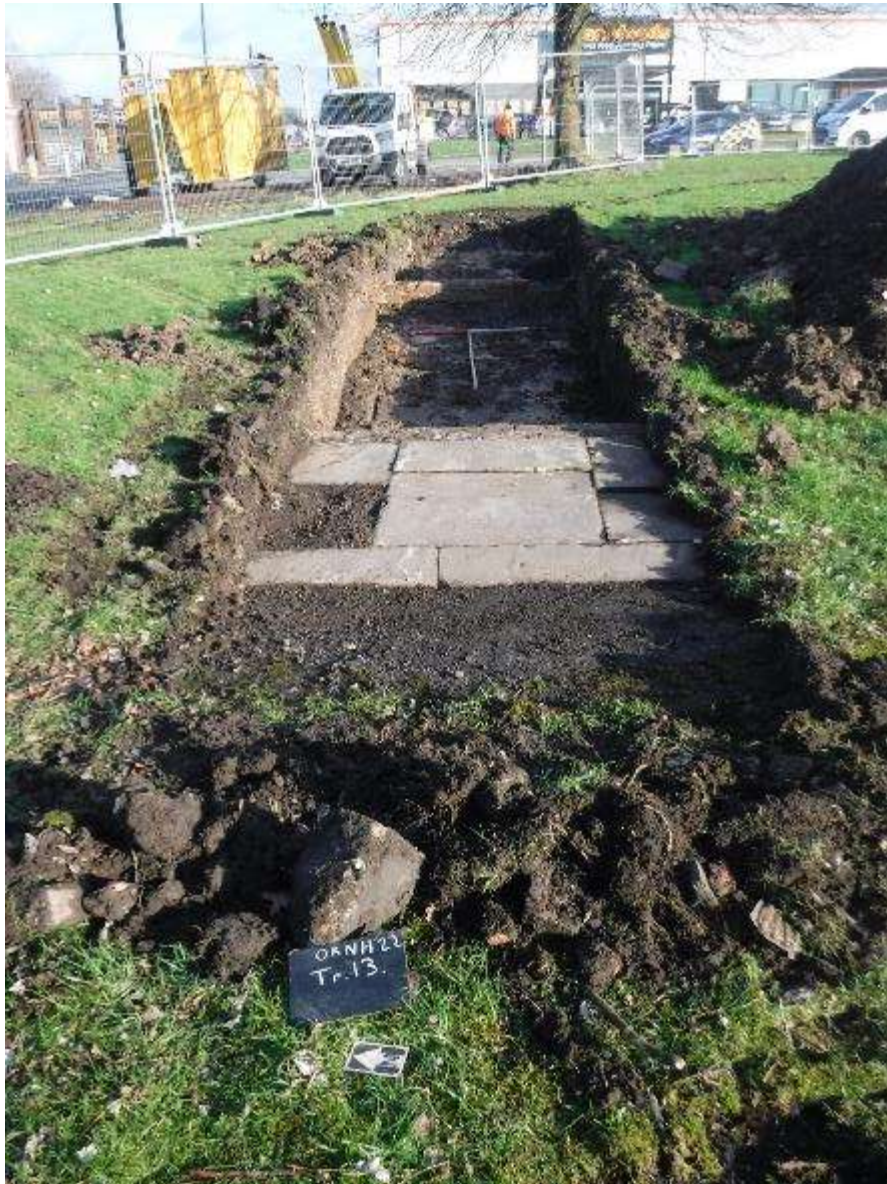
4.2.71 Trench 13 (see Figure 45) was aligned south-west to north-east and targeted a row of buildings which are shown fronting on to Oldham Road on the 1846 Tithe Plan. Topsoil (1301) was removed onto a deposit of made ground (1302) associated with the 1970s demolition. Exposed beneath deposit (1302) were the remains of two walls and a surface which were all founded directly onto the geological substrate (1303).

Figure 18: A north-east facing photograph showing Trench 13. Scale 1x1m and 1x2m in 0.5m graduations.

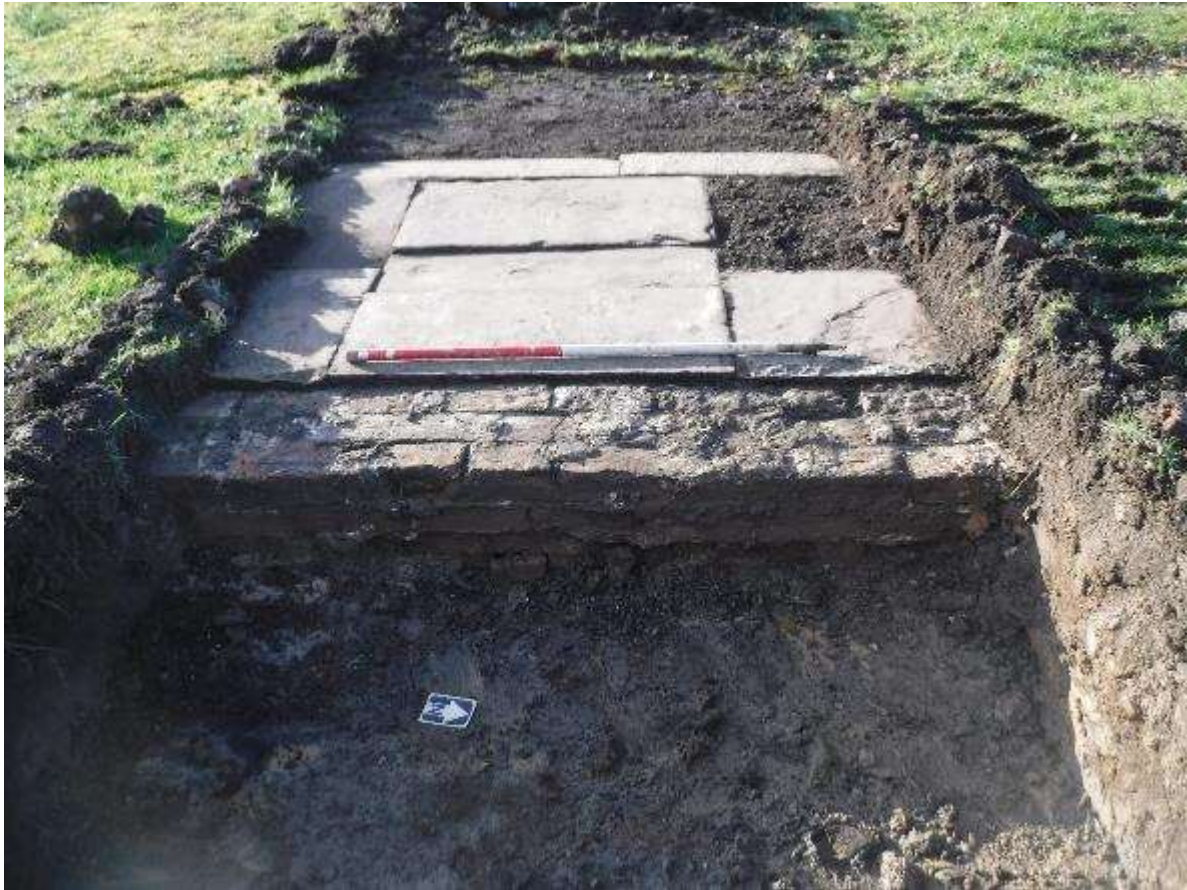
4.2.74 Surface {1306} comprised Yorkshire stone paving slabs which abutted wall {1305}. The surface likely represented a pavement associated with what was Canal/Allen Street in the mid/late 19<sup>th</sup> century.

Figure 19: A south-west facing photograph showing wall {1305} and surface {1306}. Scale 1x1m in 0.5m graduations.

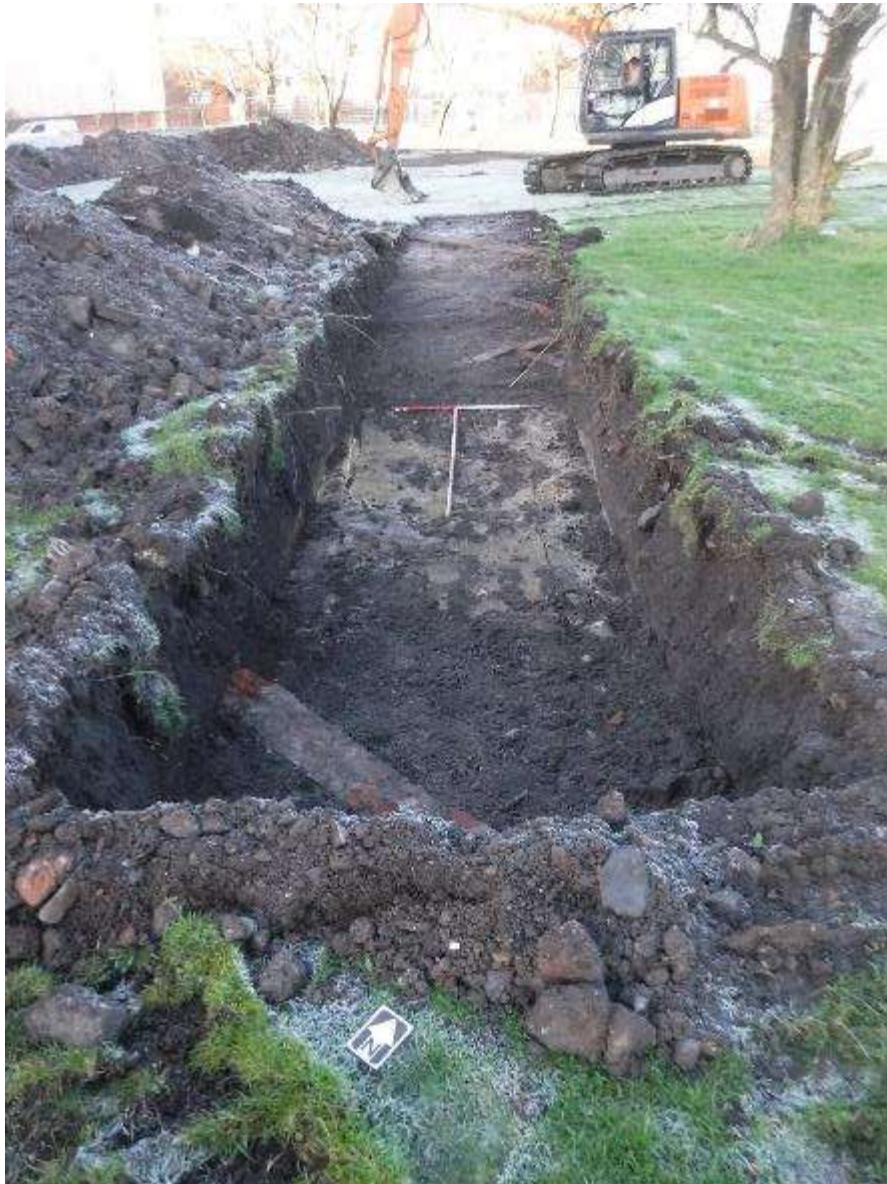
4.2.75 Trench 14 (see Figure 46) was aligned broadly east to west and targeted the yards and outhouse of terraced housing lining Heath Street as shown on the 1846 Tithe Plan. Topsoil (1401) was removed onto a deposit of made ground (1402) associated with the 1970s demolition. Exposed beneath deposit (1402) were the remains of six walls which were all founded directly onto the geological substrate (1403).

Figure 20: A north-west facing photograph showing Trench 14. Scale 1x1m and 1x2m in 0.5m graduations.

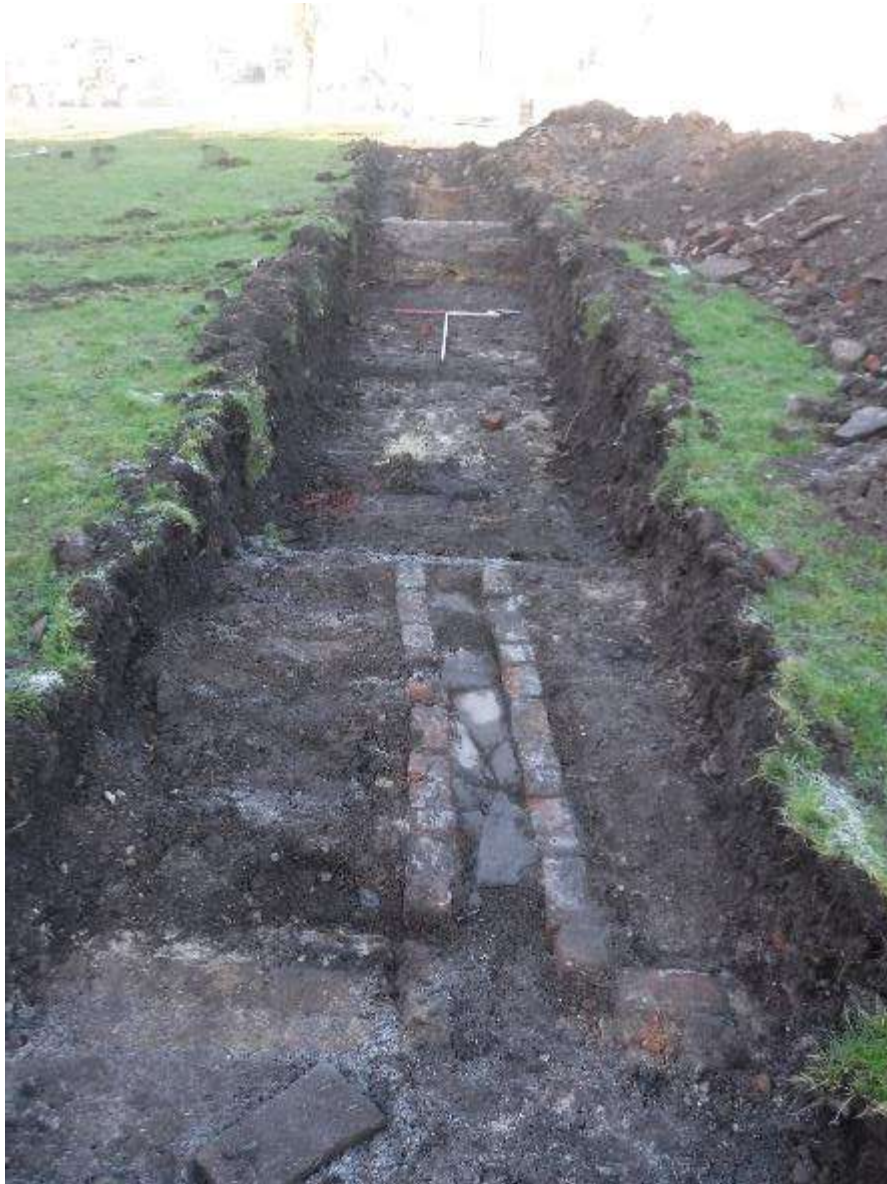
4.2.82 Trench 15 (see 47) was aligned north-west to south-east and targeted the row of terraced housing which front onto Heath Street and those which backed on to what is now Droylsden Street as shown on the 1846 Tithe Plan. Topsoil (1501) was removed onto a deposit of made ground (1502) associated with 1970s demolition activities. Exposed beneath deposit (1502) were the remains of thirteen walls and one possible surface.

Figure 21: A north-west facing photograph showing Trench 15. Scale 1x1m and 1x2m in 0.5m graduations.
