# ARCHAEOLOGICAL INVESTIGATIONS

Land at Oldham Road, Newton Heath, Greater  
Manchester

ARS Report N°: 2022/33  
OASIS ID: archaeol5-421363

# Archaeological Investigations on Land at Oldham Road, Newton Heath, Greater Manchester

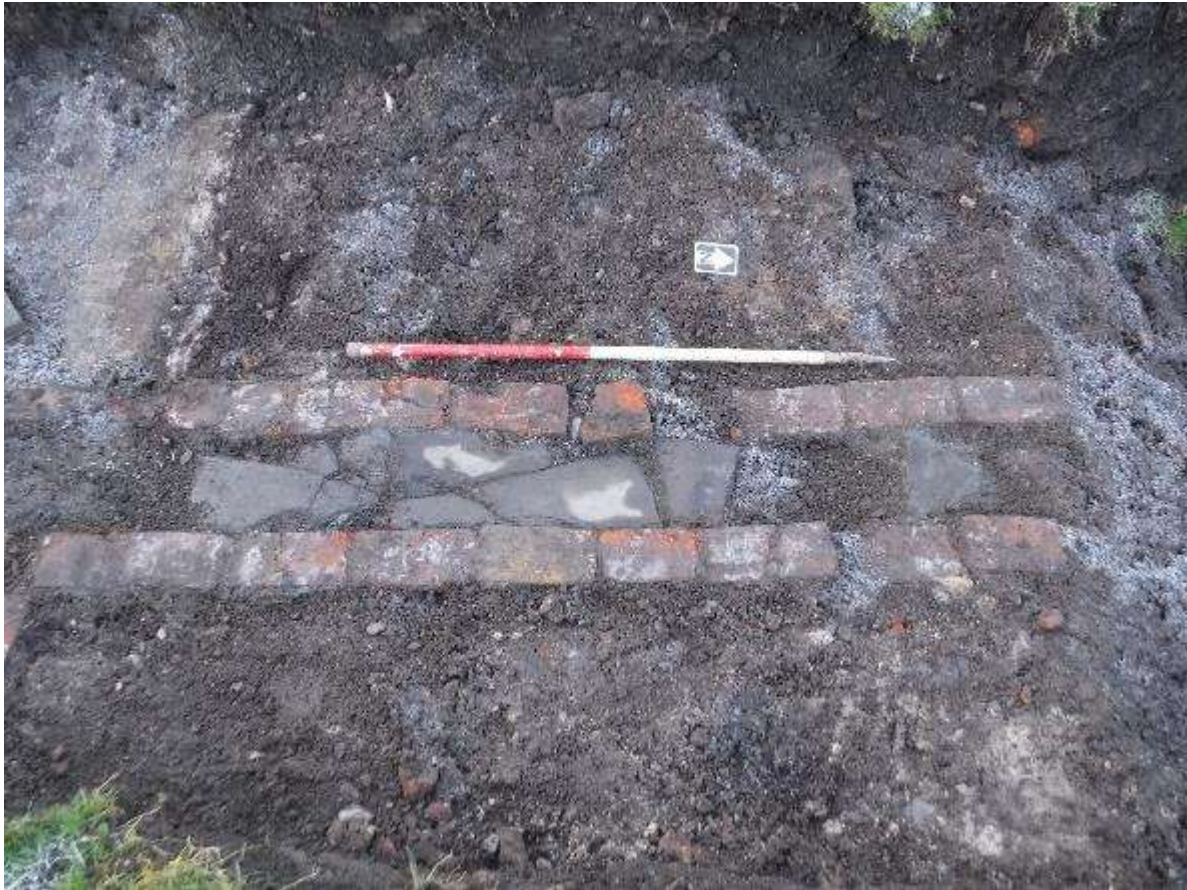
**4.2.83** Walls {1504} and {1505} were both south-east to north-west orientated and comprised a single skin of machine-made unfrogged red bricks bonded by a lime mortar. The walls ran parallel to one another and survived to one course in height. The space between the two walls was filled by grey stone slabs. The walls likely formed part of a former drain dating to the mid/late 19<sup>th</sup> century.

Figure 22: A west-facing photograph showing walls {1504/1505}. Scale 1x1m in 0.5m graduations.

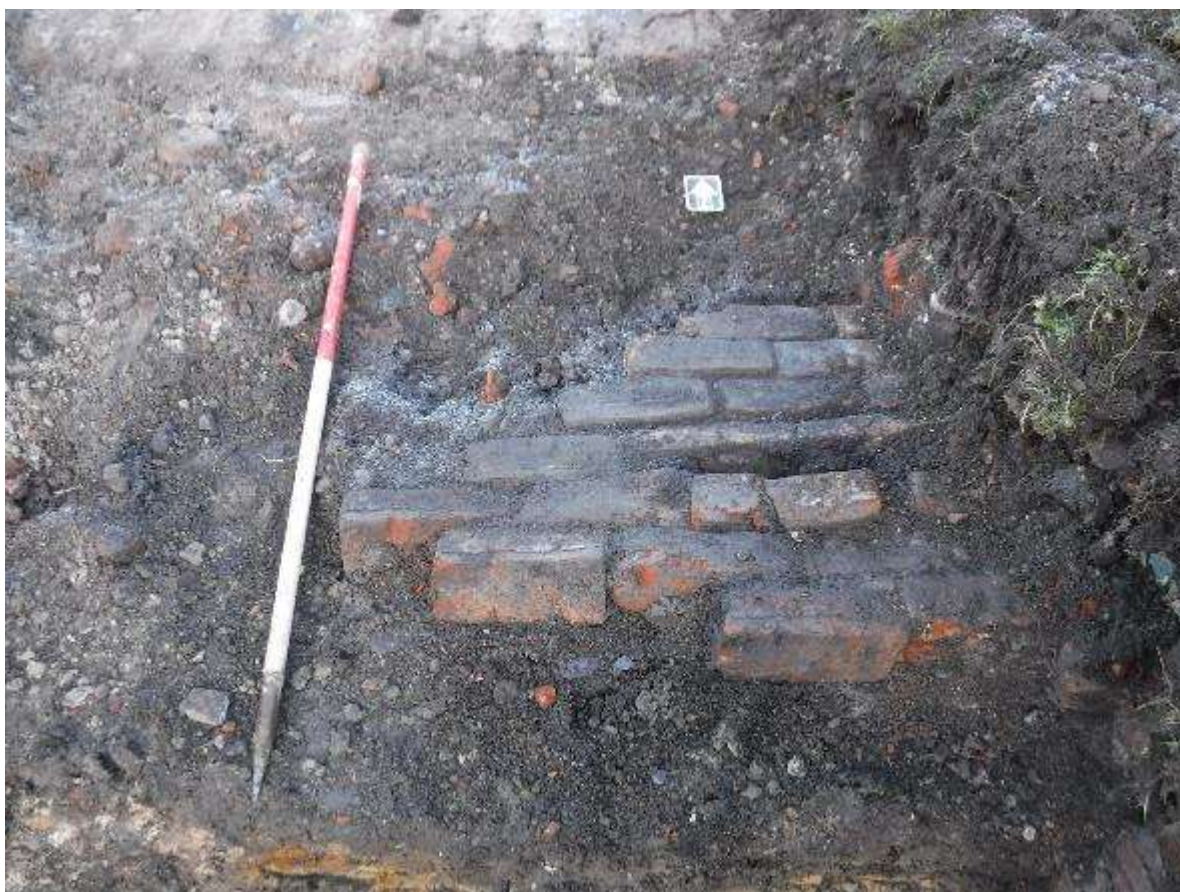
4.2.85 Surface {1507} consists of stretcher-laid, machine-made, unfrogged red bricks bonded by a lime ash mortar. The surface appeared to correspond with the location of an alleyway shown on the 1893 OS map which would have provided access to the rear of the properties which fronted on to Heath Street to the south. It is also possible that this is a section of collapsed wall. It was likely mid/late 19<sup>th</sup> century in date.

Figure 23: A north-facing photograph showing surface {1507}. Scale 1x1m in 0.5m graduations.

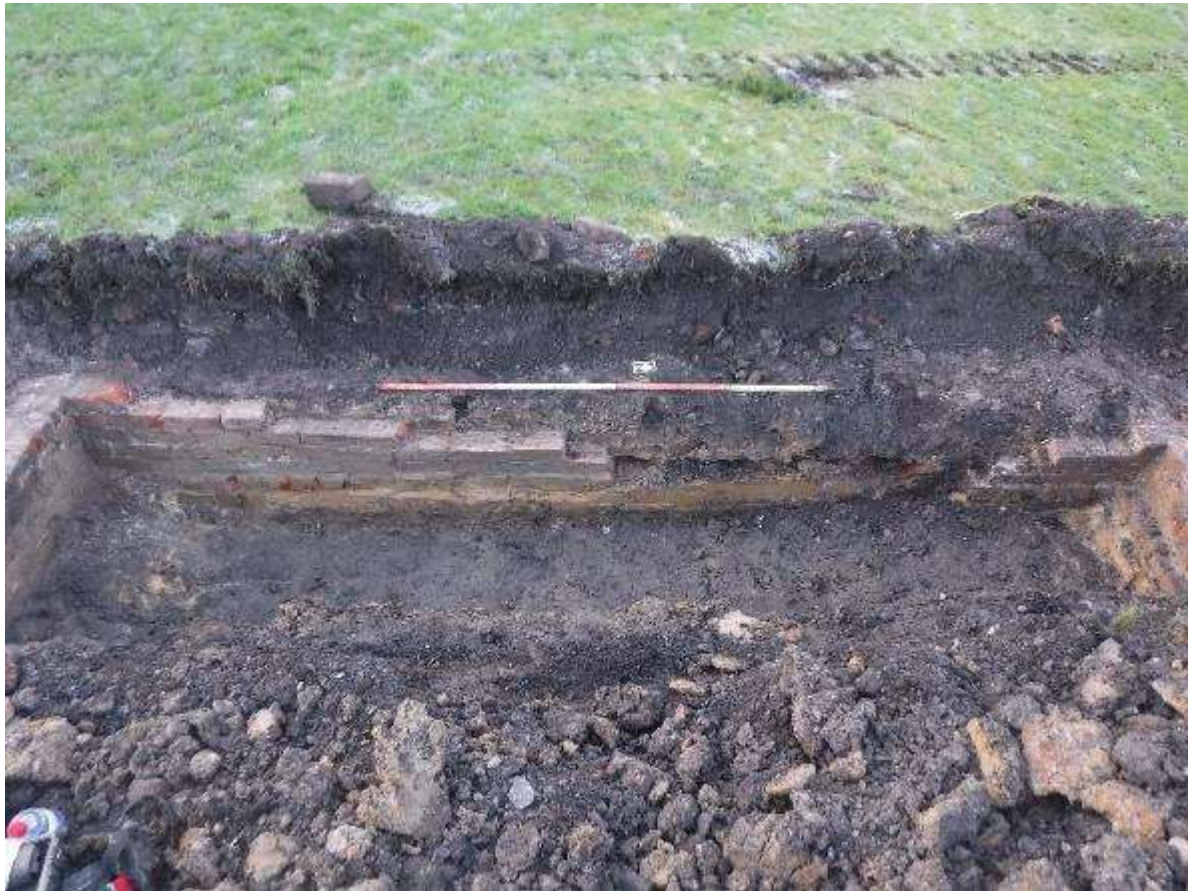
enclosed the rear of the southernmost property in that row of houses. It likely dated to the mid/late 19<sup>th</sup> century.

Figure 24: A west-facing photograph showing walls {1508/1509/1511}. Scale 1x2m in 0.5m graduations.

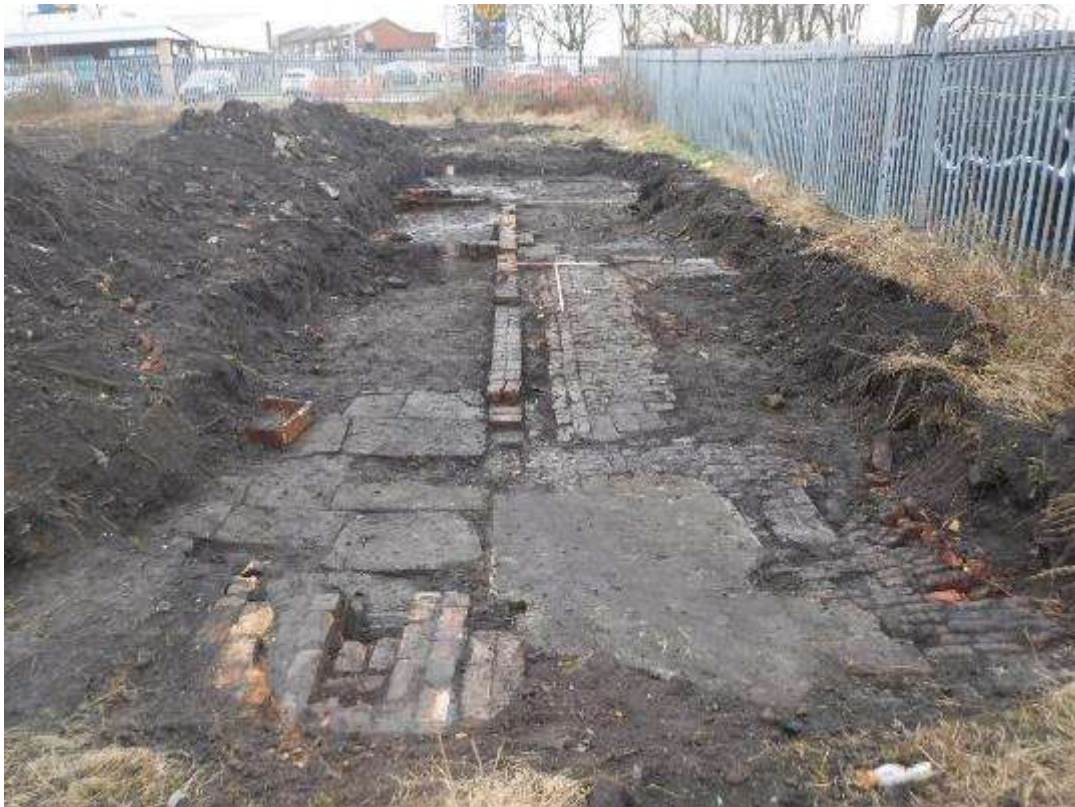
4.3.2 The remains encountered in this area relate to the remains of structures and surfaces associated with the building shown fronting on to Green Street on the 1893 OS map. The building is subdivided into a number of rooms and there is an internal partitioning wall that runs for most of the length of the building {3008}. On the western side of this wall, the area is characterised by a brick-built surface {3015} which likely represents an interior floor for a building with a probable industrial function. It is uncertain what this function was due to a lack of evidence but it was probably an ancillary building associated with the Monsall Works and likely dated to the late 19<sup>th</sup> century. This is borne out by the inclusion of numerous broken ginger beer bottles in the demolition material removed from this area as the 1908 OS map indicates that by this time the former dye works was a mineral water factory. Ginger beer was the most common product of mineral water producers.

Figure 25: A south-east facing photograph showing SMR Area 1. Scale 1x1m and 1x2m in 0.5m graduations.

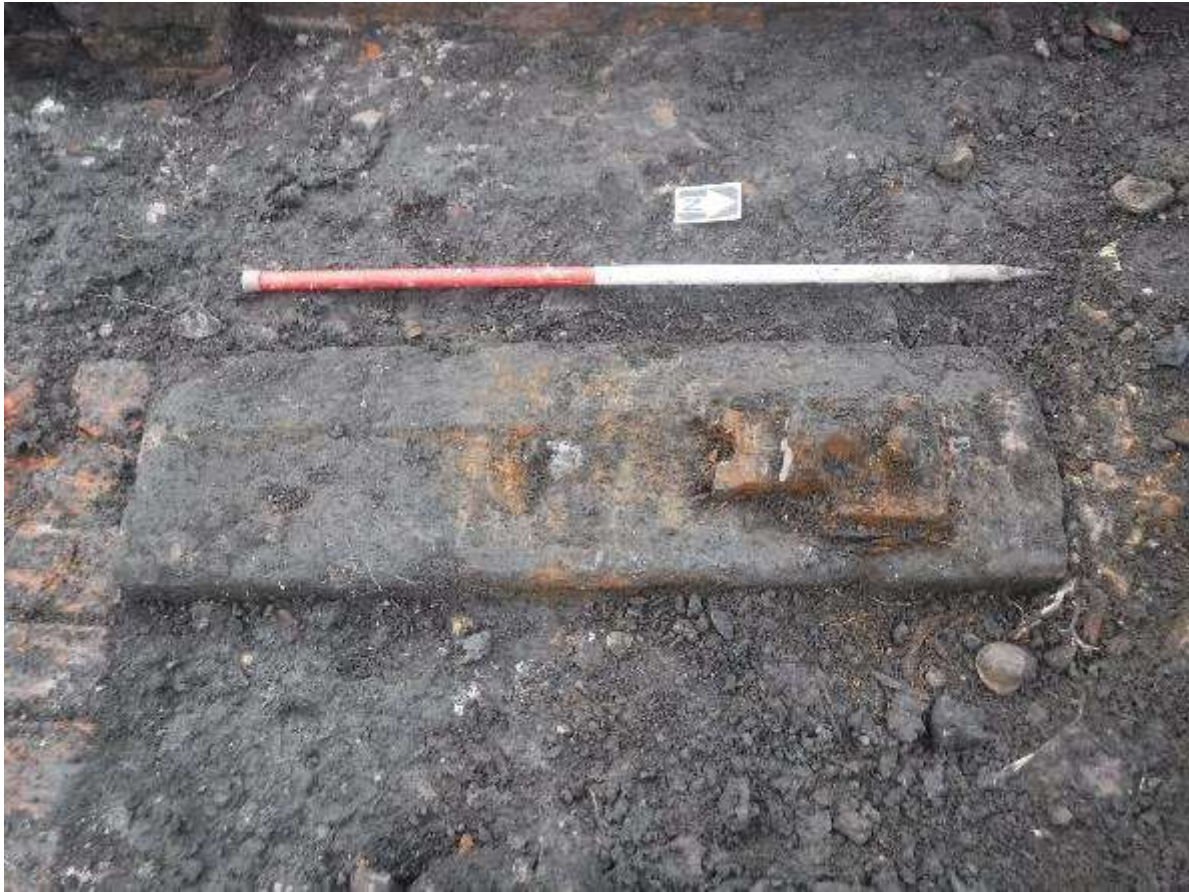
4.3.3 A small machine bed, {3011}, comprising a rectangular sandstone block with iron fittings, was located adjacent to wall {3010}. The machine it supported is unknown but given the size it would have been a smaller machine like a lathe. At the northern end of this area, but just outside of the building, were the remains of a brick-built structure bonded with a black ash mortar and cementitious mortar bonding a mixture of reused bricks (firebrick, handmade red bricks, frogged and unfrogged machine made bricks). This may have constituted the remains of an early 20<sup>th</sup> century kiln or oven base.

Figure 26: A west-facing photograph showing machine bed {3011}. Scale 1x1m in 0.5m graduations.

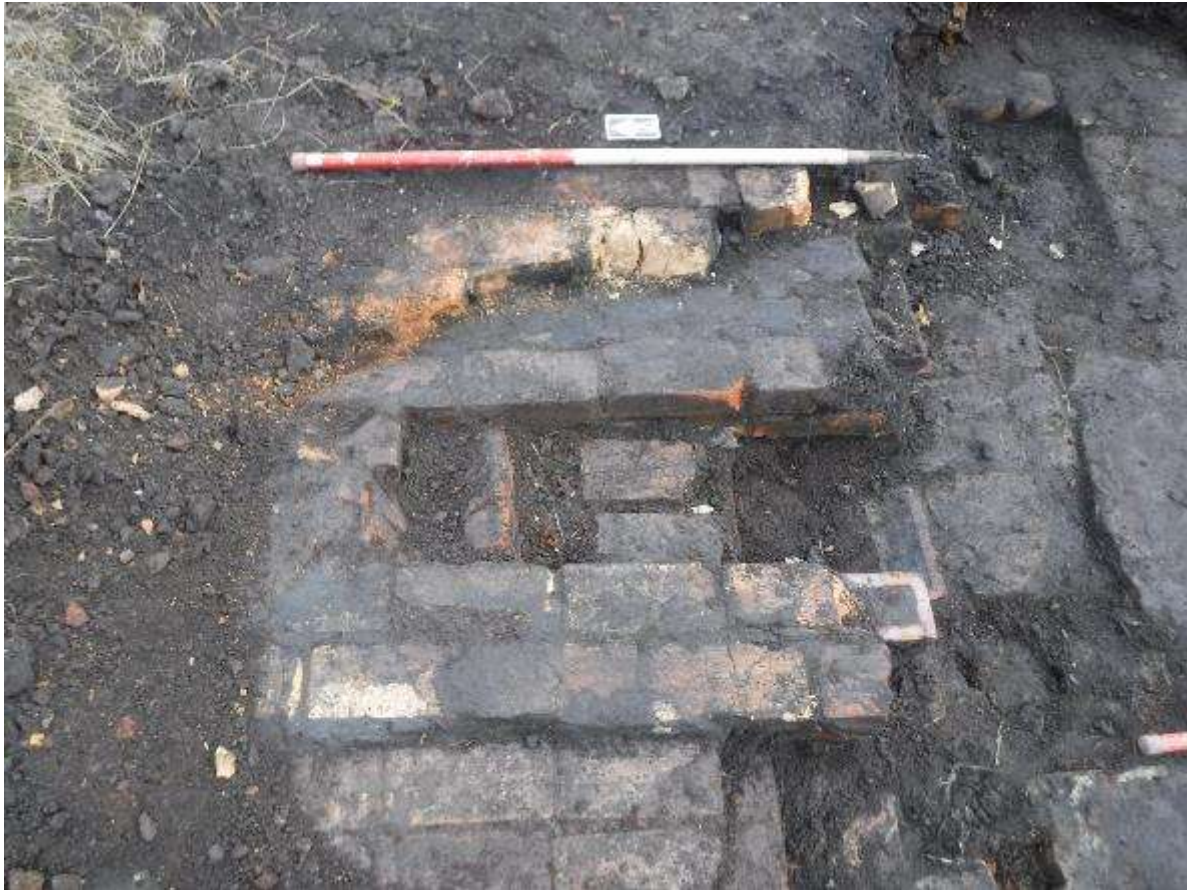
Figure 27: An east-facing photograph showing possible kiln/oven base {3018}. Scale 1x1m in 0.5m graduations.

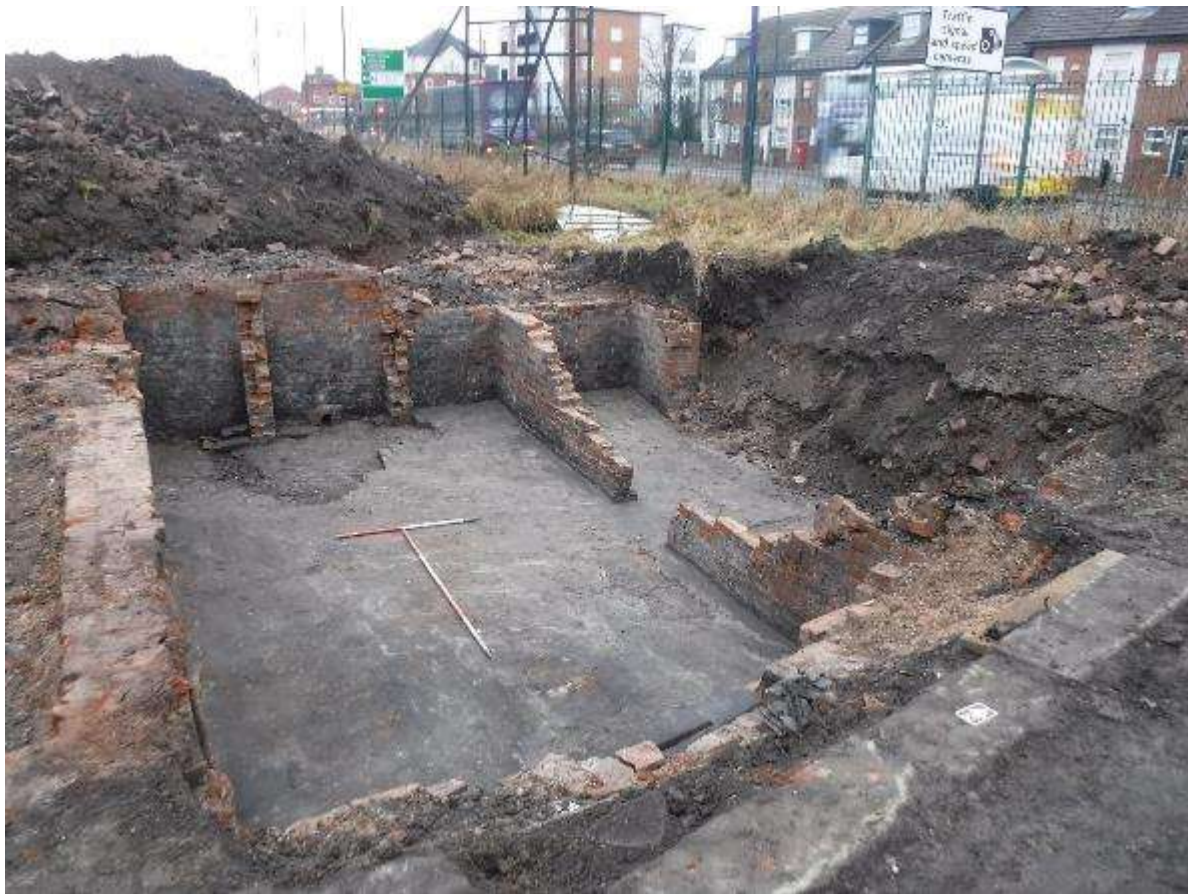
during demolition but the side walls {2012} and {2013} had scarring attesting to its former presence.

Figure 28: A north-west facing photograph showing the cellar in the northern end of SMR Area 2.  
Scale 1x1m and 1x2m in 0.5m graduations.

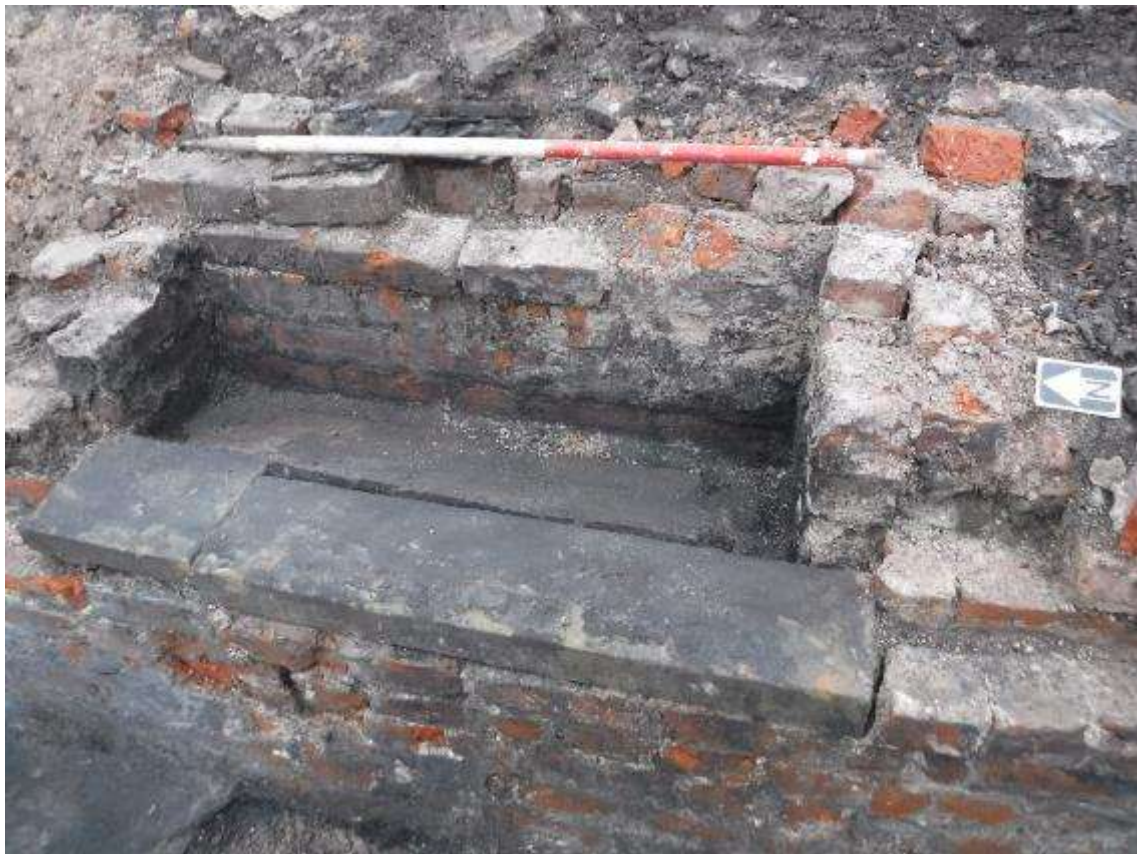
Figure 29: A north-east facing photograph showing cellar light. Scale 1x1m in 0.5m graduations.

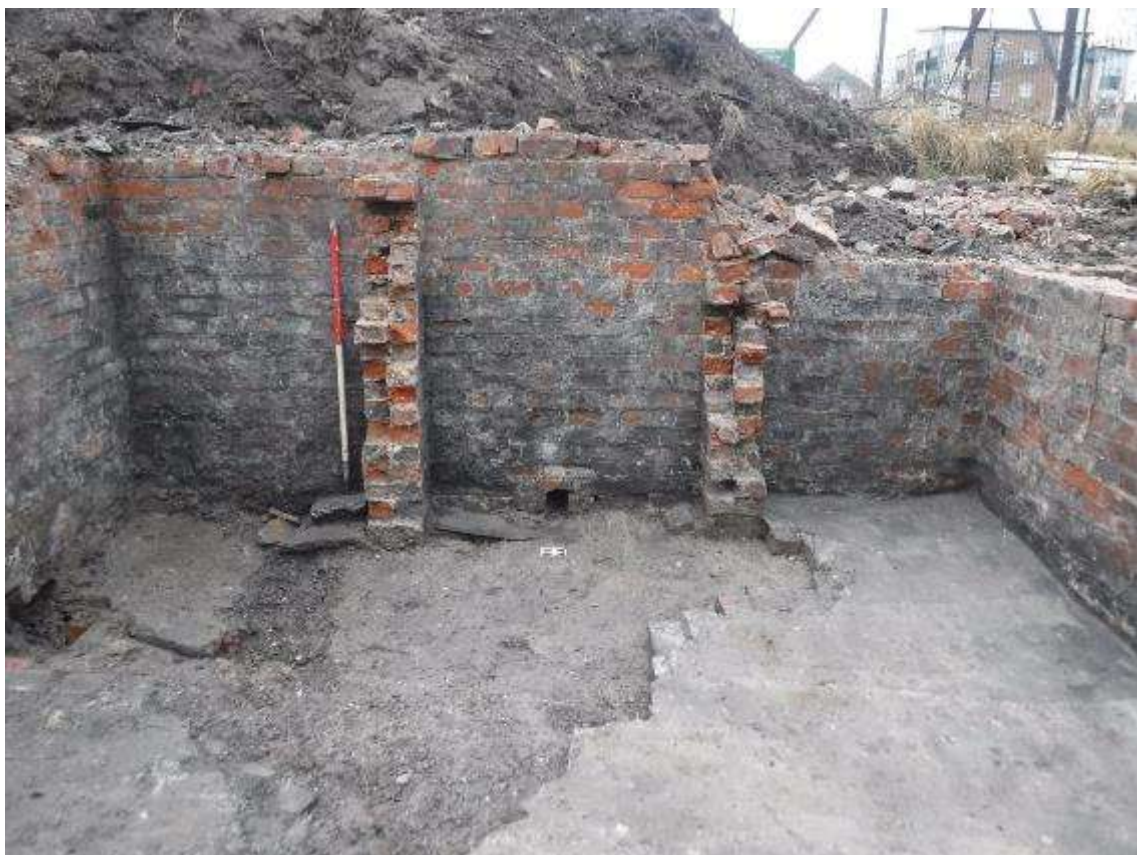
Figure 30: A west-facing photograph showing possible location of range cooker within the cellar. Scale 1x1m in 0.5m graduations.

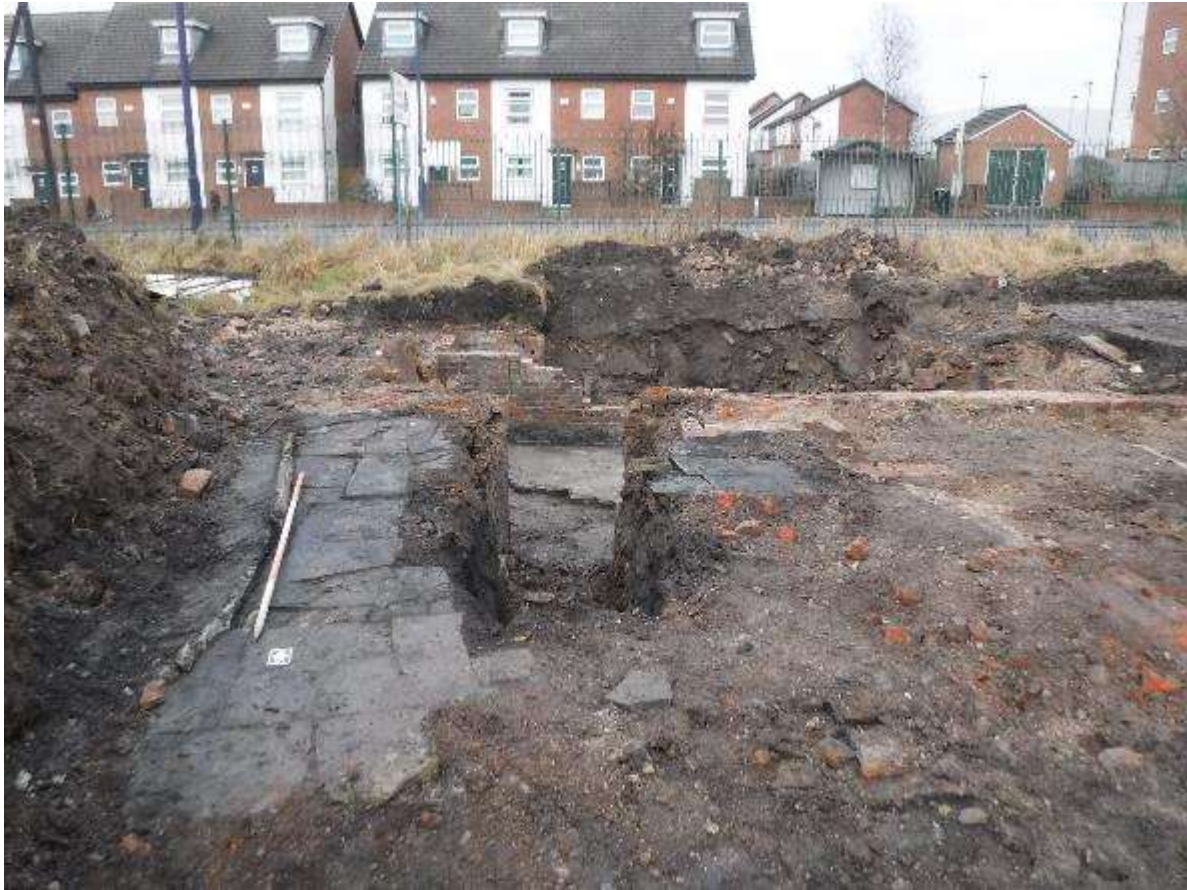
Figure 31: A north-facing photograph showing the external access to the cellar. Scale 1x2m in 0.5m graduations.

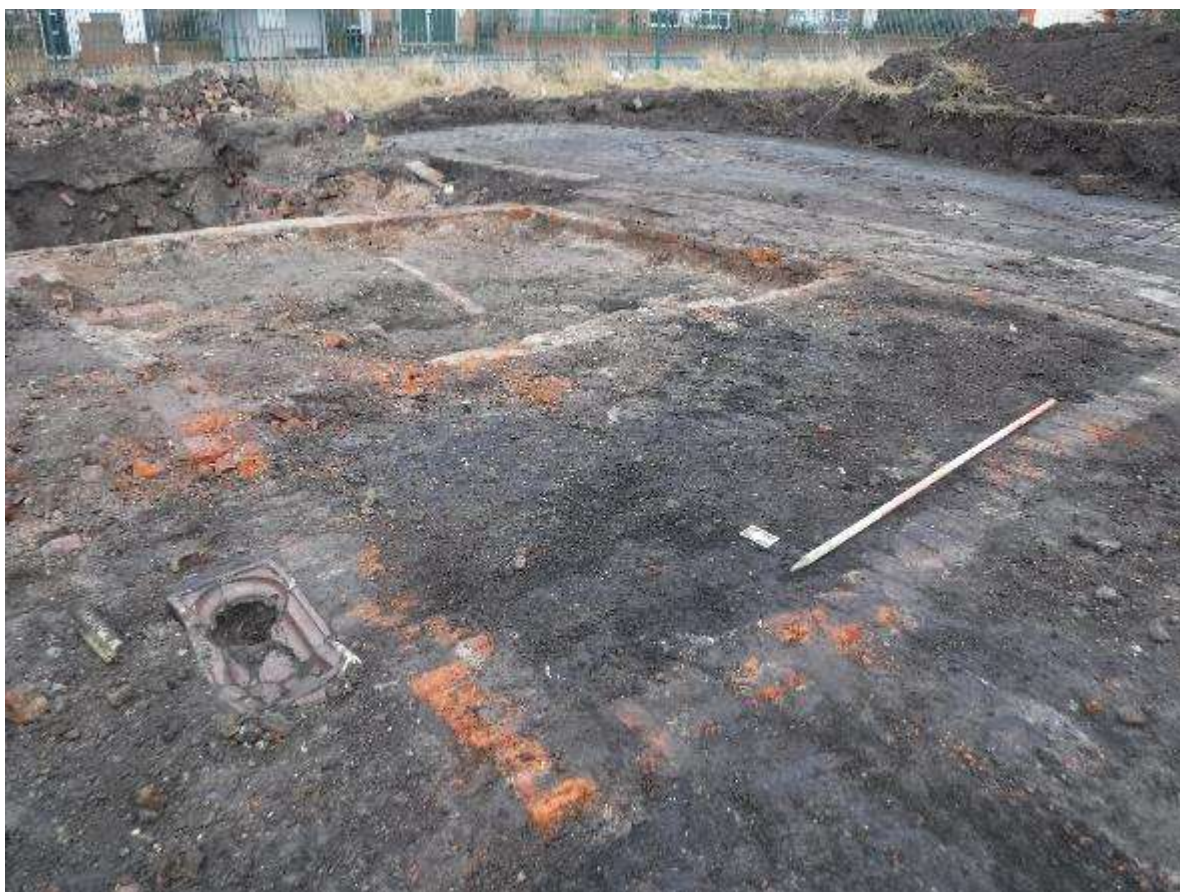
4.4.4 The southern end of this building contained the remains of an above-ground, brick-built, extension, probably added in the later 19<sup>th</sup> century. This extension was sub-divided by internal partitioning walls {2024} and {2025}. However, the orientation of these partitioning walls is slightly different to the rest of the extension and it is possible that these walls may relate to an earlier phase of the building or earlier outbuildings associated with the original house and built over when the extension was built.

Figure 32: A south-east facing photograph showing the above-ground extension. Scale 1x2m in 0.5m graduations.

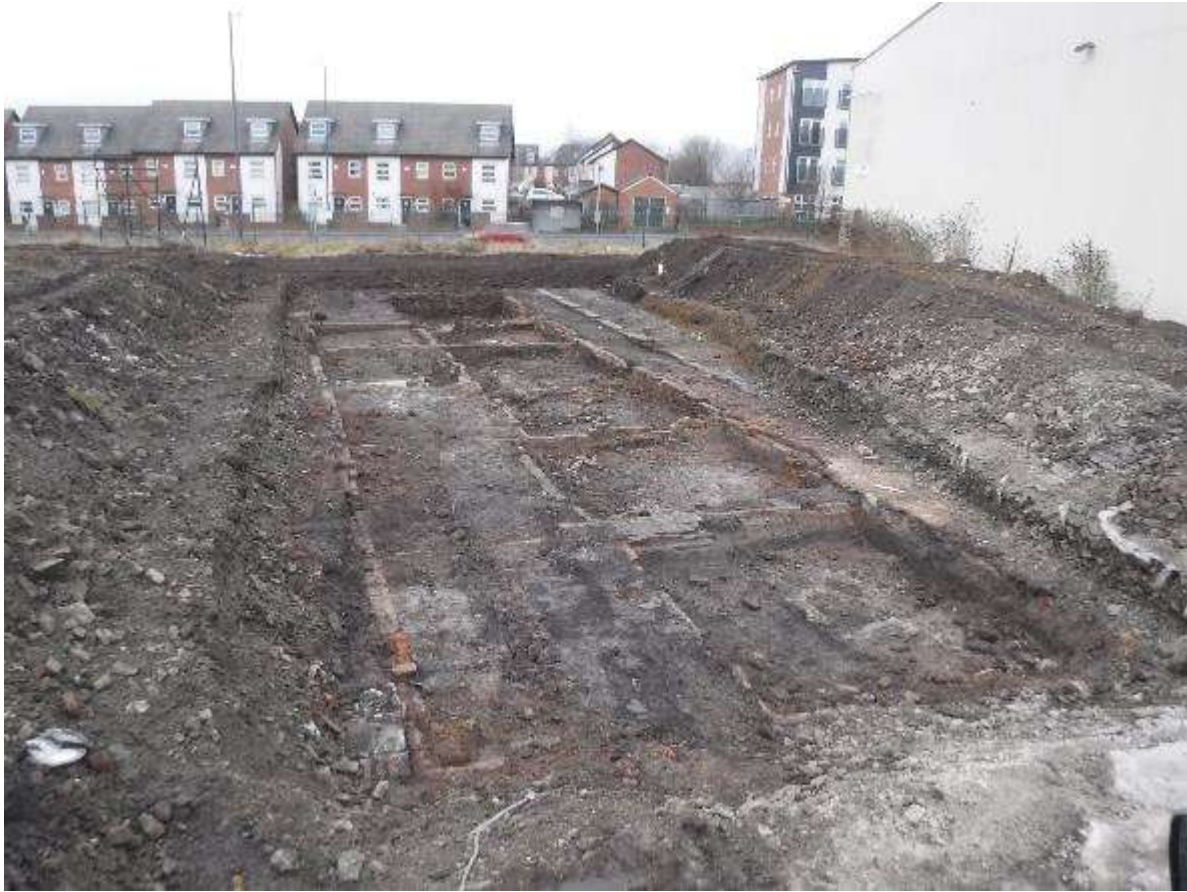
4.4.5 In the southern part of the SMR area were the remains of a row of six through-terrace houses which fronted on to Benjamin Street to the east, each with two rooms. The external walls of the entire block of houses were constructed in a single event from handmade red bricks and lime mortar and were two skins thick. The internal room divisions and party walls were built from the same construction materials and as part of the same construction event however the internal and party walls of the northern two houses were two skins thick whilst the southern four houses all had single skin internal walls. There was no evidence that the houses were built in two separate events so it is possible that this was a decision made during construction to save materials. Both rooms in each house contained fireplaces and it was noted that the fireplaces in the back rooms were wider than those in the front rooms, possibly facilitating a range in the rear room. Due to this, it was interpreted that the back rooms possibly contained the kitchen area for the property and that the front room was a smaller living space for the occupants. There were no internal floors within the houses and it is therefore most likely that any construction materials in a good state of repair were removed for reuse during demolition. The exception was a small portion of the floor of and alleyway separating the southernmost two houses. The small fragment of flooring was in poor condition which probably explains its survival. This alleyway would have provided access to the yard space at the rear of the terrace.

Figure 33: A north-east facing photograph showing the row of terraced houses.

4.4.6 The terraces, although in a poor state of preservation also demonstrated some evidence for later improvements. A salt glazed drain ran the full length of the rear of the terrace, although it had been severely damaged during demolition. This attests to a later 19<sup>th</sup> century provision for sanitation and probably corresponds with the construction of mains sewers throughout Manchester. Probably in the early 20<sup>th</sup> century, lead water pipes and gas pipes were added, being roughly punched through the external house walls from Benjamin Street, and mid 20<sup>th</sup> century electricity cables were also found indicating an eventual addition of electricity after the Second World War.

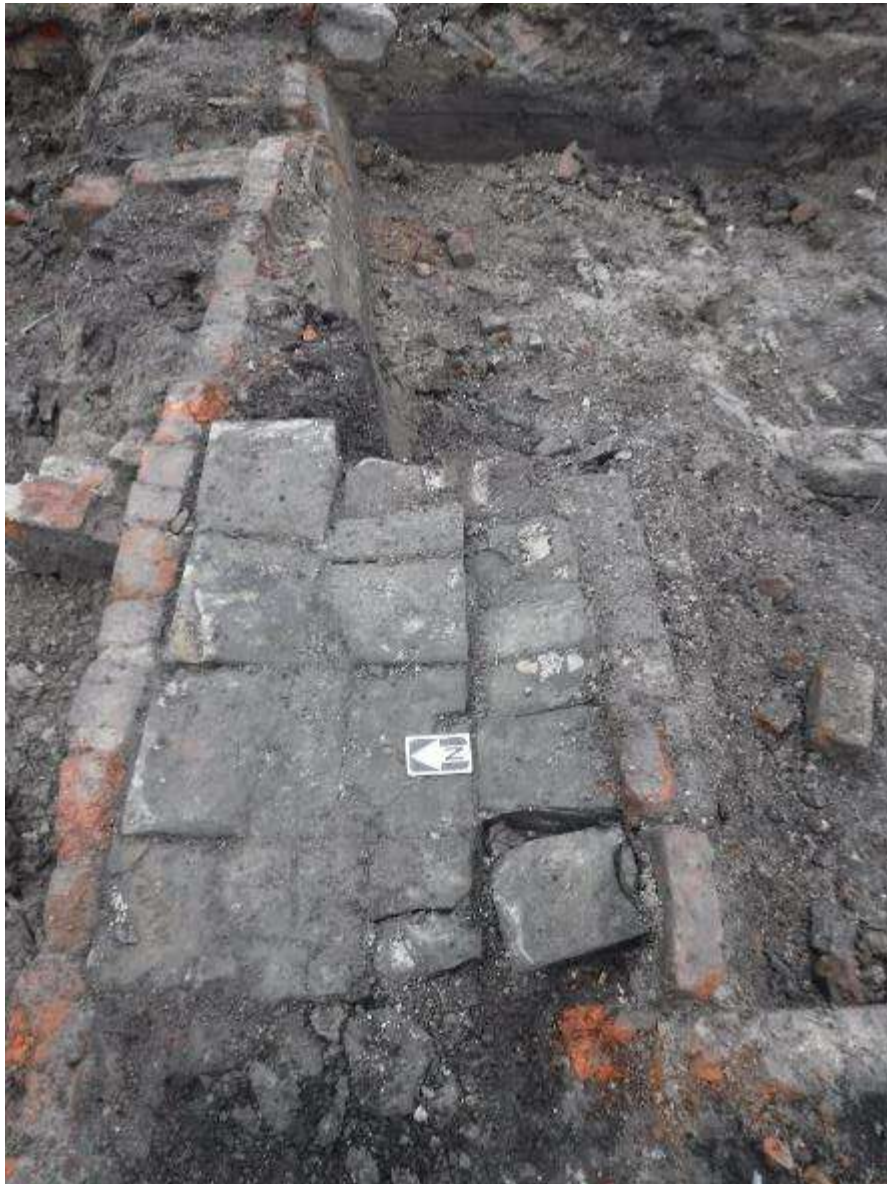
Figure 34: An east-facing photograph showing the alley between two of the terraced houses.

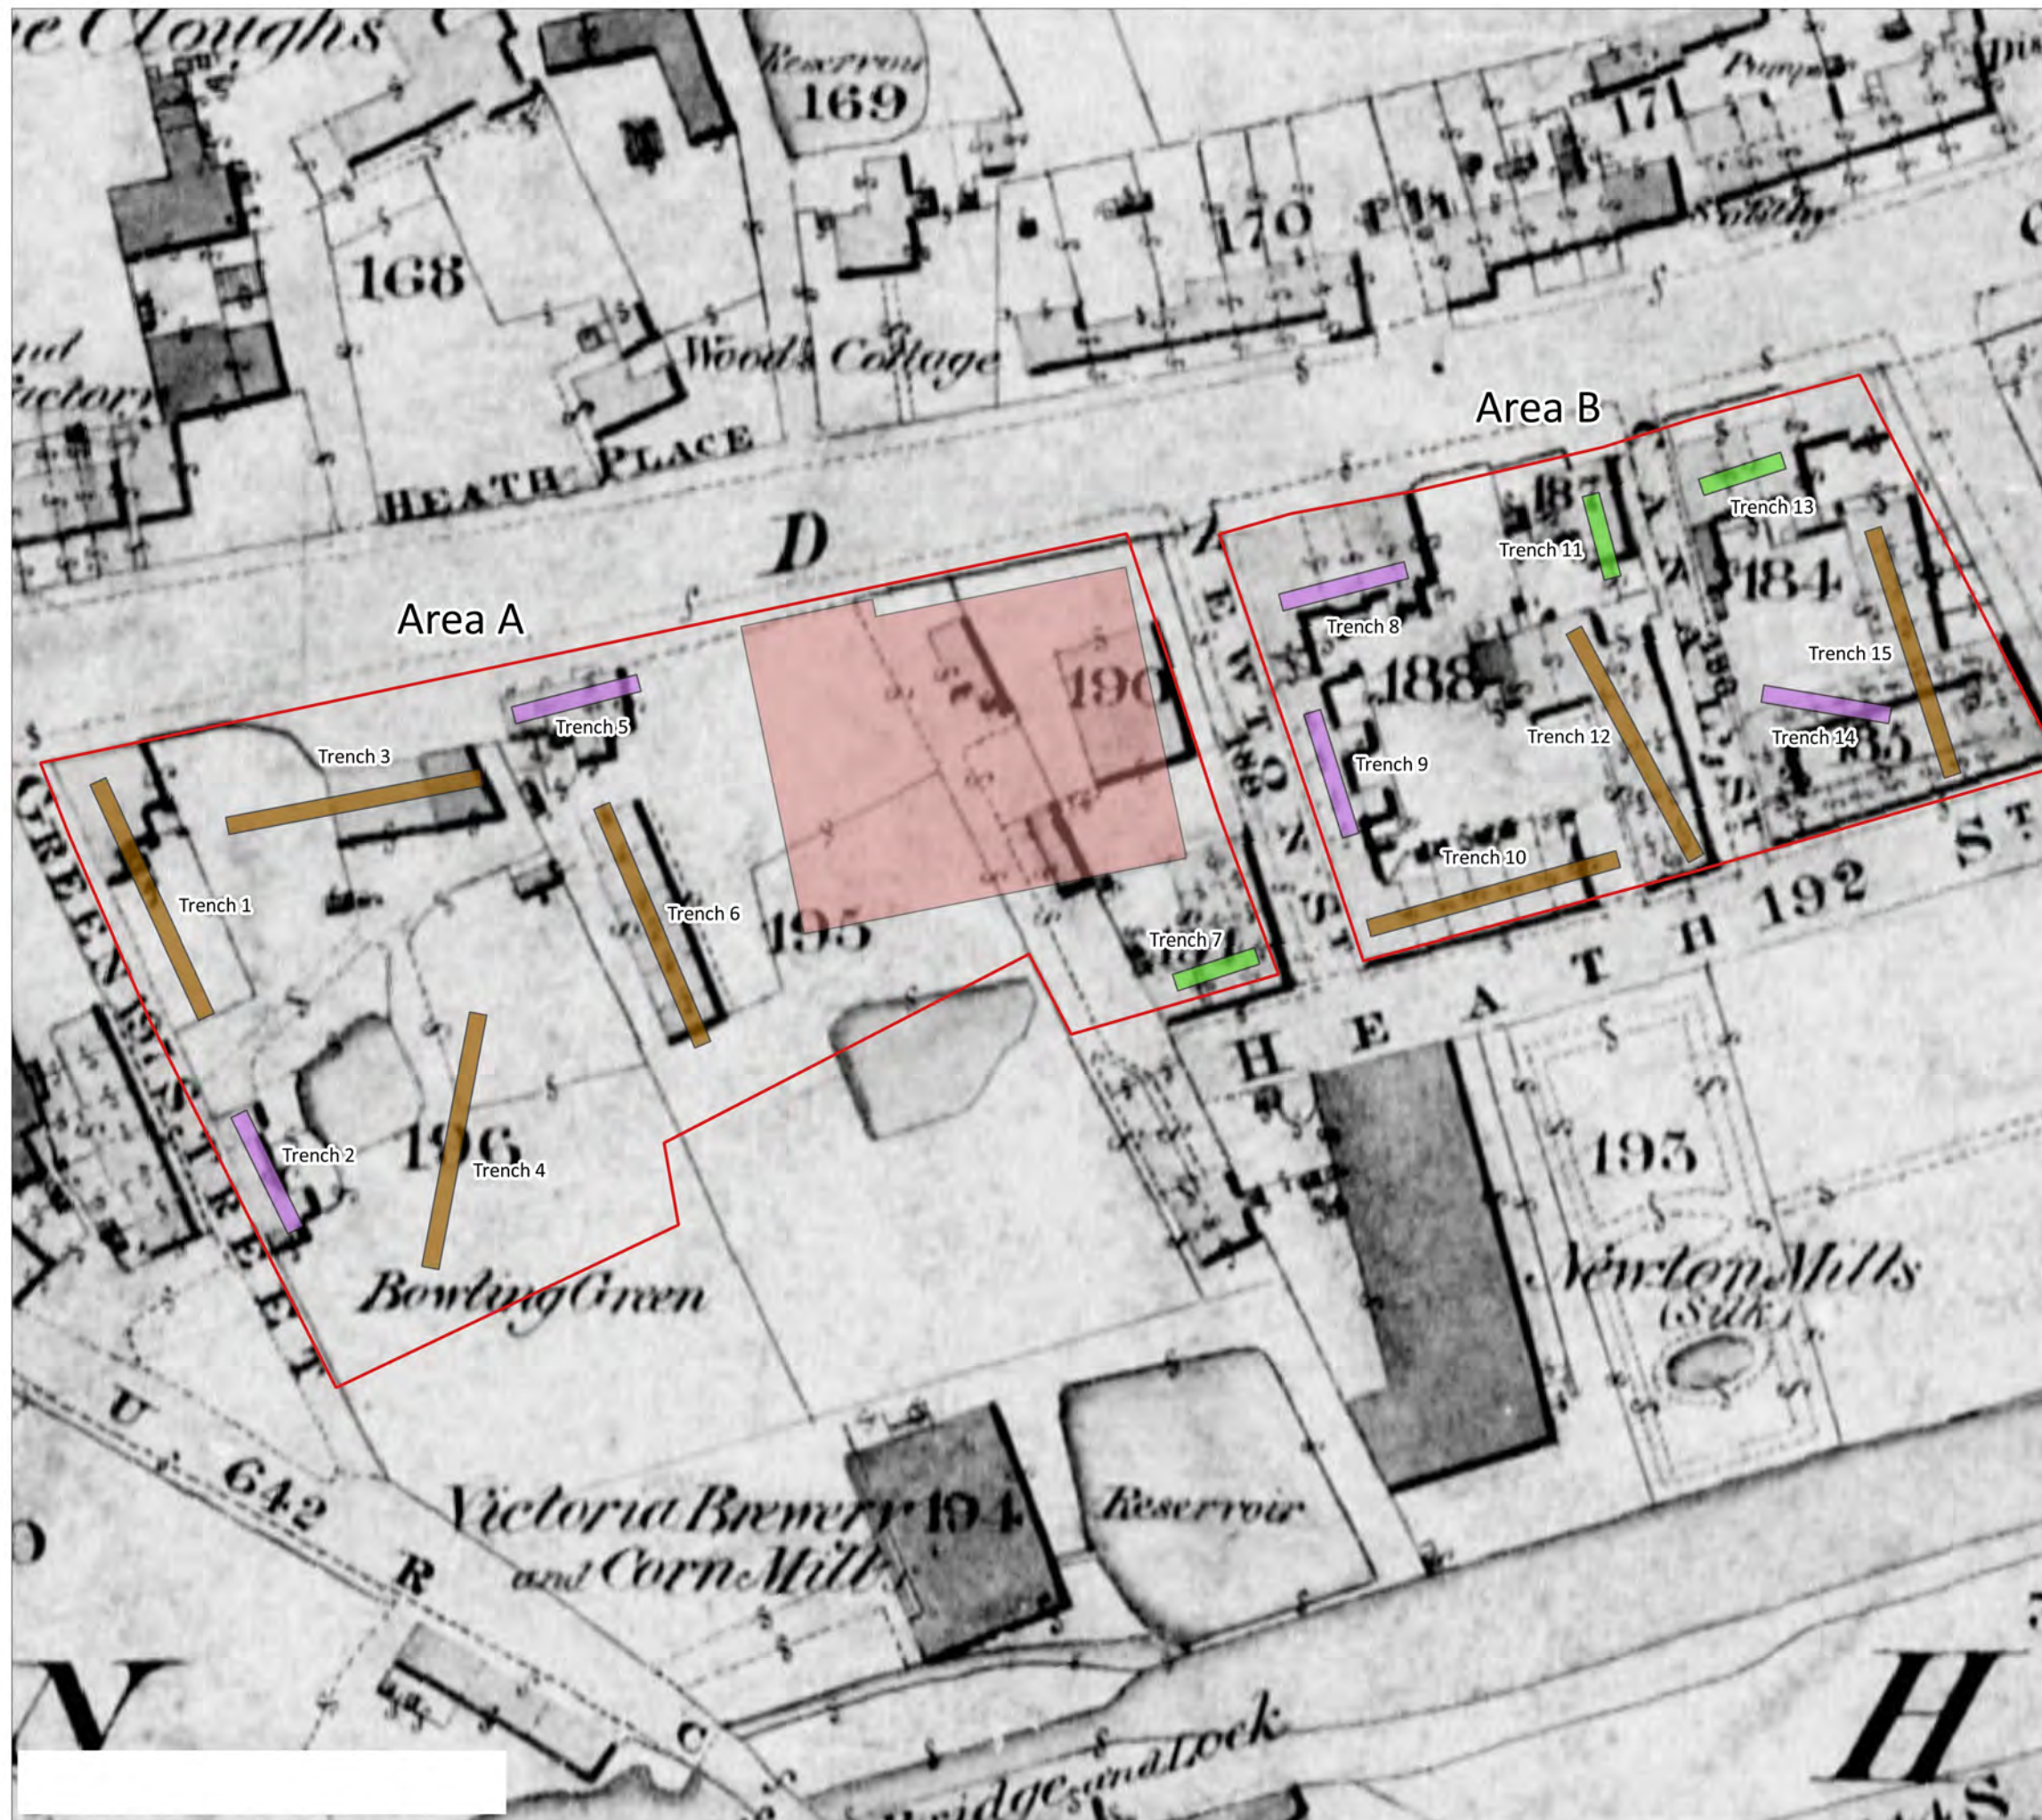
**Figure 3: Trial Trenches overlaying 1845 Tithe Plan**

- Site Boundaries
- Extant Structure
- Trial Trenches
  - 10m x 2m
  - 15m x 2m
  - 30m x 2m

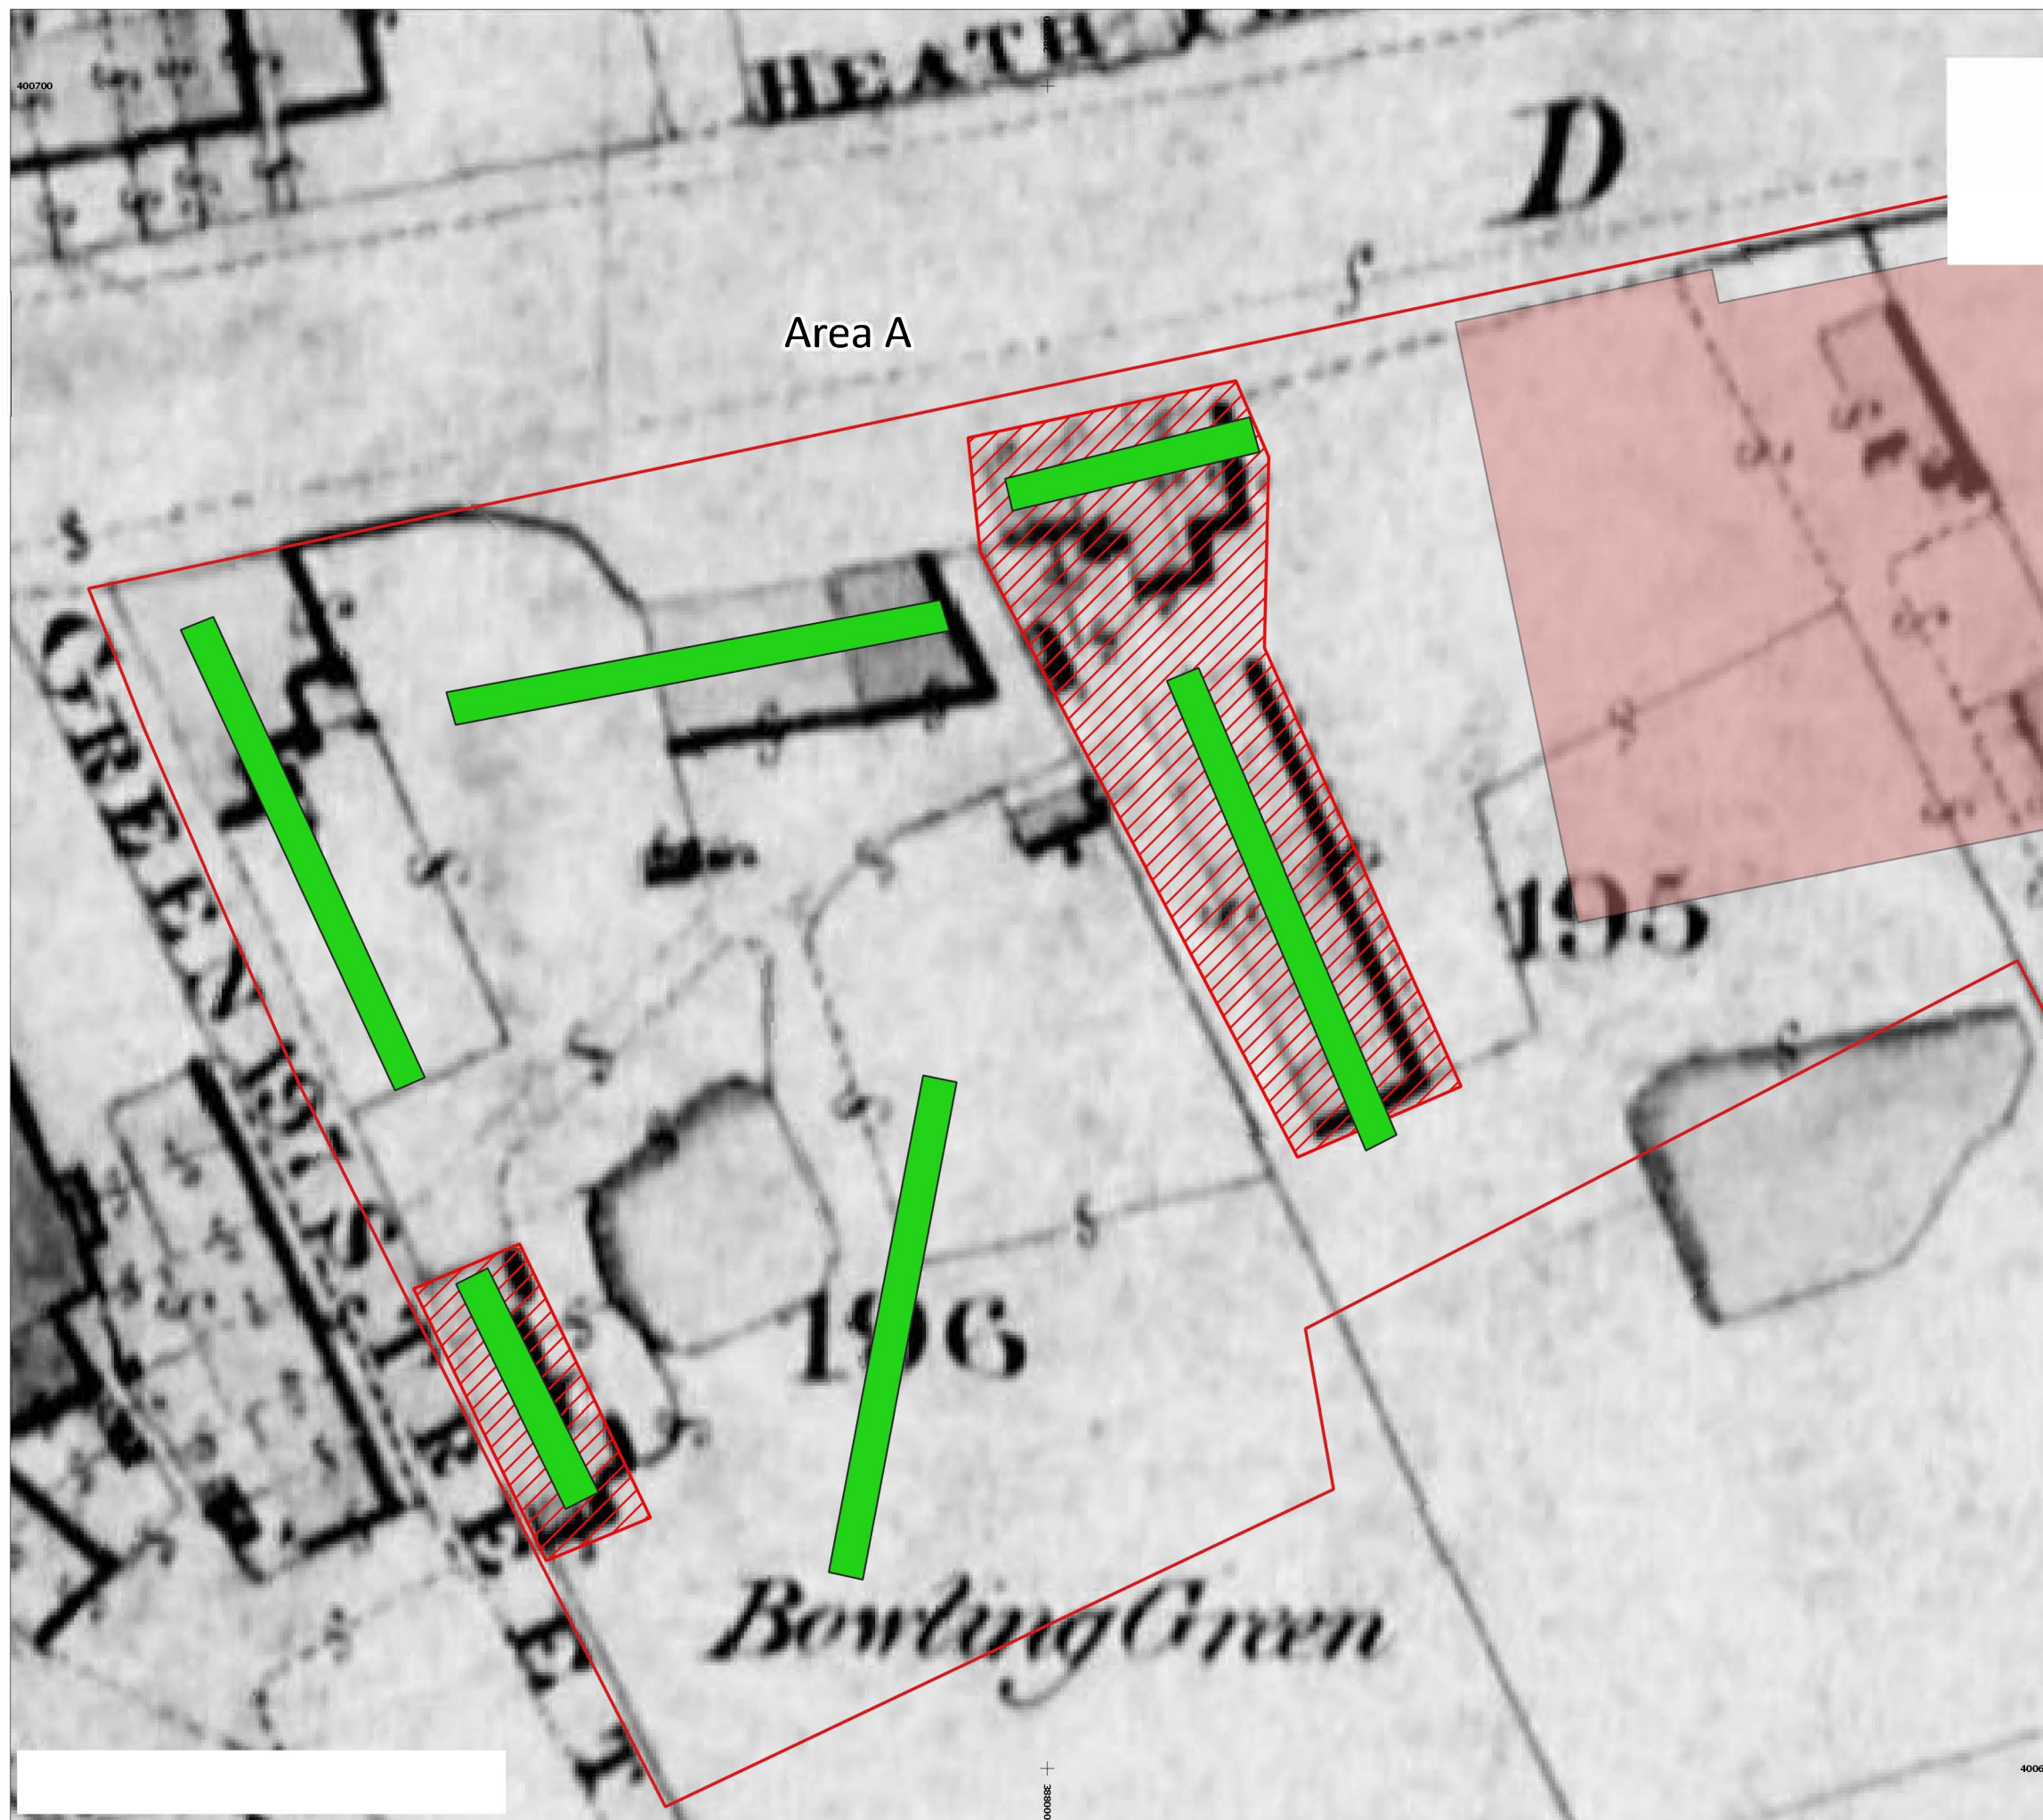
Figure 1: Site Plan with SMS Areas

- Site Boundaries
- Trenches
- SMS Area

1.5 Excavation of the area around trench 2, trench 5 and Trench 6 (figure 1) are of “particular interest and merit further investigation” (Miller *pers coms*, 2022). Due to the shallow depth to foundations in these areas, the archaeology present will be lost during the site development and construction phase. Previous fieldwork methodology regarding recording, sampling, post-excavation, and archiving as outlined in the original WSI (Archaeological Research Services 2021) will be adhered to during this additional phase of works.
