# **Mather & Platt Foundry Site: Land at Grimshaw Lane, Newton Heath, Manchester**

## **Archaeological Evaluation Report**

**March 2022**

**Client: Canmoor Projects**

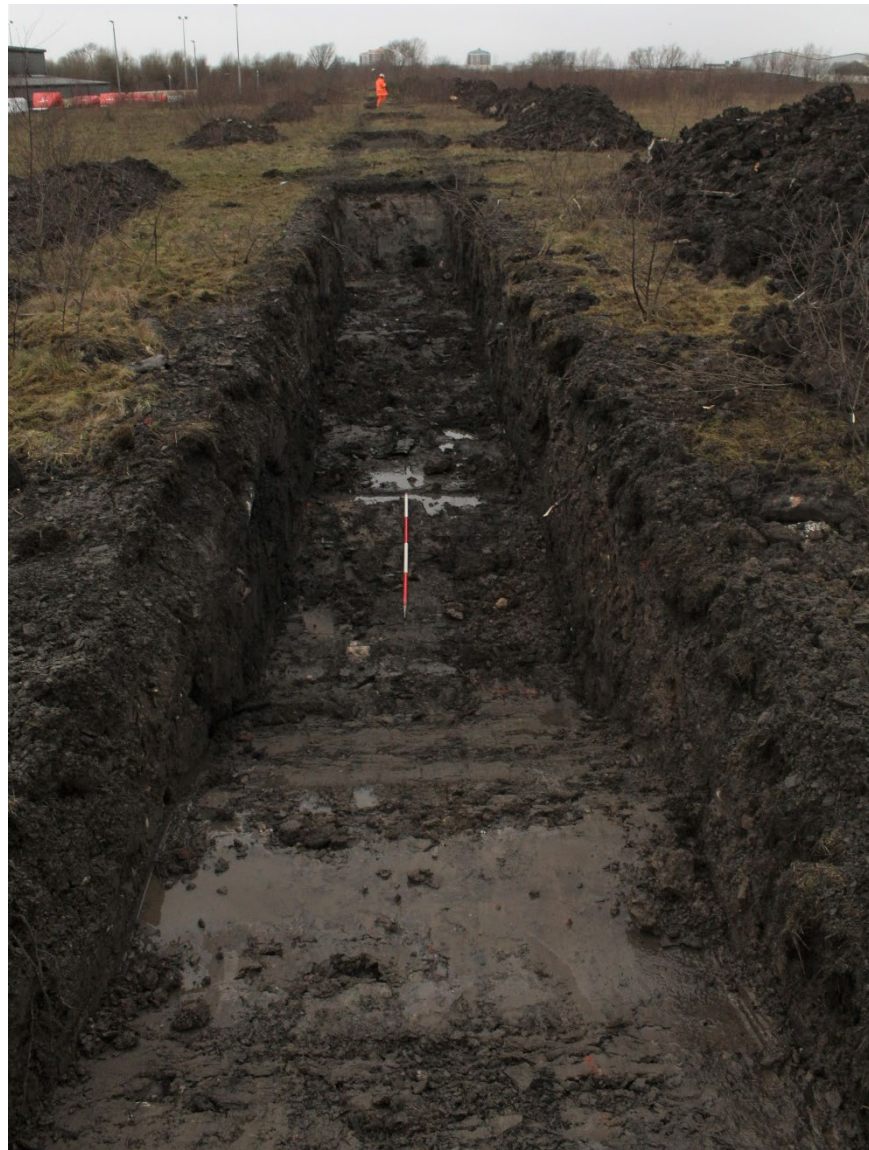
*Plate 1: Trench 2, general shot looking West*

- 3.4.1 Trench 2 was the easternmost trench excavated and targeted the remains of 'Block A' of the Mather & Platt works (as seen on architects plans c 1901, Fig 5). Measuring 100m x 2m it was aligned north-west/south-east. Due to the presence of services this trench was excavated in five separate sections. The average depth reached throughout

the trench was 1.2m below ground level (bgl), with sondages excavated periodically to a maximum depth of 2m (Plate 1).

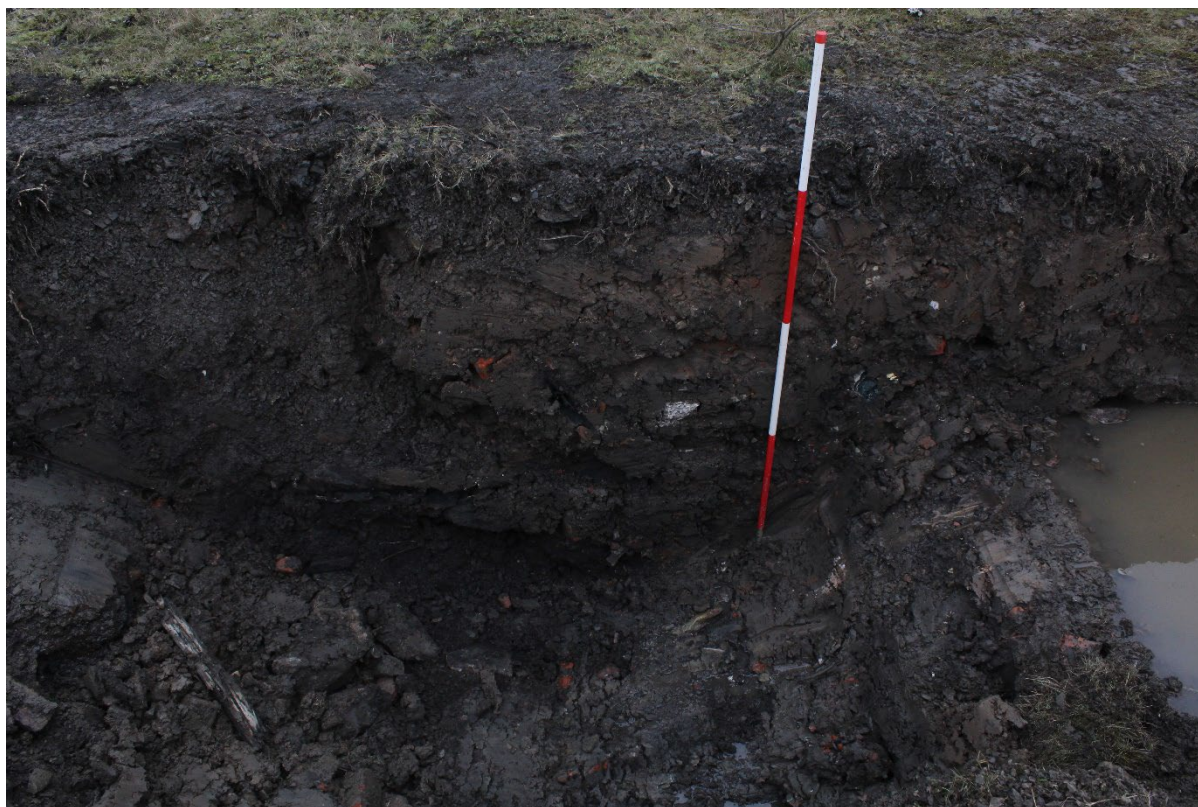
*Plate 2: Trench 2, section of machine sondage*

- 3.4.2 Within each excavated section of the trench, a thin grass/topsoil layer was removed to reveal deposit **200**, a mid-brown/grey shale levelling deposit up to 0.30m thick. This deposit overlay a mid-yellow/brown clay (**201**), that contained frequent demolition material and other modern rubbish. This material formed the bulk of the observed deposits within the trench and measured approximately 1.5m thick. Where sondages were excavated, another deposit (**202**) was recorded, this material was largely the same composition as deposit **201**, but darker in hue due to hydrocarbon contaminates. Due to issues of contamination, depth, and edge stability, no excavation was able to progress beyond this made ground deposit, and an average depth of 2m bgl in the machine sondages. Within this excavated horizon no archaeology was observed (Plate 2).

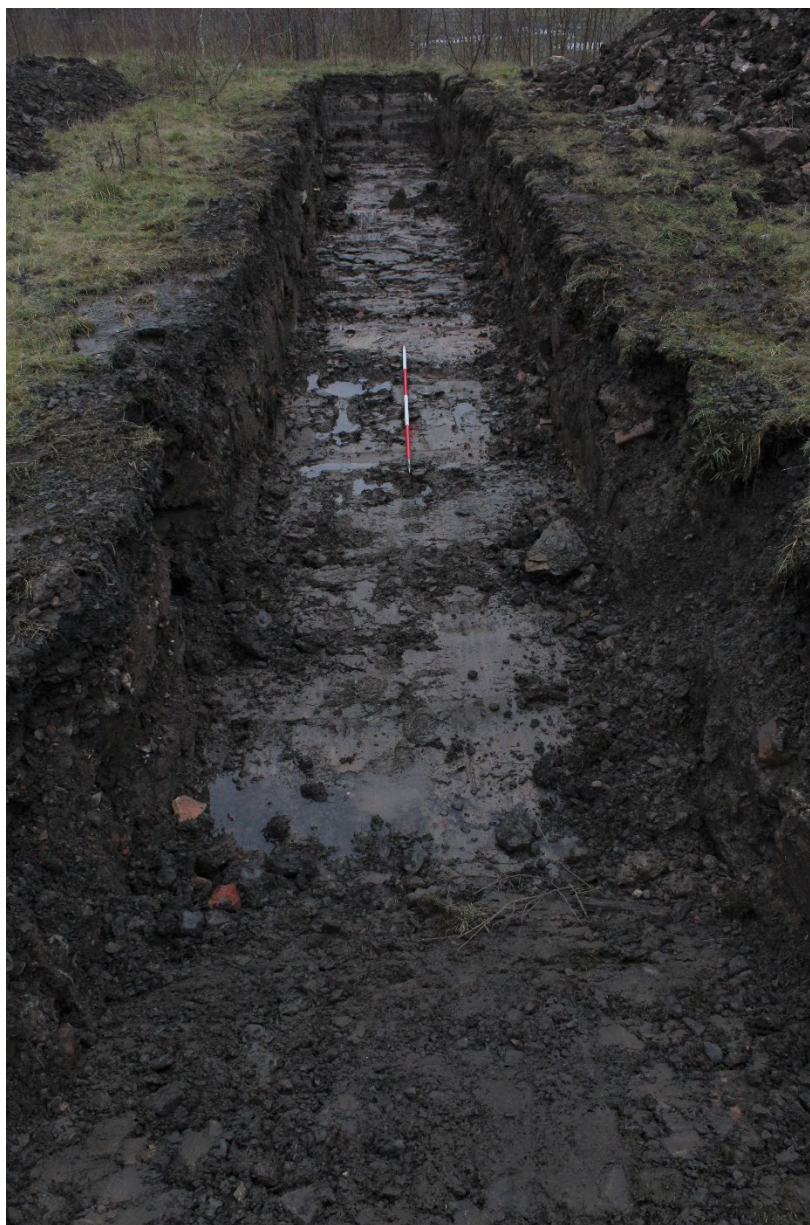
*Plate 3: Trench 4, general shot looking West*

3.5.1 Trench 4 was located to the west of Trench 2 and followed the same north-west/south-east alignment and the same intended measurements (100m x 2m). This trench was targeted on 'Block C' of the Mather & Platt works, thought to be the location of the engine and boiler house (architects plans, c 1901). Again, service exclusion zones were implemented, dividing the eastern part of the trench into three separate sections. The large steel fence and associated acoustic spoil bund that divided the PDA also bisected the trench on a north/south alignment, west of its centre. This further reduced the available area of the trench for excavation, with a smaller section, further impacted by other service lines and exclusion zones, located in the western half of the site (Fig 2).

- 3.5.2 Similar stratigraphy to Trench 2 was observed within Trench 4 (Plate 3), with the same shale levelling deposit (**400**) observed overlying redeposited clay/demolition rubble (**401**). Again, machine sondages excavated within various parts of the excavated trench sections, revealed the same underlying darker made ground deposit (**401**) extending to depth. The sondages achieved a maximum depth of 2m bgl, with an average trench depth of 1.2m elsewhere, in which no archaeology was observed (Plate 4).

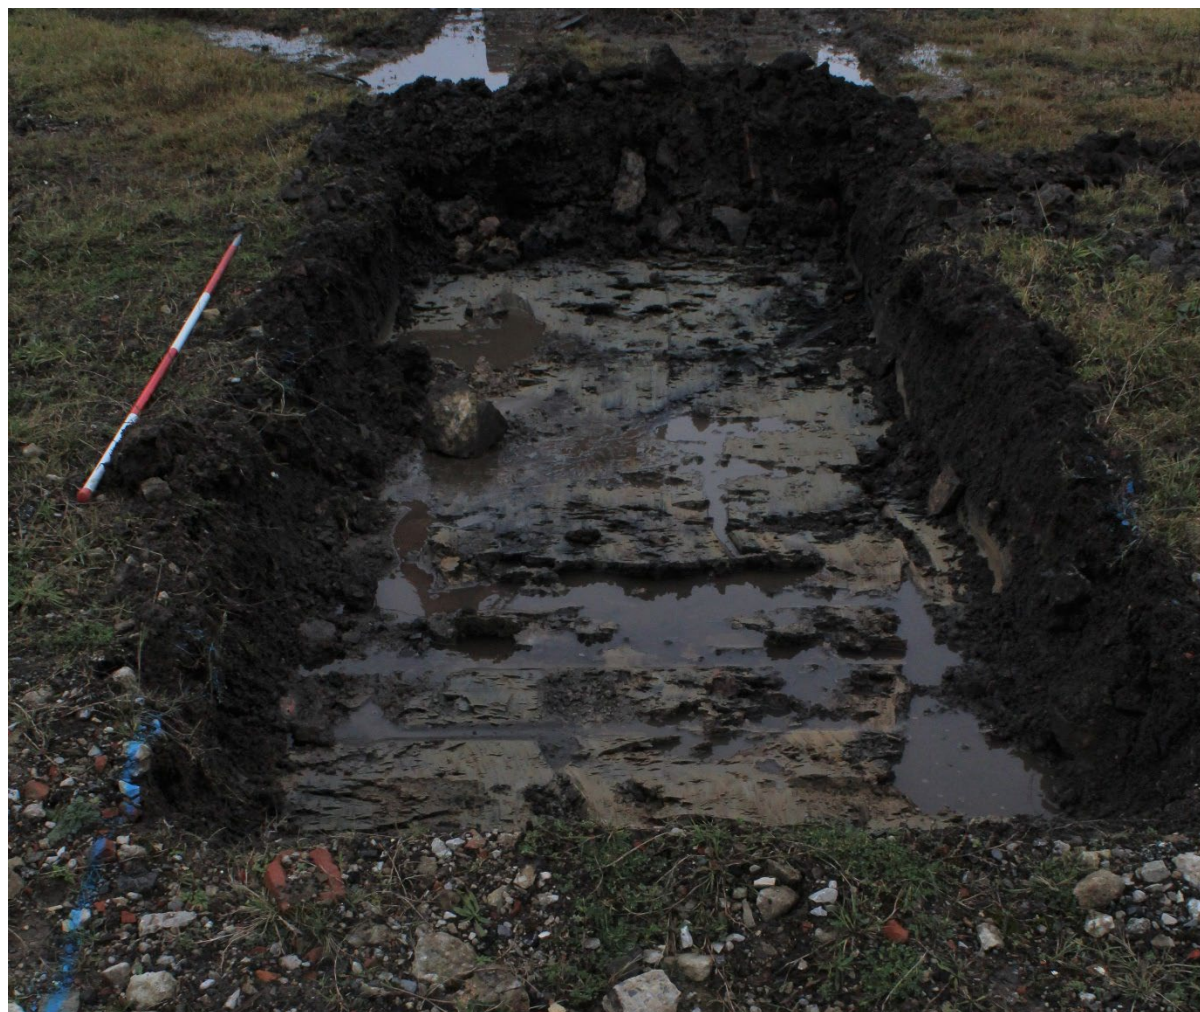
*Plate 5: Trench 4, cast-iron pipe*

- 3.5.3 The westernmost end of Trench 4 differed slightly to the above as it lay within the area of lower lying ground in the western half of the PDA (west of the steel fence). While the same made ground deposit (**401**) was observed, this part of the site did not have the shale levelling deposit observed in trench sections in the eastern half of the PDA. This end of the trench was again restricted by the presence of service exclusion zones resulting in a length of 2m being the only available area in which ground could safely be broken. Excavation of this section was halted at 0.40m due to the presence of a large cast-iron pipe crossing the area. Due to the possibility this was also a live service (use of the Cable Avoidance Tool determined it carried a signal) excavation was ended on safety grounds (Plate 5).

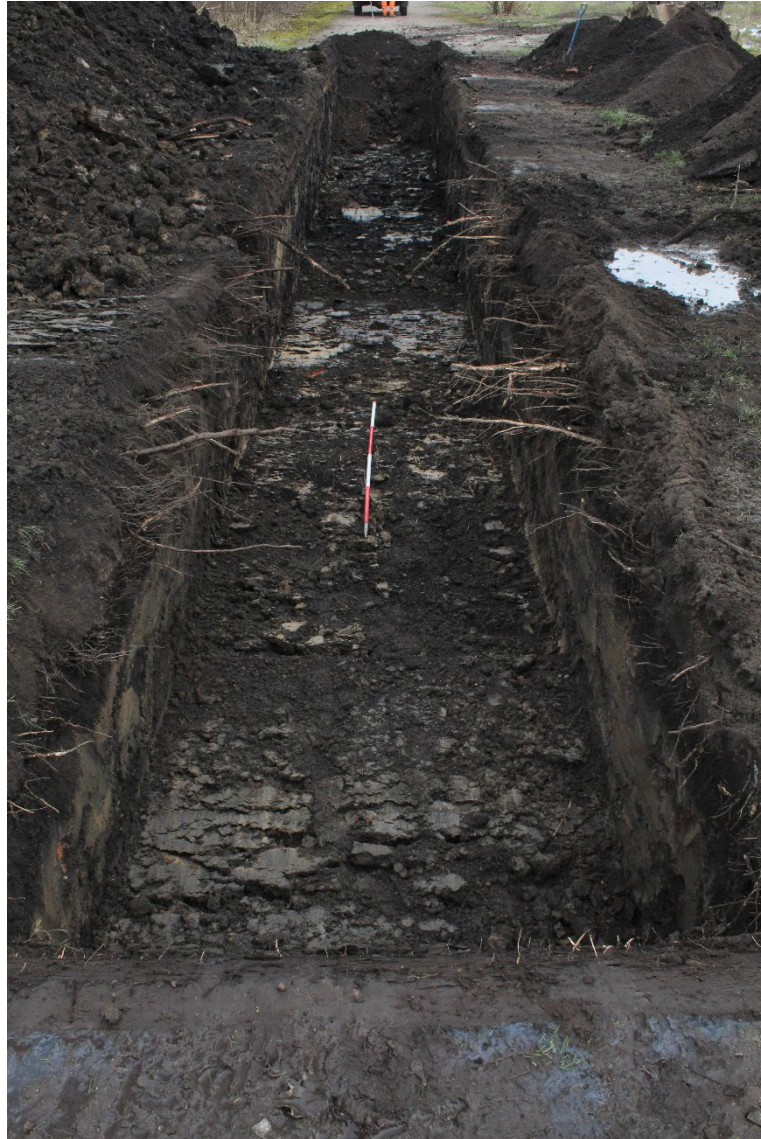
*Plate 6: Trench 3, general shot looking North*

3.6.1 Trench 3 was situated to the west of the trenches 2 and 4 and targeted the location of a putative brickyard identified on historic mapping (Fig 5). Measuring 20m x 2m and aligned north/south, the trench had to be moved 3m east of its original location due to the presence of mature trees, fencing, and a manhole, indicating the presence of a drain. This trench lay across a sports field and the path accessing it and therefore was capped by different deposits to those observed elsewhere on site (Plate 6). This comprised a sequence of topsoil (**300**) with a tarmac surface (**303**) and bedding gravel (**304**) to the north and beyond the limit of the sports field, correlating with an access track in this location. These deposits overlay a clinker leveling layer (**301**) up to 0.10m thick. Beneath the clinker was a similar redeposited clay layer (**302**) to that observed elsewhere across the site. Deposit **302** comprised a mixed deposit of yellow/brown clay containing occasional demolition debris and clinker and formed the bulk of the deposit within the trench. Excavation of a machine sondage identified that this deposit continued to a depth of 2m bgl and beyond. The average trench depth was 1.2m and no archaeology was observed (Plate 7).
