# CONTRACTOR MANAGEMENT PLAN

| Company Name & Post Code Address: | W. Maher and Sons Ltd. |
| Package Name | St Johns Bulk Earthworks |
| Project Address | Water Street , Manchester |

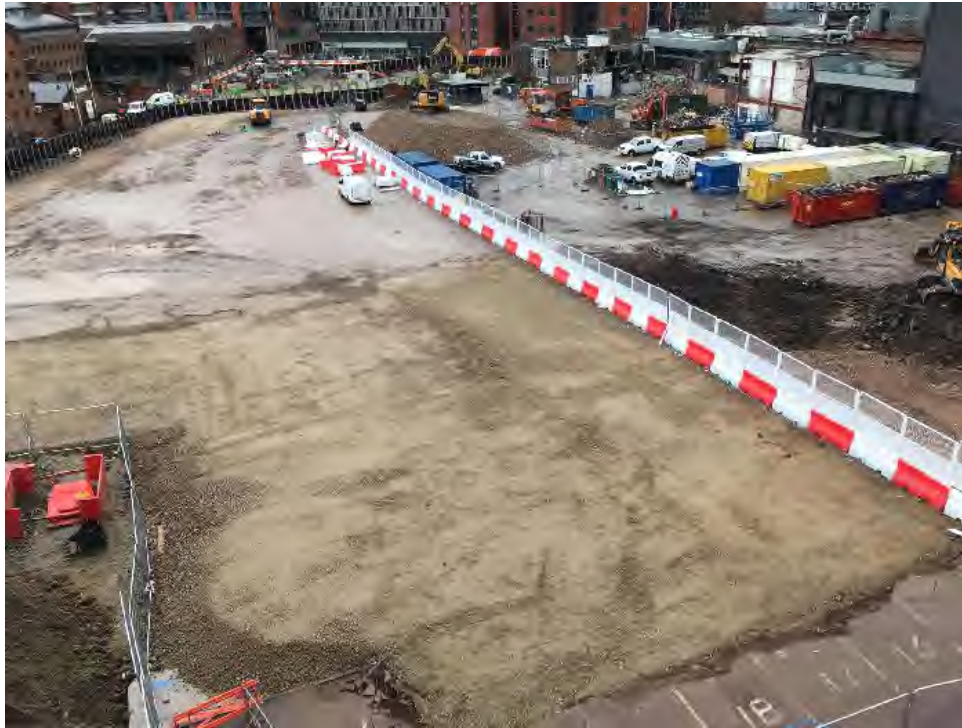
Photograph 1. Display of the current site border between divided site

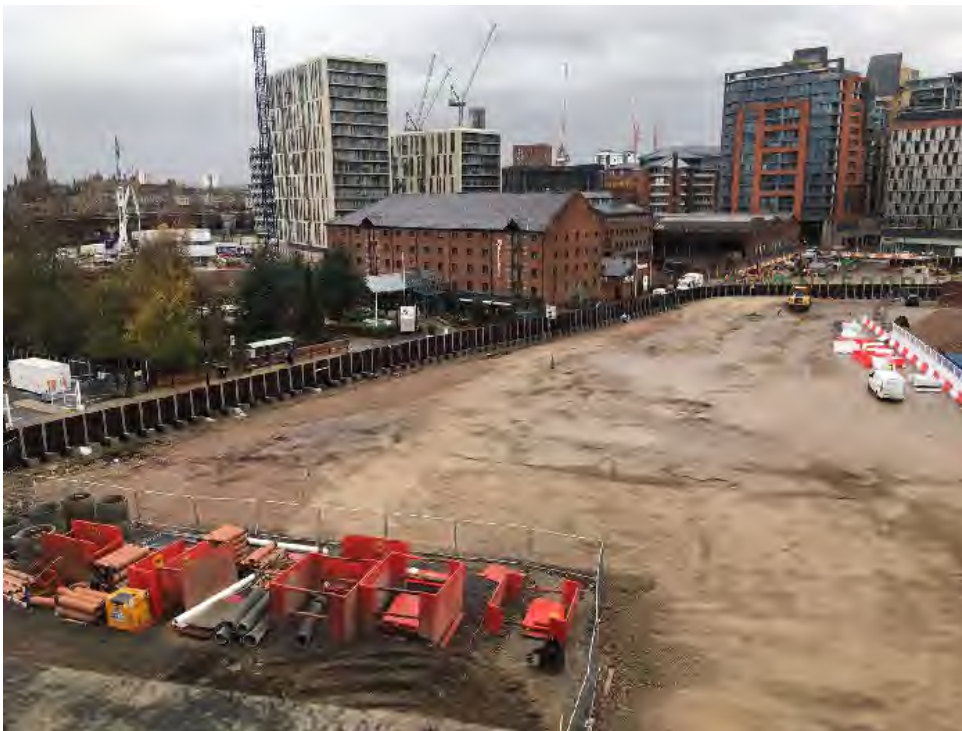
Photograph 2. Extents of piling mat

It should be noted that the maximum excavation depth of the guide wall installation is ~600mm and the clean piling mat is only 300mm in some locations. However, pile probing has been undertaken to an average depth of 2.4m to ensure no Made Ground nor obstructions are present below the pile locations.
