## **BAT SCOPING SURVEY**

**St. John Vianney Presbytery**  
Poynter Street  
Manchester  
M40 0DH

**NGR: SD 88385 02288**

| UES reference: | UES03659/01 |

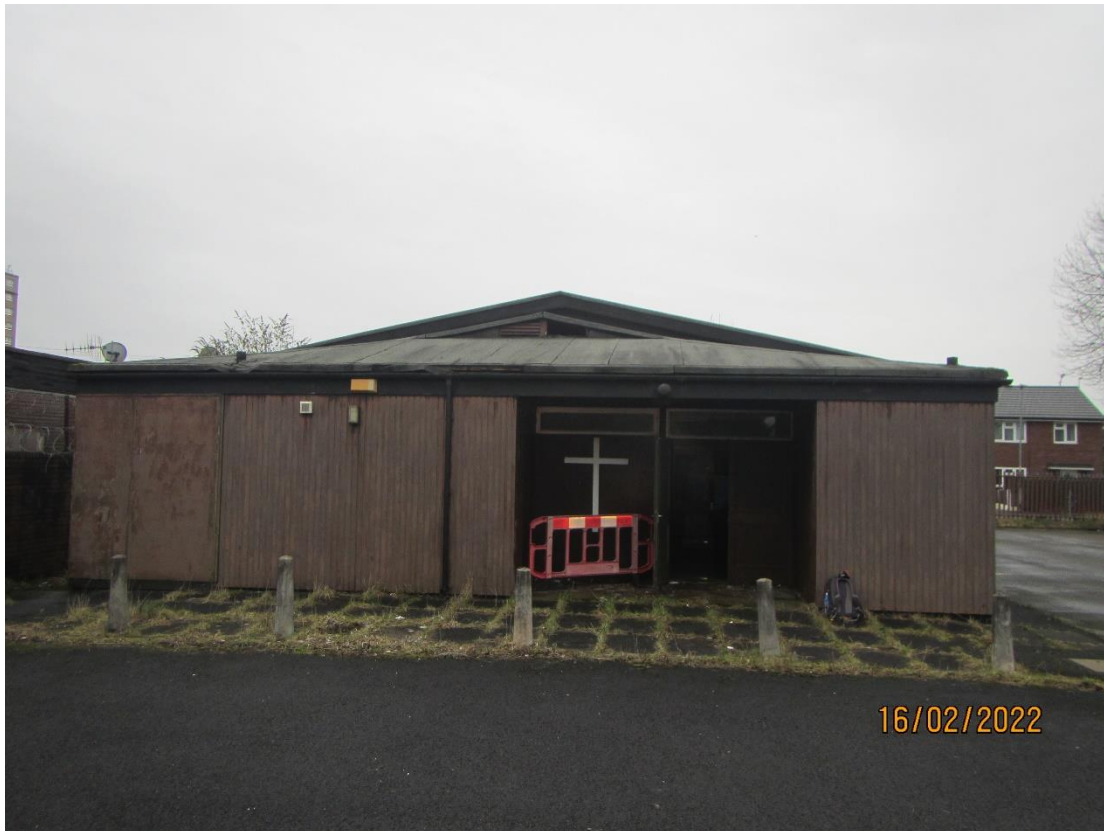
Photograph 1 – The north-eastern aspect of St. John Vianney Presbytery, with pitched roof and hipped extension clad with bitumen roof membrane and various timber features

St. John Vianney Presbytery is a disused, single-storey, detached building, with a pitched roof and hipped roof extension to the north-east (see Appendix 3 – Photographs, Photograph 1).

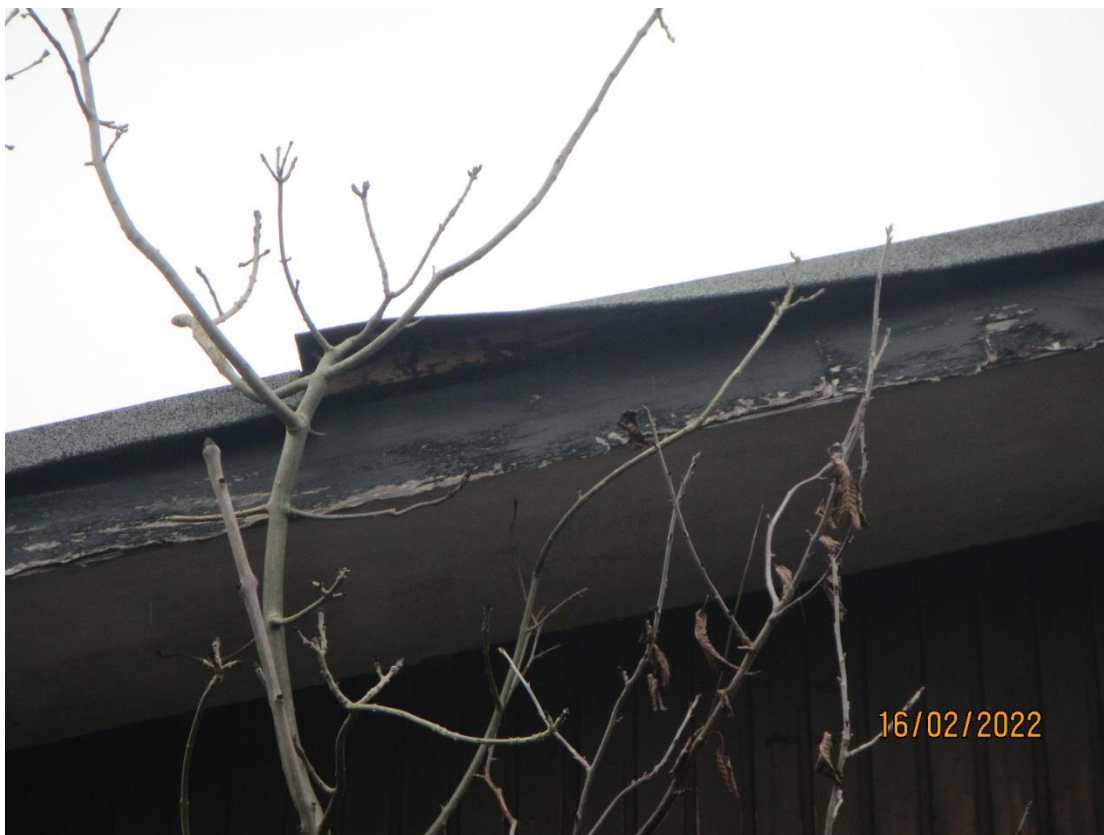
Photograph 2 – The south-western aspect where a section of the bitumen roofing felt has raised from the pitched roof. Access under the felt is impeded by the raised timber batten.

The building's large, pitched roof lacks roof tiles and is clad with a bitumen roofing membrane. The membrane is generally tightly sealed to the underlying timber structure although a small section of the membrane has lifted away at the south-western aspect (Photograph 2). This feature has been deemed unsuitable for use by bats due to the presence of the raised batten, which is intact and prohibits access for bats. Four skylights are integrated into the pitch of the roof. These skylights were found to be tightly sealed to the roof with bitumen roof felt after full inspection with binoculars and high-powered torch (Photograph 3). Timber barge boards are present at the gable ends of the building, tightly sealed to the wall. Boxed soffits at the eaves are all intact and tightly-sealed except for at the north-western aspect where access into the soffit is provided by mossing panels (Photograph 4). This area of the building is cluttered by ash and butterfly bush, which will obscure the entrance in the summer months. Furthermore, the internal feature is considered to be largely unsuitable for bats due to the large and open nature of the interior of the boxed soffit. No access is provided from the boxed soffit under the pitched roof, which is tightly sealed against the wall plate. The building is clad with timber panels on all aspects which is in good condition and presents no roosting opportunities for bats. Several windows in rotting timber frames are present on the north-western and south-eastern aspects, each of the windows is tightly sealed to the wooden box soffits and timber clad. Furthermore, two fire exits are present at the southern end of the north-western aspect, each of which is in good condition and lacks any roost any PRFs (Photograph 5). There are dense growths of young trees ash trees and butterfly bush at the south-eastern and south-western aspects. A historical blackbird nest was recorded within one of the ash trees at the south-western aspect (Photograph 14).

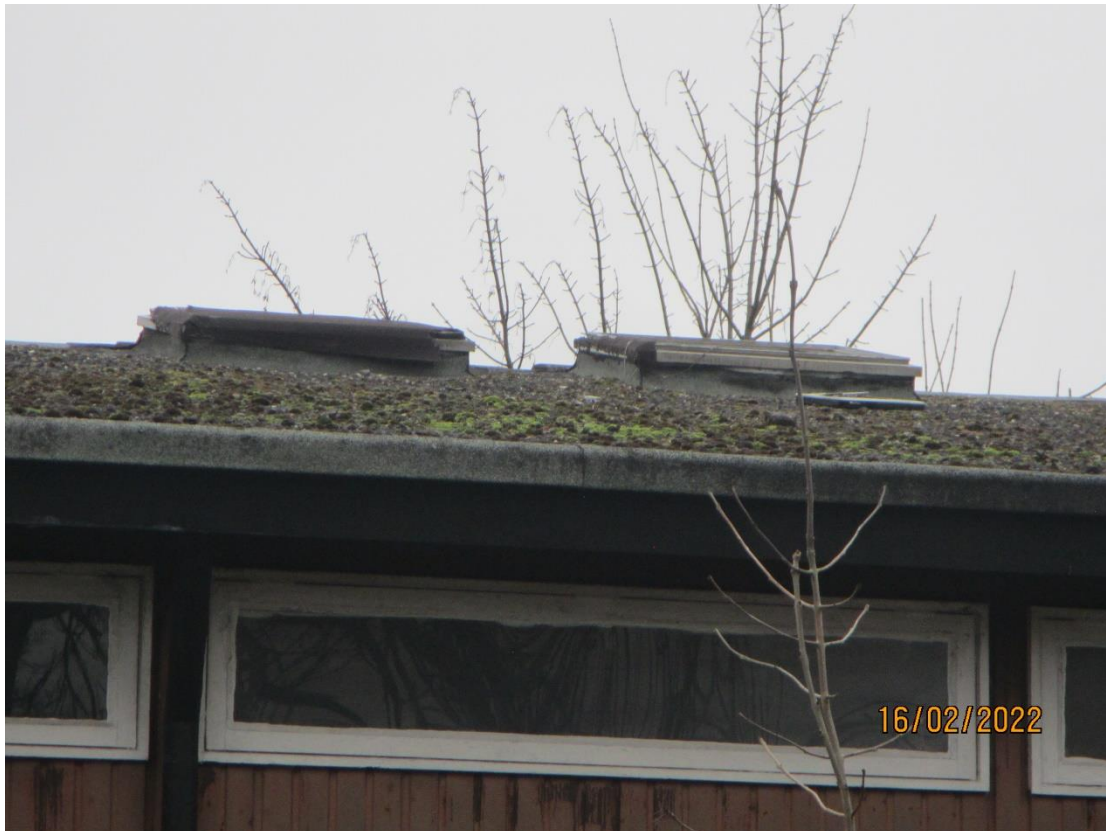
Photograph 3 – Two skylights at the north-western aspect, tightly sealed to the roof with bitumen roof felt, and raised timber roof plank. Wood fascia and windows are also visible.

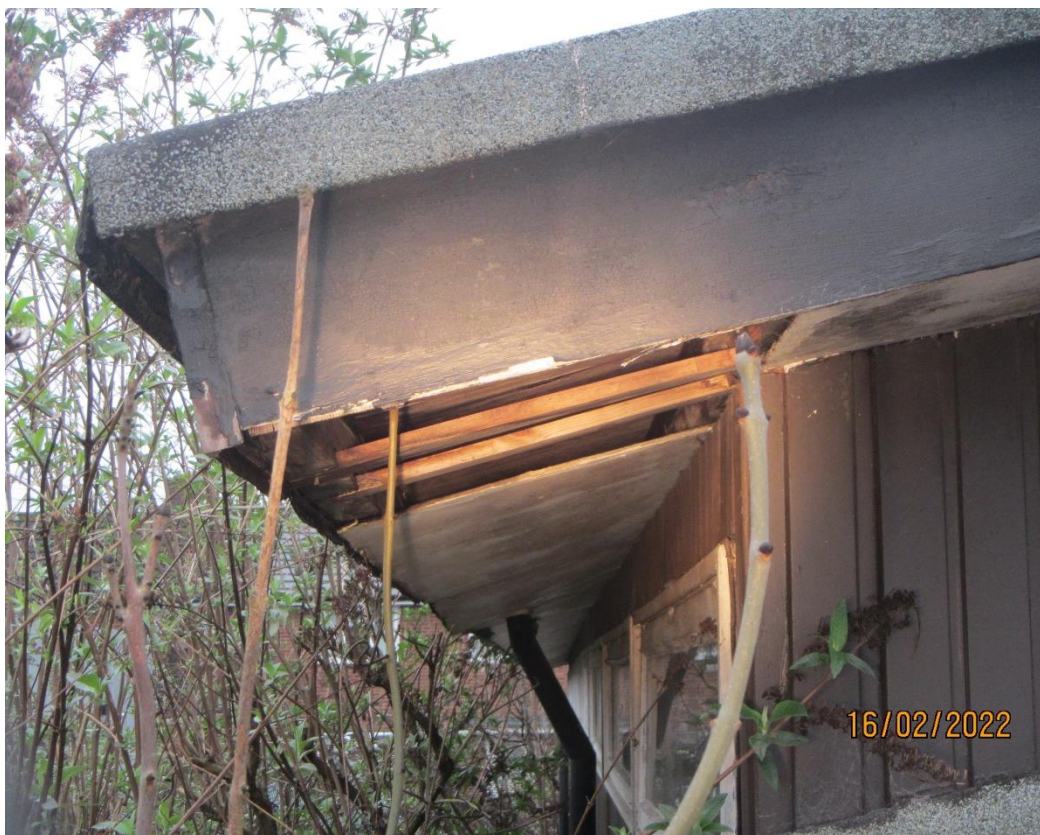
Photograph 4 – Damaged timber box soffits creates a generally unsuitable feature for roosting bats due to the absence of internal roosting features, and cluttered access point.

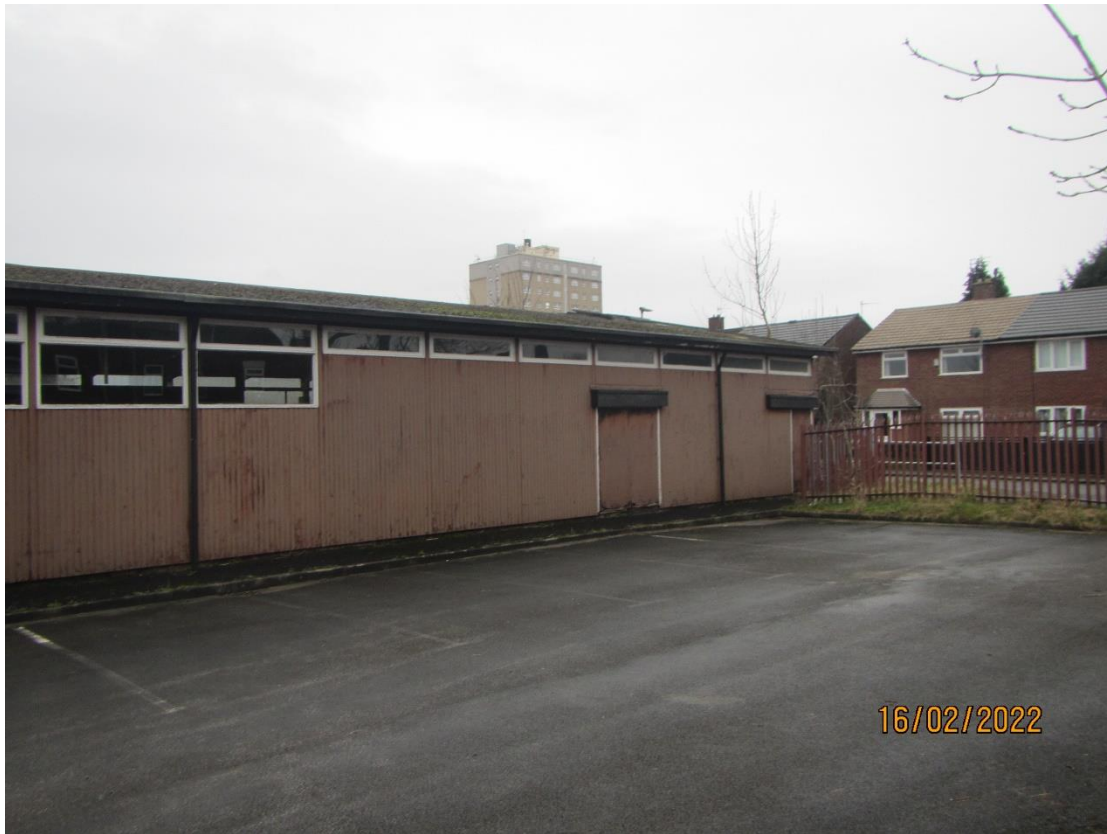
Photograph 5 – North-western aspect, showing the primary pitched roof, wooden cladding, large windows in timber frames and fire exits with timber fascia all tightly sealed.

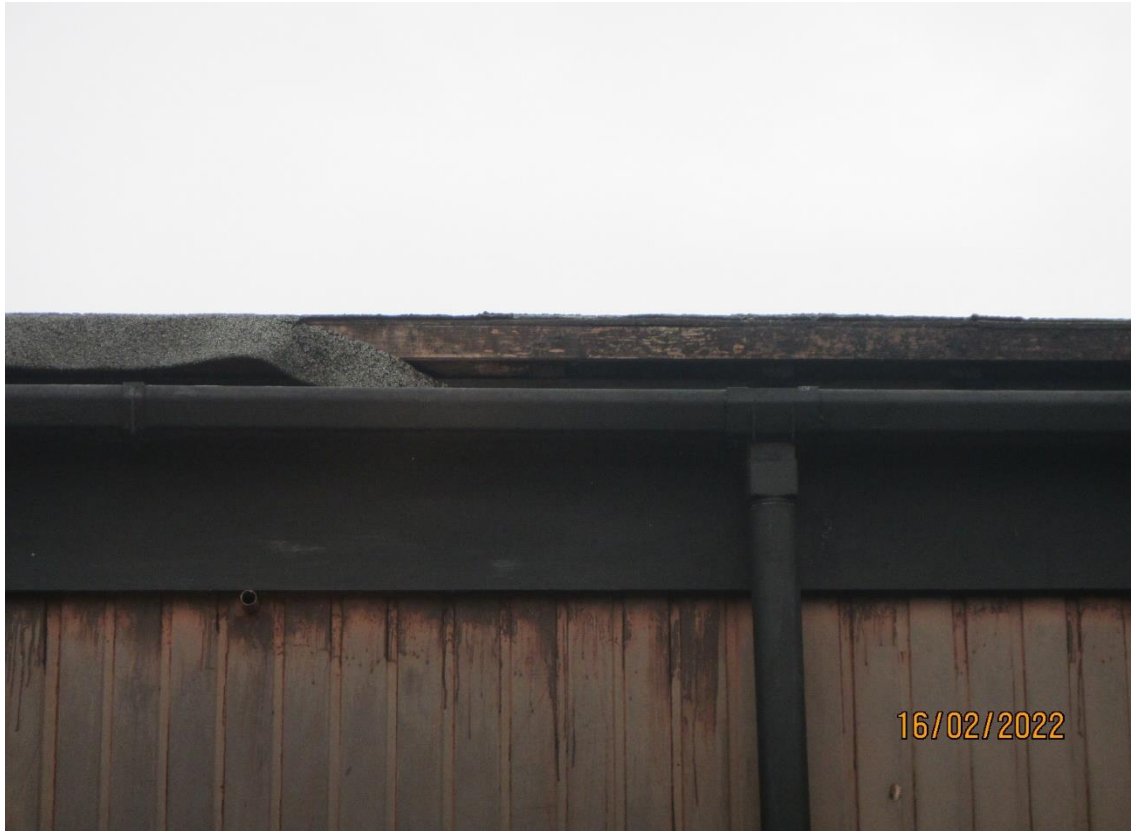
Photograph 6 – The north-eastern aspect of the hipped extension where the bitumen roof felt and the timber fascia have degraded, creating a gap into the structure.

**The hipped extension** is present above the entrance to St. John Vianney and is also lined with bitumen roofing felt, in the same fashion as the primary pitched roof. However, large gaps are present above the guttering and fascias which provide access into the interior (Photographs 6 and 7). A ventilation feature present beneath the apex of the extension has degraded and provides additional access into this loft void (Photograph 7). A hole in the ceiling of above the porch provides an additional access point into the void, although the access point is broadly unsuitable for bats as it leads into the floor of the void and is set away from the walls such that bats would have to fly directly into the void from the porch (Photograph 8).

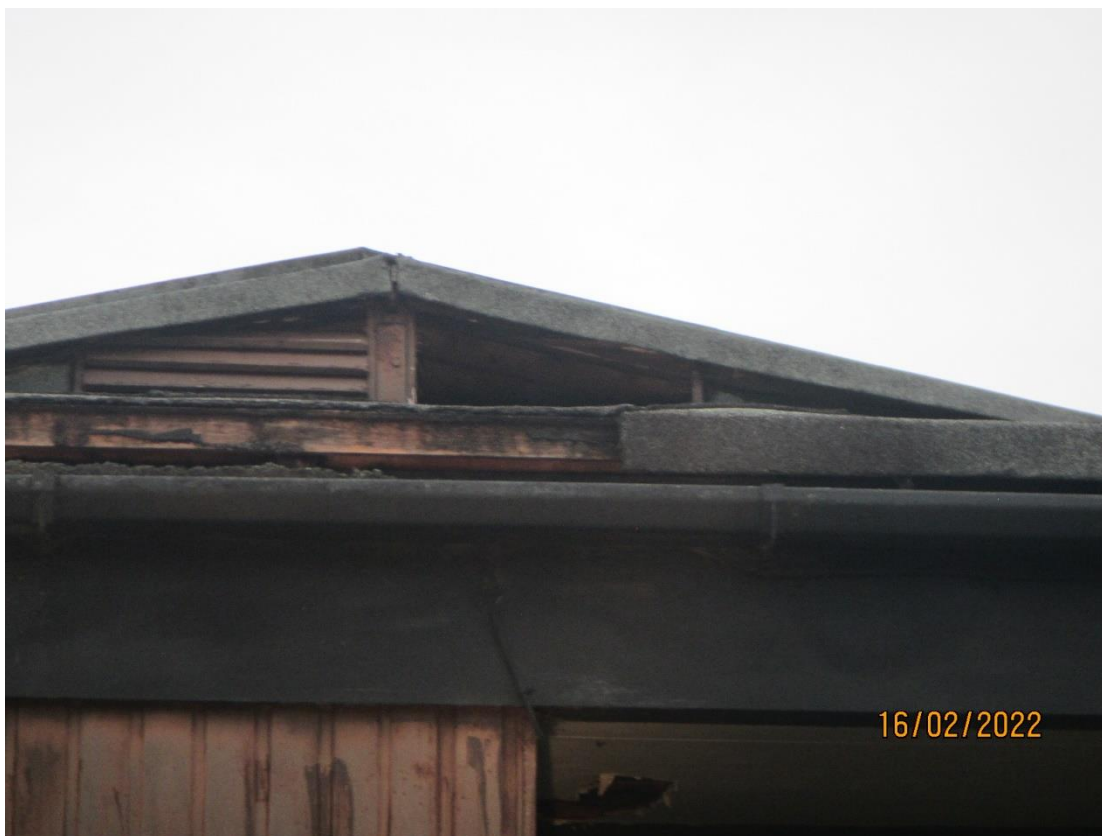
Photograph 7 – A close up of the damaged timber ventilation feature which faces north-west on the hipped roof extension and provides easy access into the structure.

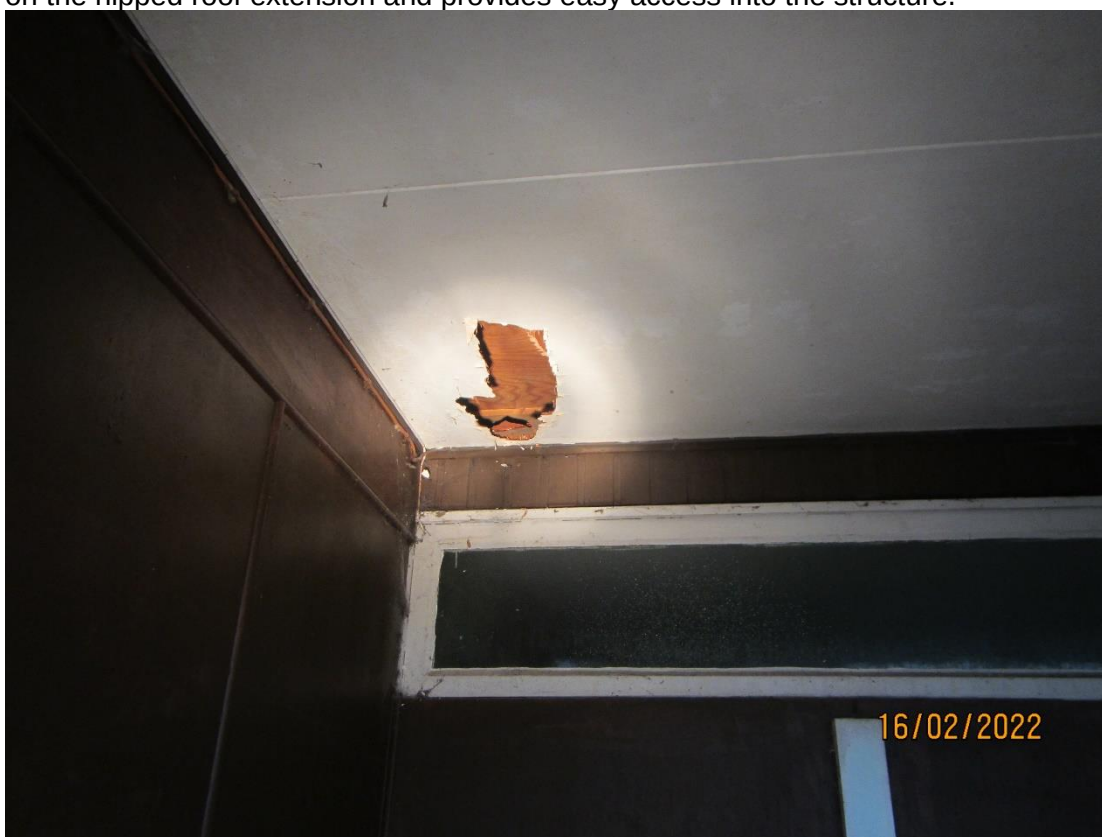
Photograph 8 – A gap located at the eaves within the building's porch, assessed as being unsuitable for bats as its positioning restricts access for bats.

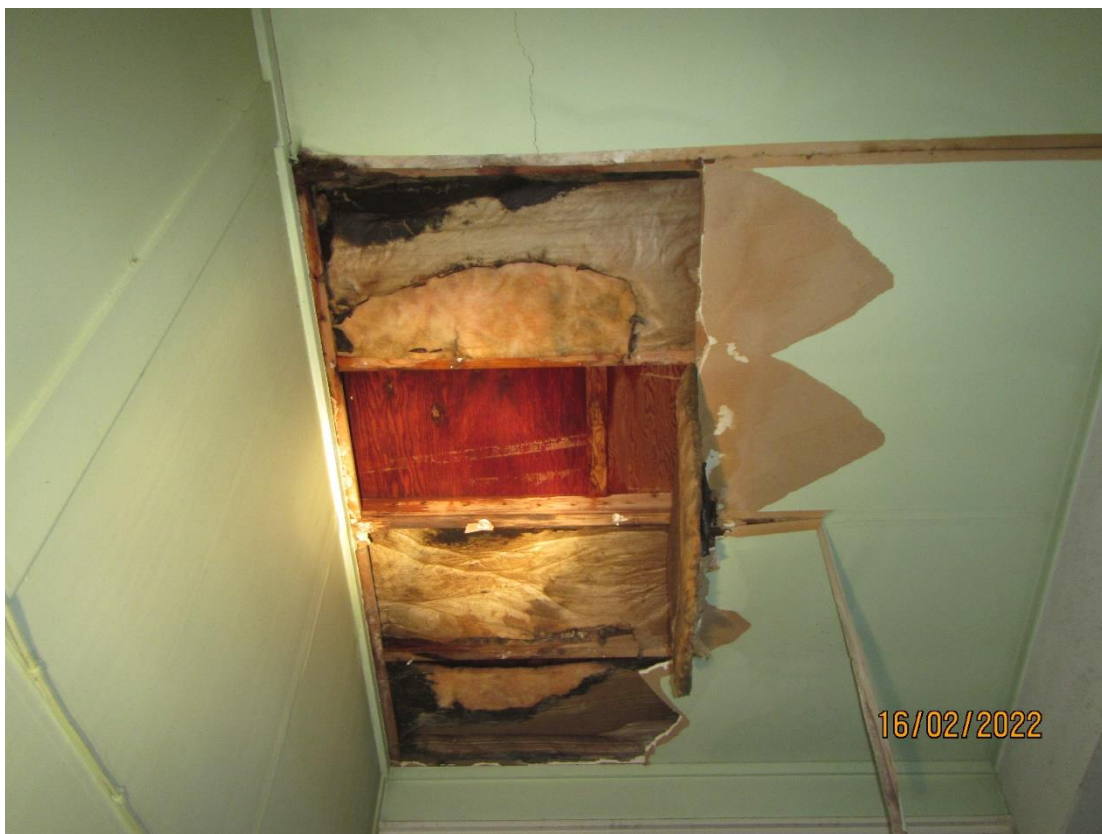
Photograph 9 – The water damaged roof at the north-eastern end of the main hall, revealing the single skin plywood, timber beam and insulation construction of the roof.

The main pitch of the roof has a vaulted ceiling and lacks a loft void entirely. The ceiling is constructed from single skin plywood attached to timber beams with mineral wool insulation between the beams (Photograph 9). The interior is divided into a large main hall, and several interconnected rooms. A large amount of water damage is present throughout the structure of the roof, particularly at the north-eastern end of the building (Photograph 9) and surrounding the skylights which are in derelict condition within the large southern room (Photograph 10). All of these rooms lack any loft voids or sheltered features suitable for roosting bats. Furthermore, no evidence of bat activity, such as droppings or field signs, was identified despite a thorough assessment with endoscope and torches..

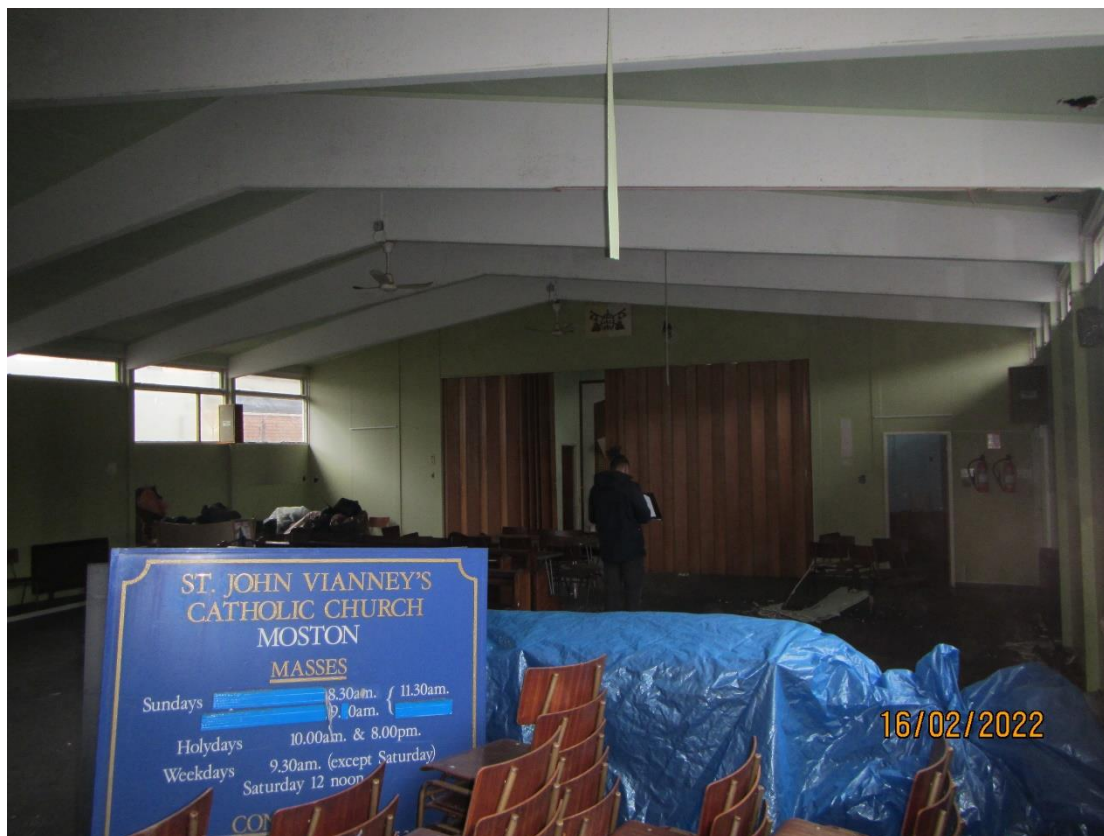
Photograph 11 – Looking south-west within the main hall of the building, showing the high levels of natural light entering through large windows and the doorways to the backrooms.

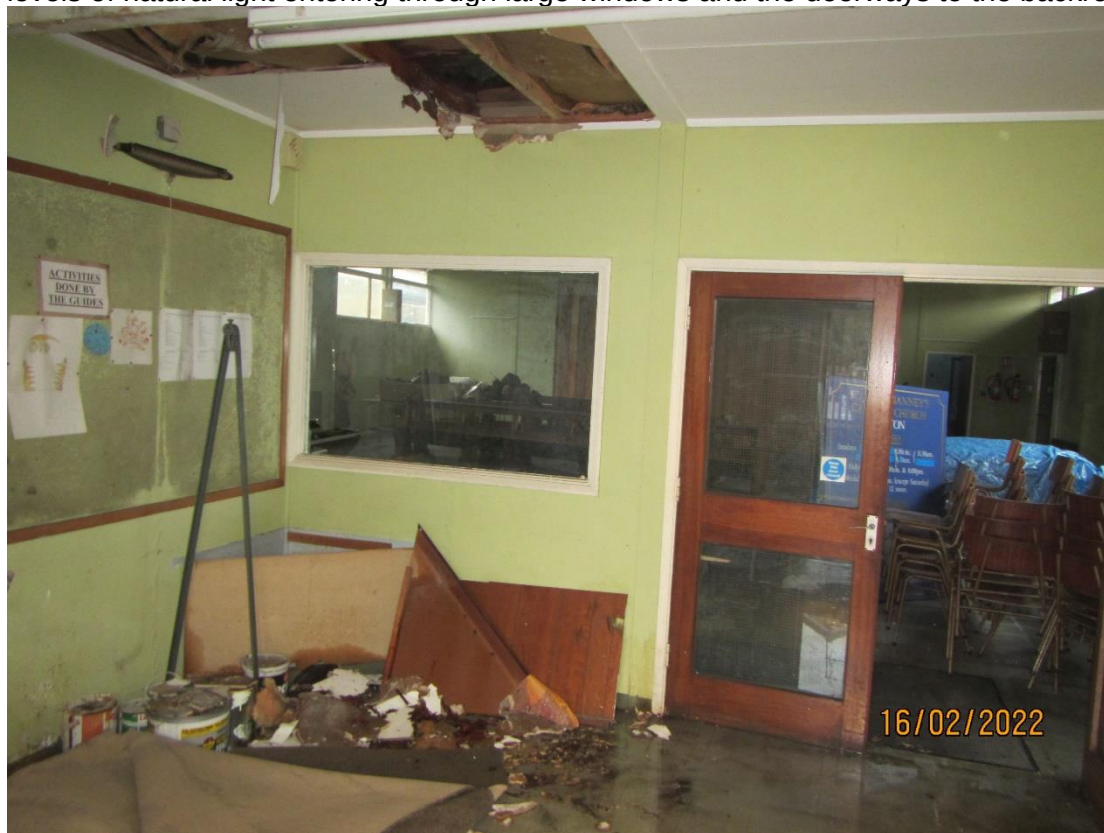
Photograph 12 – A large hole in the single skim plywood ceiling of the foyer leading to the hipped extensions loft void, which has been created through water damage.

There is a loft void present beneath the building's hipped roof extension, which is accessible through a large hole in the ceiling of the foyer, which has been created by water damage (Photograph 12). The void has been formed by building a hipper roof above the flat roof of the entrance to the building, presumably to prevent water damage. The hipped roof structure is supported by timber rafters, with a single skin plywood structure above which bitumen felt is lined (Photograph 13). The void is approximately 1m in height to the apex and lacks any form of insulation. Gaps at the eaves, which were noted from the exterior of the building (Photograph 6 and 7), provide access into this void. However, the area is considered to be unsuitable for roosting bats as PRFs are limited to the junctions of the timber frame. These features are highly exposed and subject to high levels of natural light and rain, as evidenced by the water damage beneath the void (Photograph 12 and 13). Furthermore, no internal field signs of bats were visible, such as droppings or feeding remains.

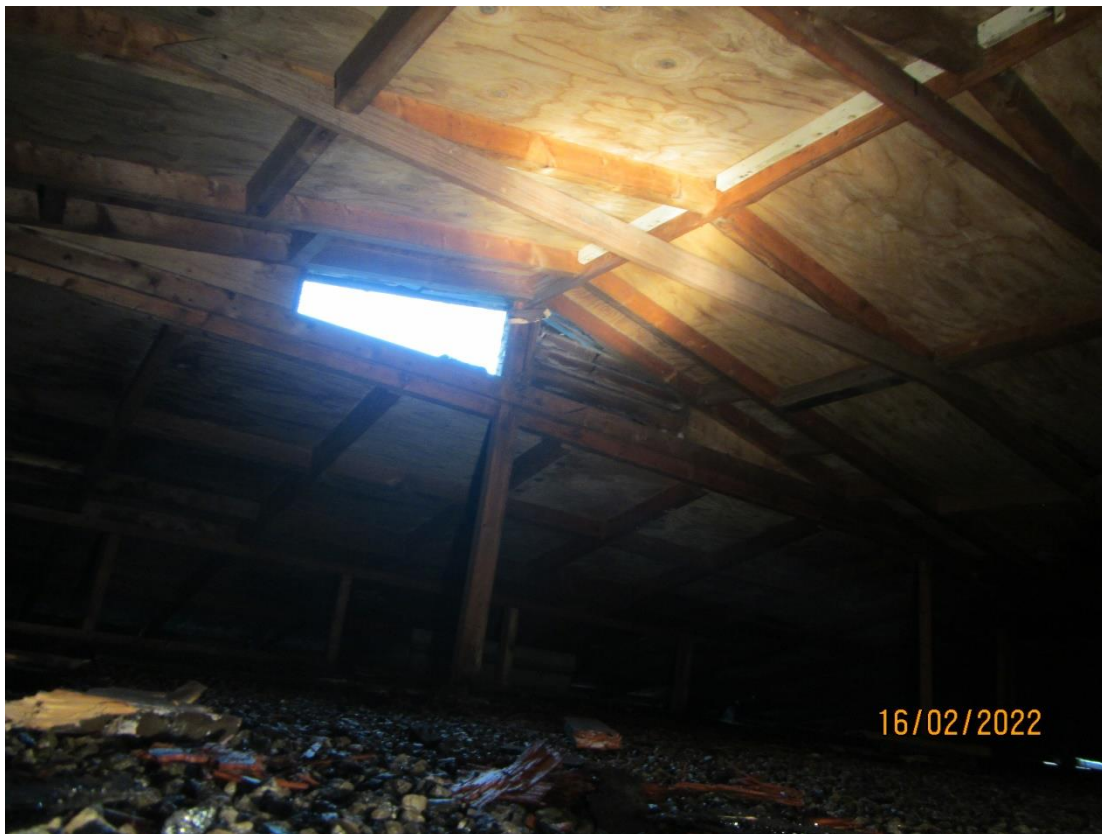
Photograph 13 – Looking north-east within the hipped extensions loft void, largely unsuitable for bats, with single skin plywood timber, rafters, and all external features visible from within and exposed to high levels of natural light.

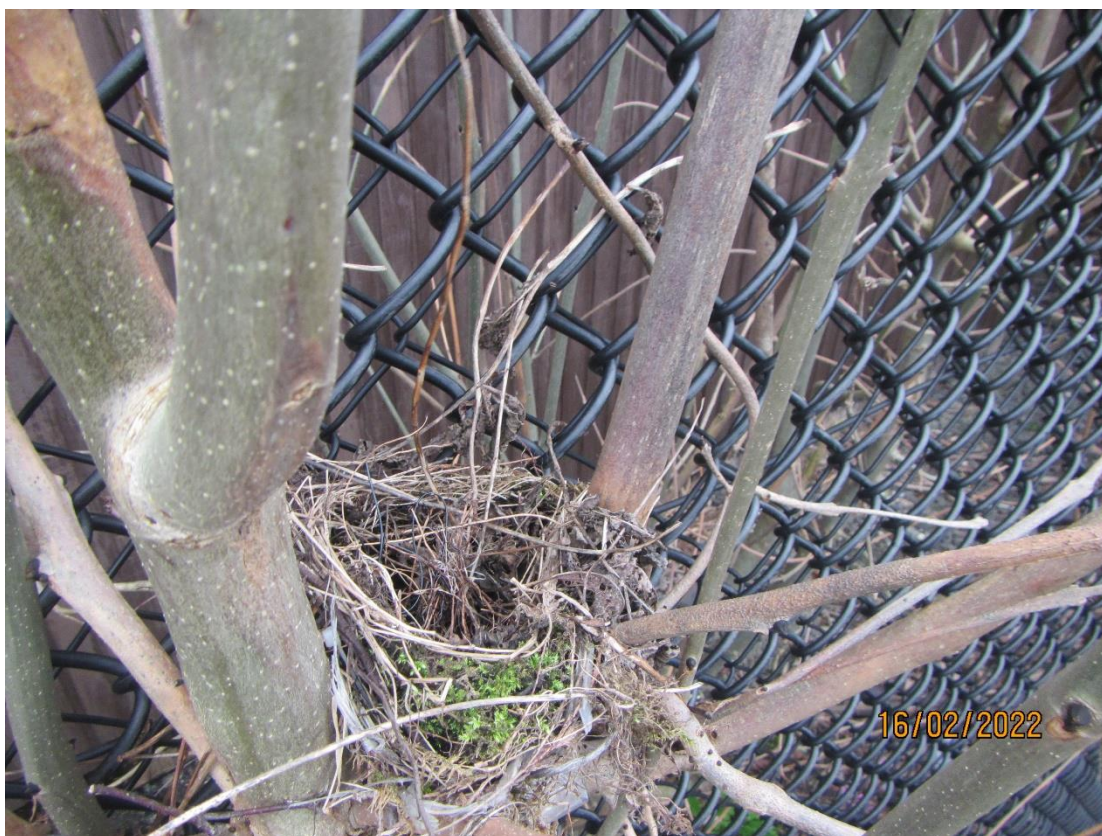
Photograph 14 – A historical blackbird *Turdus merula* nest located within a self-seeded ash tree at the south-western aspect of the building.
