**Site:** COSH Before / After School Childcare  
**Date:** May 2022  
**Subject:** Watching Brief  
**Reference:** LKC 22 1199-01r1

LK Consult Ltd (LKC) has been appointed by Chorlton Out of School Hours (COSH) Ltd to provide a Watching Brief inspection in support of the proposed before and after school childcare development at Chorlton Sports and Social Club, Hardy Lane, Chorlton.

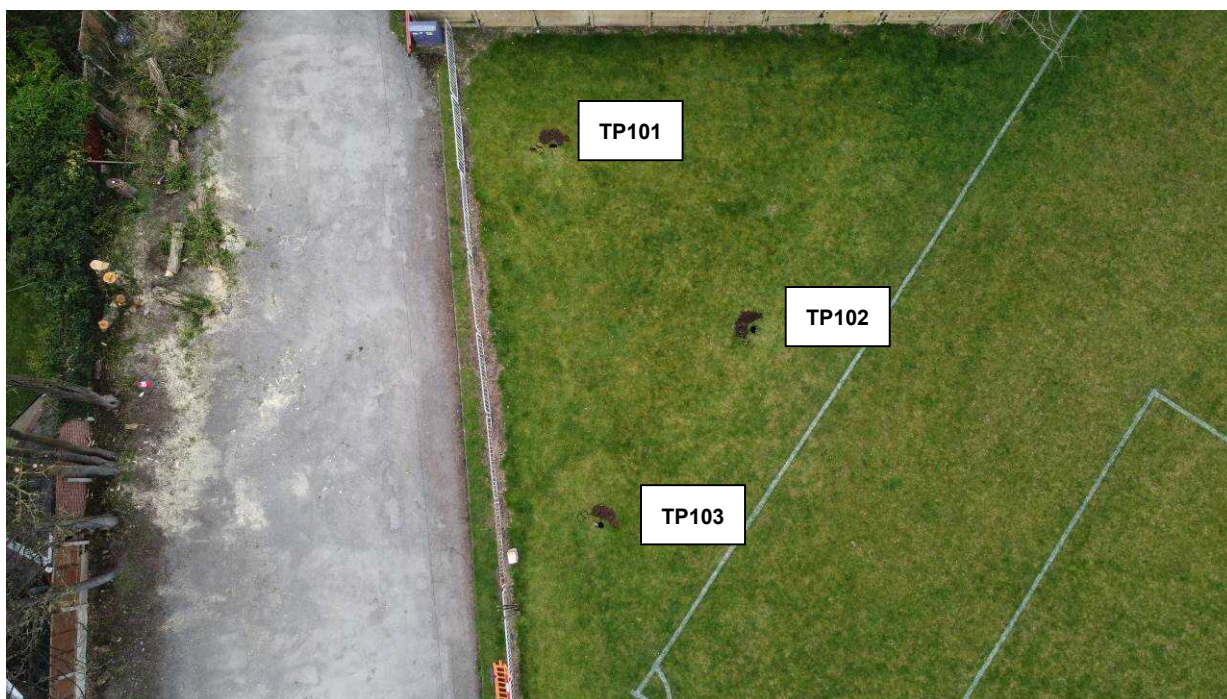
Plate 4-1: Trial Pit Locations. Football pitch present to right of photograph.

LKC attended site on 21<sup>st</sup> March 2022. During the inspection LKC excavated 3no. trial pits (ref. TP101 to TP103) to examine soil conditions for anthropogenic inclusions and potential contamination. The locations are shown on Plate 4-1.

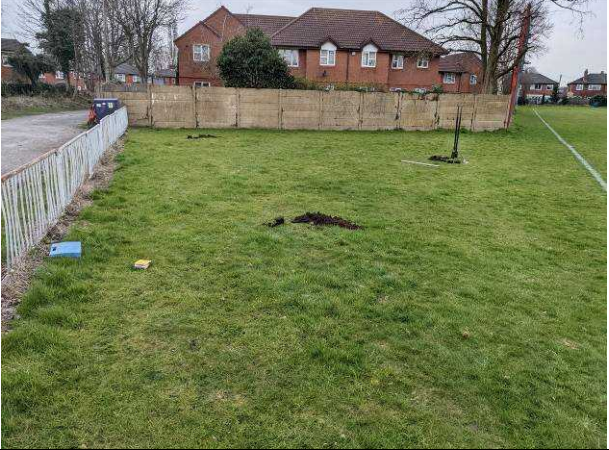
| <p>View of proposed building area from west. Touchline to existing football pitch visible right of photograph.</p> | <p>View of proposed drop off and pick up area – using existing Sports and Social Club access.</p> |

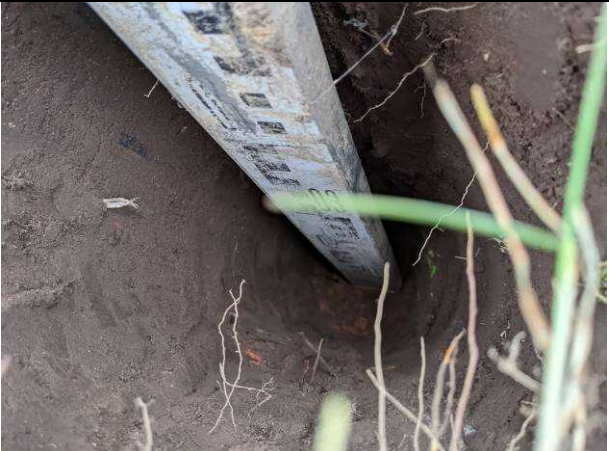
| <p>TP101 downhole.</p> | <p>TP101 arisings. Orange glaciofluvial sand in subsoil and topsoil.</p> |

The trial pits generally encountered a greyish brown slightly silty sand (topsoil) with rootlets to depths of 0.15-0.2m. Rare brick gravel and rare coal noted in TP101.

The topsoil graded into a grey brown slightly silty sand subsoil – with an absence of rootlets. This was observed to 0.55mbgl in TP101, 0.6mbgl in TP102 and 0.45mbgl in TP103.

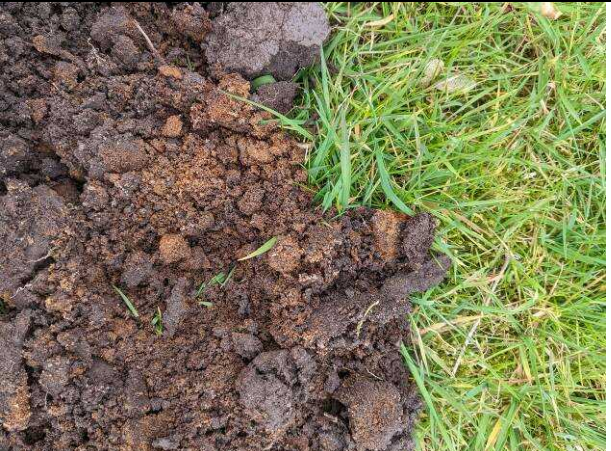
Apparently natural orange glaciofluvial sand superficial deposits were recorded in all three locations (from depths of 0.45-0.6mbgl).

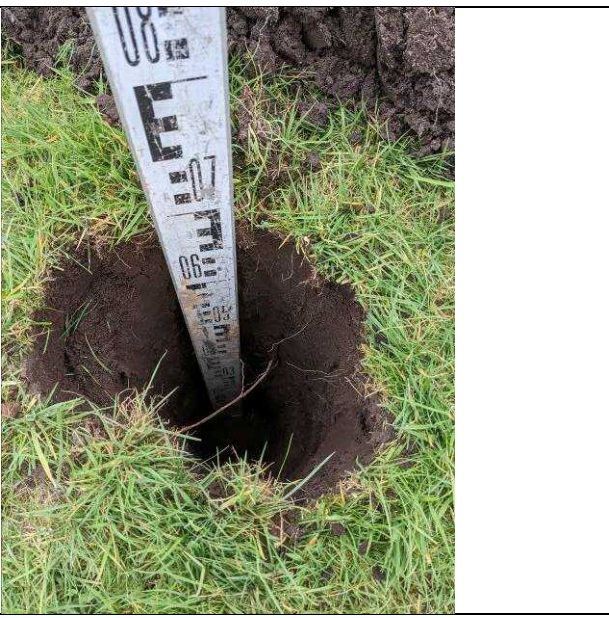
| <p>TP102 downhole.</p> | <p>TP102 excavation. Orange glaciofluvial sand at base. Difficult to excavate.</p> |

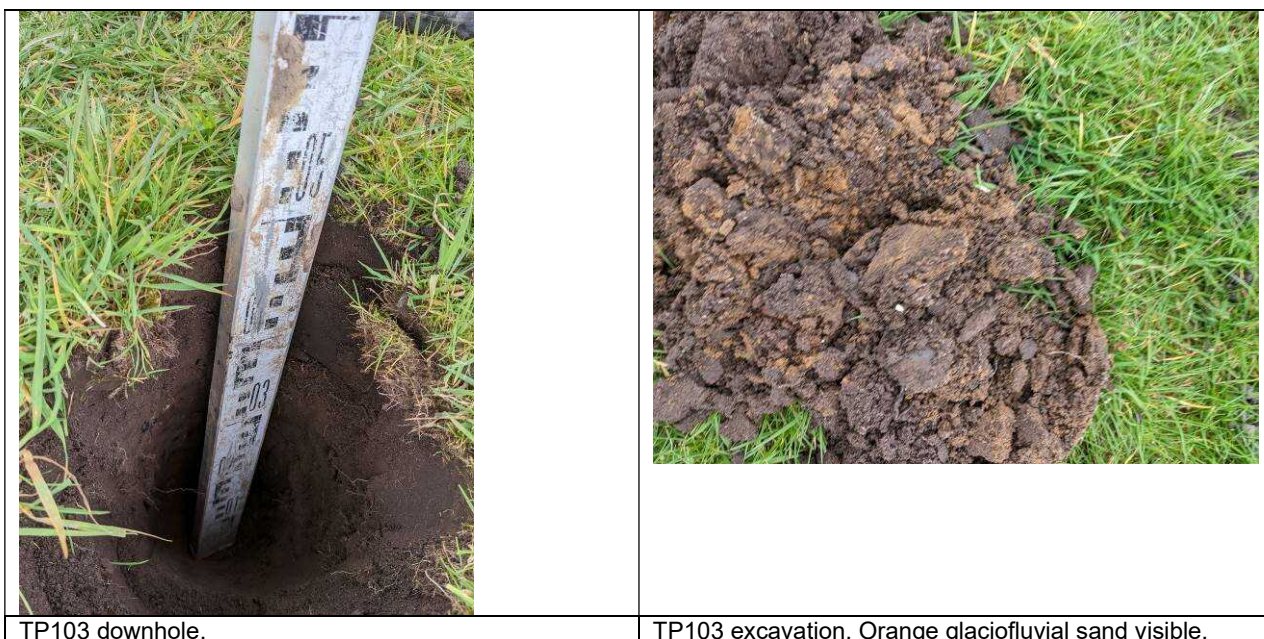
Plate 4-2: Site Inspection.

No visual or olfactory evidence of contamination was noted.

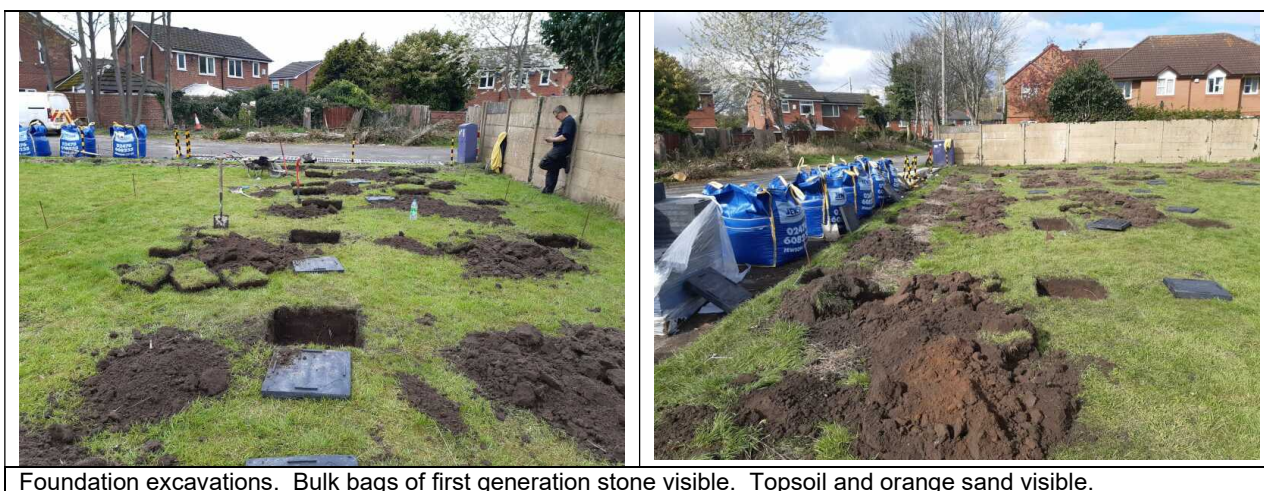
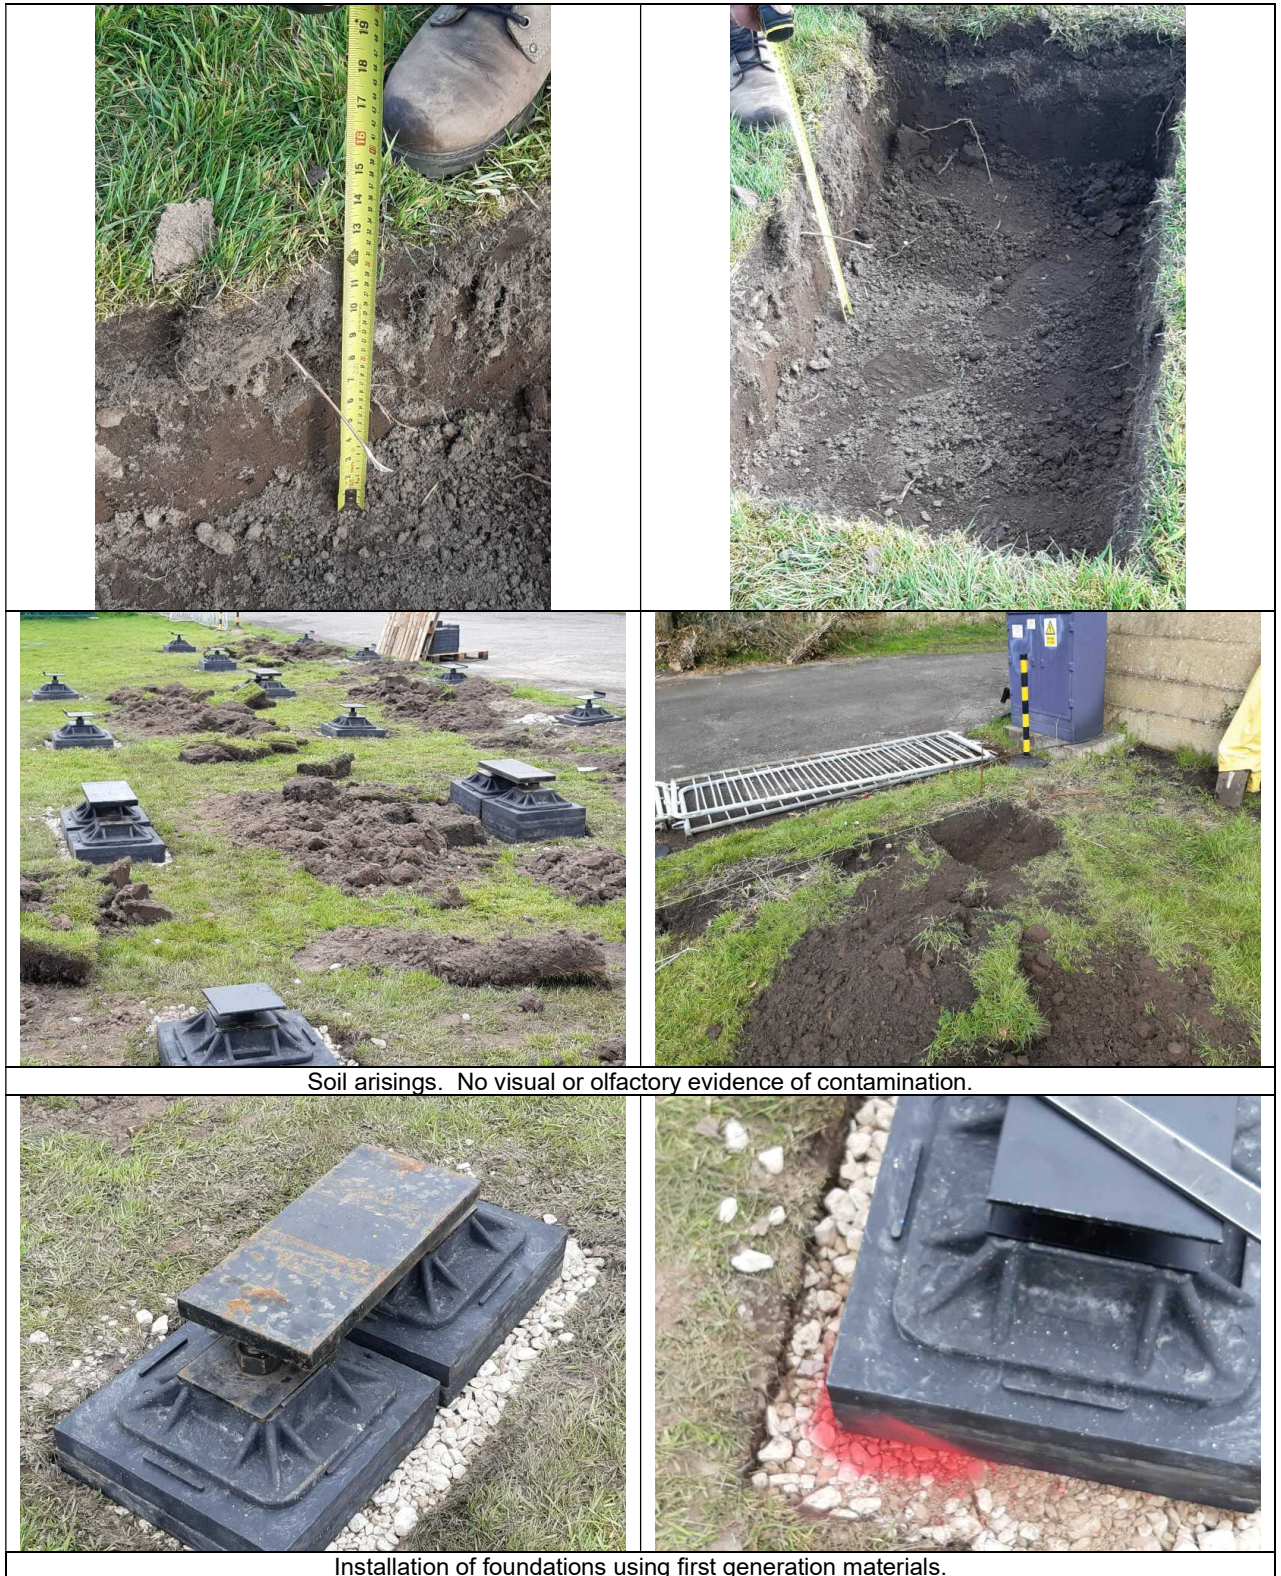
Plate 4-3: Excavations for foundation installations.

Following the above, the foundation pads were excavated and installed 16<sup>th</sup> and 17<sup>th</sup> April 2022 using compacted first-generation materials. Similar ground conditions to the initial inspection were encountered – in that no visual or olfactory evidence of contamination was noted.
