Edge Lane, Openshaw  
Pre- Construction Remediation Verification Report  
Your Housing Group

REPORT No: 19YHG001/VR

Date: April 2021

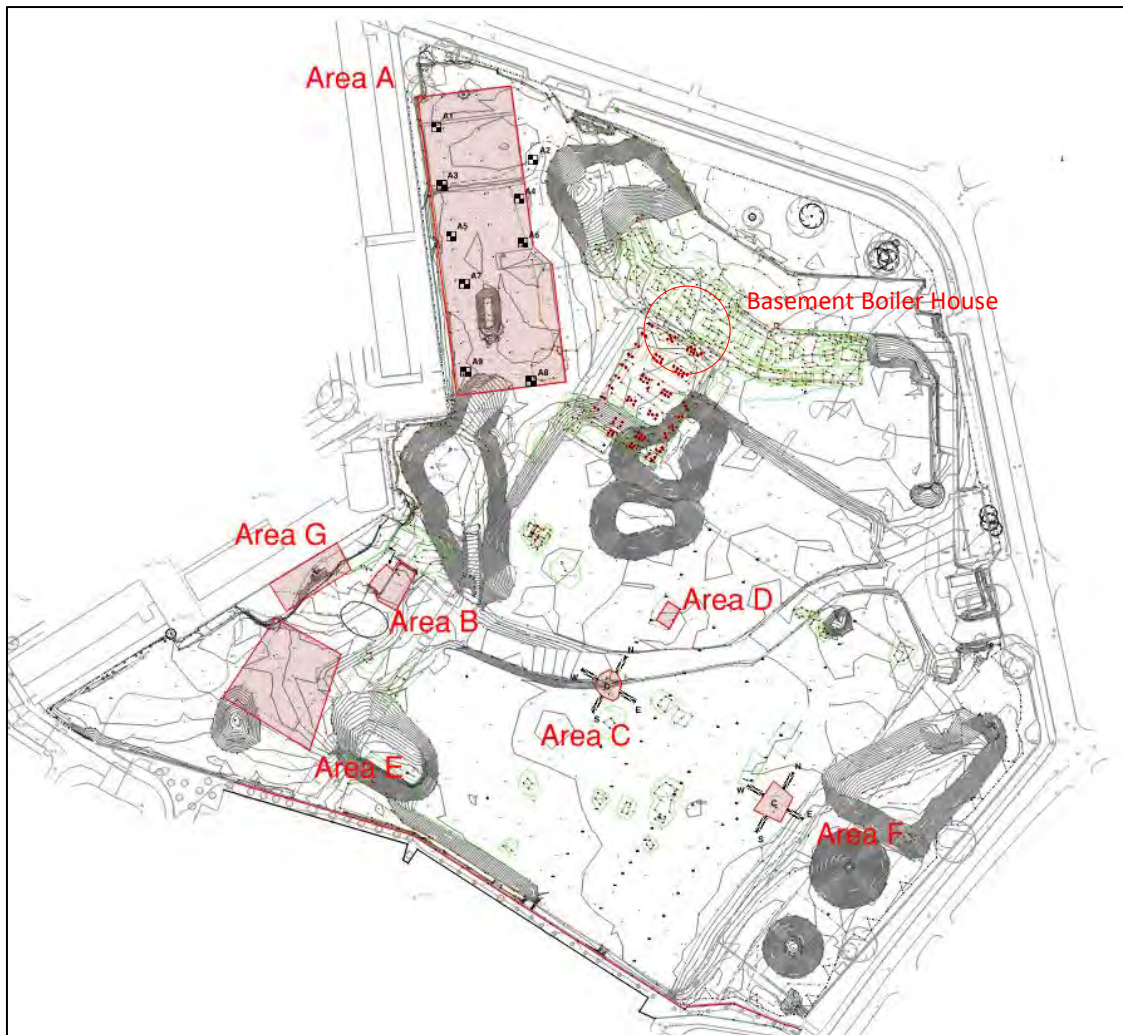
For ease of use, the remaining areas for remediation after the issue of the intrusive investigation report (19YHG001/GI/Rev1) were numbered as per the below sketch to aid in identification and description between site and office staff;

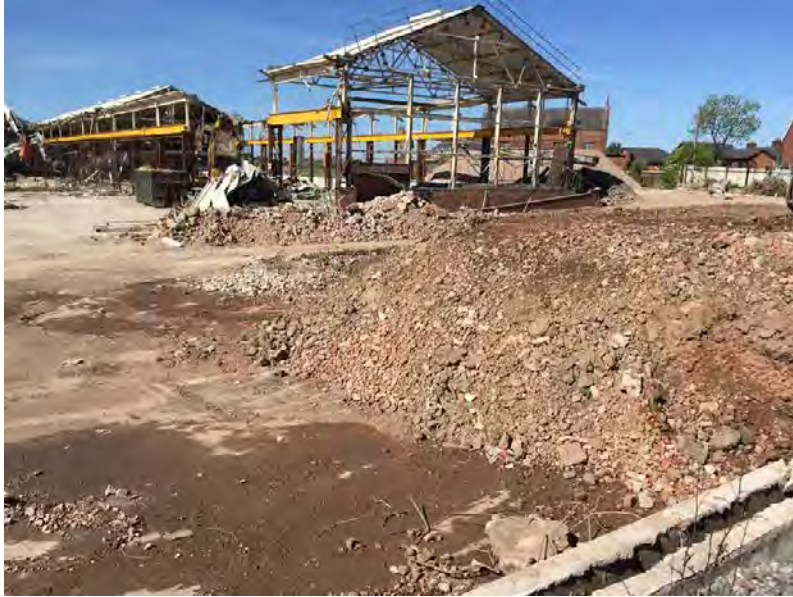
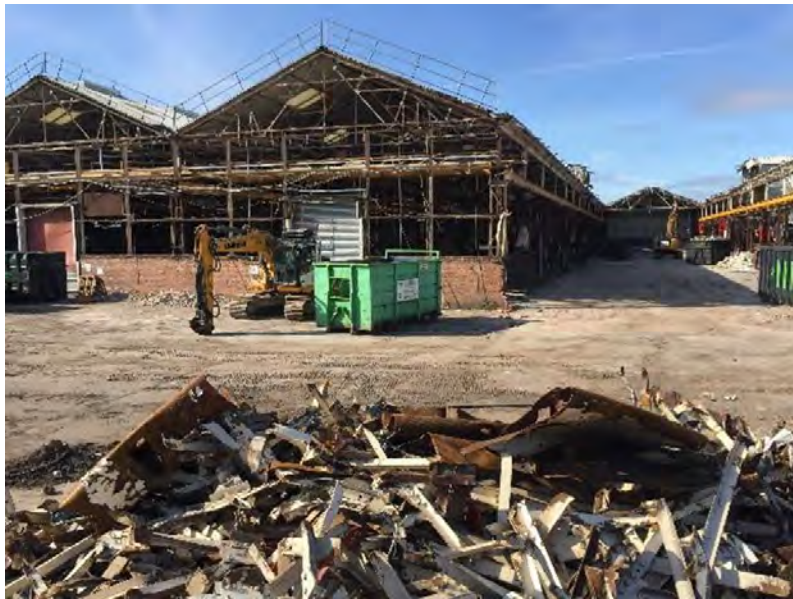
Prior to the start of the remedial work, Skillings were commissioned to demolish and process the remaining factory buildings and sub-surface obstructions. The resulting stockpiles were left on site for reuse with appropriate crush testing certificates. Skillings completed the demolition prior to Civils and Remediation Ltd arriving onsite to undertake part of the earthworks. The earthworks were then revisited by Skillings to complete the work.

The selected photos below show the demolition works;

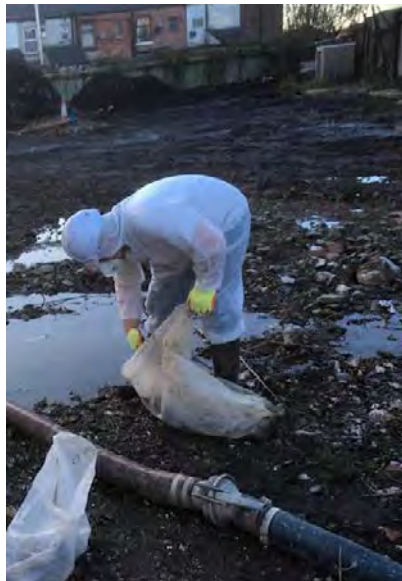
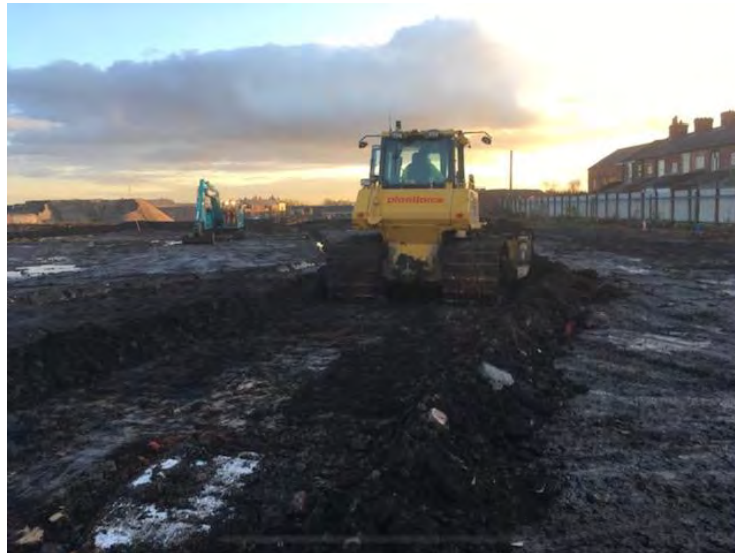
Delineation of Area A TP104 was taken to the approximate boundaries of the historical building and showed minor exceedances of various determinants. To remove traces of asbestos the area was scraped and a surface pick was carried out with suspected materials placed within the burial cells, as described within Section 5.

The selected photos below show the scrape and asbestos pick and site scrape;

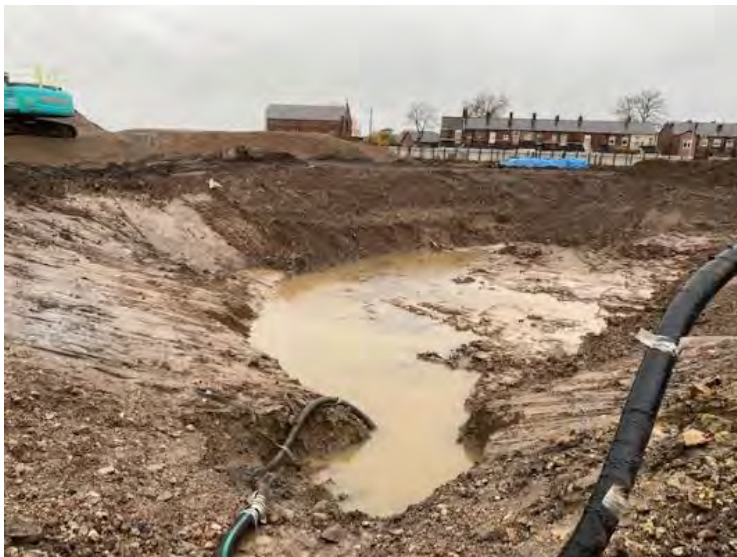
Samples collected from the base of the excavation showed no significantly elevated PAH, TPH or VOC/SVOC readings. The impacted materials are therefore considered to have been removed during the enabling works. The resulting void was backfilled by Skillings. Photo below shows the boiler house dig area;

No further remedial action required.

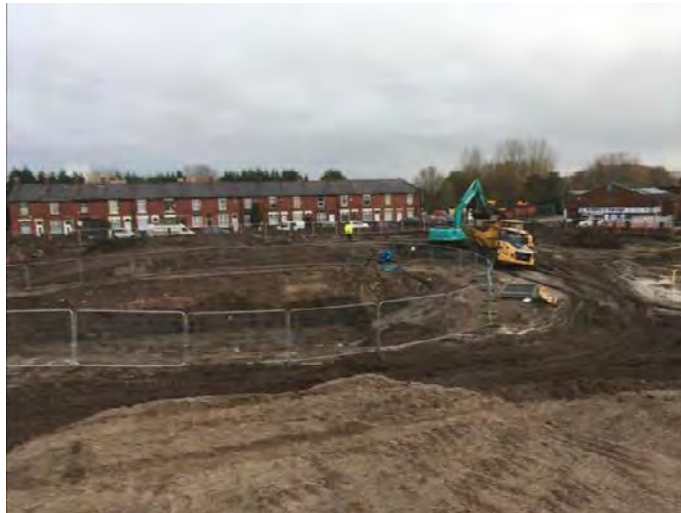
Photo of the northern pit excavation and burial is shown below;

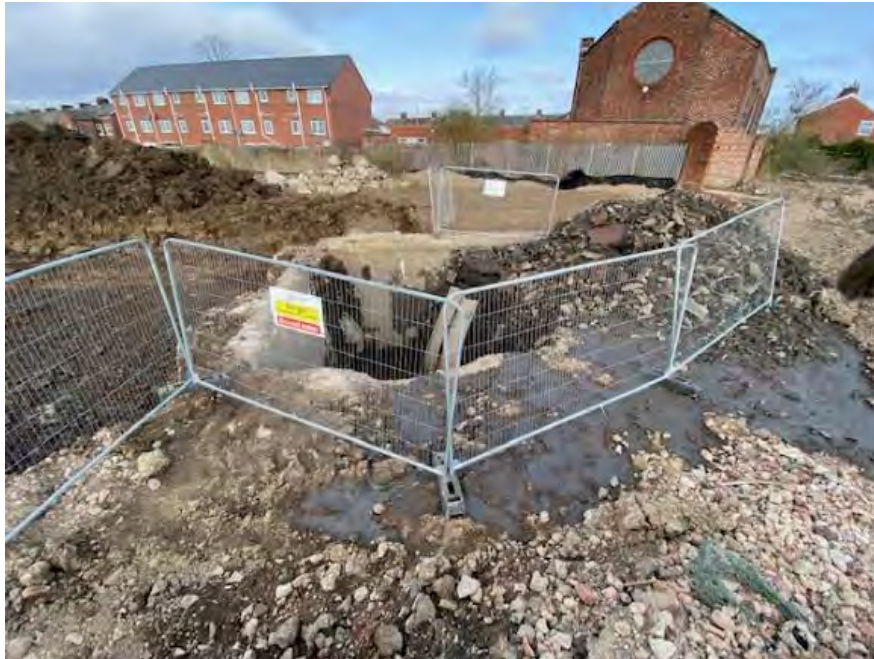
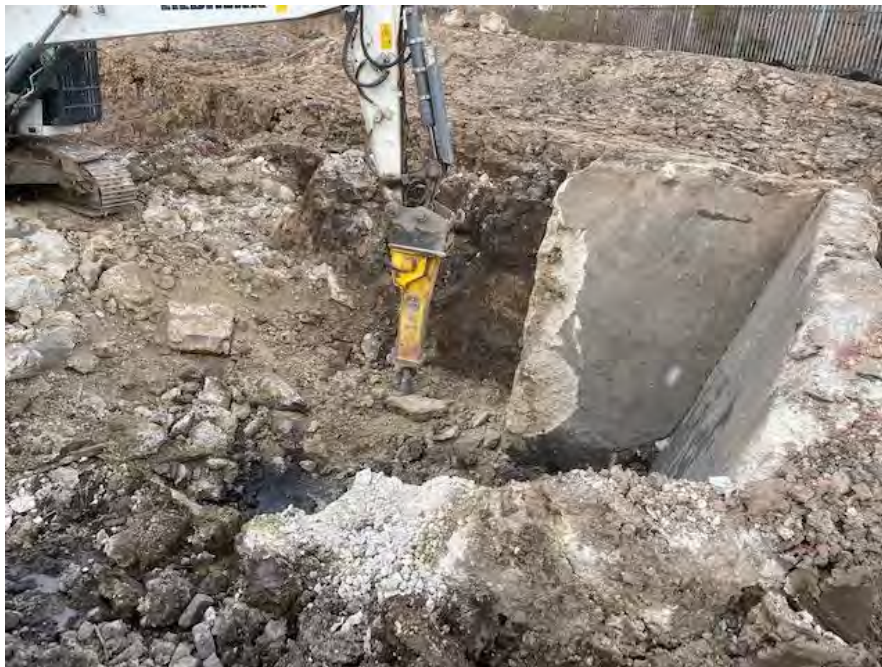
This area contained a deep concrete lined void that had been backfilled with general demolition waste, this void had accumulated water overtime which required pumping to tanker and removing from site. The water was tested, prior to offsite disposal, by CSG Ltd and removed by CSG Ltd under supervision of Skillings (certificates attached).

Backfill previously identified as the hotspot was excavated and disposed off site to a suitably licensed landfill with certification provided (attached) circa 700m<sup>3</sup> were removed.

The concrete structure was broken out using large (48T tracked excavator) sides benched down to the west to make safe access and resultant void backfilled with site won granular material tracked in 200mm layers. This area was previously down to be vibro improved but due to the depth of the fill and clay sides a piled solution is to be adopted. The concrete

was removed by Skillings for crushing and samples collected from the surrounding natural stiff clay strata for validation purposes. All results came back as below residential threshold.

No further remedial action required.

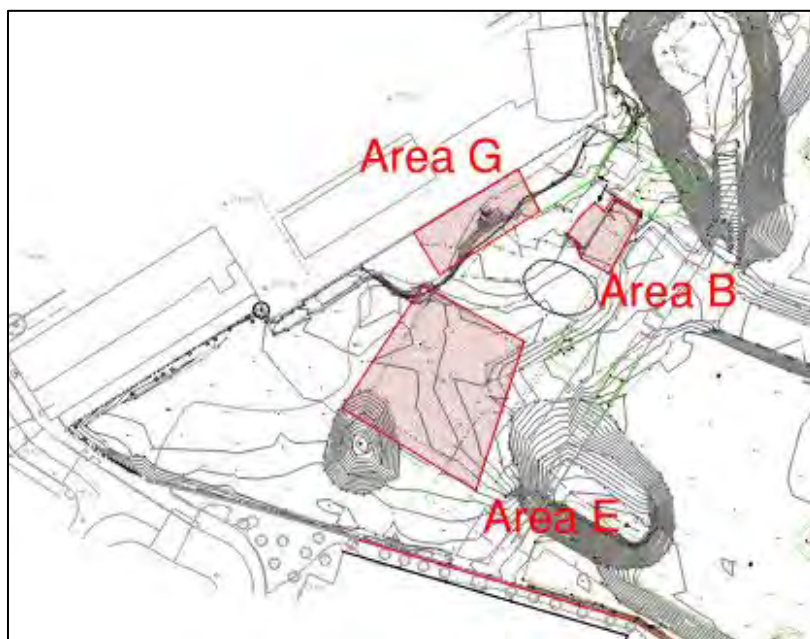
During the Japanese knotweed scrape further basements / air raid shelters were noted on the western boundary. Their location is shown on the sketch below;

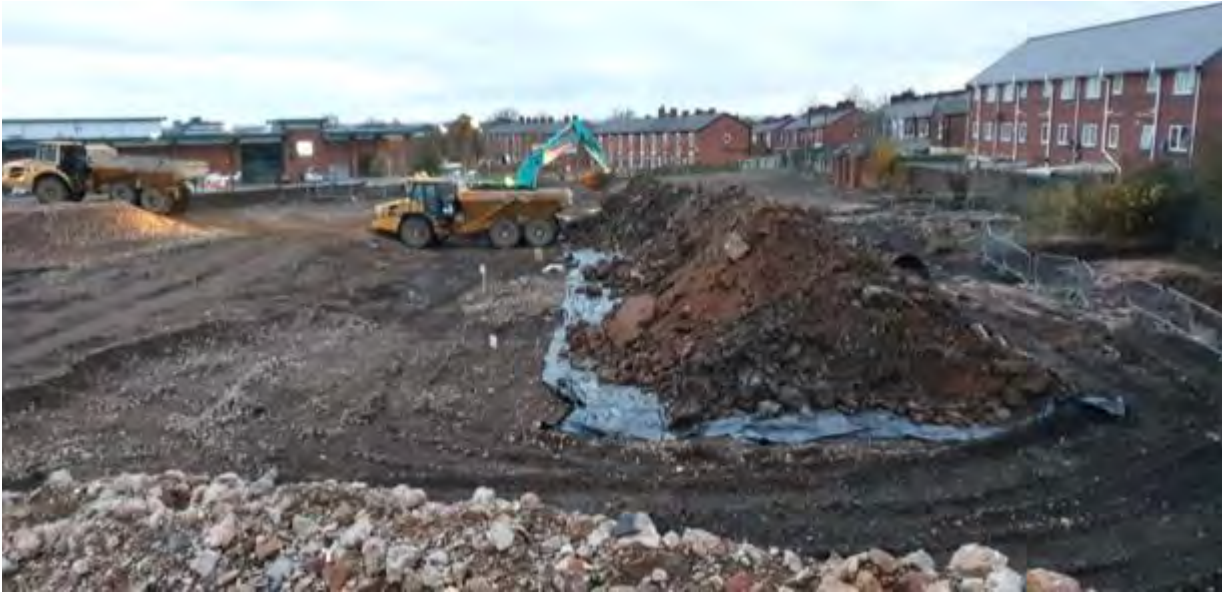
These locations were treated in two phases. The top half, above the water line was broken out and stockpiled separately over Visqueen, before being deposited in the Japanese knotweed cell.

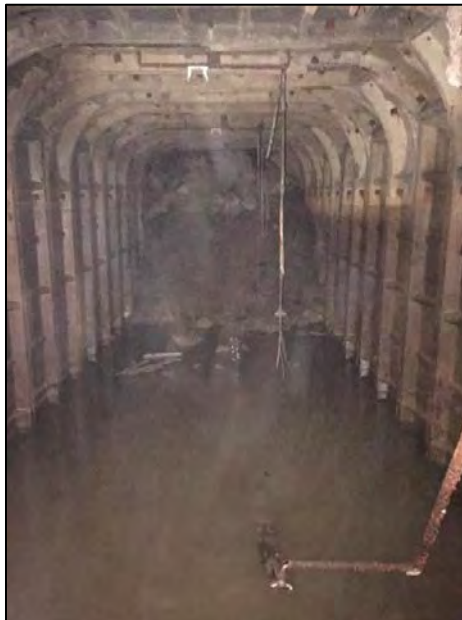
The water contained within the void was pumped out and the remaining structure broken down and crushed on site for reuse.

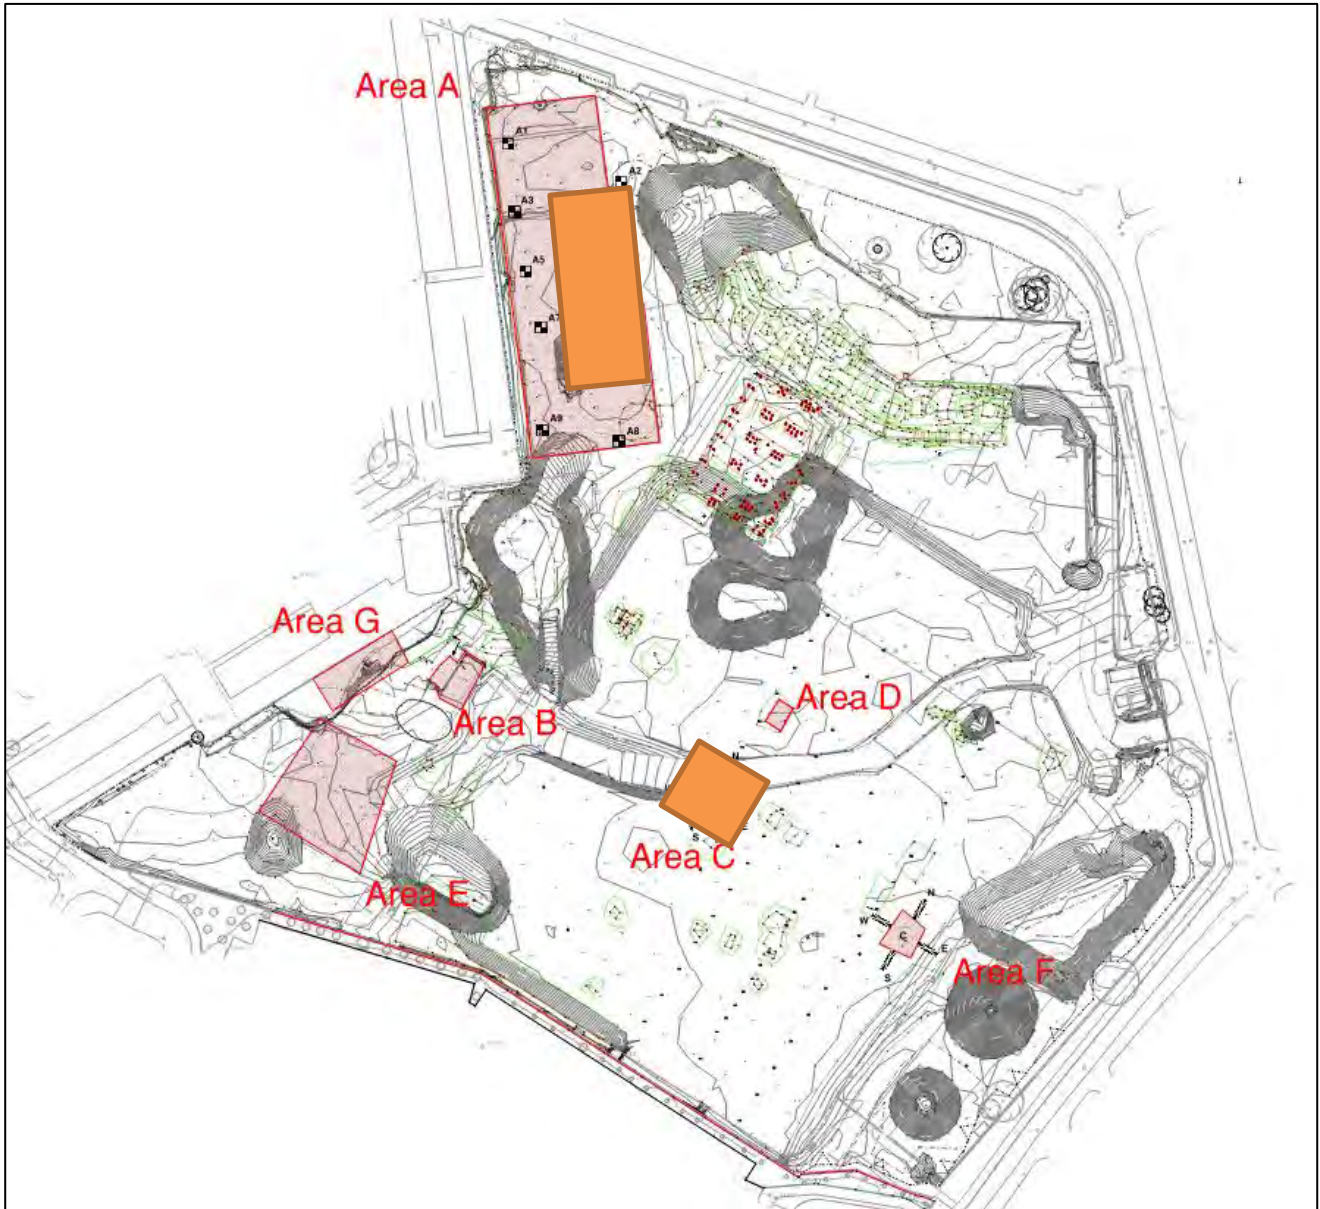
Whilst there is little guidance for the determinants it is deemed prudent on a nuisance level that a HC / VOC membrane is installed along with a ventilated void. These are shown on the below sketch and will need replication on the foundation zoning plan.

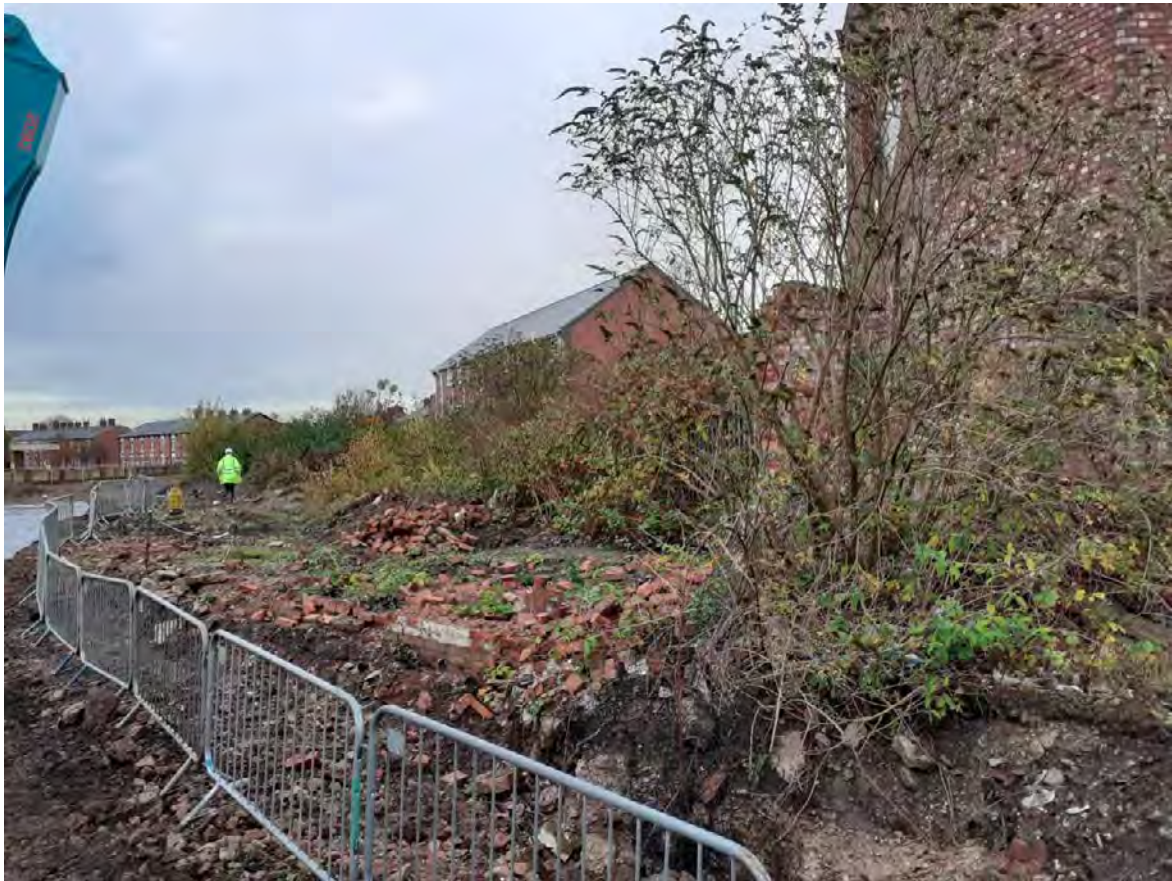
Pic 1 - JK Area 1 before

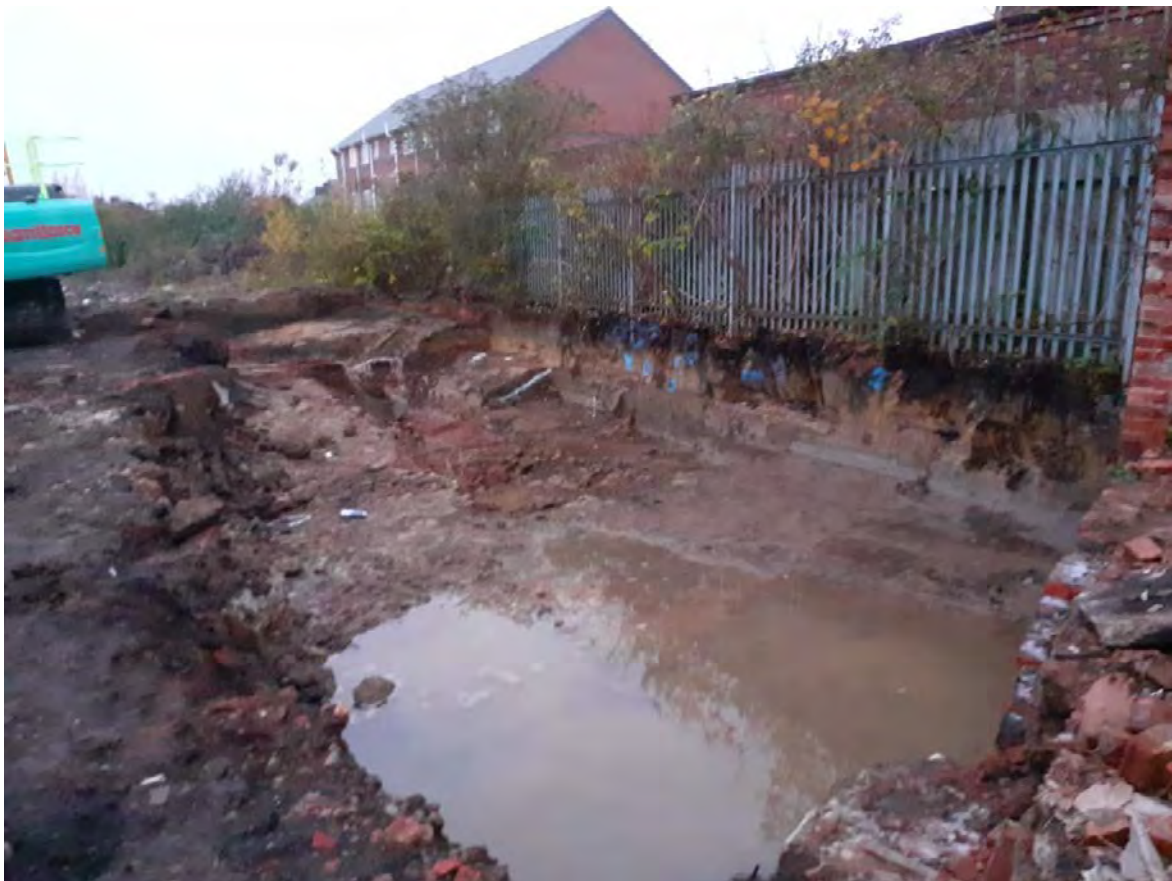
Pic 2 - JK area 1 after excavation

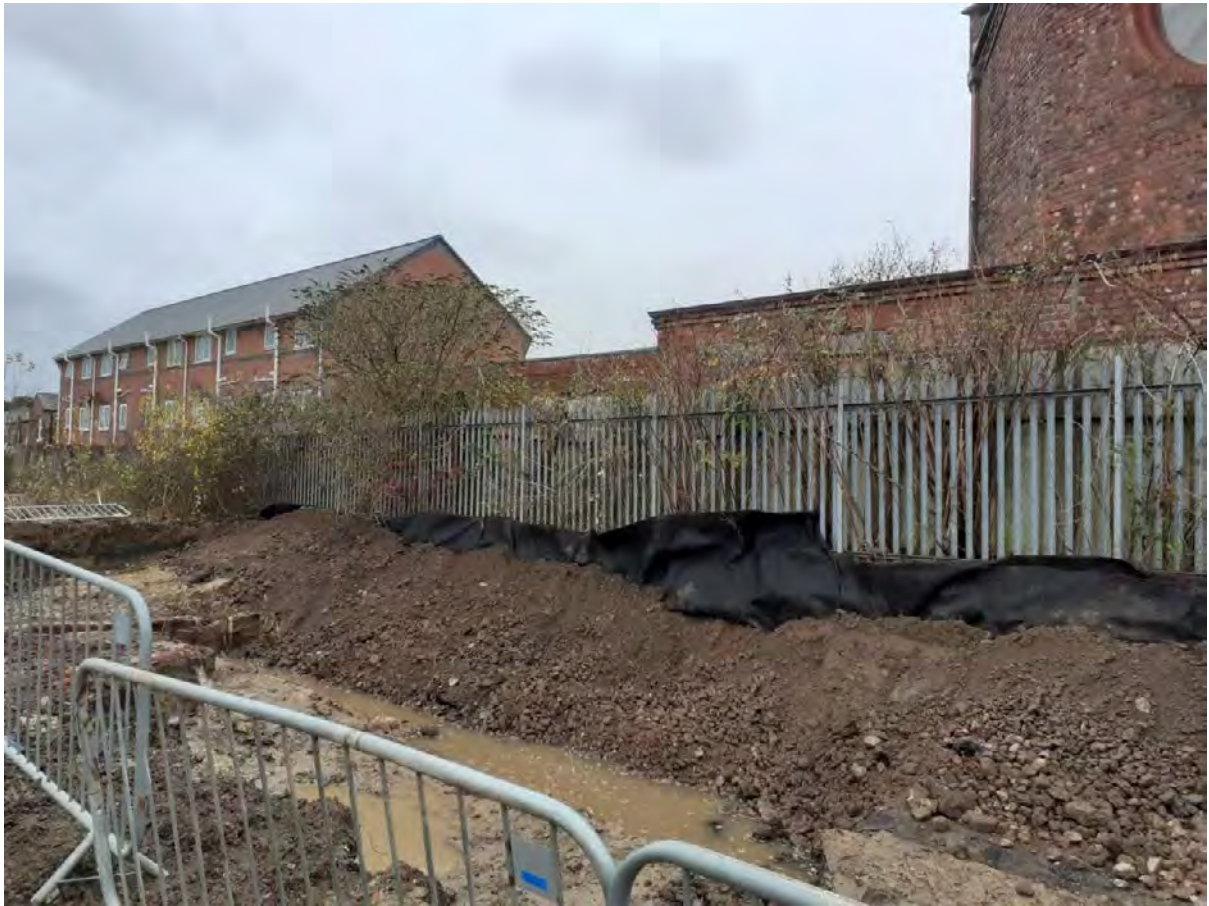
Pic 3 - JK area 1 with cutex along fence boundary

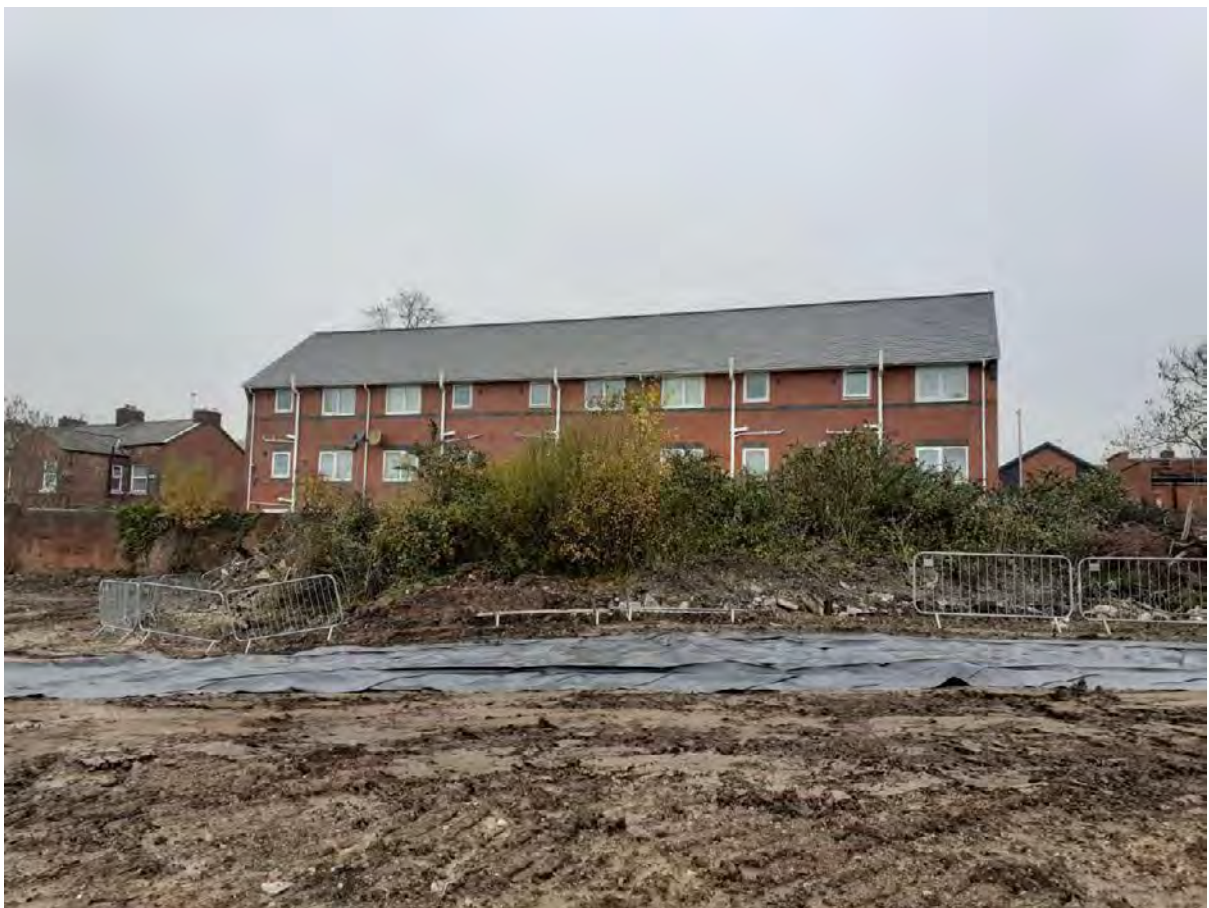
Pic 4 - JK area 2 before

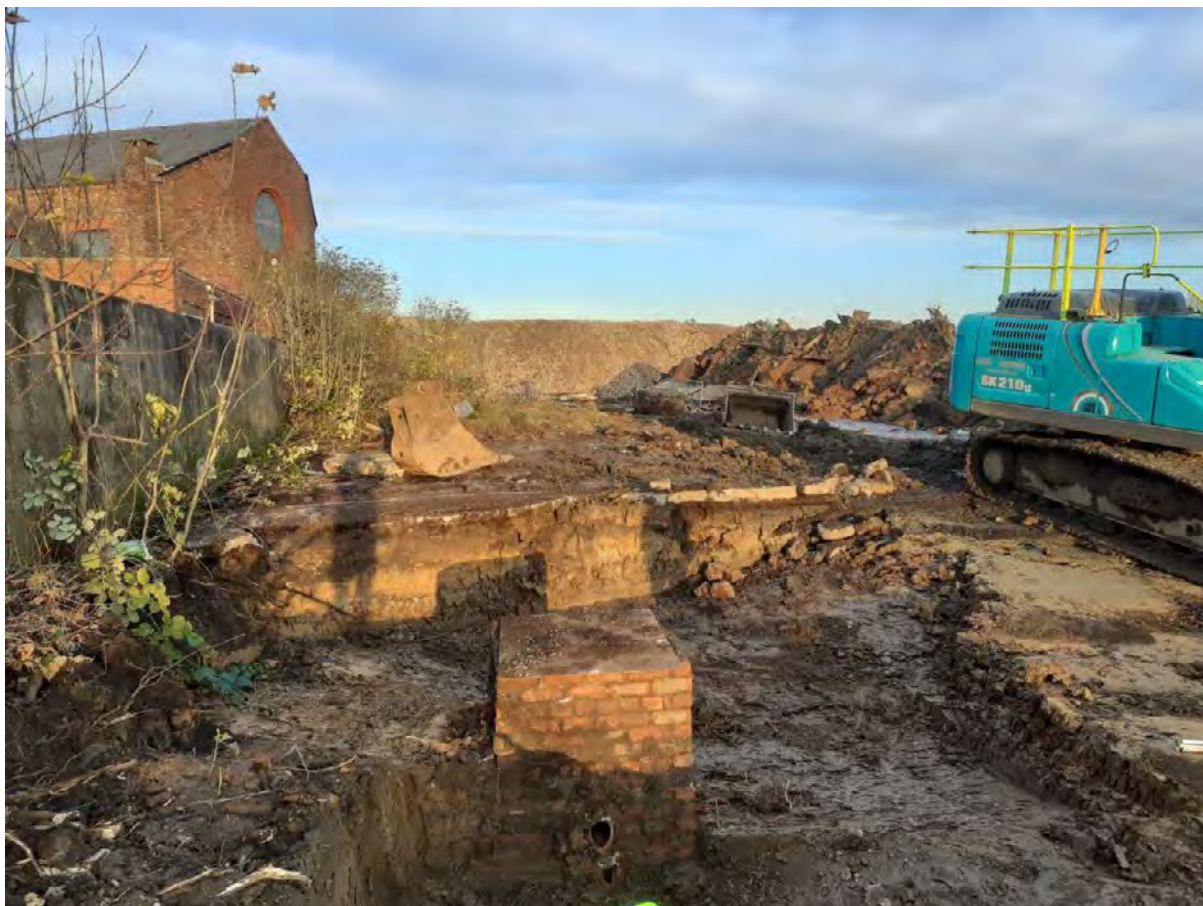
Pic 5 - JK area 2 after

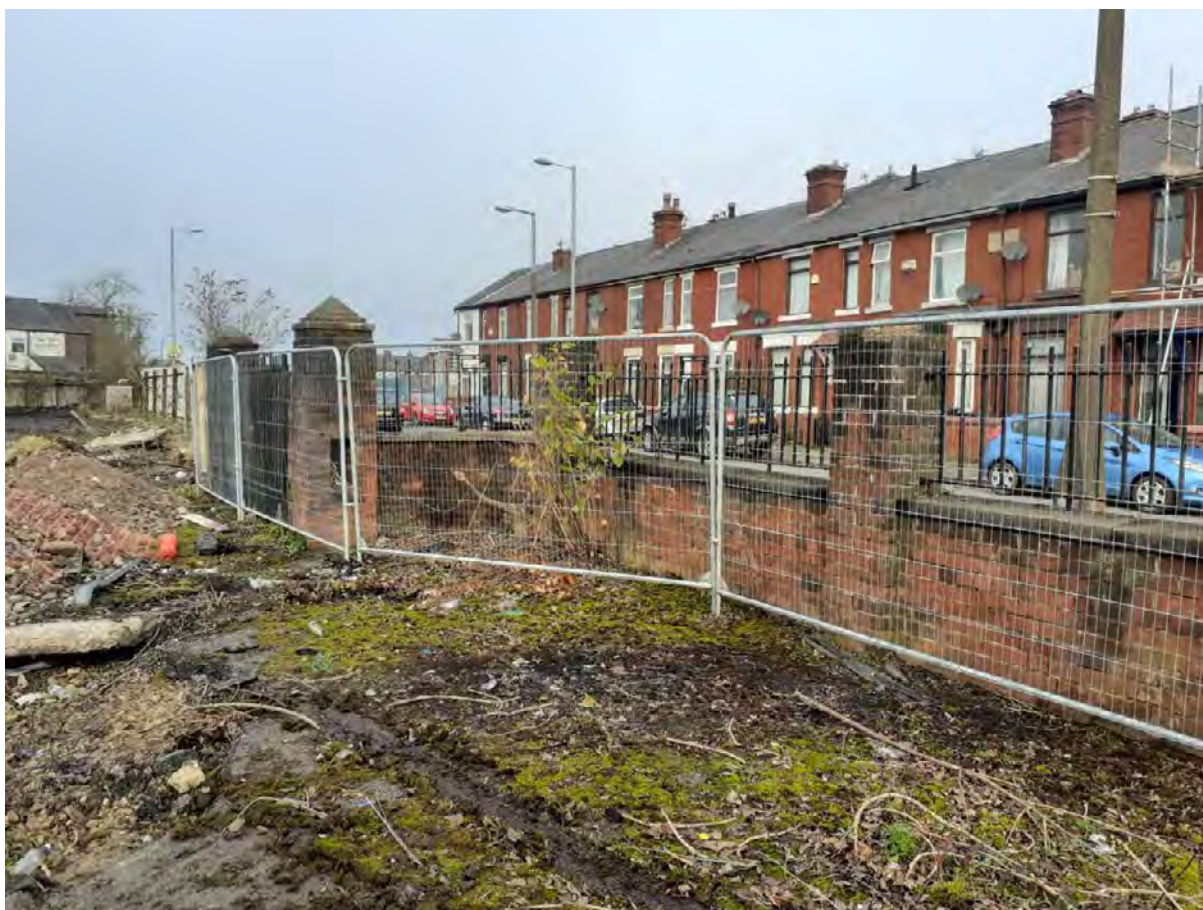
Pic 6 - JK Area 3 before

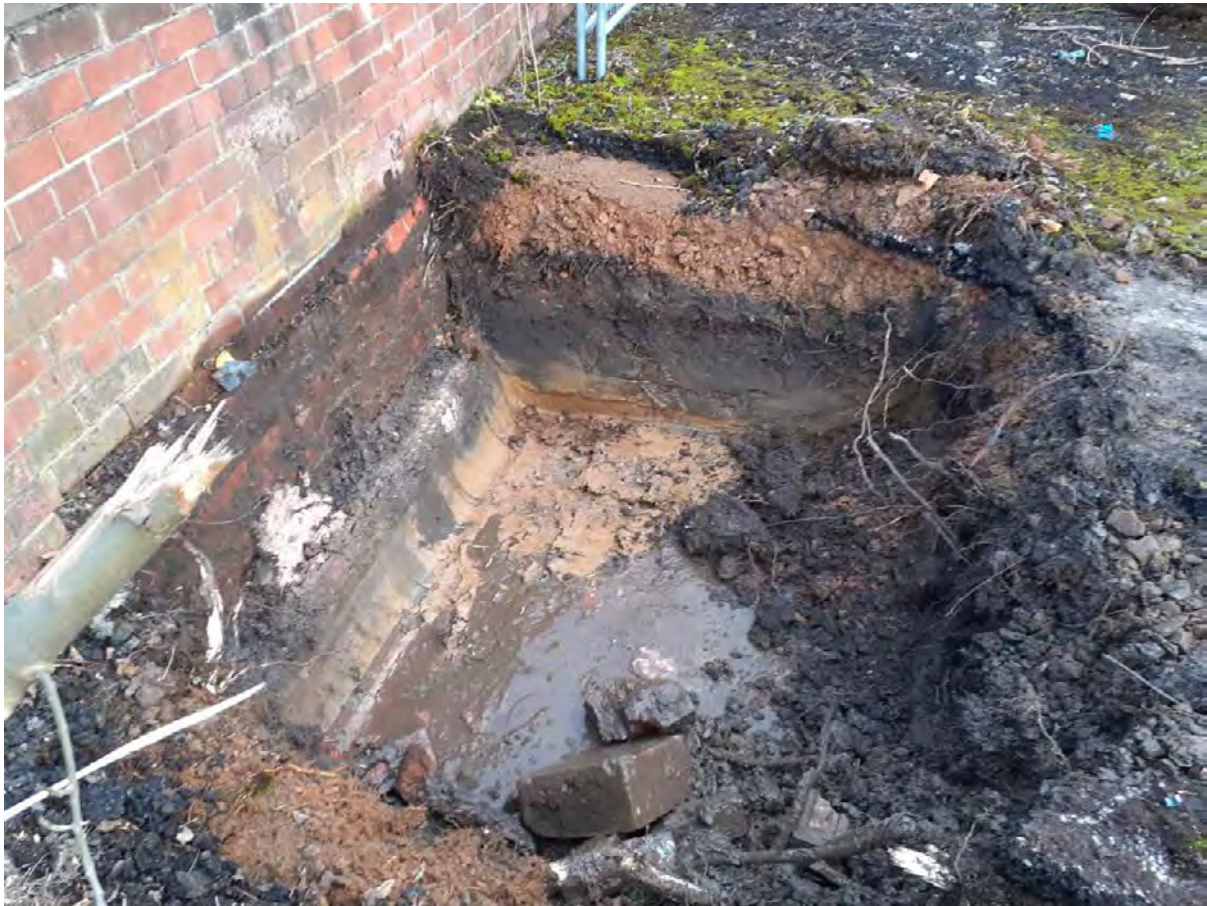
Pic 7 – JK area 3 after excavation

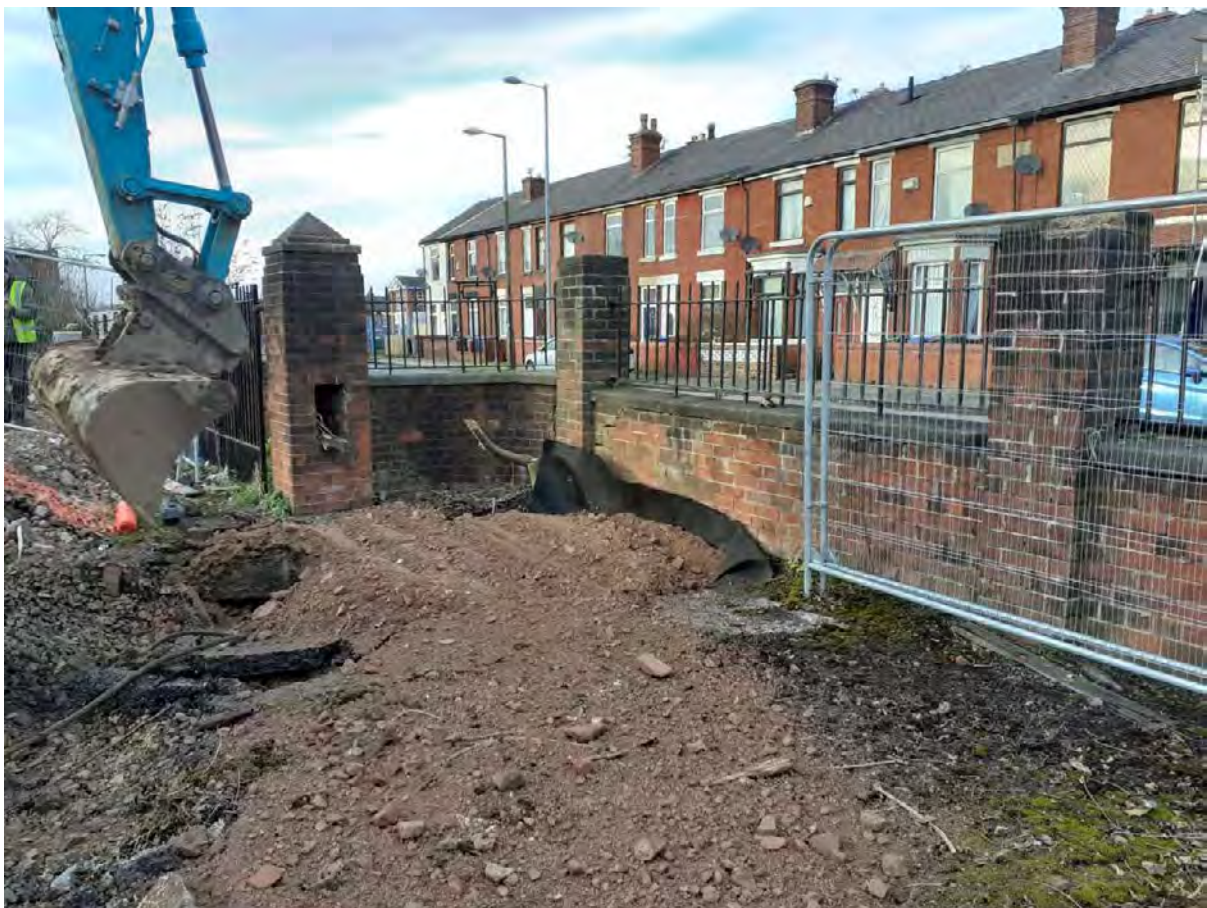
Pic 8 – JK Area 3 with CuTex and backfilled

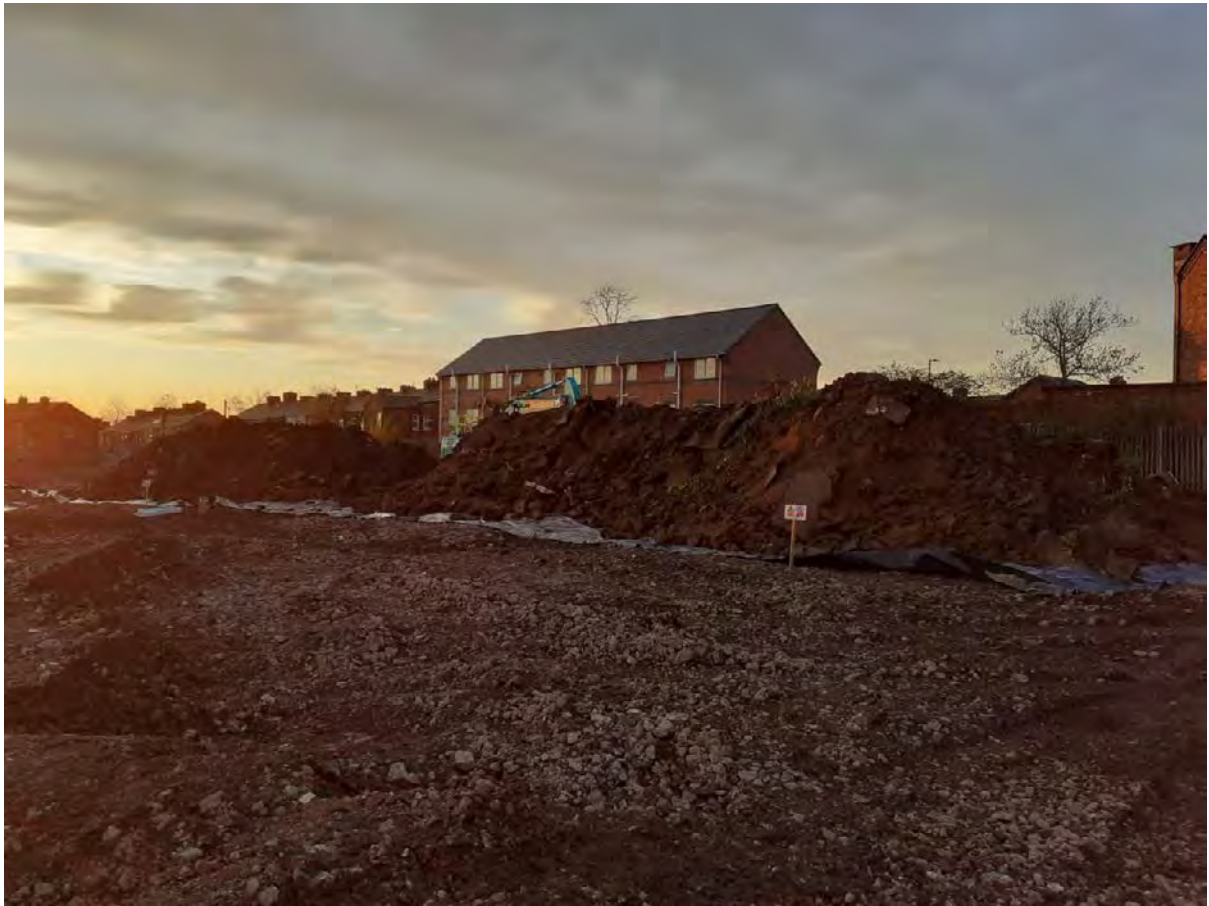
Pic 9 - Final excavated stockpile prior to being moved

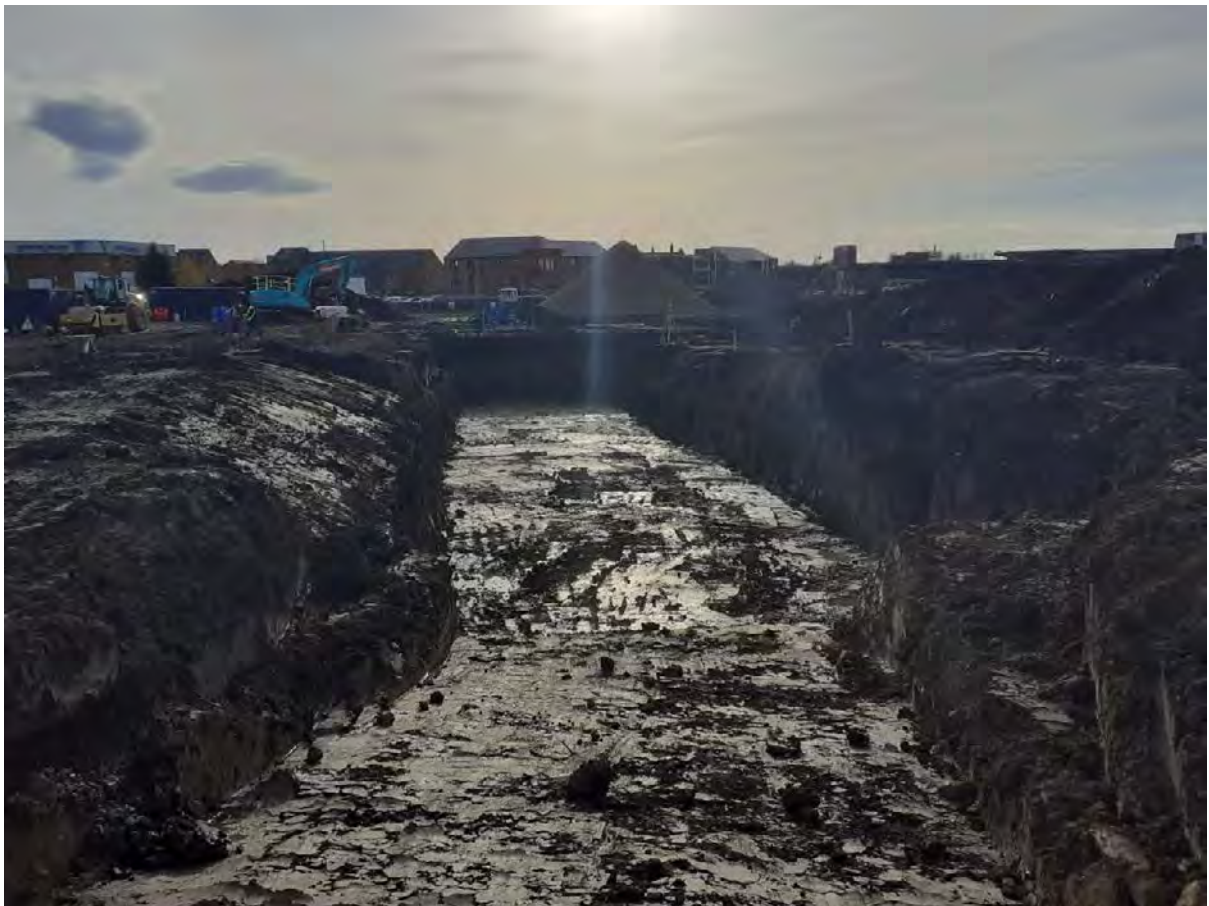
Pic 10 - burial cell before cutex

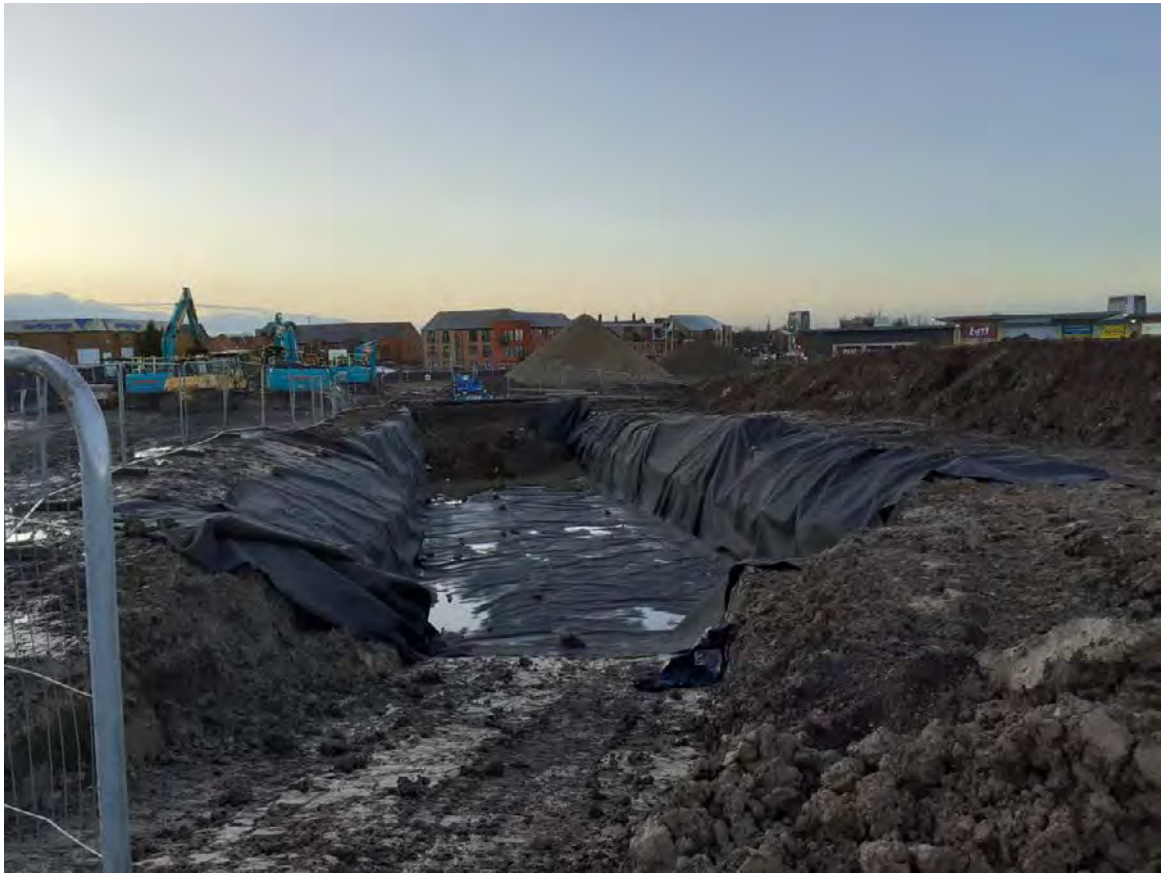
Pic 11 – Cutex burial cell before

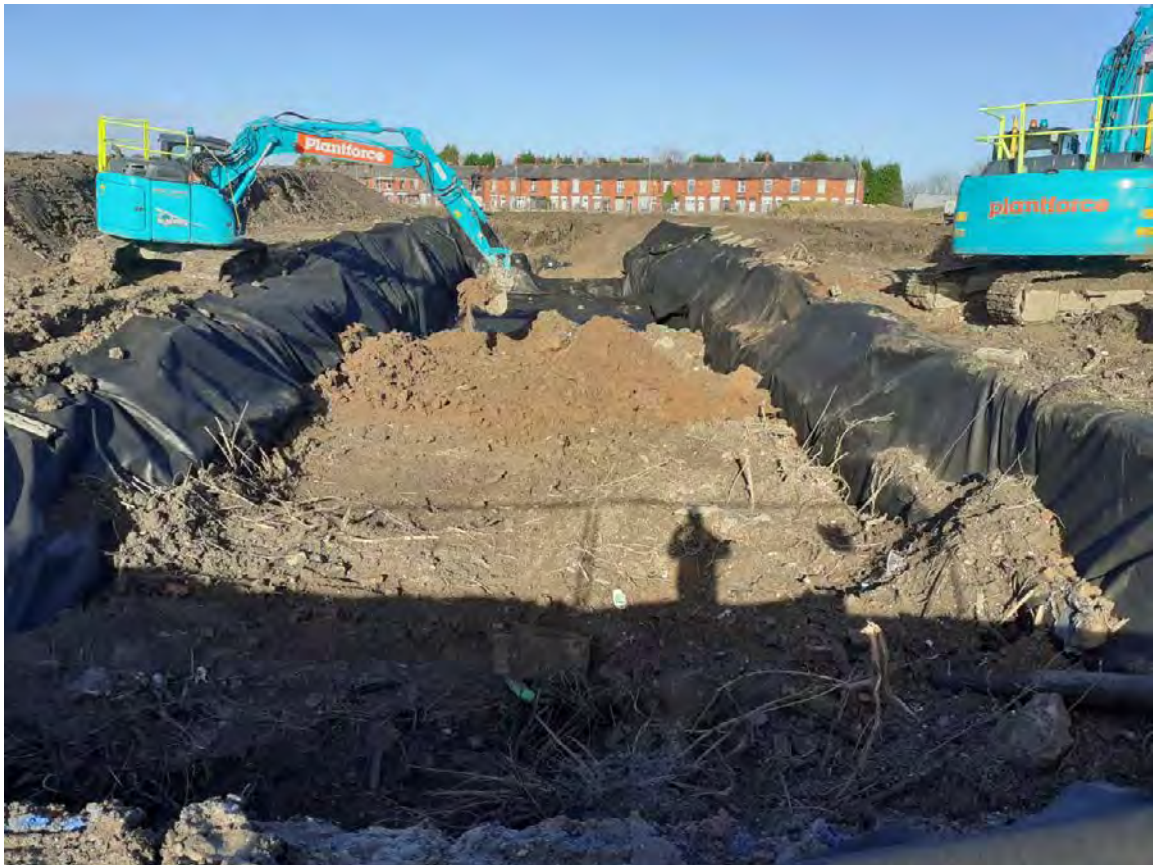
Pic 12 – Cell being filled with JK material

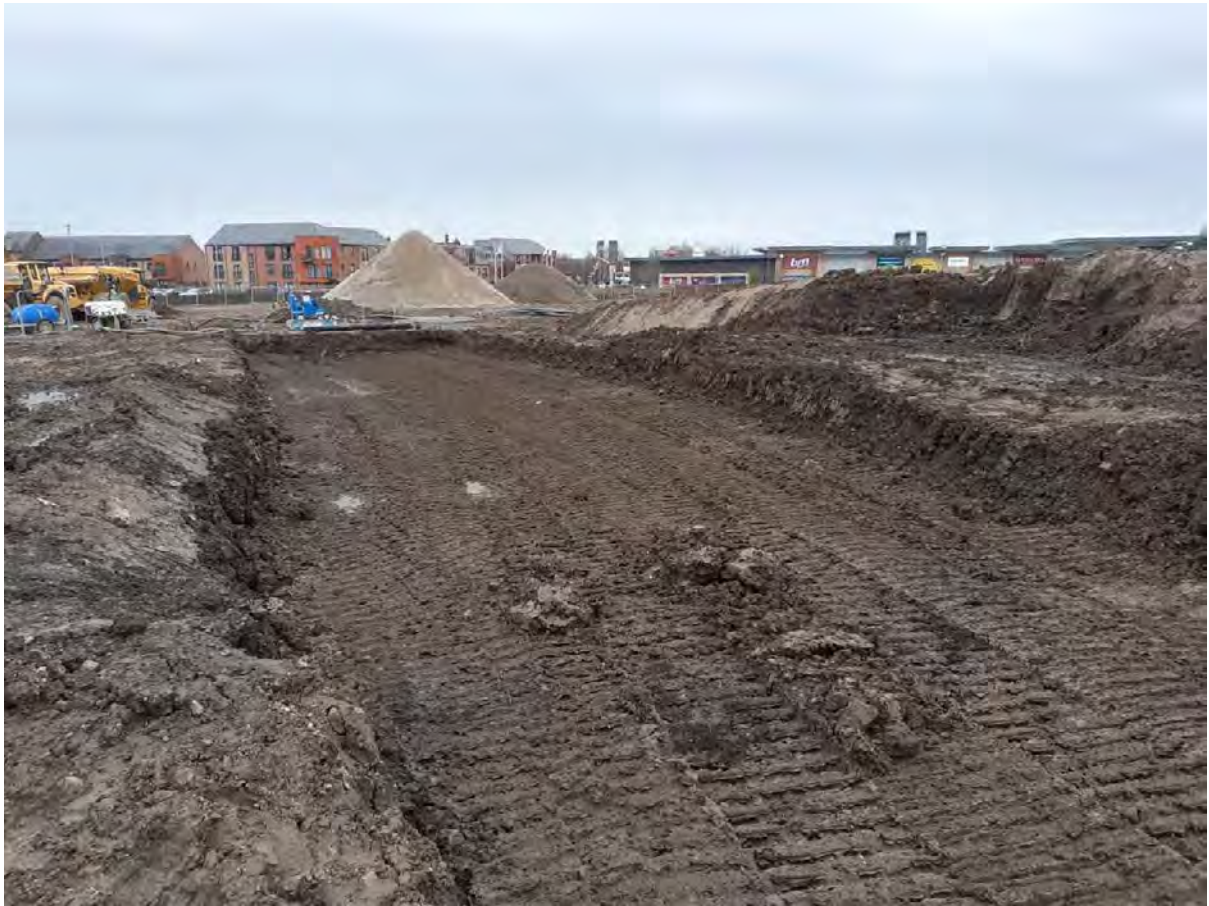
Pic 13 - Burial cell completed
