# St John's Quarter

Waste Management – MGY Earthworks

| <b>Appointment</b> | <p>In February 2018, Curtins were instructed by Manchester Quays Ltd to undertake a Phase 2 Intrusive Investigation at the St. John's development site in Manchester city centre. The site is approximately centred on NGR 383110, 398029, and covers an area of approximately 5.4 ha.</p> <p>This investigation addresses recommendations as presented in previous Phase 1 reports, with the aim of the Phase 2 works to characterise geo-environmental conditions prior to redevelopment as generally high rise (up to 52-storeys) buildings comprising residential apartments with retail, leisure and commercial spaces, and dual storey basements.</p> |

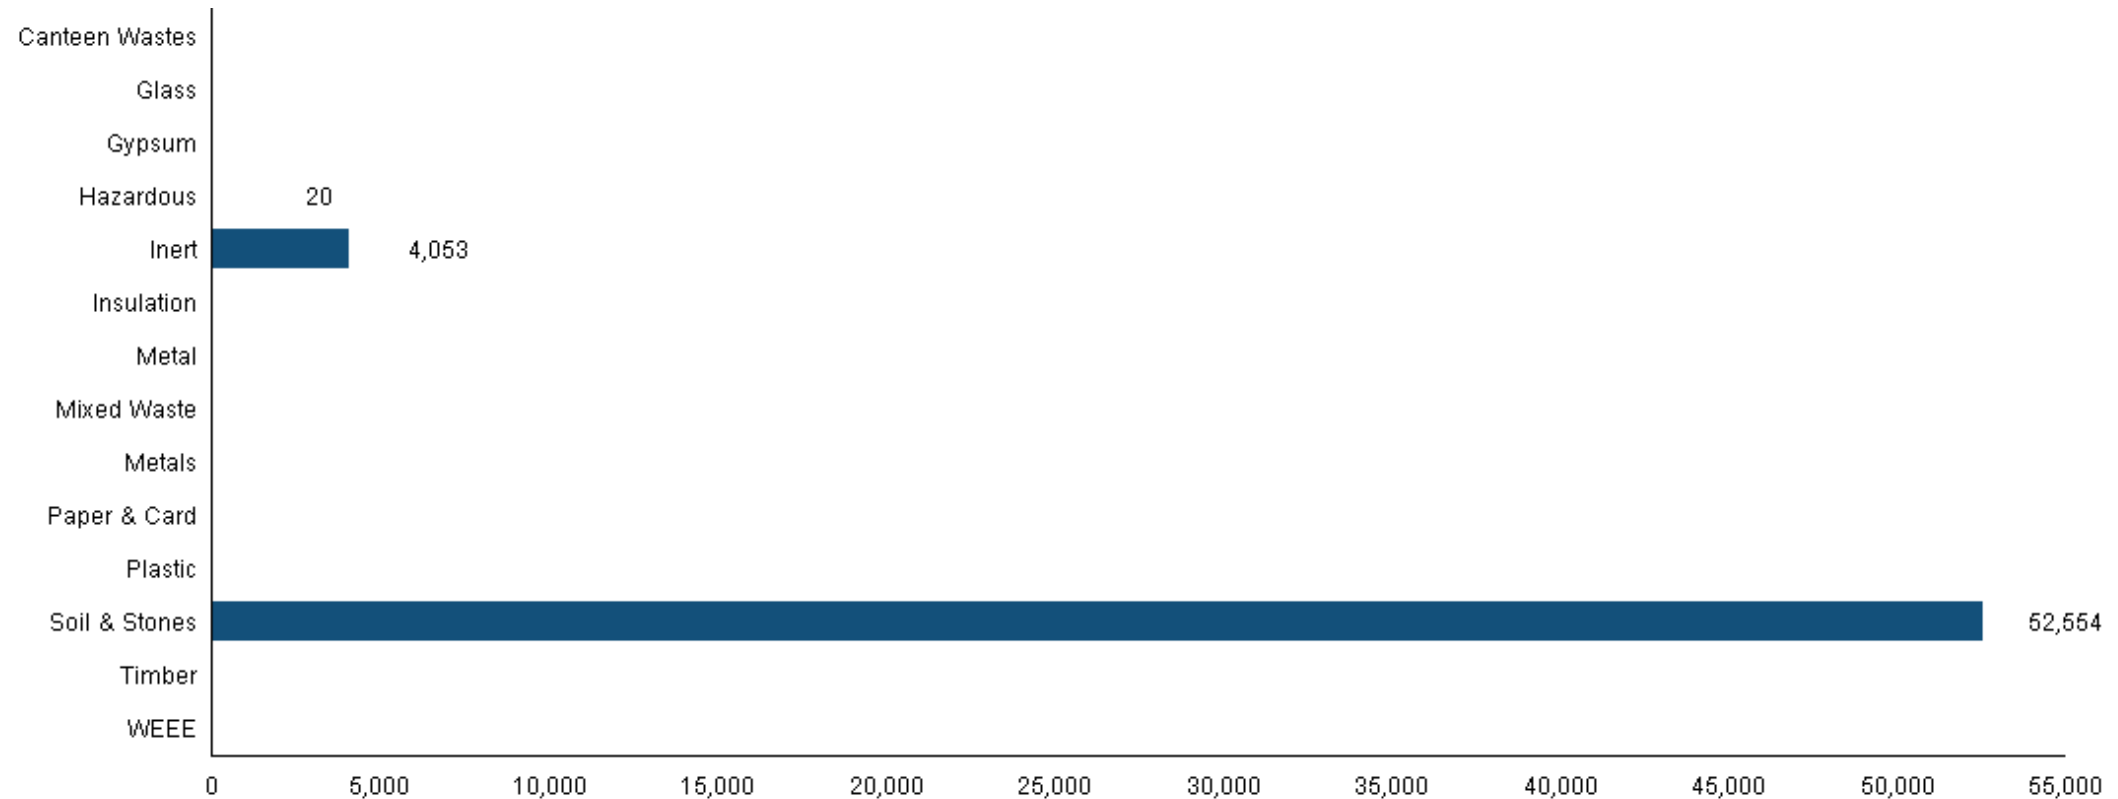
# Waste by Waste Grouping

- MGY basement excavation required the removal of 56,627 tonnes of soil and stone.
- Prior to removal retention on site for use in the scheme was considered however due to logistical constraints and quantity it was not possible.
- Earthworks contractor was W. Maher & Sons. They were required to remove and dispose of soil arisings.
- To ensure legal compliance all destination paper work was provided prior to removal.

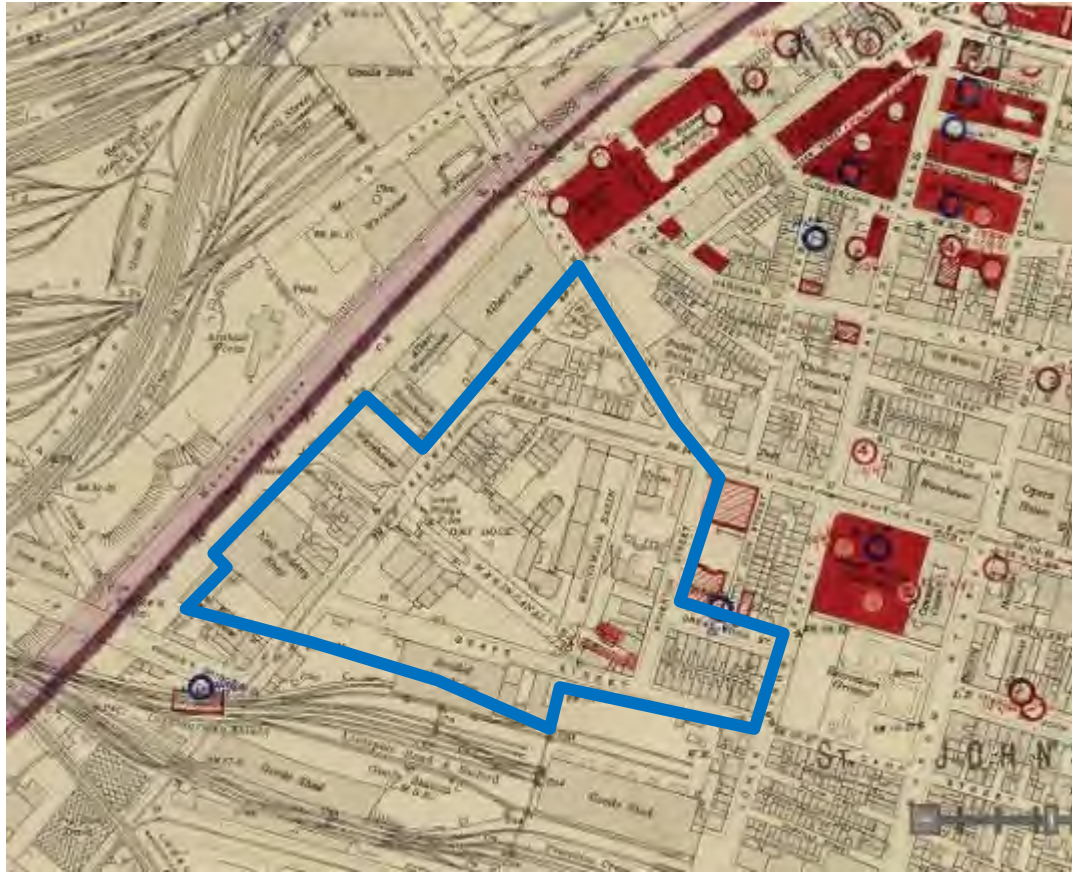
**Figure 2.6** – Historic Records showing bombing incidents during WWII. Site boundary marked in **Blue**. **Red** circles indicate fire bombs, **Blue** circles indicate high explosives, **Pink** shading indicates damaged buildings, **Red** shading indicates demolished buildings, **Green** marks indicate line mines.

A review of historical maps (Ref. 5) indicate bomb ruins within the south-eastern corner of the site, with damaged and demolished buildings in the vicinity to the east, north and south. Several fire bombs and high explosives were dropped in the vicinity of the site. *Figure 2.6* overleaf shows the impacted land during WWII.

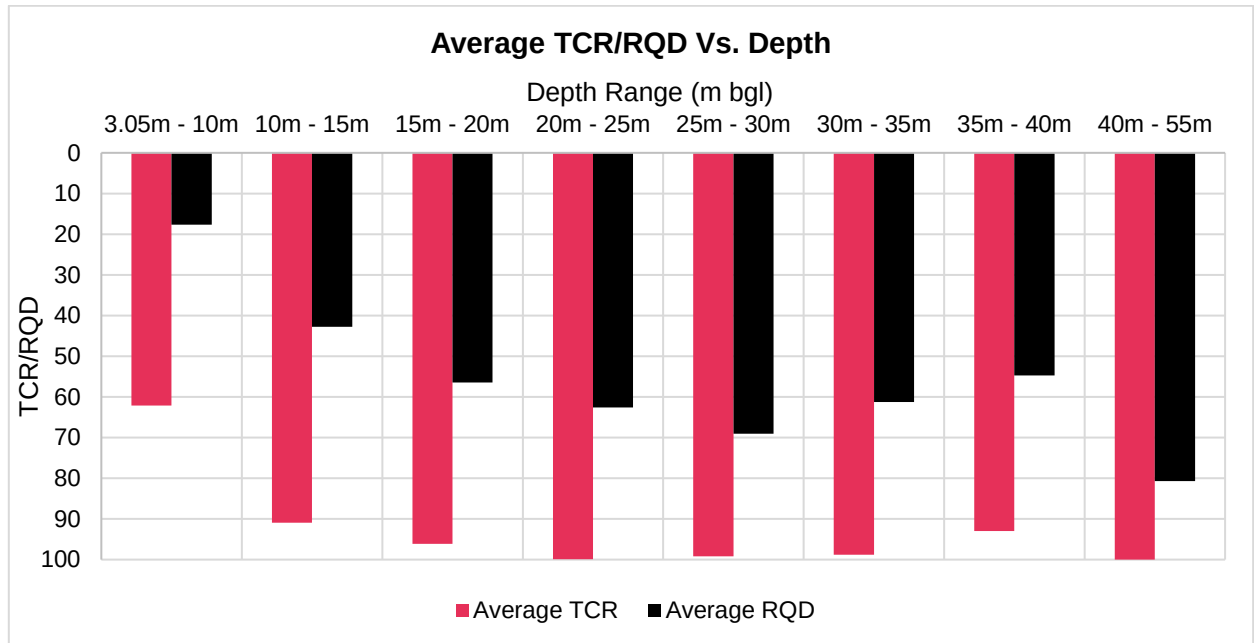
**Figure 5.4.1 – Average TCR and RQD Plotted Against Rock Depth**

The top of the strata is generally highly weathered and was recovered as sand and gravel in several locations, occasionally with clay lenses. Material recovered as rock was heavily fractured with very closely spaced, undulating and rough sand and gravel infilled fractures. The total core recovery (TCR) in the top 5m of rock (<10m bgl) was 62%, approximately 30% lower than the TCR between 10m – 15m bgl (91%), with corresponding average Rock Quality Designations (RQD) of 18 at depths <10m bgl and 43 between 10m – 15m bgl. The average TCR and RQD for rock at depths >15m were calculated to be 96 and 62 respectively. The above indicates that the rock at depths <10m bgl is of poor to very poor rock mass quality, increasing to poor to fair between 10m – 15m bgl. Rock at depths >15m bgl is generally of good rock mass quality. Generally, the RQD increases with depth, as shown in Figure 5.4.1 overleaf.

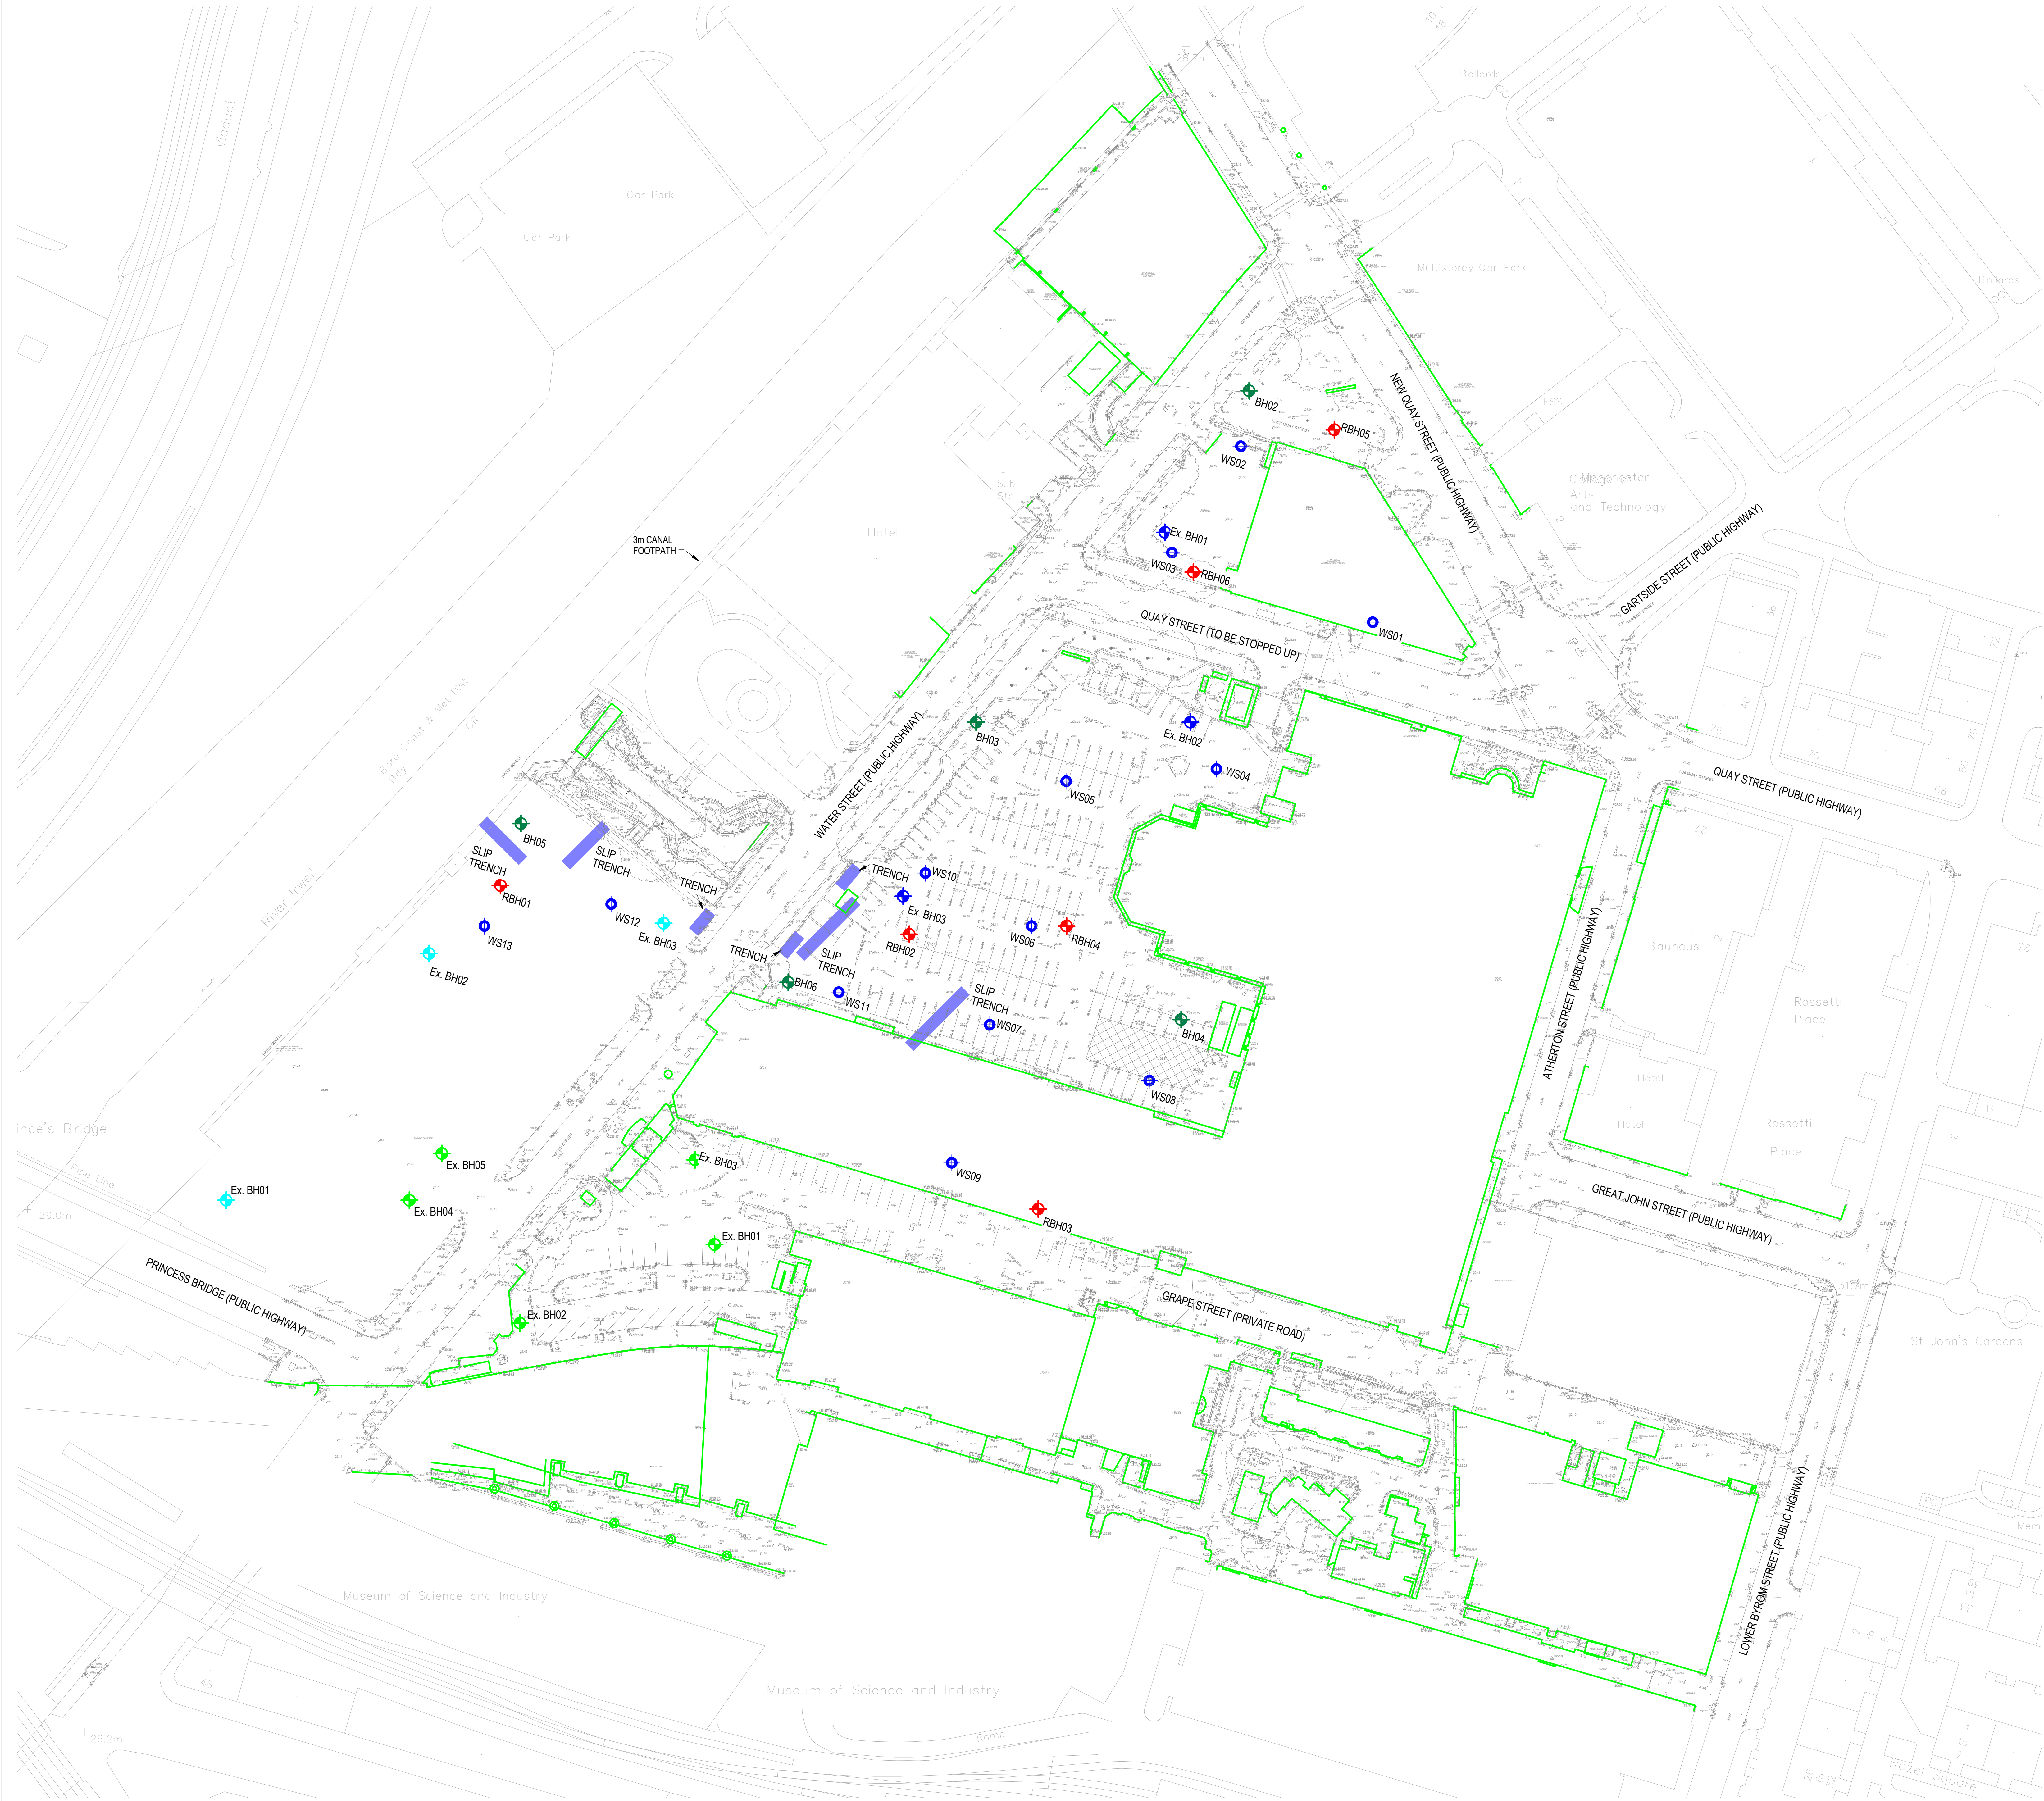
## Appendix A – Drawings

- Curtins drawing ref. 065330-CUR-TMP-XX-DR-S-20059 Geotechnical Masterplan Without Proposed Buildings
- Curtins drawing ref. 065330-CUR-TMP-XX-DR-S-20055 Geotechnical Masterplan Stage 1
- Curtins drawing ref. 065330-CUR-TMP-XX-DR-S-20056 Geotechnical Masterplan Stage 2
- Curtins drawing ref. 065330-CUR-TMP-XX-DR-S-20057 Geotechnical Masterplan Stage 3
- Curtins drawing ref. 065330-CUR-TMP-XX-DR-S-20058 Geotechnical Masterplan Stage 4

- KEY**
- Ex.BH\*\* BOREHOLES TAKEN FROM THE LAND CONSULTANCY LIMITED REPORT FOR CURTINS DATED 26th MAY 2016
  - Ex.BH\*\* BOREHOLES TAKEN FROM ESG REPORT UNDERTAKEN FOR BURD HAPPOLD DATED 15th MARCH 2017
  - Ex.BH\*\* BOREHOLES TAKEN FROM CCG REPORT UNDERTAKEN FOR NORTHERN HUB ALLIANCE DATED 27th OCTOBER 2015
  - RBH\*\* PROPOSED OPEN HOLE ROTARY THROUGH SUPERFICIAL PLUS ROTARY CORED TO BASE THROUGH INTACT ROCK
  - BH\*\* PROPOSED CABLE PERCUSSIVE BOREHOLE THROUGH SUPERFICIAL PLUS ROTARY CORED TO BASE THROUGH INTACT ROCK
  - TP\*\* PROPOSED TRIAL PITS
  - WS\*\* PROPOSED WINDOW SAMPLES

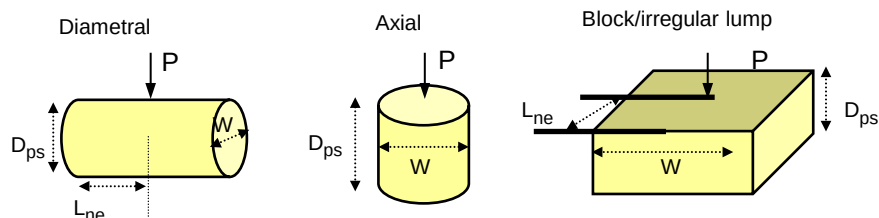
Detailed legend for test and dimensions, based on ISRM

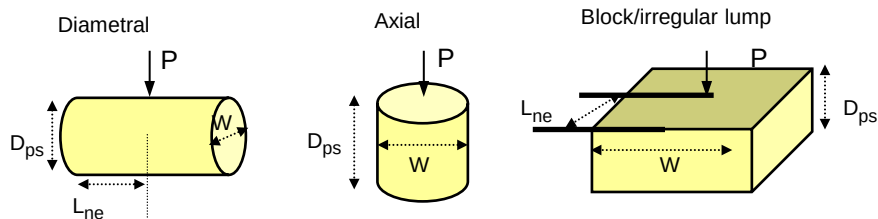
Detailed legend for test and dimensions, based on ISRM

Dps - Distance between platens ( platen separation )  
Dps' - at failure ( see ISRM note 6 )  
Lne - Length from platens to nearest free end  
W - Width of shortest dimension perpendicular to load, P  
Size factor, F = (De/50)0.45 for all tests.

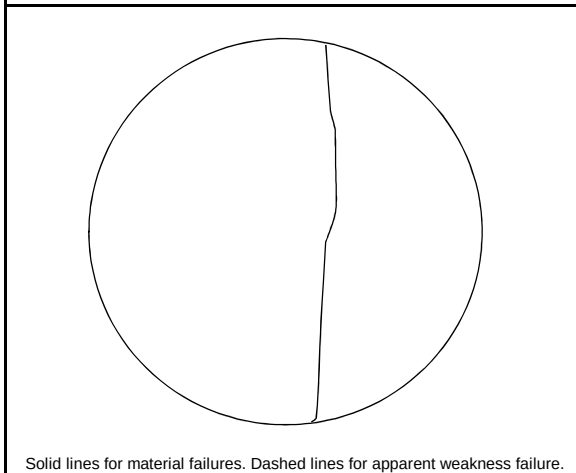
Full details of the lithologies, rock properties, and fracture notes are presented within exploratory borehole logs, attached within *Appendix B*.

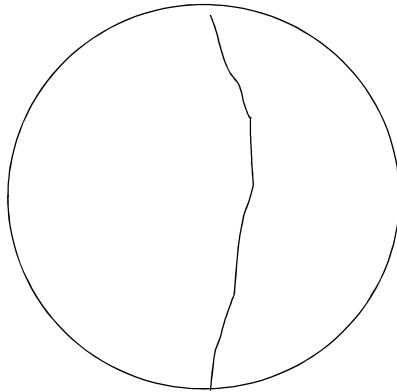
Eight Hoek Triaxial Compression Tests were undertaken in sandstone bedrock at depths between 11.00m – 21.86m bgl. Test results indicate an internal angle of friction of between 20.5° -40.9° with an apparent cohesion of between 3 and 7 MPa.

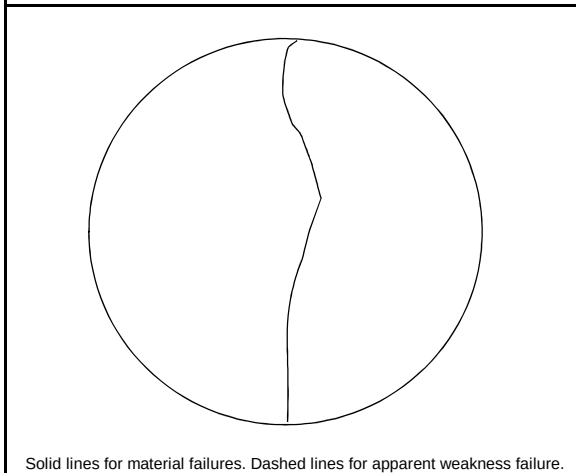
| RBH06 | SANDSTONE | 10.20 – 10.50 | 3.90 | - |

Groundwater levels within the bedrock deposits typically rose above the monitoring installation response zone, to depths of between 1.97m – 4.44m bgl.

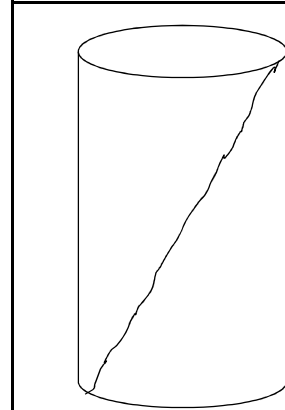
## Failure Sketch

Solid lines for material failures.  
 Dashed lines for apparent weakness failure.

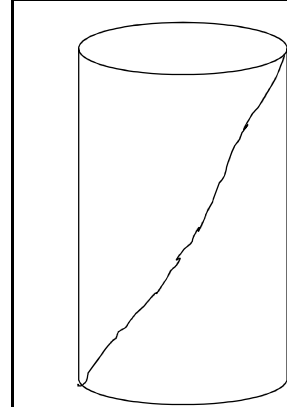
## Failure Sketch

Solid lines for material failures.  
 Dashed lines for apparent weakness failure.

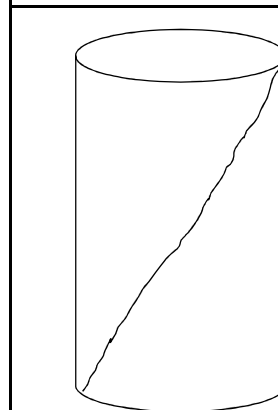
## Failure Sketch

Solid lines for material failures.  
 Dashed lines for apparent weakness failure.

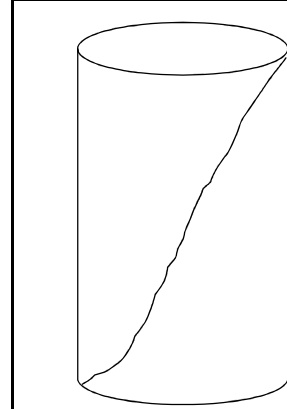
**Failure Sketch**

Solid lines for material failures.  
 Dashed lines for apparent weakness failure.

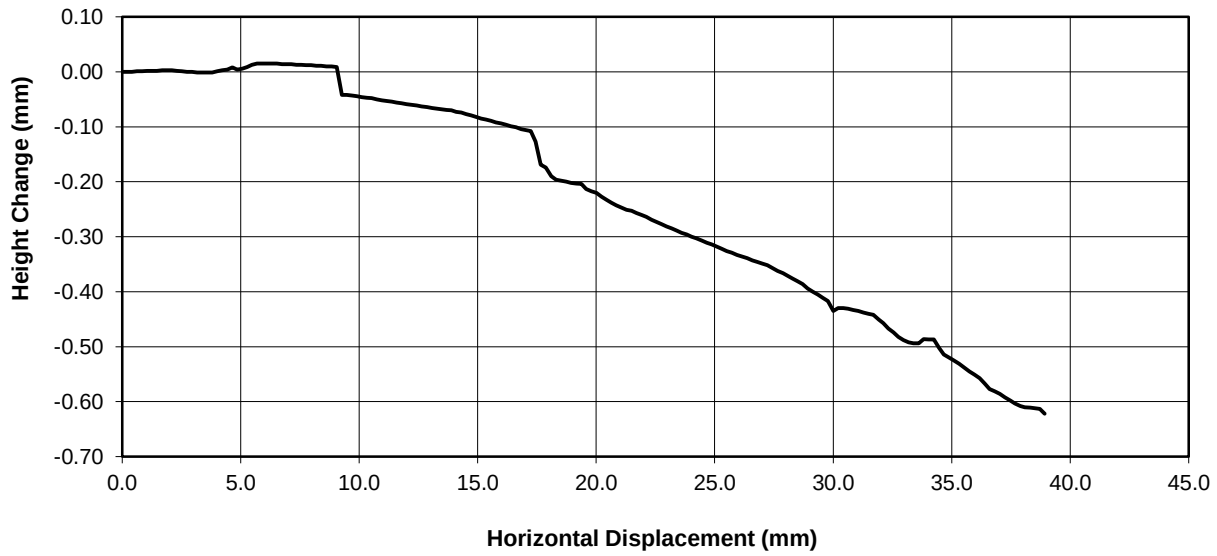
Height Change v Horizontal Displacement

Description:  
Medium strong to weak orangish brown fine to medium grained SANDSTONE. Moderately weathered.  
Natural shear plane with no infill material.  
Joint roughness coefficient = 2-4.  
Debris is abundant sand and fine to medium gravel.

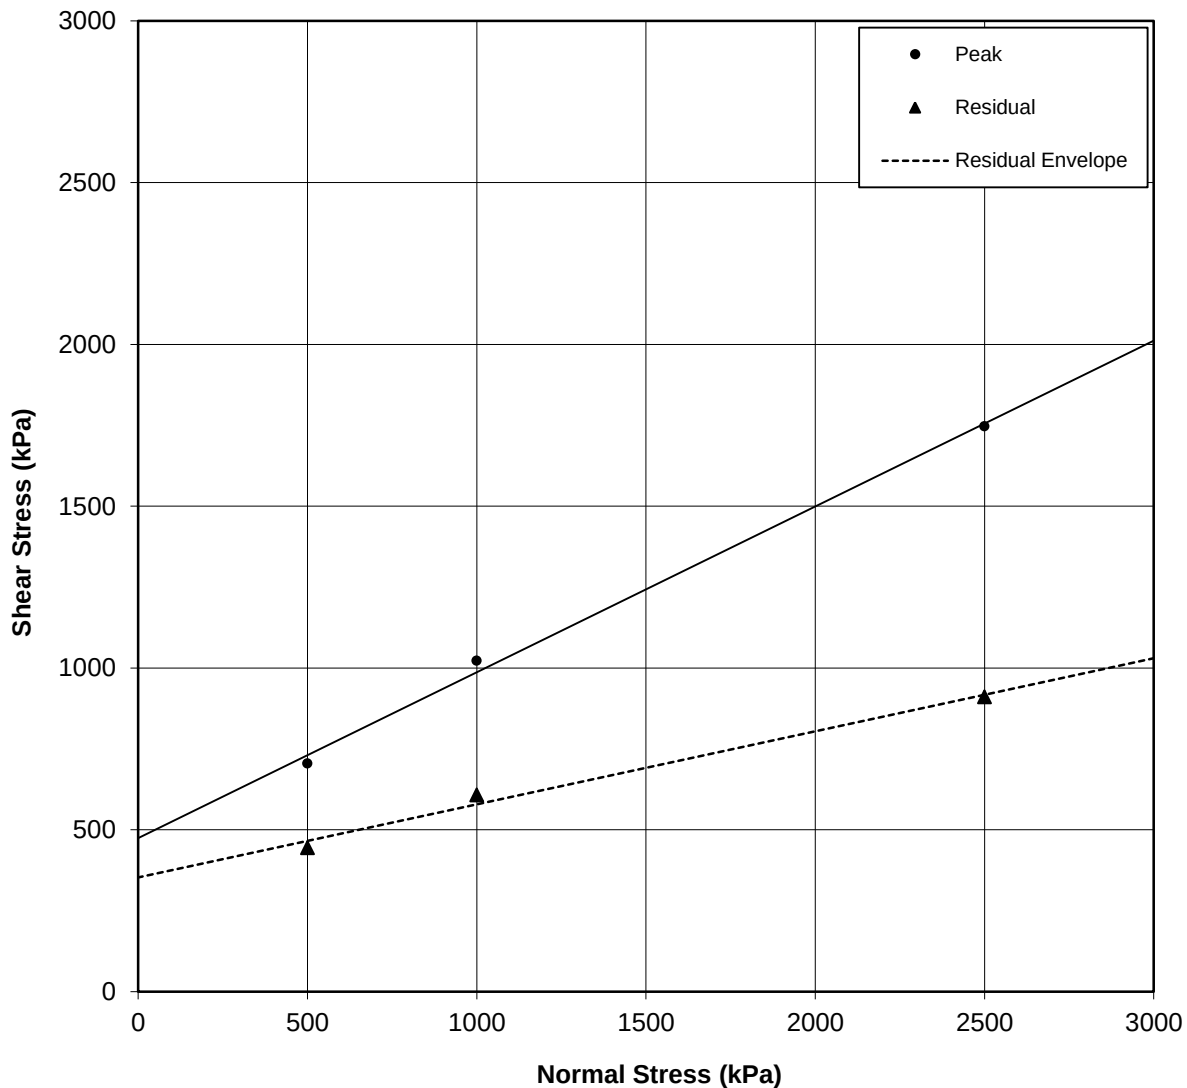
### Shear Stress v Normal Stress

Medium strong orangish brown fine to medium grained SANDSTONE. Moderately weathered. Natural shear plane with no infill material. Joint roughness coefficient = 10-12. Debris is fine to coarse sub-angular gravel and sand.

**Peak:**  $c' = 475$   
 $\phi' = 27^\circ$

**Residual:**  $c' = 354$   
 $\phi' = 12.5^\circ$

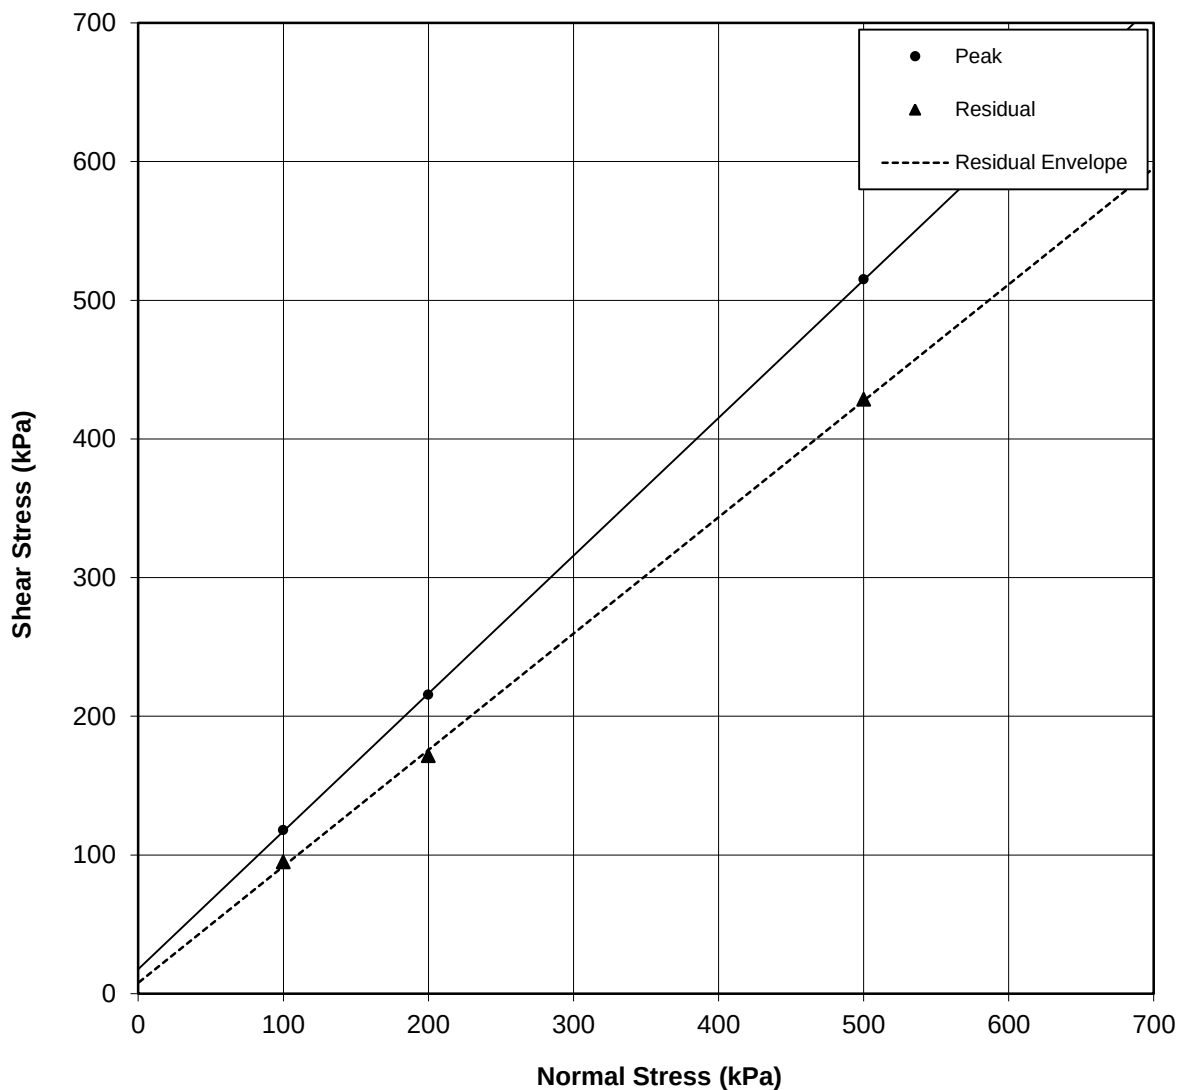
## Shear Stress v Normal Stress

Description:  
Medium strong to weak orangish brown fine to medium grained SANDSTONE. Moderately weathered.  
Natural shear plane with no infill material.  
Joint roughness coefficient = 6-8.  
Debris is negligible.

**Peak:**  $c' = 18$   
 $\Phi' = 45^\circ$

**Residual:**  $c' = 8$   
 $\Phi' = 40^\circ$

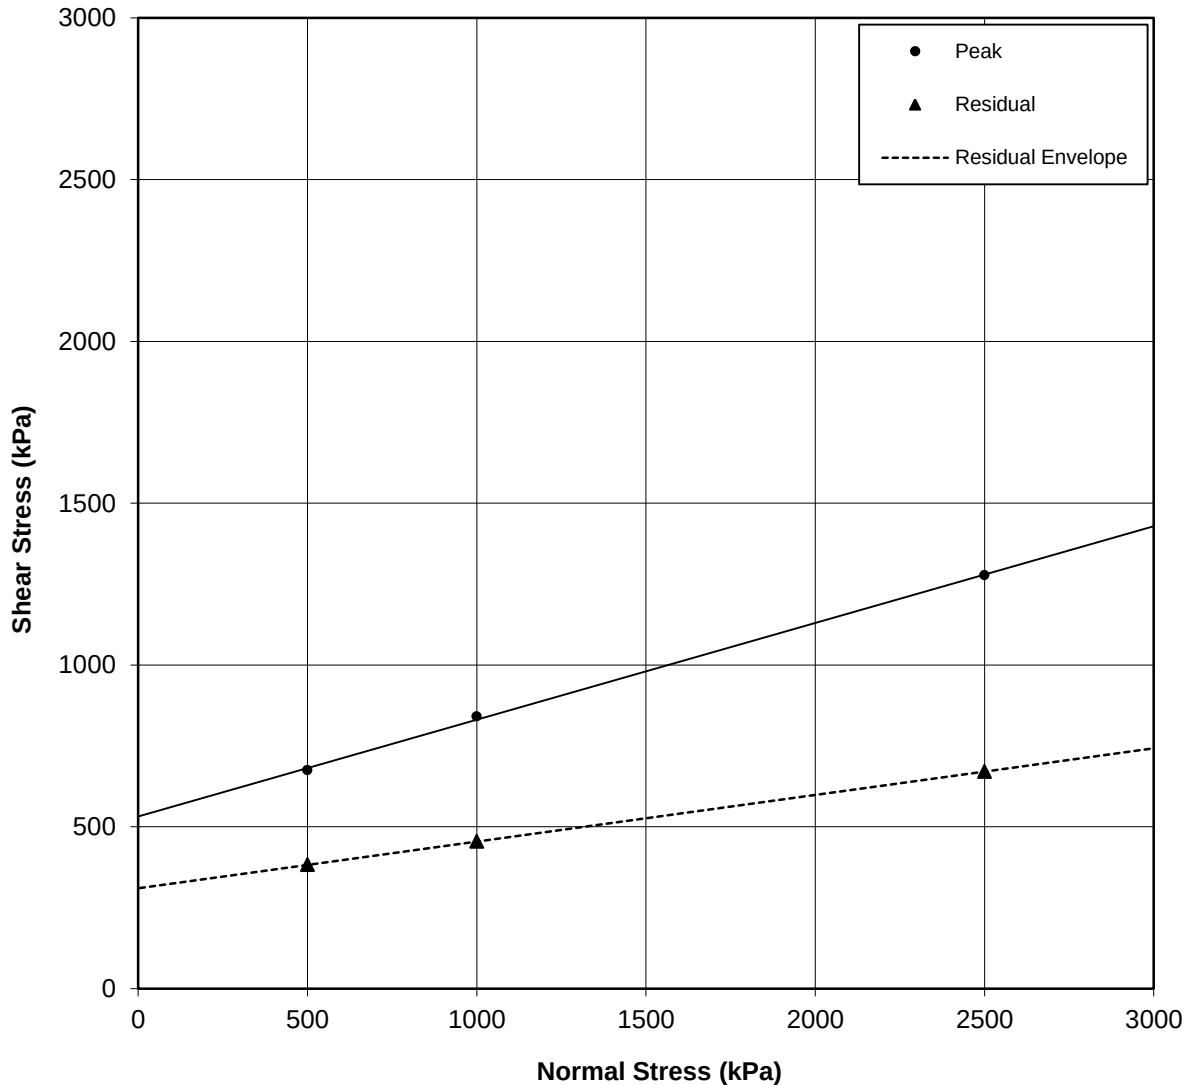
### Shear Stress v Normal Stress

Description:  
Medium strong to weak orangish brown fine to medium grained SANDSTONE. Moderately weathered. Natural shear plane with no infill material.  
Joint roughness coefficient = 6-8.  
Debris is sand and fine to medium sub-angular gravel.

**Peak:**  $c' = 533$       **Residual:**  $c' = 311$   
 $\Phi' = 16.5^\circ$        $\Phi' = 8^\circ$

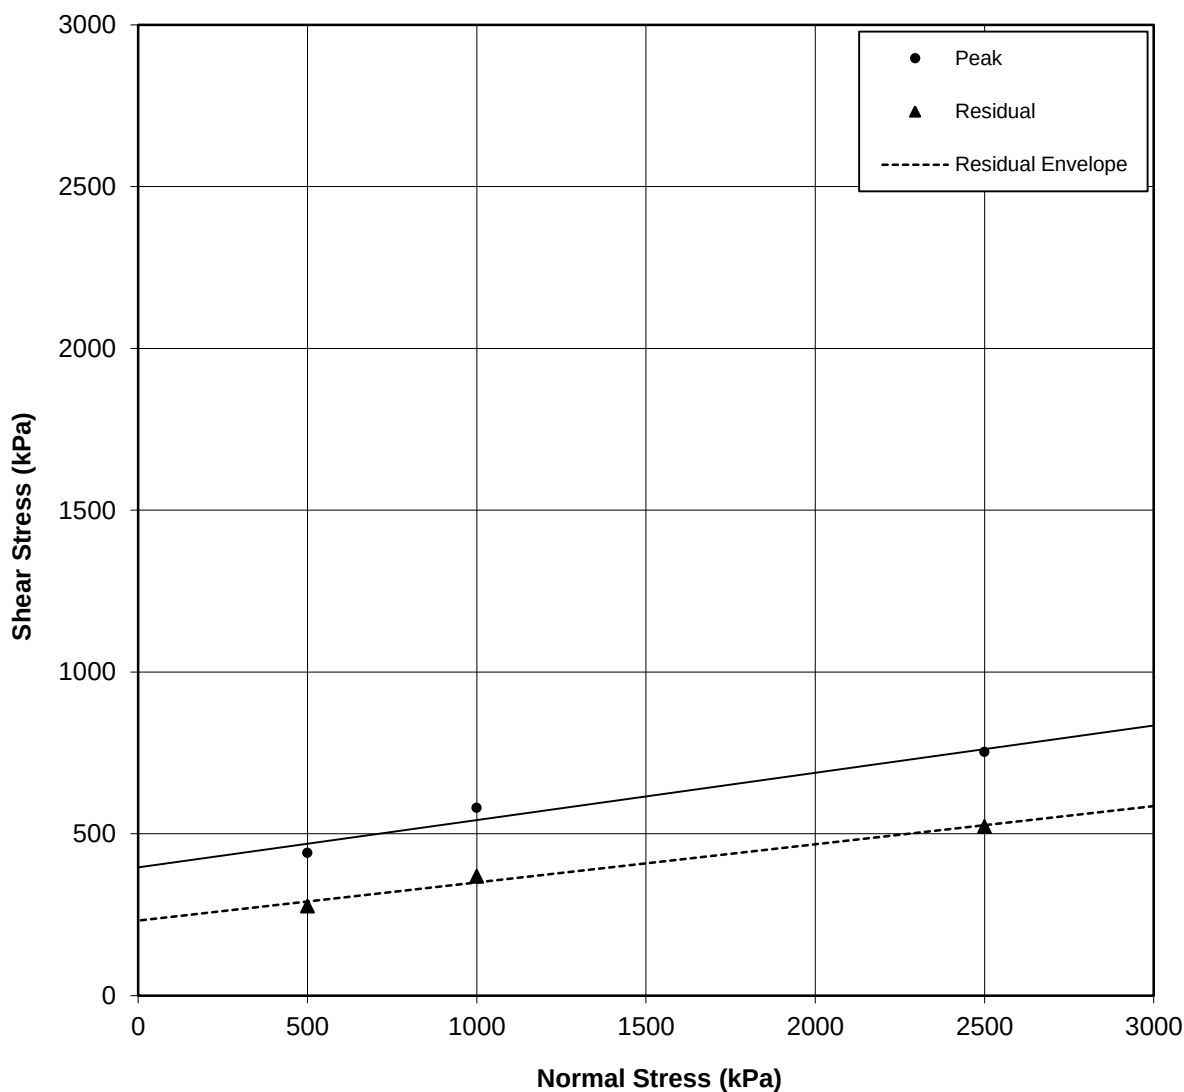
## Shear Stress v Normal Stress

Debris is sand and fine sub-rounded gravel.

**Peak:**  $c' = 396$   
 $\phi' = 8.5^\circ$

**Residual:**  $c' = 233$   
 $\phi' = 6.5^\circ$

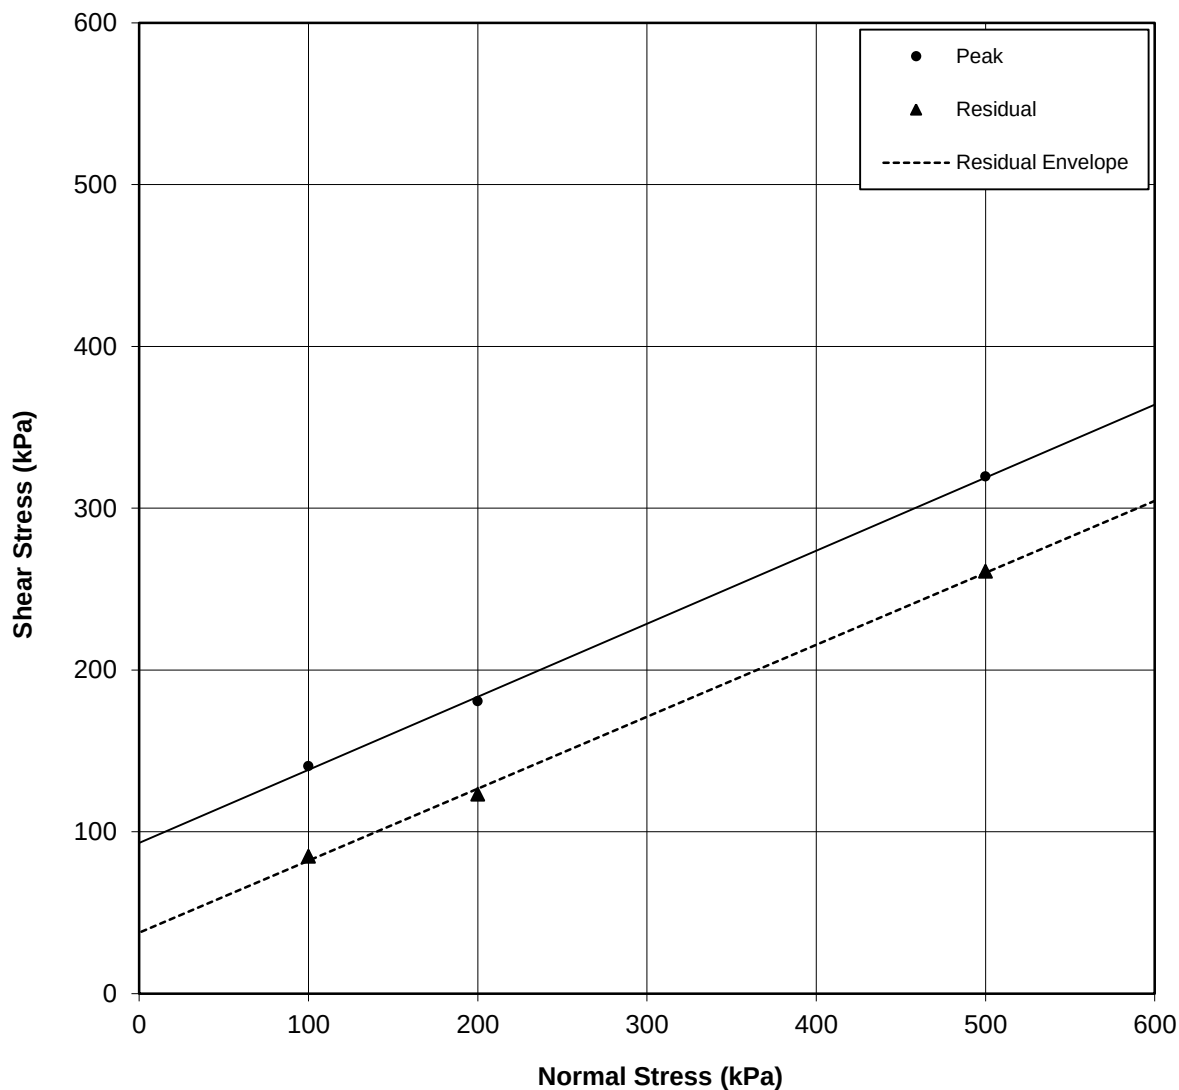
## Shear Stress v Normal Stress

Description:  
Medium strong to weak orangish brown fine to medium grained SANDSTONE. Moderately weathered.  
Natural shear plane with no infill material.  
Joint roughness coefficient = 4-6.  
Debris is sand and fine to medium gravel.

**Peak:**  $c' = 93$   
 $\Phi' = 24.5^\circ$

**Residual:**  $c' = 38$   
 $\Phi' = 24^\circ$

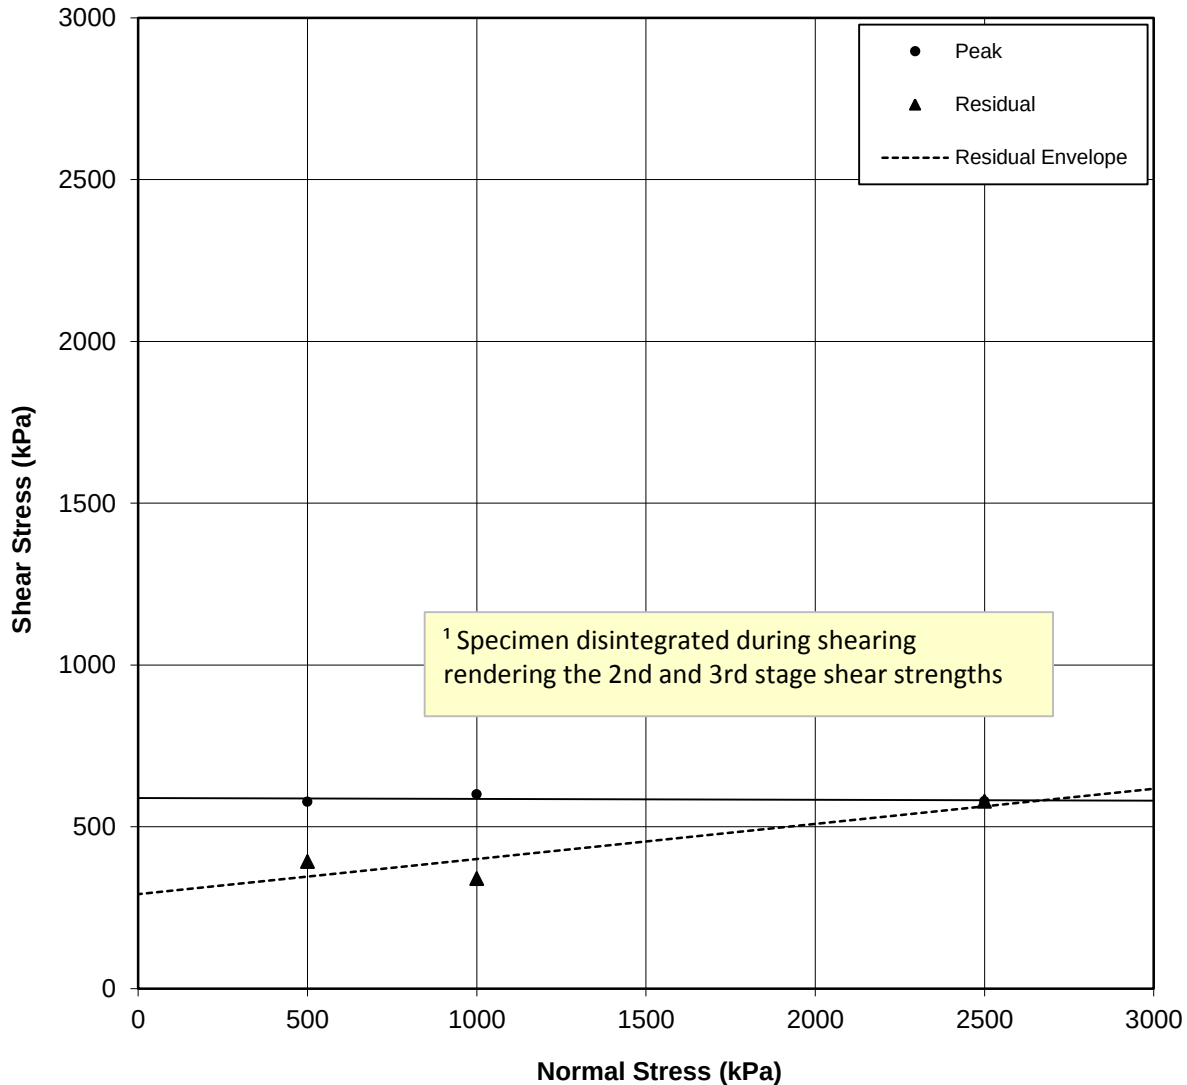
### Shear Stress v Normal Stress

Description:  
 Medium strong to weak orangish brown fine to medium grained SANDSTONE. Moderately weathered. Natural shear plane with no infill material.  
 Joint roughness coefficient = 2-4.  
 Debris is abundant sand and fine to coarse gravel.<sup>1</sup>

**Peak:**  $c' = n/a$   
 $\Phi' = n/a$

**Residual:**  $c' = n/a$   
 $\Phi' = n/a$
