# VITA T2, St Johns

## Phase 2 Ground Investigation

Curtins Ref: T2-CUR-JC10-TS-XX-001

Issue Date: 03 November 2021

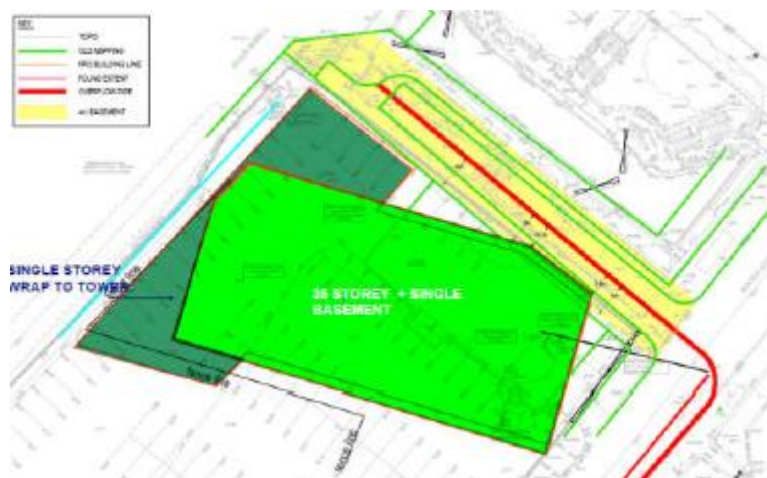
Development proposals include the construction of a 36 storey building with single storey basement beneath the tower footprint. A single storey wrap is proposed at the west of the proposed structure, as detailed in *Figure 1.1*.

**Figure 1.1** – Summary of Development Proposal

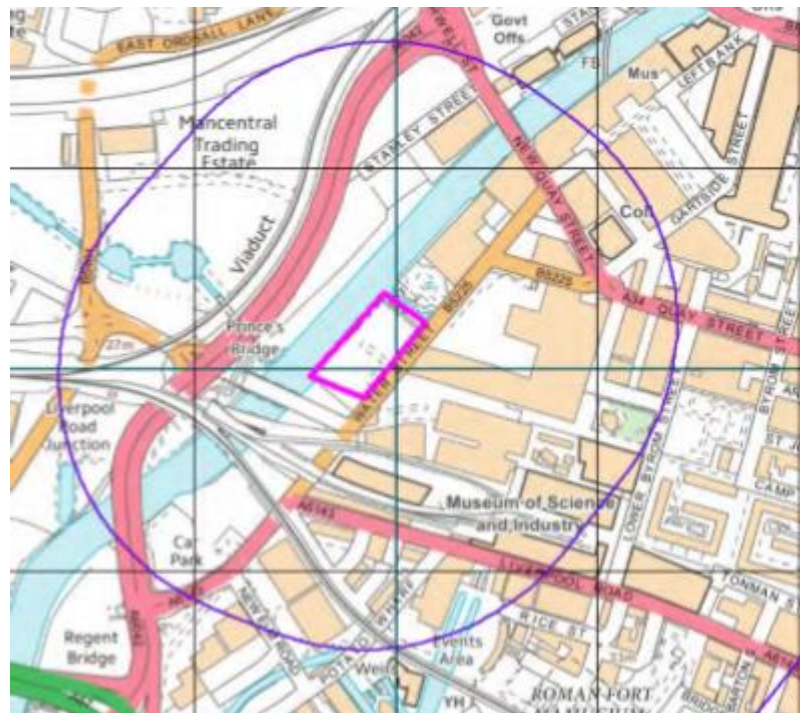
**Figure 2.1** – Site Location Plan (site boundary shown in pink. 250m buffer in purple).  
Crown Copyright. License Number 100022432.

The relatively flat site is currently occupied by a car park with tarmac surface cover. The site is bound by hoarding and/or fencing, with Water Street immediately south, from which the site can be accessed.

The site location and boundary are illustrated in *Figure 2.1*.

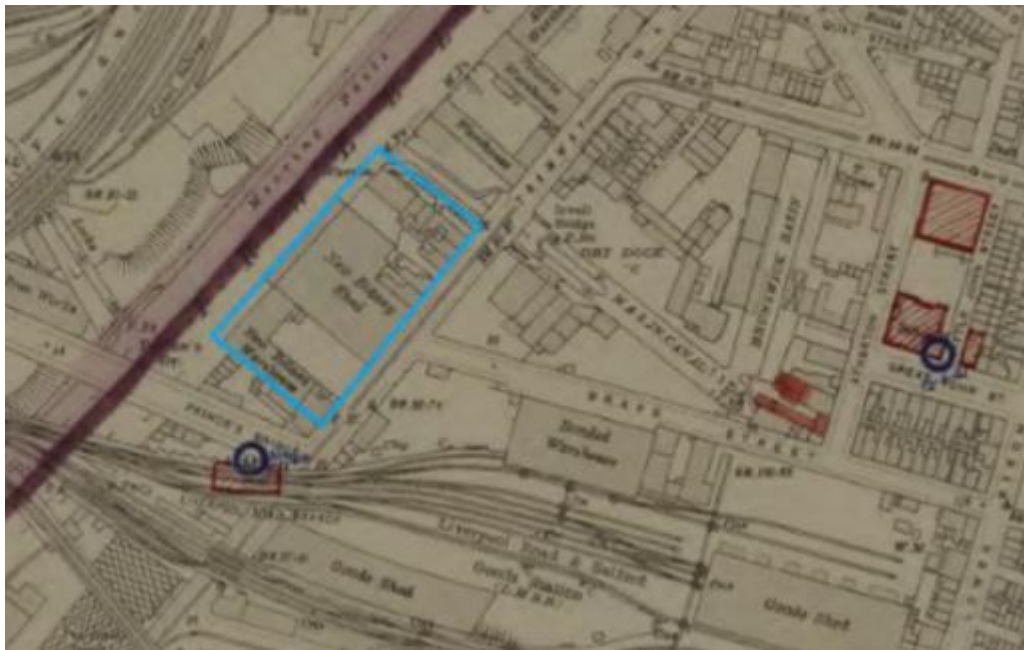
Analysis of historical bomb mapping from the University of Manchester (Ref. 6) (*Figure 2.5*) shows that a high explosive bomb hit occurred approximately 50m southwest of the site, with damage to the railway line. A second high-explosive strike was recorded approximately 200m east, with further bomb damage and demolished buildings recorded in the vicinity.

**Figure 2.5:** Site boundary shown in light blue. Blue circles represent high-explosive bomb hits. Pink shading for demolished buildings, lines mark bomb damage during the Blitz.
