Phase I & II Geoenvironmental Site Assessment  
Loom Street, Ancoats

Reference: 15-018-R1-1  
Date: February 2022

Loom Street  
Ancoats  
Manchester  
M4 6AN

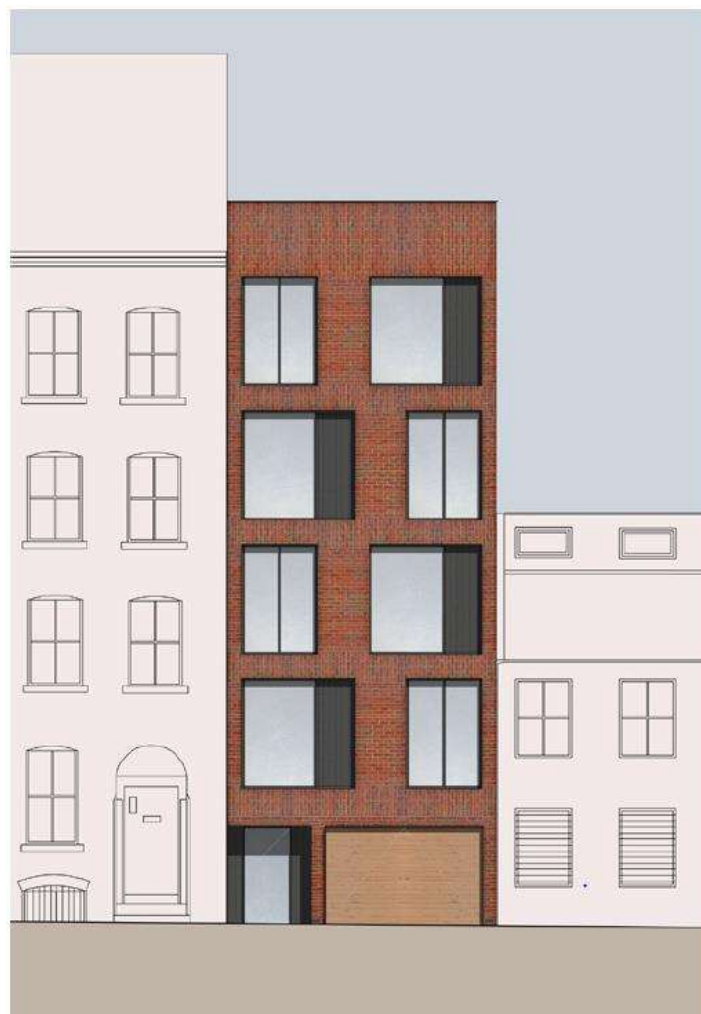
FIGURE 1.1      SNAPSHOT OF PROPOSED DEVELOPMENT

A snapshot of the proposed development layout is indicated in Figure 1.1.

Forshaw Group intends to construct a four-storey residential townhouse. Drawing 15-018-002 (Appendix XI) identifies the proposed development layout.

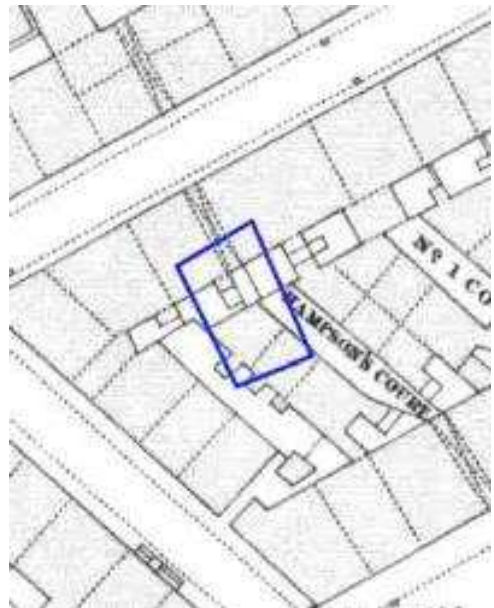
| MAP EDITION | HISTORICAL LAND USE | HISTORICAL MAP EXCERPT |
|---|---|---|
| 1851<br>1:1,056 | The site is intersected by multiple structures, as well as a courtyard that runs across the centre of the site. | |

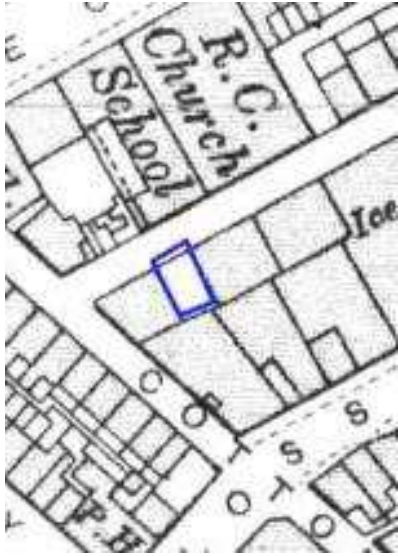
| MAP EDITION | HISTORICAL LAND USE | HISTORICAL MAP EXCERPT |
|---|---|---|
| <p><b>1908</b><br/><b>1:2,500</b></p> | <p>The previous building has been demolished.</p> <p>The site was vacant at this point.</p> | |
