## Soil Contamination Investigation Report

| <b>LOCATION</b> | Groundsource Heating Installation, Hough End Leisure Centre, 480 Princess Road, Manchester, M20 1HD |
| <b>ISSUE DATE</b> | 18 <sup>th</sup> February 2022 |
| <b>OUR REF.</b> | G22017 |

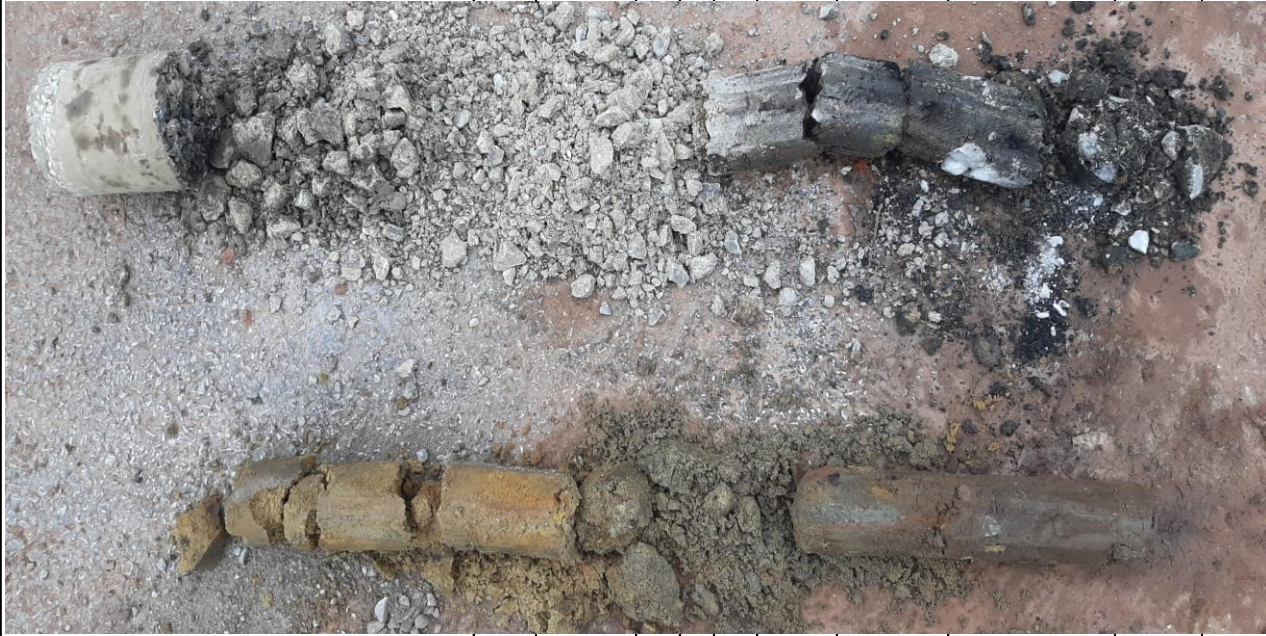
| Depth (m) | Description of Strata | Thickness | Legend | Gas Well | Sample | Test Type Result | SPT N Value (Depth) | Depth to Water | Depth (m) |
|---|---|---|---|---|---|---|---|---|---|
| | Borehole terminated at 2.00m | | | | | | | | 1.25 |
| | Cores recovered from borehole: | | | | | | | | 1.50 |

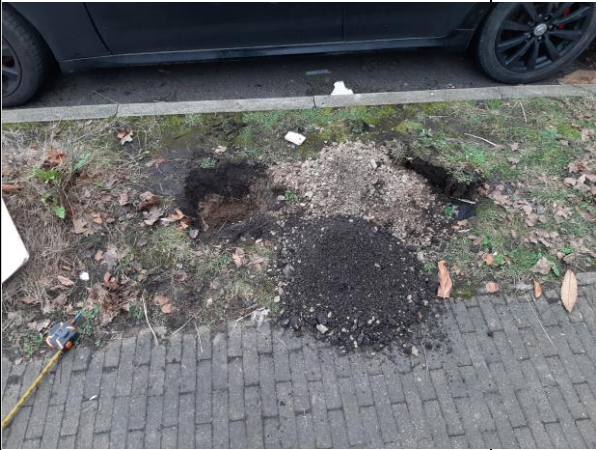
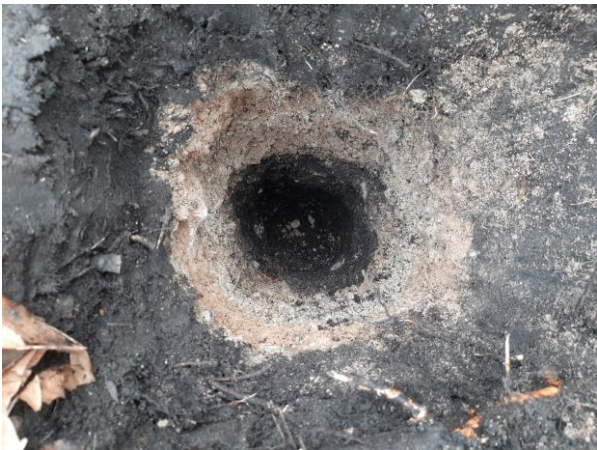
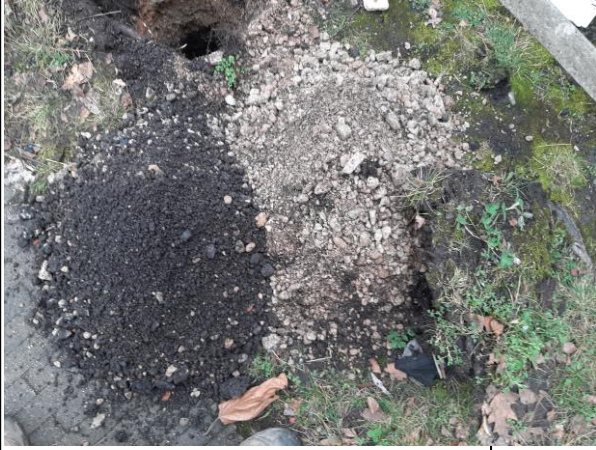
TPA found 150mm of topsoil underlain by dolostone gravel to 0.40m BGL. Dark fill akin to that found at BH1-BH3 was then encountered to termination at 0.75m BGL. Some slag was also noted in this fill and it was noted to possibly mostly comprise road planings. A slight ashy odour was noticeable in this material, which could also be noticed in the fill at BH1.

| Depth (m) | Description of Strata | Thickness | Legend | Gas Well | Sample | Test Type Result | SPT N Value (Depth) | Depth to Water | Depth (m) |
|---|---|---|---|---|---|---|---|---|---|
| 0.15 | TOPSOIL. Loose dark brown silty sand. Many roots. | 150 | | | O | Cv kN/m <sup>2</sup> | | | 0.25 |
| 0.40 | MADE GROUND. Loose pale yellowish brown sandy fine to coarse dolomitic limestone gravel. | 250 | | | O | | | | 0.50 |
| 0.75 | MADE GROUND. Loose dark grey to black sandy gravel. Gravel is mostly fine to medium of sandstone, limestone, probable asphalt, brick and slag. Some coarse gravel also present. Slight ashy odour, probably mostly road planings. Trial pit terminated at 0.75m | 350 | | | | | | | 0.75 |
| <p>Trial pit location:</p> <p>Close up of trial pit:</p> <p>Soils excavated from trial pit:</p> | | | | | | | | | |

Hand excavated to 0.75m
