# MAG Building 402

Arboricultural Impact Assessment

60663052-ACM-402-XX-RP-AR-00001

February 2022

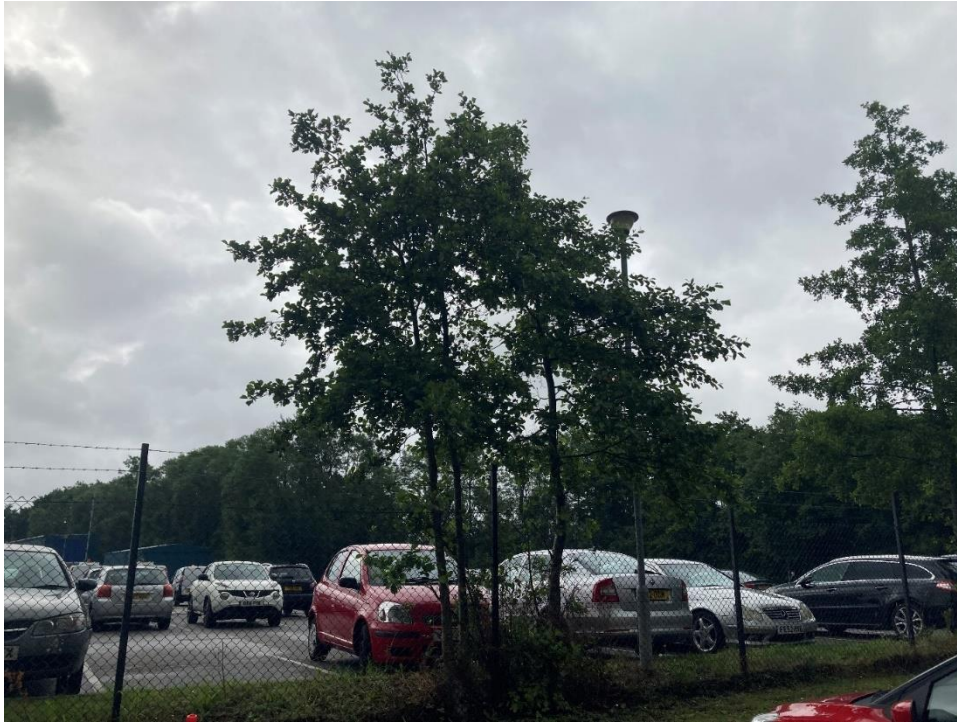
Image 1 T28 & T29 just within the Site on the northwest boundary

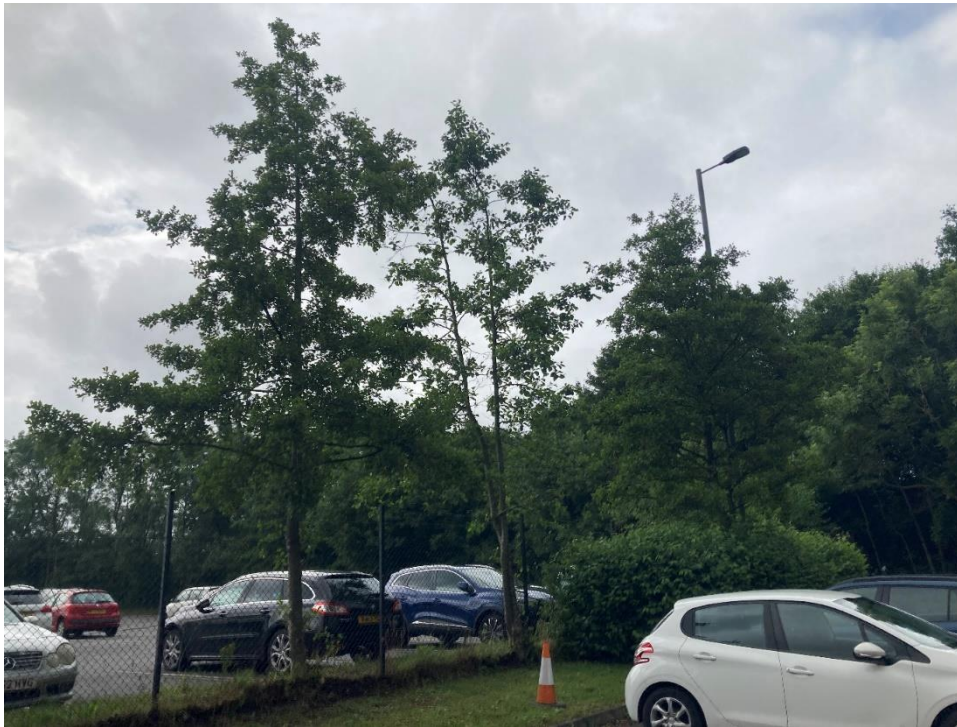
Image 2 Looking south towards T30, T31 & G35 with T34 within the group

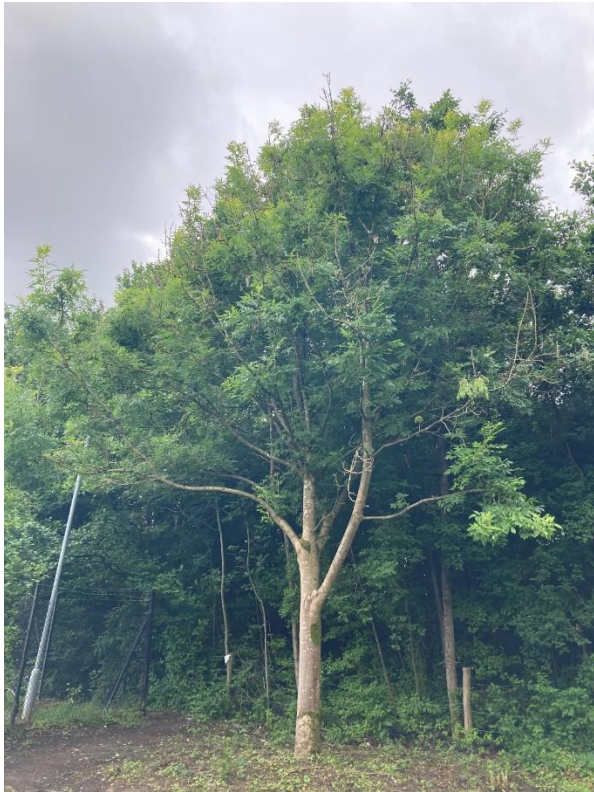
Image 3 T36 a standalone ash outside W26

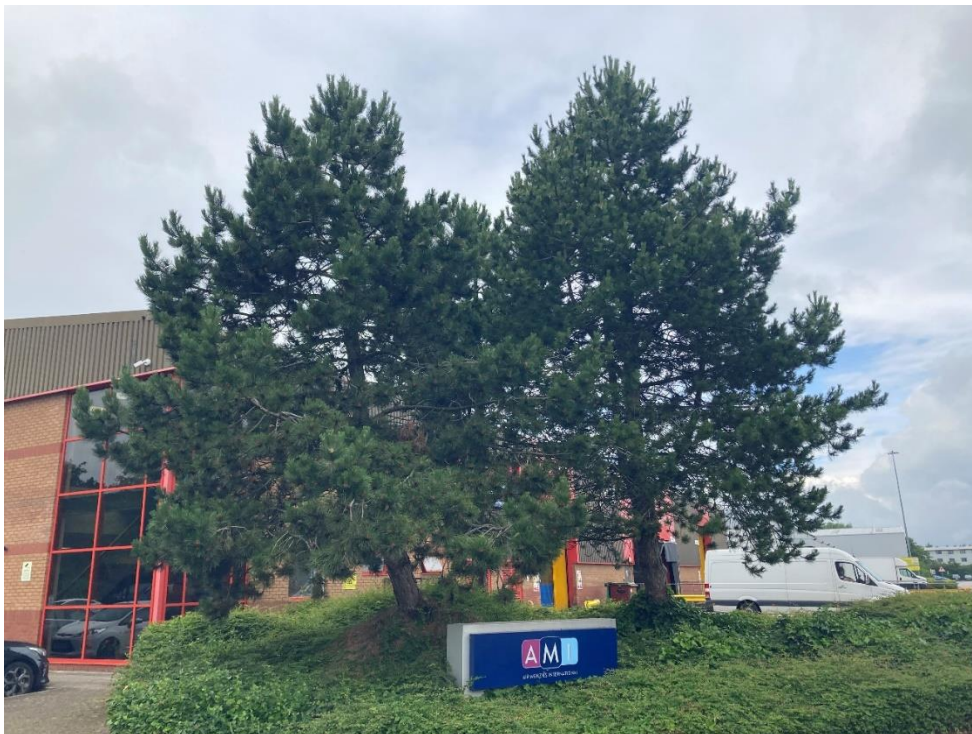
Image 4 G37, a close group of 3 black pines, one presents a minor stem lean

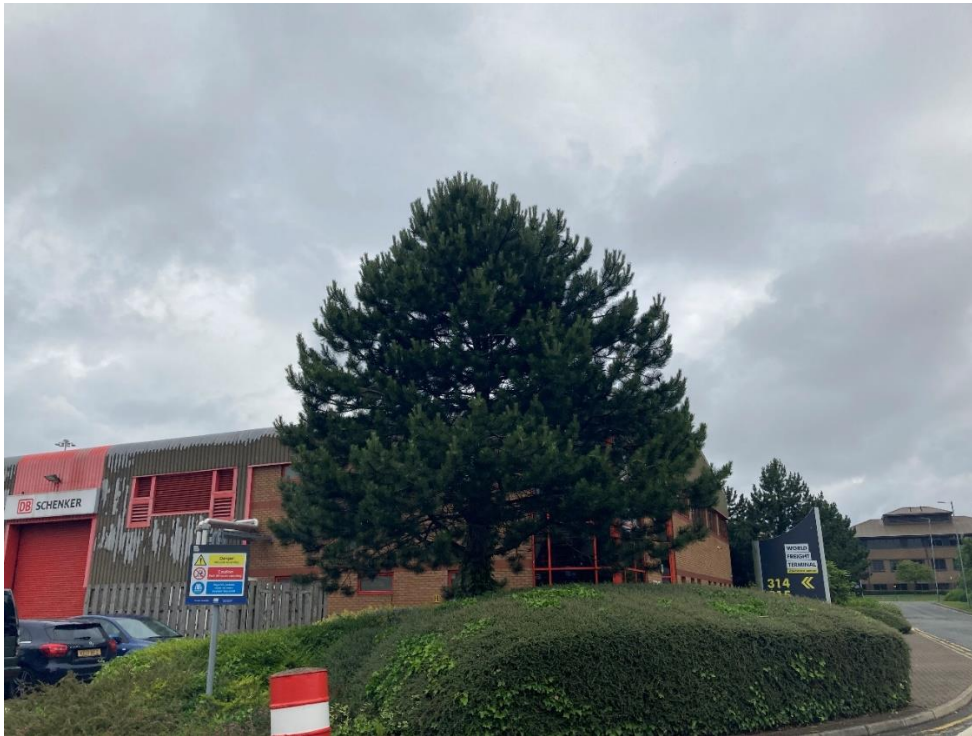
Image 5 T38 a singular category B black pine

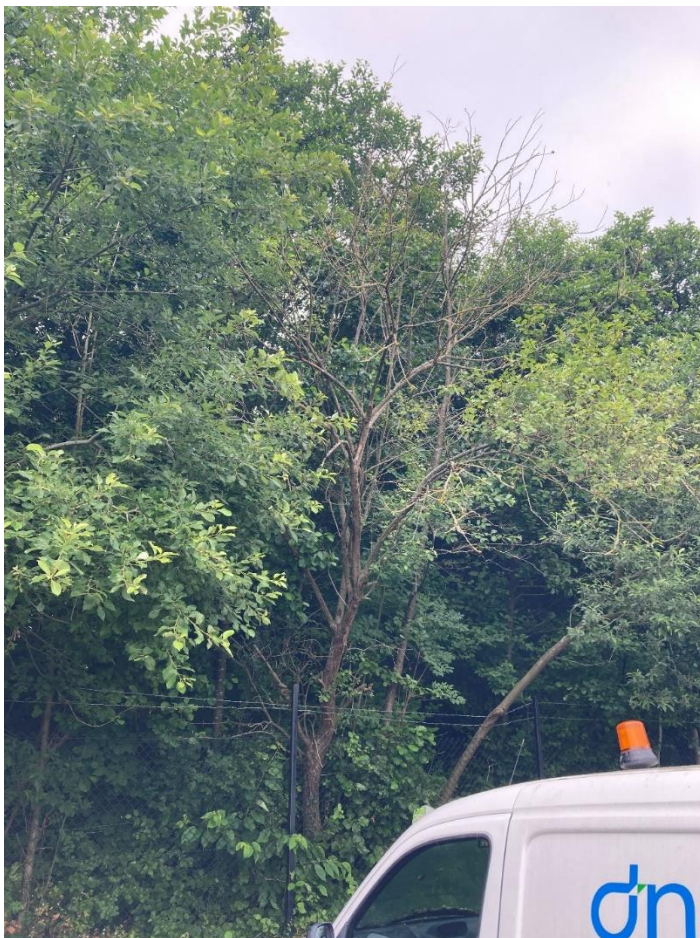
Image 6 G39 containing a dead cherry tree and one tree hung up on car park fence

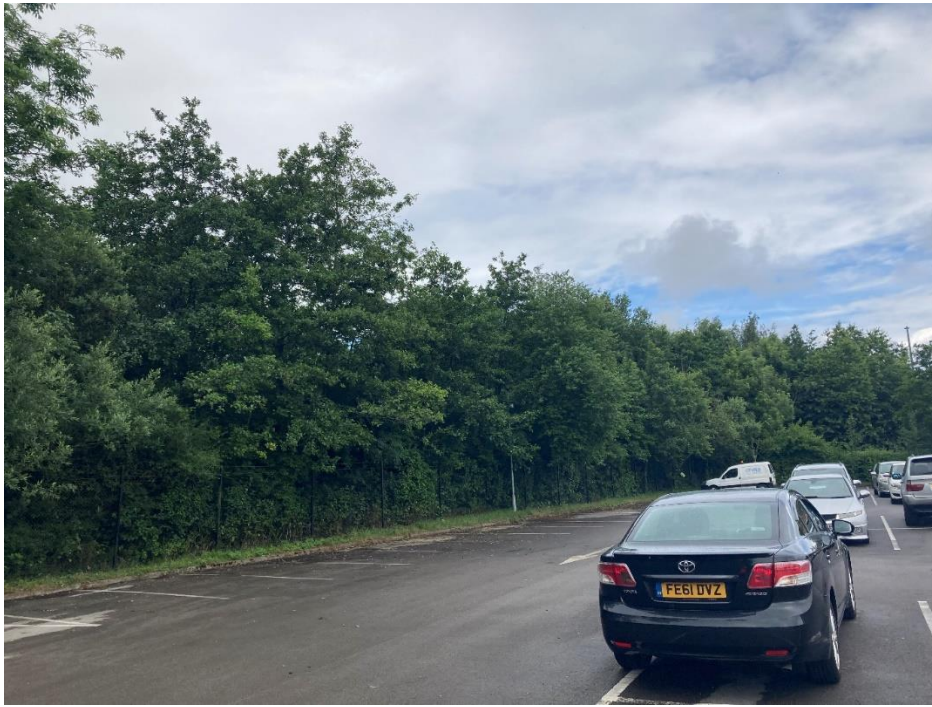
Image 7 North-eastern edge of W26
