## Desk Study & Phase I Risk Assessment.

Dolphin Street, Ardwick,  
Manchester, M12 6BG.

Date: April 2017  
Report No: 1718-0019-DS

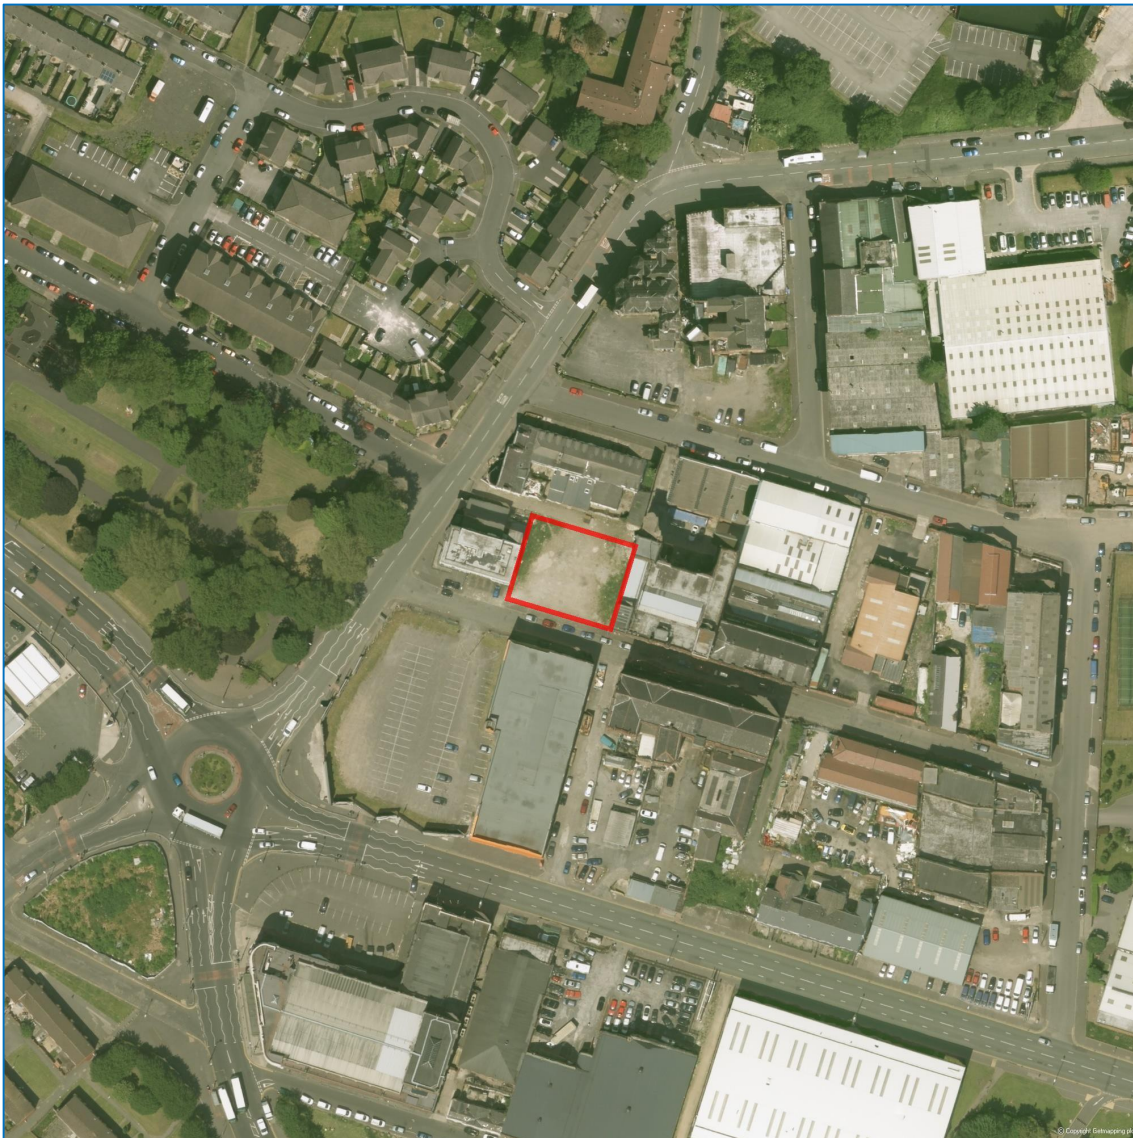
*Figure 3. Aerial Photograph.*

Aerial photographs from 2000 show the site clear of buildings but with a covering of vegetation. A number of trees can be seen to be present along the western boundary with others on the southern boundary and towards the rear north-eastern corner. By 2003 the site has been cleared of the vegetation and is vacant. A higher resolution and better lit photograph later in the same year shows a covering of low vegetation with some small bushes along the boundary. The 2005 image shows only a small amount of vegetation remaining in the north-west corner of the site with the majority of the site bare. There are no significant changes on the 2009 photograph and by 2013 the north-western corner of the site has also been cleared of vegetation. The last image of 2016 shows some low level vegetation returning along the western boundary of the site and this was confirmed during the walkover survey of the site.

No vehicles have been identified on the site from the aerial photographs, however there is a distinct possibility that the site has been used for parking, evident in the lack of vegetation regrowth within the centre of the site.
