# 807 Wilmslow Road

Defective Arch Replacement

Design, Access & Heritage Impact Statement  
April 2022

Project name: 807 Wilmslow Road  
Project number: 9298  
Client: Helena Gilbert

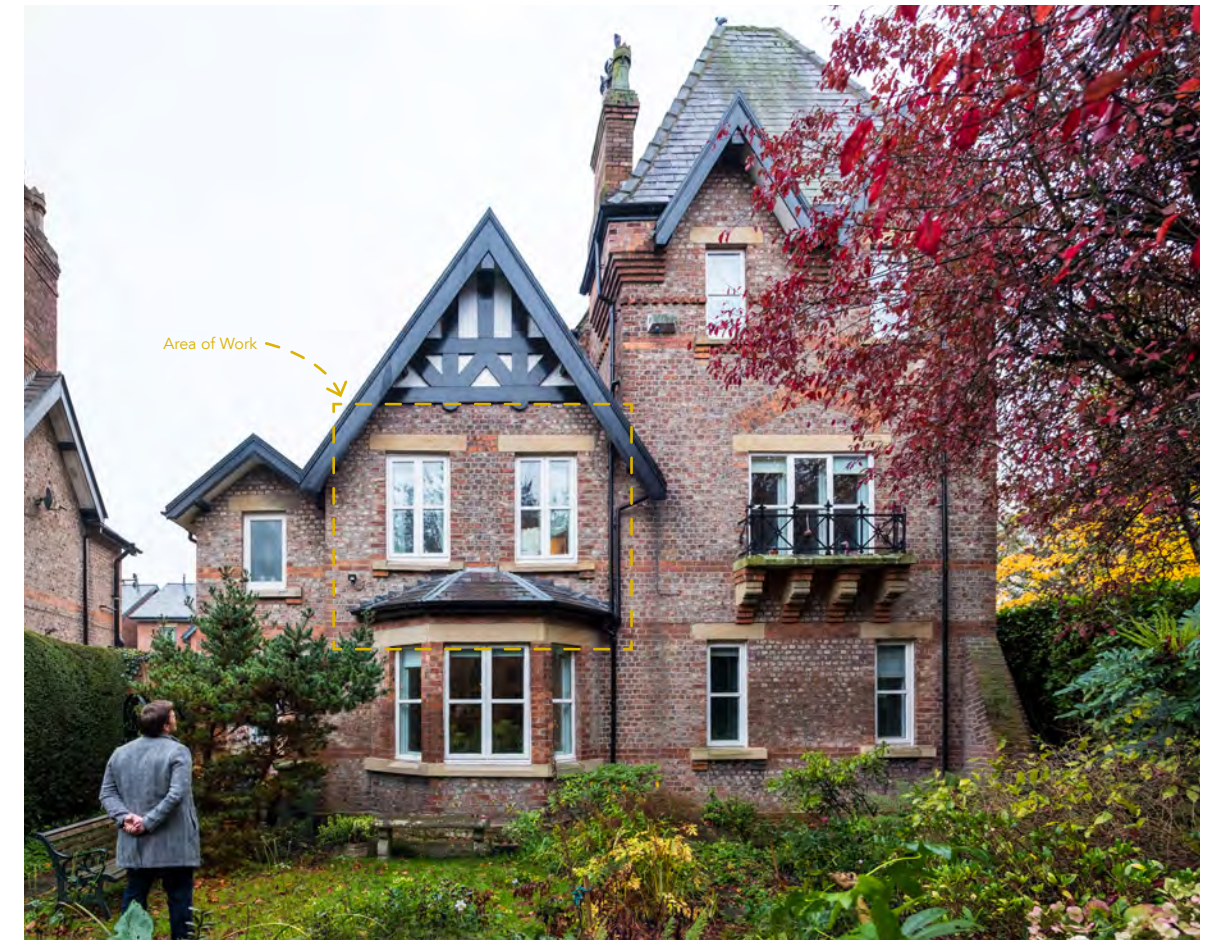
Figure 3 Photograph of Existing West Elevation, with the area of work highlighted

The proposed work is limited to addressing a structural defect on the west elevation, above the ground floor bay window.

Concealed within the pitched roof of the bay window, the existing structural opening has been formed with a grossly undersized timber lintel and crudely made relieving arch. This awkward packing arrangement appears to have compressed and progressively slipped.

Given its concealed location and inability to build a sufficiently strong arch within the same space, it is proposed the existing arrangement is removed and replaced with a new steel beam. Existing masonry would be rebuilt above the new beam, level to the first floor window cills.

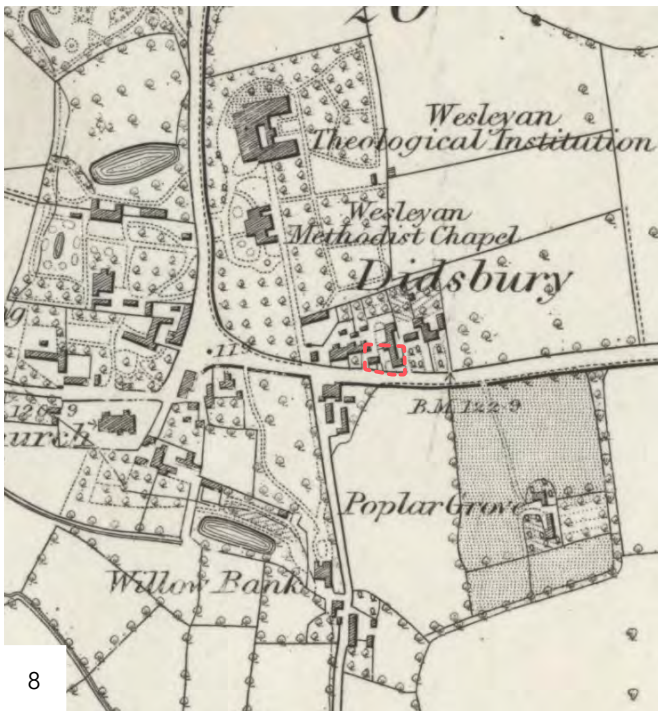
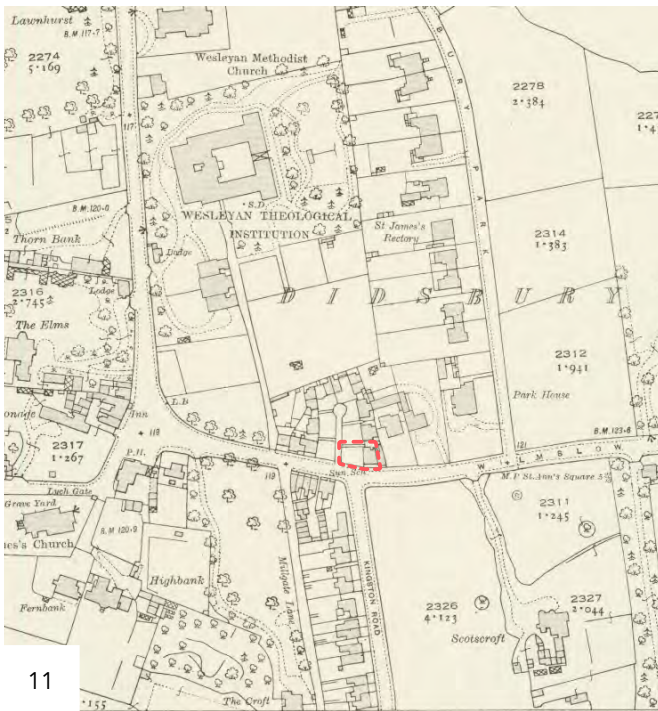
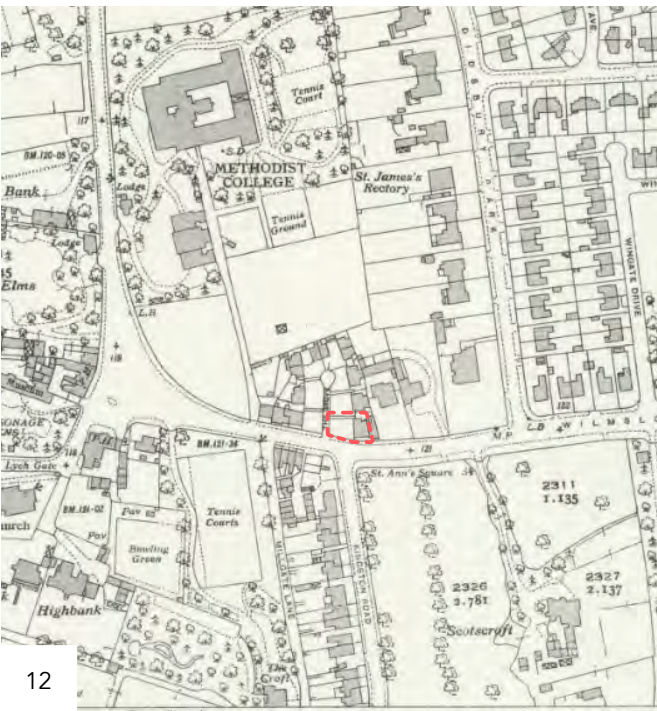
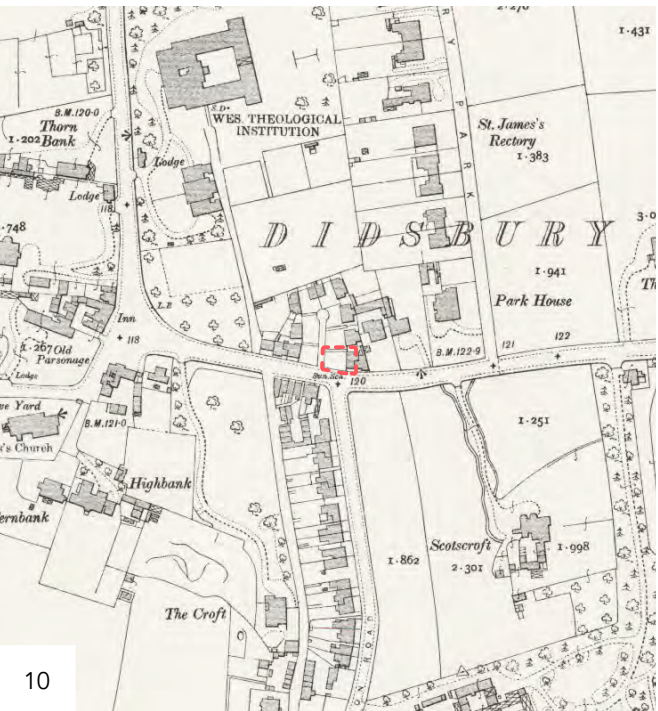
Figure 8 Lancashire Sheet CXI - Surveyed 1845, Published 1848  
Figure 11 Lancashire Sheet CXI.11 - Revised 1916, Published 1922

Figure 9 Withington - Lancashire CXI.11.22 - Surveyed 1892, Published 1893  
Figure 12 Lancashire Sheet CXI.11 - Revised 1934, Published 1936

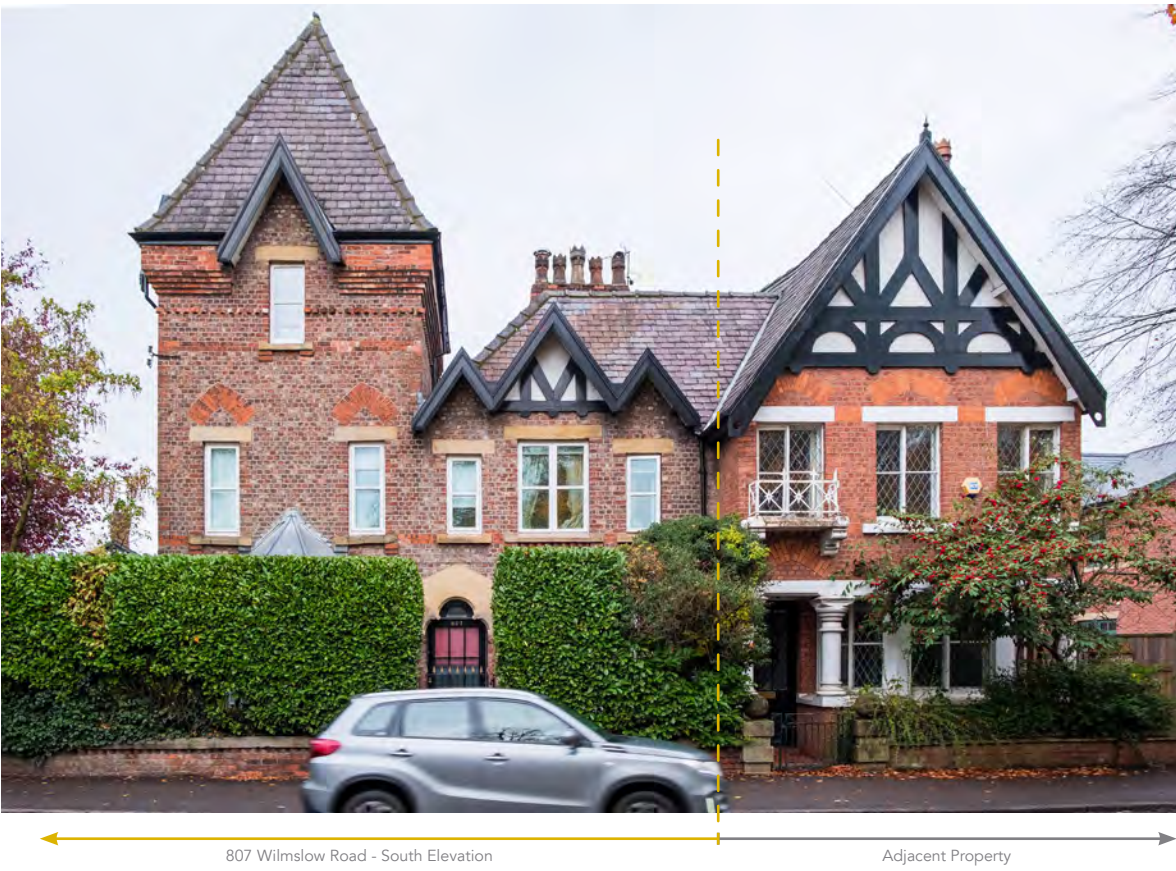
Figure 14 Photograph of South Elevation

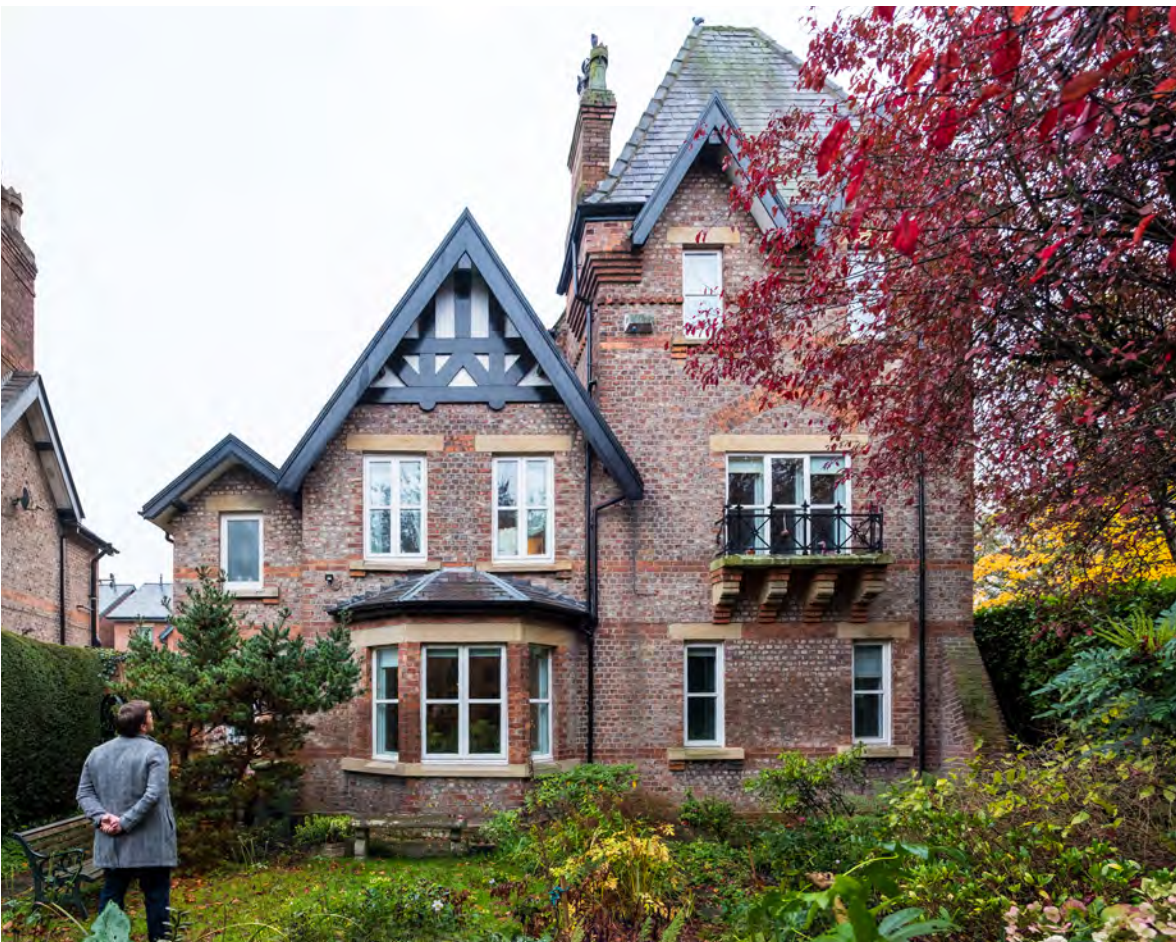
Figure 15 Photograph of Existing West Elevation

The proposed work is limited to addressing a structural defect on the west elevation, above the ground floor bay window.

Due to the calculated loads it is assumed the timber beam is to purely a construction former on which to build the shallow, tapered relieving arch which itself is poorly packed and together is inherently defective, having have compressed and progressively slipped. With the original shallow arrangement being inherently defective, the remedial solution to be adopted will incur a detail change.

Given its concealed location and practical infeasibility to build sufficiently strong arch within the same space, it is proposed the existing arrangement is removed and replaced with a new steel beam. Above the new, level, beam existing masonry will be instated as a masonry spandrel and rebuilt pier to the first floor window lintels. Once completed, the visible fabric will effectively reinstate the its original appearance prior to the drop and ongoing movement.

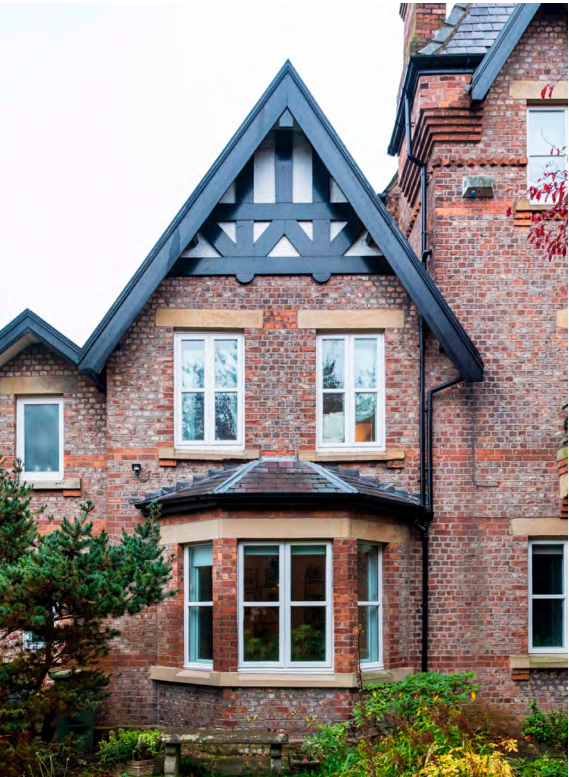
Existing West Elevation Photograph  
Not to Scale

Figure 16 Existing and Proposed Photographs with Respective Obscured Structural Arrangement Overlays

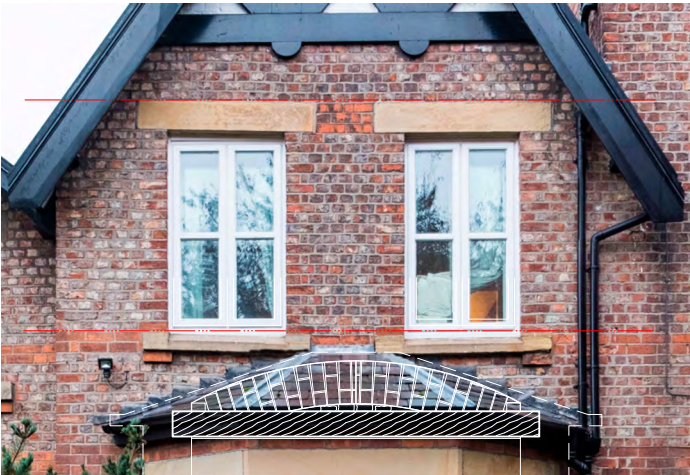
Existing Part West Elevation Photograph with Arch Overlay  
Not to Scale

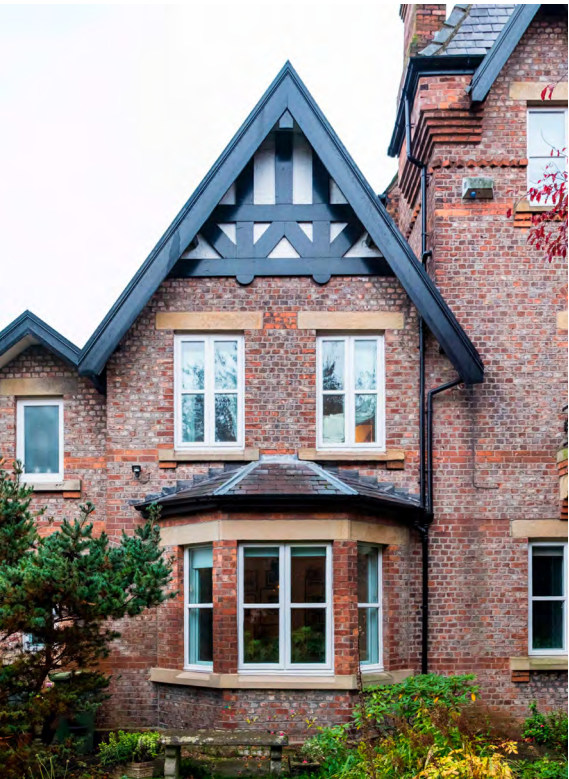
Proposed West Elevation Montage Photograph  
Not to Scale
