## Red Bank Neighbourhood Infrastructure Works

Manchester

## Bat Survey Report

| Document Ref | 9082.008 |

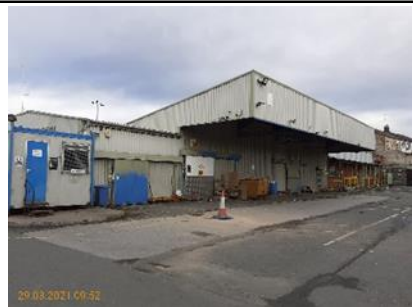
| Ref | Description | Photographs |
|---|---|---|
| B1 | <p>Main Creamline double height building comprising corrugated iron with a mono pitched corrugated iron roof with skylights. There are no suitable features for roosting bats.</p> <p>Roost suitability: Negligible</p> | |

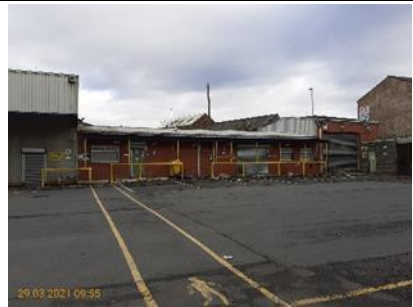
| Ref | Description | Photographs |
|---|---|---|
| B2 | <p>A single storey and double height brick building previously used as offices for Creamline Dairy. The roof is pitched comprising corrugated iron. The window and door frames are uPVC. There are wooden fascia boards but no gaps between the boards and brick were identified. There are no suitable features for roosting bats.</p> <p>Roost suitability: Negligible</p> | |

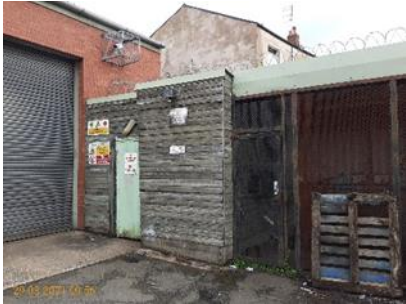
| Ref | Description | Photographs |
|---|---|---|
| B3 | <p>A small storage outbuilding comprising wooden panelling and wire mesh. The roof is flat and comprised of sheet iron. There are no suitable features for roosting bats.</p> <p>Roost suitability: Negligible</p> | |

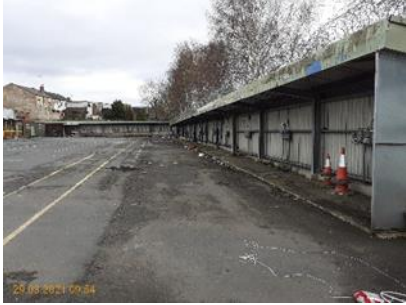
| Ref | Description | Photographs |
|---|---|---|
| B4 | <p>Single storey loading bays comprising corrugated iron and brick. One side is open fronted. There are no suitable features for roosting bats.</p> <p>Roost suitability: Negligible</p> | |

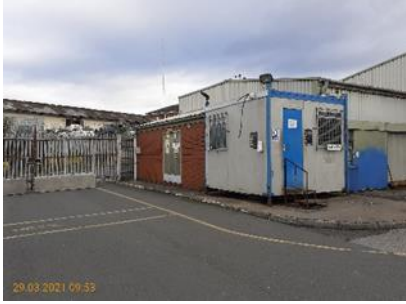
| Ref | Description | Photographs |
|---|---|---|
| B5 | <p>A security lodge porta cabin and adjoining brick electricity store. The porta cabin has a flat roof and steel frame. There are no suitable features for roosting bats.</p> <p>The brick electricity store has a corrugated asbestos lean to roof and wooden fascia boards. No gaps between the boards and brick were identified. There are no suitable features for roosting bats.</p> <p>Roost suitability: Negligible</p> | |

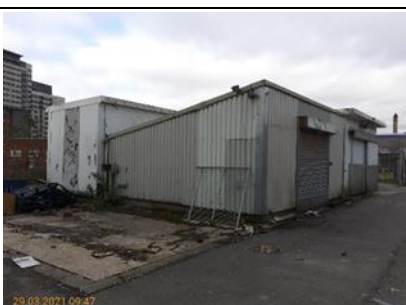
| Ref | Description | Photographs |
|---|---|---|
| B6 | <p>A metal shed with adjoining porta cabin. The shed is comprised of corrugated iron with a corrugated iron lean to roof. The porta cabin is wooden with a flat roof. There are no suitable features for roosting bats.</p> <p>Roost suitability: Negligible</p> | |

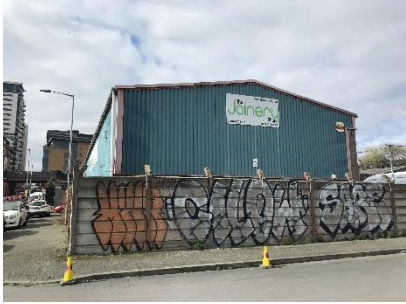
| Ref | Description | Photographs |
|---|---|---|
| B7 | <p>A double storey warehouse comprised of corrugated iron. The roof is pitched and made from corrugated iron. There are no suitable features for roosting bats.</p> <p>Roost suitability: Negligible</p> | |

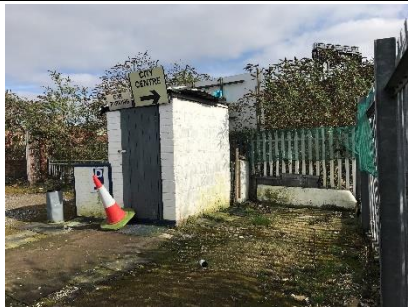
| Ref | Description | Photographs |
|---|---|---|
| B8 | <p>A small brick security lodge with a wooden door. The roof is flat comprised from corrugated iron. There are no suitable features for roosting bats.</p> <p>Roost suitability: Negligible</p> | |

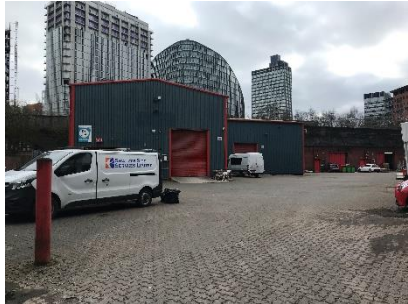
| Ref | Description | Photographs |
|---|---|---|
| B9 | <p>A double and single storey warehouse comprised of corrugated iron. The roof is pitched corrugated iron. There are no suitable features for roosting bats.</p> <p>Roost suitability: Negligible</p> | |

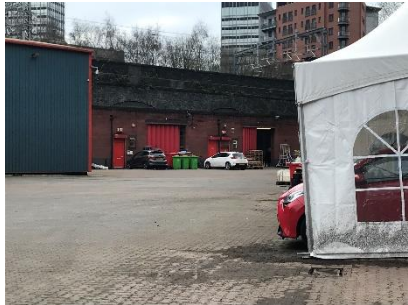
| Ref | Description | Photographs |
|---|---|---|
| B10 | <p>A single storey brick building used for commercial services. No windows present with large sliding corrugated iron doors. The roof is flat. There are no suitable features for roosting bats.</p> <p>Roost suitability: Negligible</p> | |

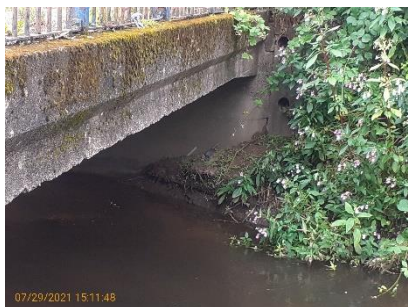
- 3.4 Two bridge crossings over the River Irk are present within the site boundary; one at St. Catherine's Wood (A) and one at Packaging Products (B). These structures were only viewed at a distance as there was no safe access into the River and limited views from the road side. It is thought that these structures would have only low suitability for roosting due to the fluctuating water levels of the River Irk making any potential roost features liable to flooding & less suitable for roosting bats in the long term.

| Ref | Description | Photographs |
|---|---|---|
| A | <p>Bridge crossing to access St. Catherine's Wood. The structure is comprised of concrete and appears to be well sealed. No obvious gaps were visible from the roadside, however no access within the structure was possible. It may be possible there are small gaps where the concrete joins at either end of the bridge. A precautionary assessment has been made.</p> <p>Roost suitability: Low</p> | |

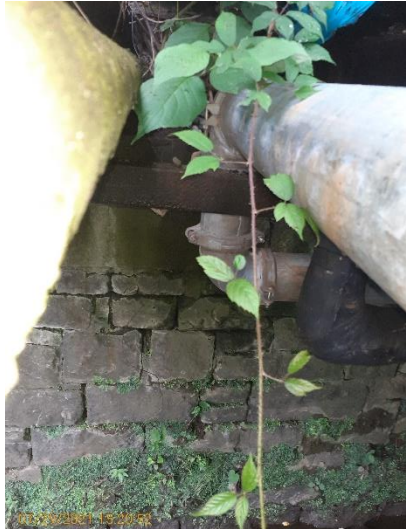
| Ref | Description | Photographs |
|---|---|---|
| B | <p>Bridge crossing at Packaging Products. This is a small structure comprising a steel bridge and the supporting walls made of sandstone. Gaps between the sandstone blocks, where cement had eroded was visible from the roadside, however close inspection of these features was possible. A precautionary assessment has been made.</p> <p>Roost suitability: Low</p> | |

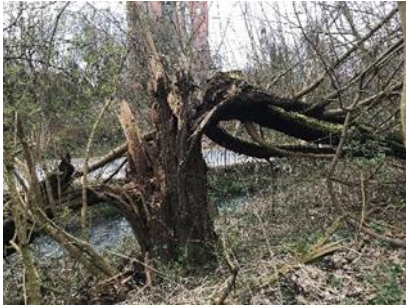
- 2.12 Tree T1 was identified during the daytime evaluation to have moderate suitability for roosting bats. This tree was therefore subject to further nocturnal surveys in accordance with their evaluation (moderate suitability receiving two nocturnal surveys).

| Ref | Description | Photographs |
|---|---|---|
| T1 | <p>A willow on the bank of the River Irk which has a severe transverse snap creating small crevices suitable for a small number of bats.</p> <p>SJ 84845 99639</p> <p>Roost suitability: Moderate</p> | |

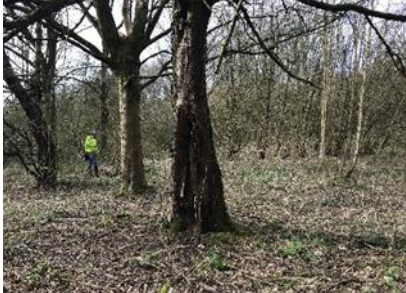
| Ref | Description | Photographs |
|---|---|---|
| T2 | <p>A cherry species with a large east facing cavity. The cavity is well occluded and is c. 0-1.5m in height. This feature could be used on an opportunistic basis.</p> <p>SJ 84760 99625</p> <p>Roost suitability: Low</p> | |

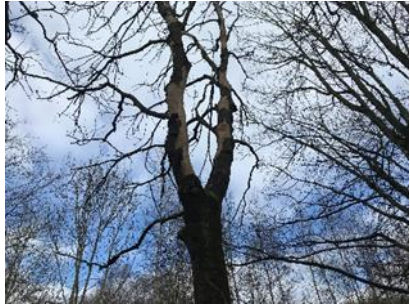
| Ref | Description | Photographs |
|---|---|---|
| T3 | <p>Sycamore tree with flaking bark in the upper branches. The conditions of this feature are not suitable for long term use, but may be used opportunistically.<br/>SJ 84754 99627</p> <p>Roost suitability: Low</p> | |

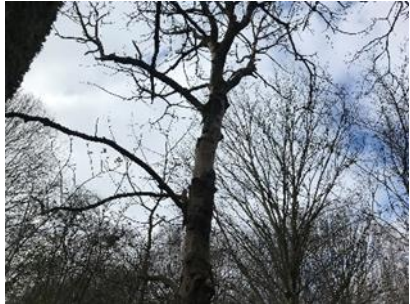
| Ref | Description | Photographs |
|---|---|---|
| T4 | <p>Sycamore tree with flaking bark in the upper branches. The conditions of this feature are not suitable for long term use, but may be used opportunistically.<br/>SJ 84752 99626</p> <p>Roost suitability: Low</p> | |

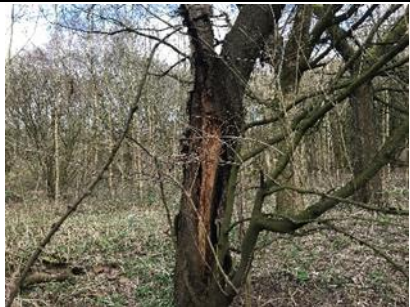
| Ref | Description | Photographs |
|---|---|---|
| T5 | <p>A cherry species with a tear out in the main stem &amp; exposed heartwood. Small crevices suitable for opportunistic roosting.<br/>SJ 84756 99625</p> <p>Roost suitability: Low</p> | |
