## **Appendix D – Historical Plans**

1, Portugal Street East, MANCHESTER, M1 2WX

## **Appendix E – Window Sample Logs**

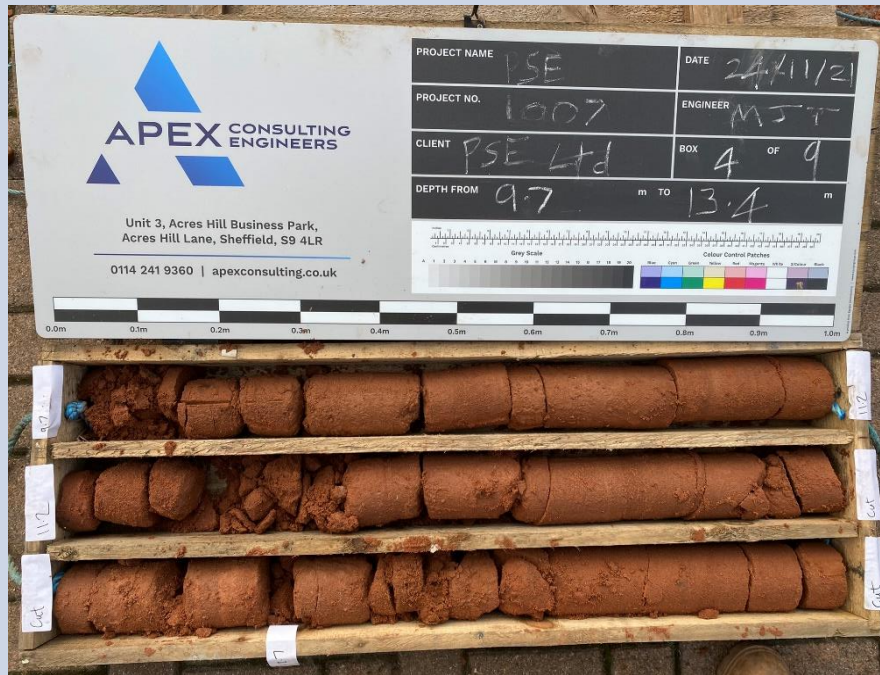
Box ID : 4

Borehole ID : BH01

9.70

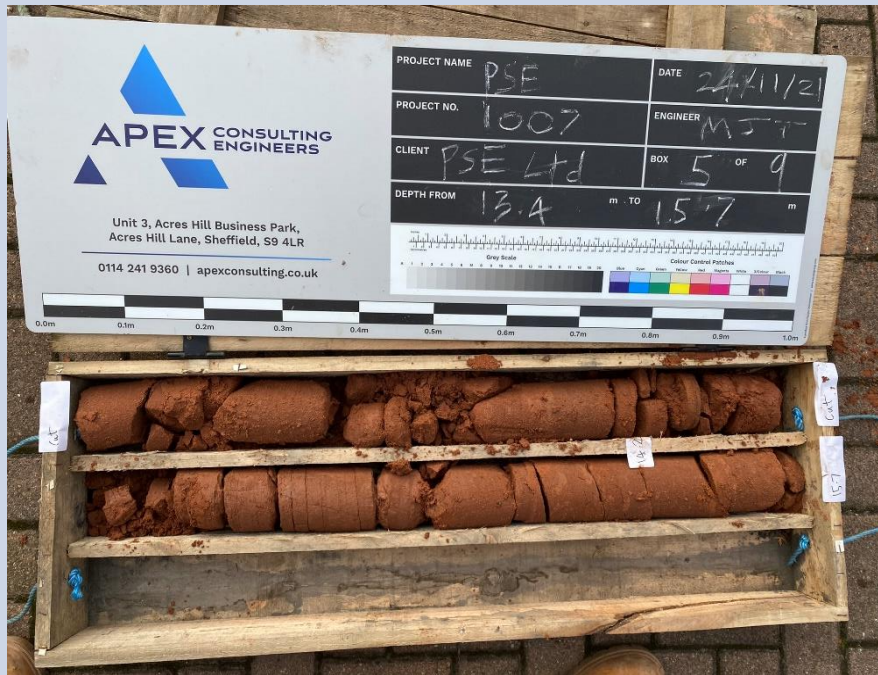
Box ID : 5

Borehole ID : BH01

13.40

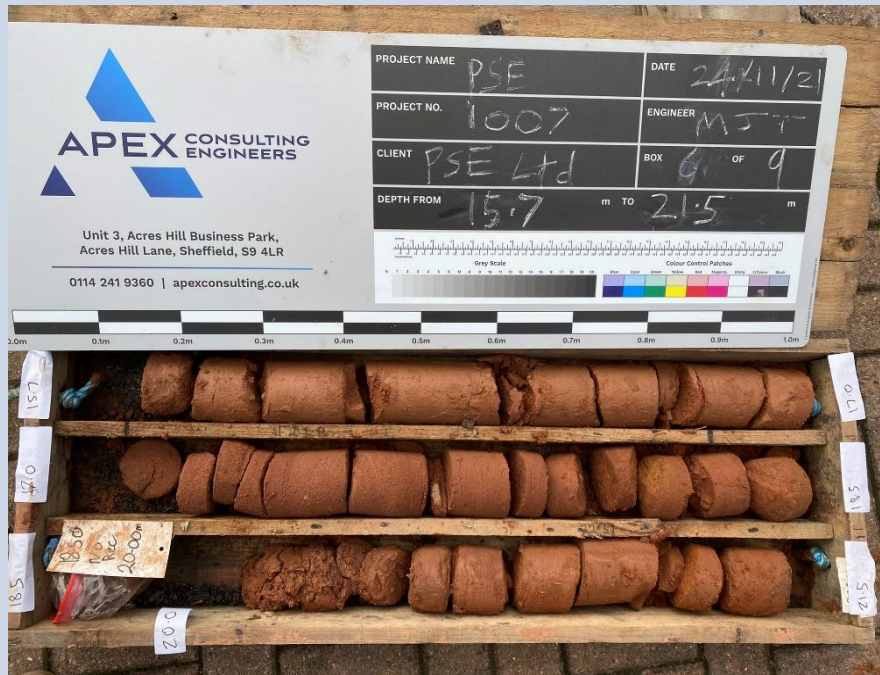
Box ID : 6

Borehole ID : BH01

15.70

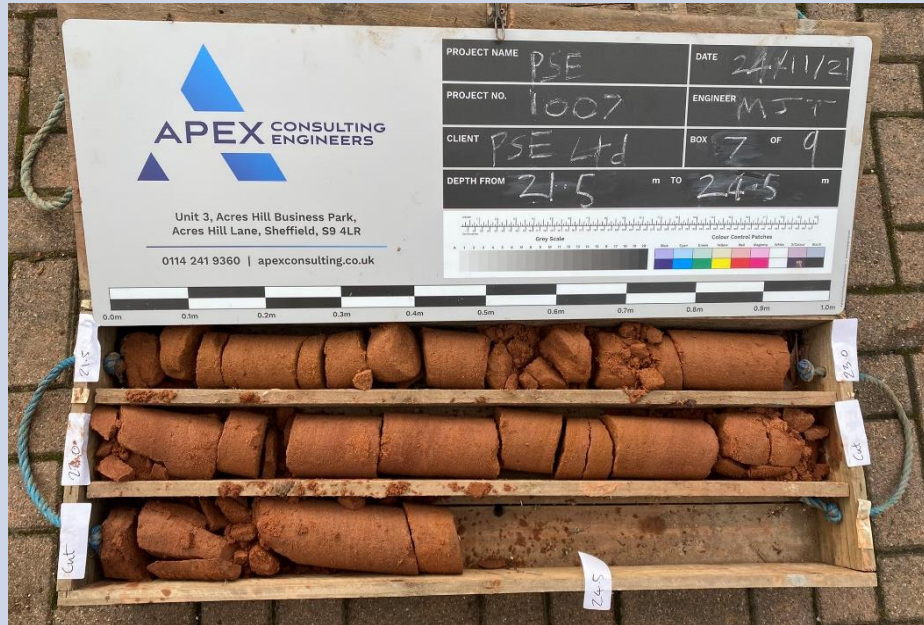
Box ID : 7

Borehole ID : BH01

21.50

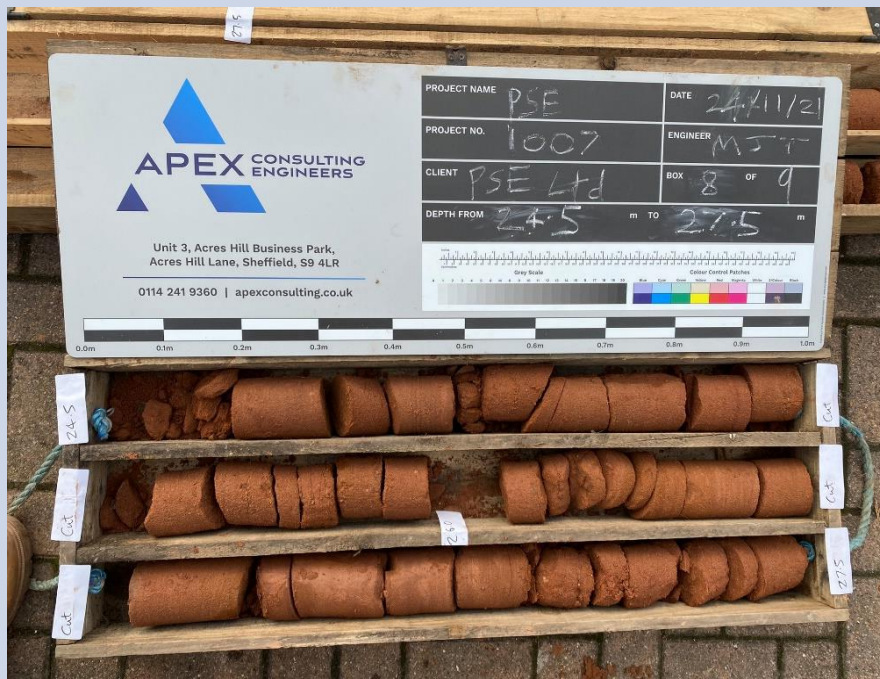
Box ID : 8

Borehole ID : BH01

24.50

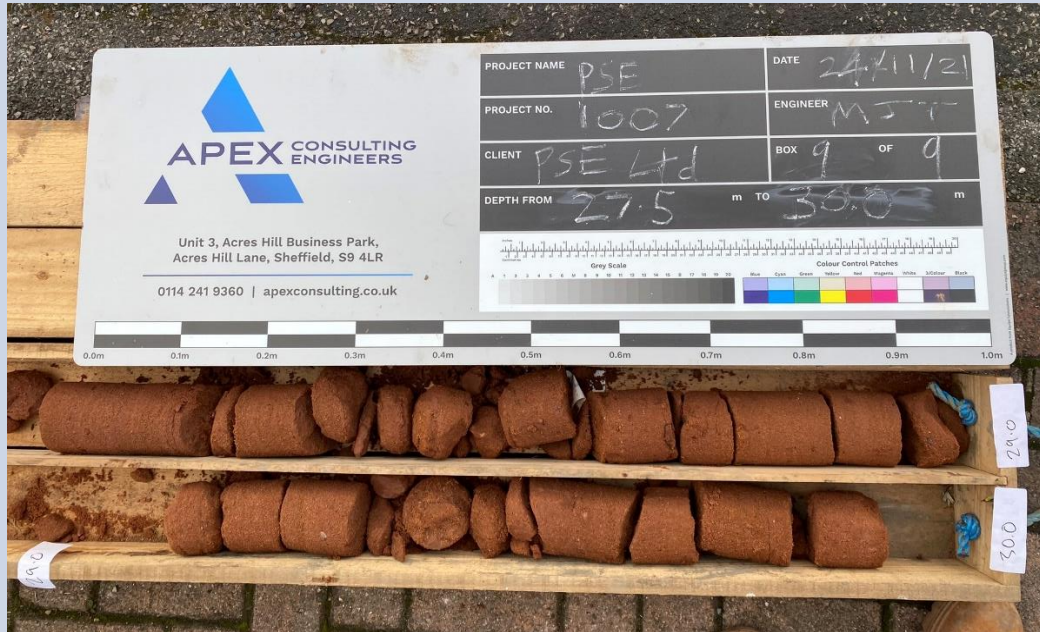
Box ID : 9

Borehole ID : BH01

27.50
