| PROJECT | LAYSTALL STREET | | | | | | |
| DRAWING | DEMOLITION IMAGES INTERNAL | | | | | | |
| JOB NO. | 1383 | DWG.NO. | 1383-OMI-00-ZZ-DR-A-L0217-- | | | | |

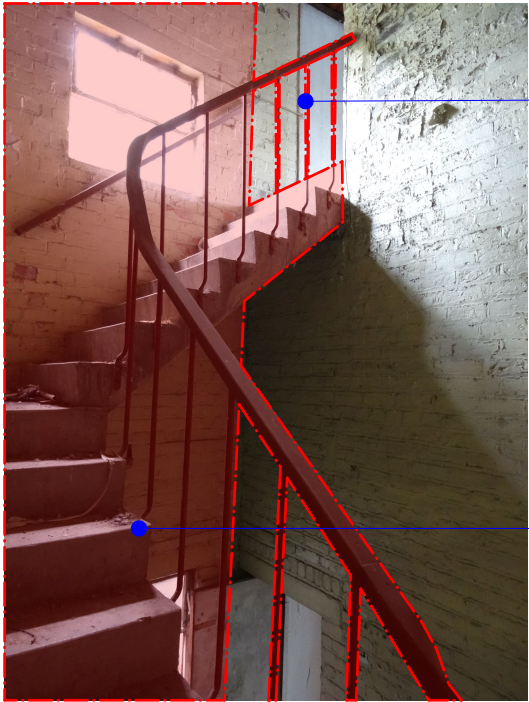
IMAGE 001 - INTERNAL - Junction between retained and demolished

OPENINGS TO BE CHECKED AND  
TEMPORARY SUPPORT DETERMINED BY  
STRUCTURAL ENGINEER

STAIRCASE TO BE SUPPORTED TO ENGINEER'S  
DETAIL AND MANUALLY REMOVED TO  
ENSURE THERE IS NOT CONSEQUENT  
DAMAGE TO ADJACENT SURFACES

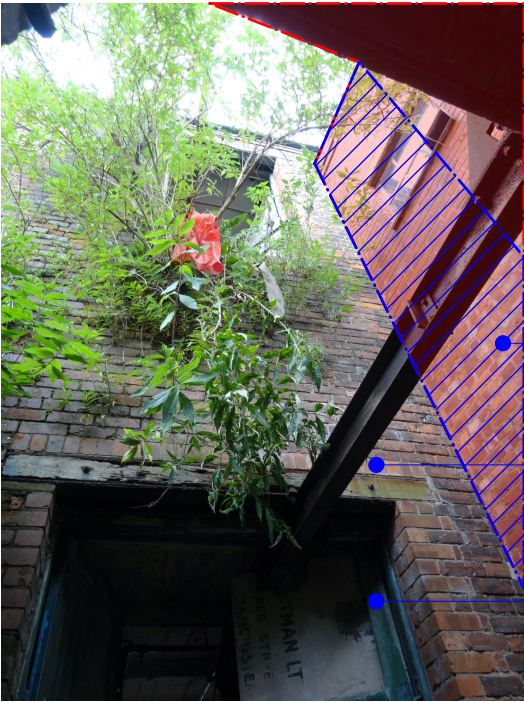
IMAGE 002- Internal - Junction between retained and demolished - Lightwell

4m MIN TO BE DISMANTLED MANUALLY

ALL CONNECTING BEAMS AND JOISTS  
CONNECTING TO THE EXISTING BUILDING  
TO BE REMOVED MANUALLY AND IN  
SEQUENCE. ALLOW TO PIECE IN BRICKWORK  
IN LIME MORTAR TO ENSURE WORK  
REMAINS STABLE

OPENINGS TO BE CHECKED AND  
TEMPORARY SUPPORT DETERMINED BY  
STRUCTURAL ENGINEER

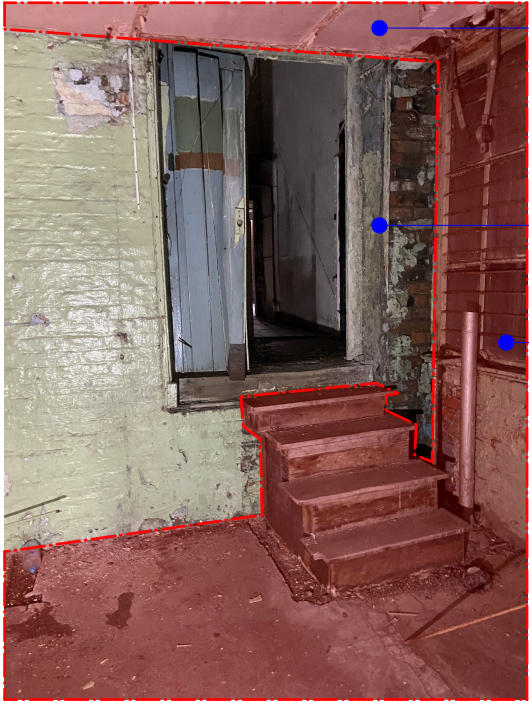
IMAGE 003- INTERNAL - Junction between retained and demolished - Warehouse

ALL CONNECTING BEAMS AND JOISTS  
CONNECTING TO THE EXISTING BUILDING  
TO BE REMOVED MANUALLY AND IN  
SEQUENCE. ALLOW TO PIECE IN BRICKWORK  
IN LIME MORTAR TO ENSURE WORK  
REMAINS STABLE

OPENINGS TO BE CHECKED AND  
TEMPORARY SUPPORT DETERMINED BY  
STRUCTURAL ENGINEER

4m MIN TO BE DISMANTLED MANUALLY
