# PHASE 2 SITE INVESTIGATION

## Proposed Temporary Classroom Replacement Building

Manchester Enterprise Academy

| DESCRIPTION | | DATE | AUTHOR | REVIEWED BY | APPROVED BY |
|---|---|---|---|---|---|
| Phase 2 Site Investigation Report<br>FINAL | | 16/07/20 | Reece McGuinness<br> | Alex Smiles<br> | Alex Smiles<br> |

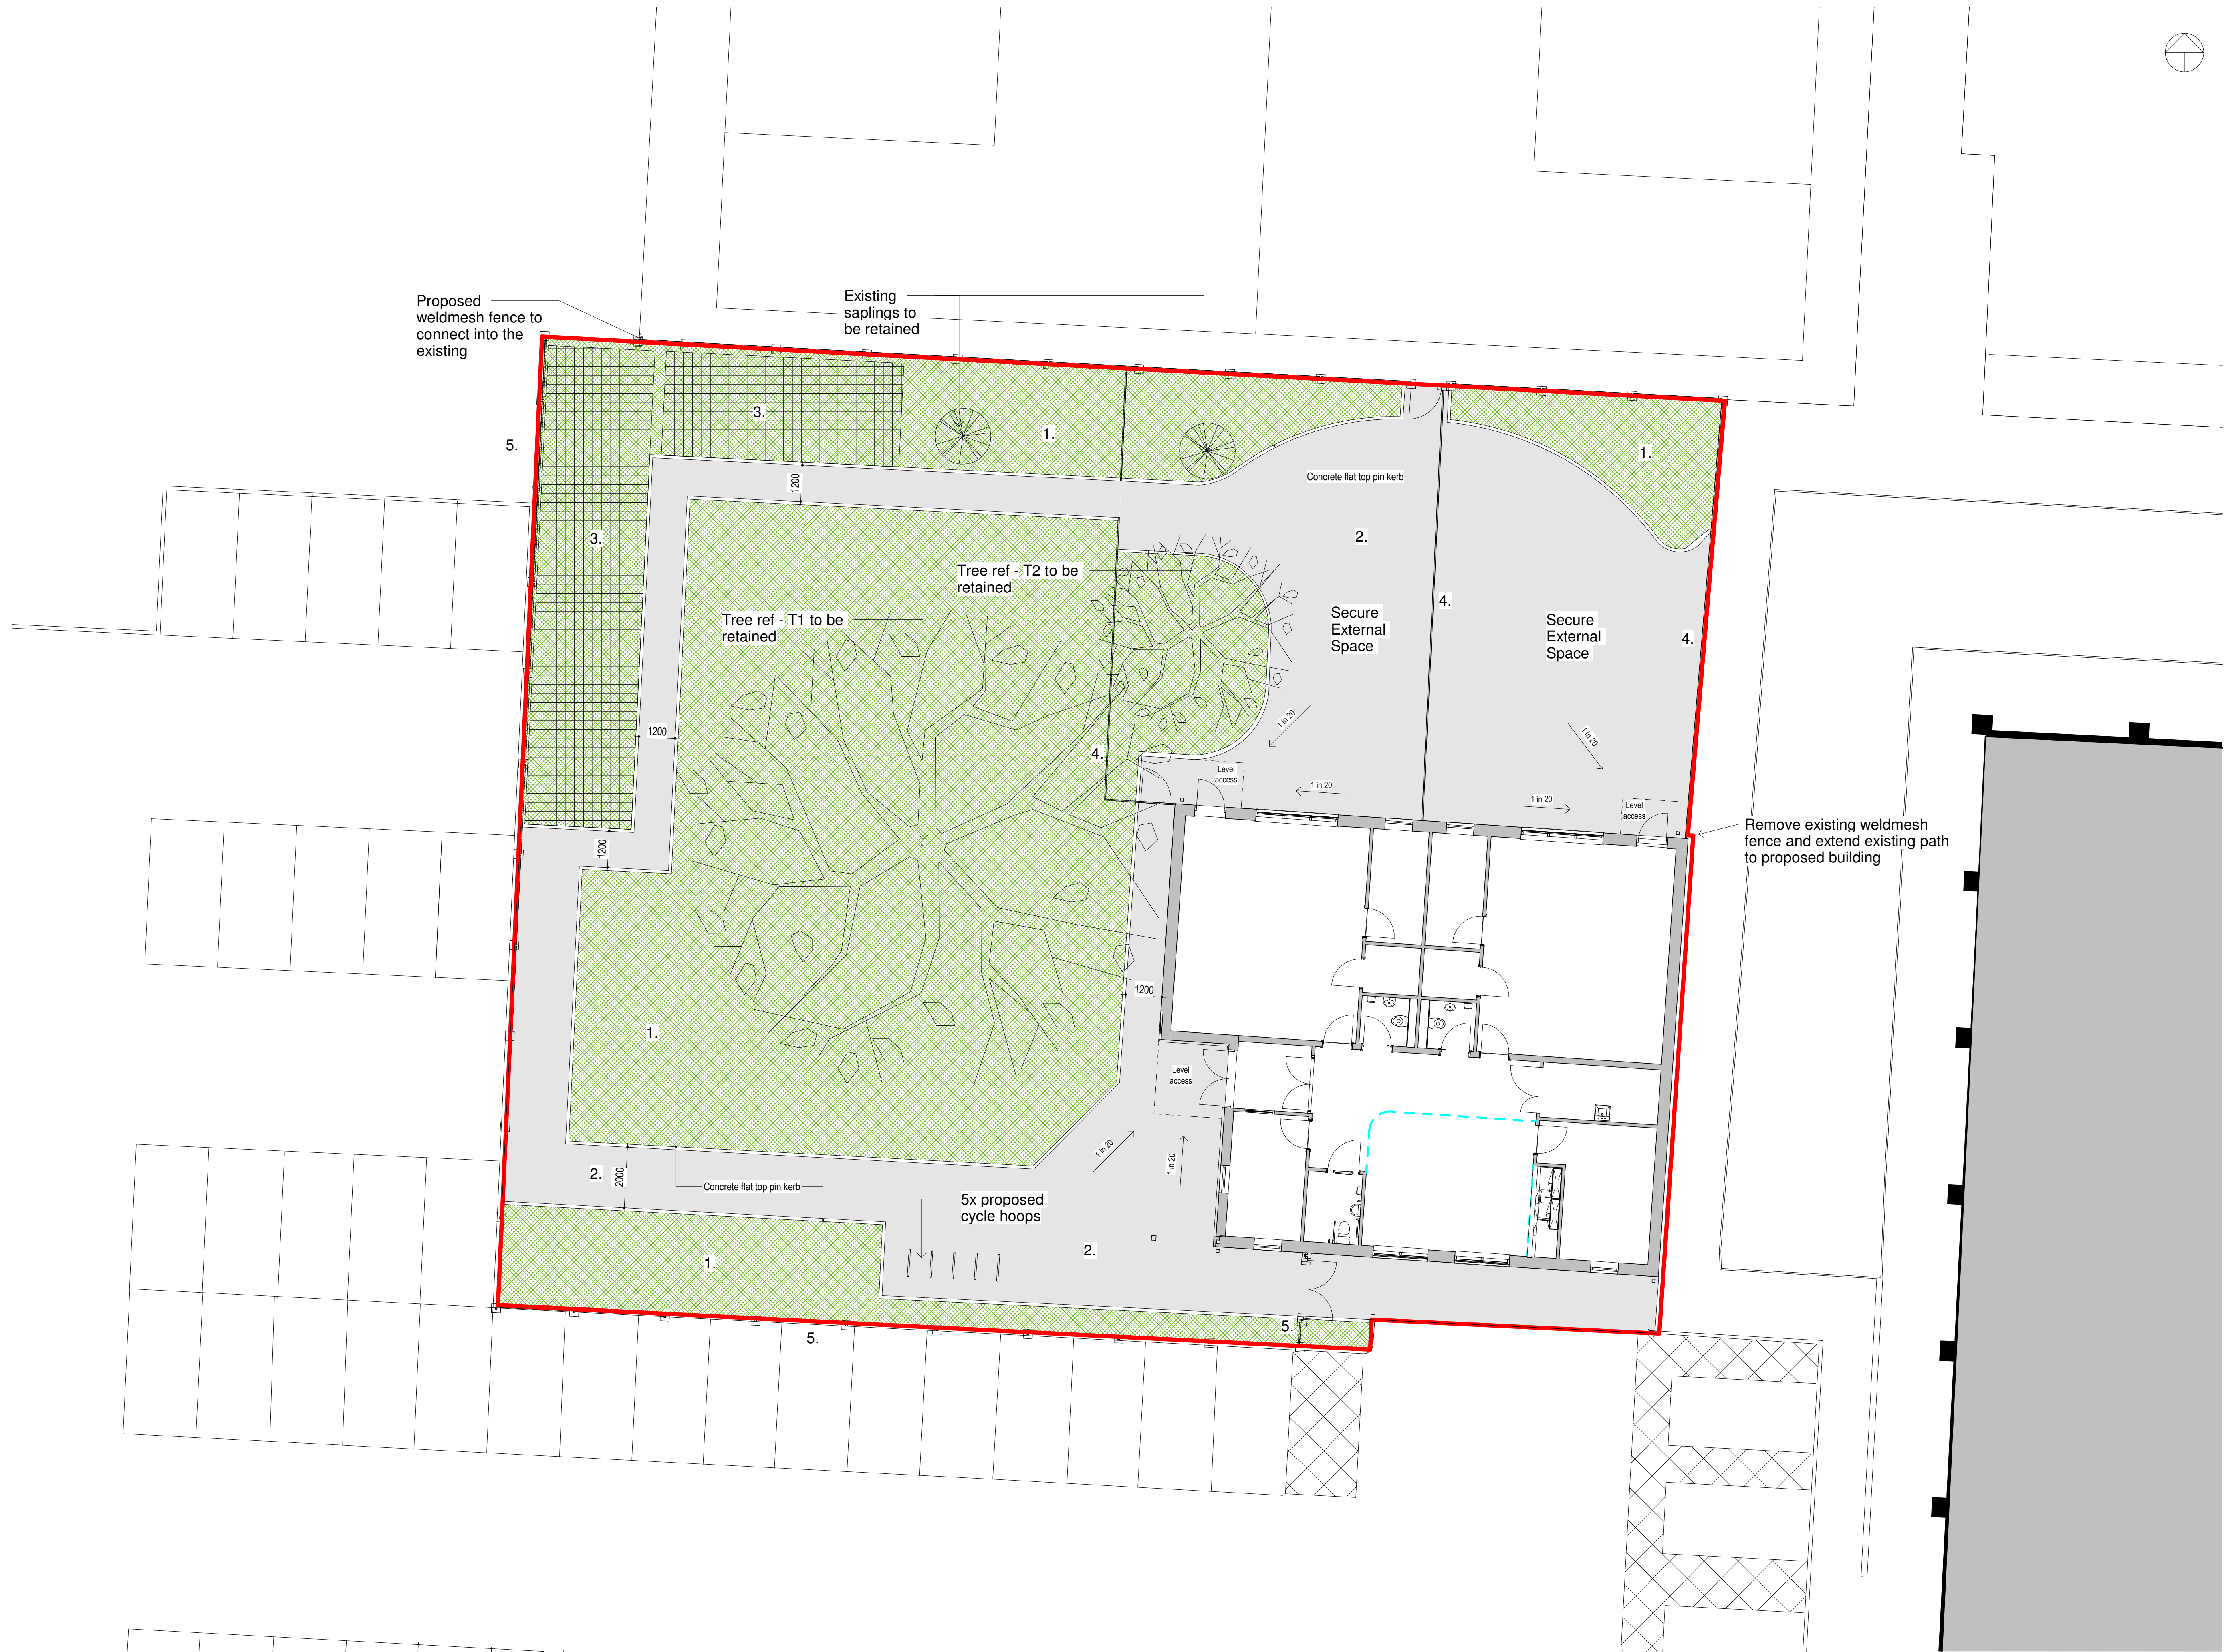
Site Plan - Proposed  
1 : 100

1. Grass
2. Tarmac
3. Allotments
4. 2.7m high Solid Fence
5. 2.7m high Weldmesh anti-climbing fence

- 1.1.4 The scope of the report and its assessment has been based around the site's redevelopment proposals as outlined in the Pozzoni proposed site plan (Ref: 5606-PAL-XX-XX-DR-A-8000) included in Appendix A. It should be noted that any subsequent revision of the proposed redevelopment or site boundary away from the above-mentioned drawing may result in the full or partial re-interpretation of this report and assessment.
