# PHASE 2 ENVIRONMENTAL REPORT

| job number<br><b>C482/20/E/1669</b> | date<br><b>15/12/2020</b> |
| site address<br><b>29 Berry Brow (Land to Rear of),<br/>Clayton Bridge,<br/>Manchester,<br/>M40 1GR</b> | |

## Report on a Phase 2 Environmental Investigation

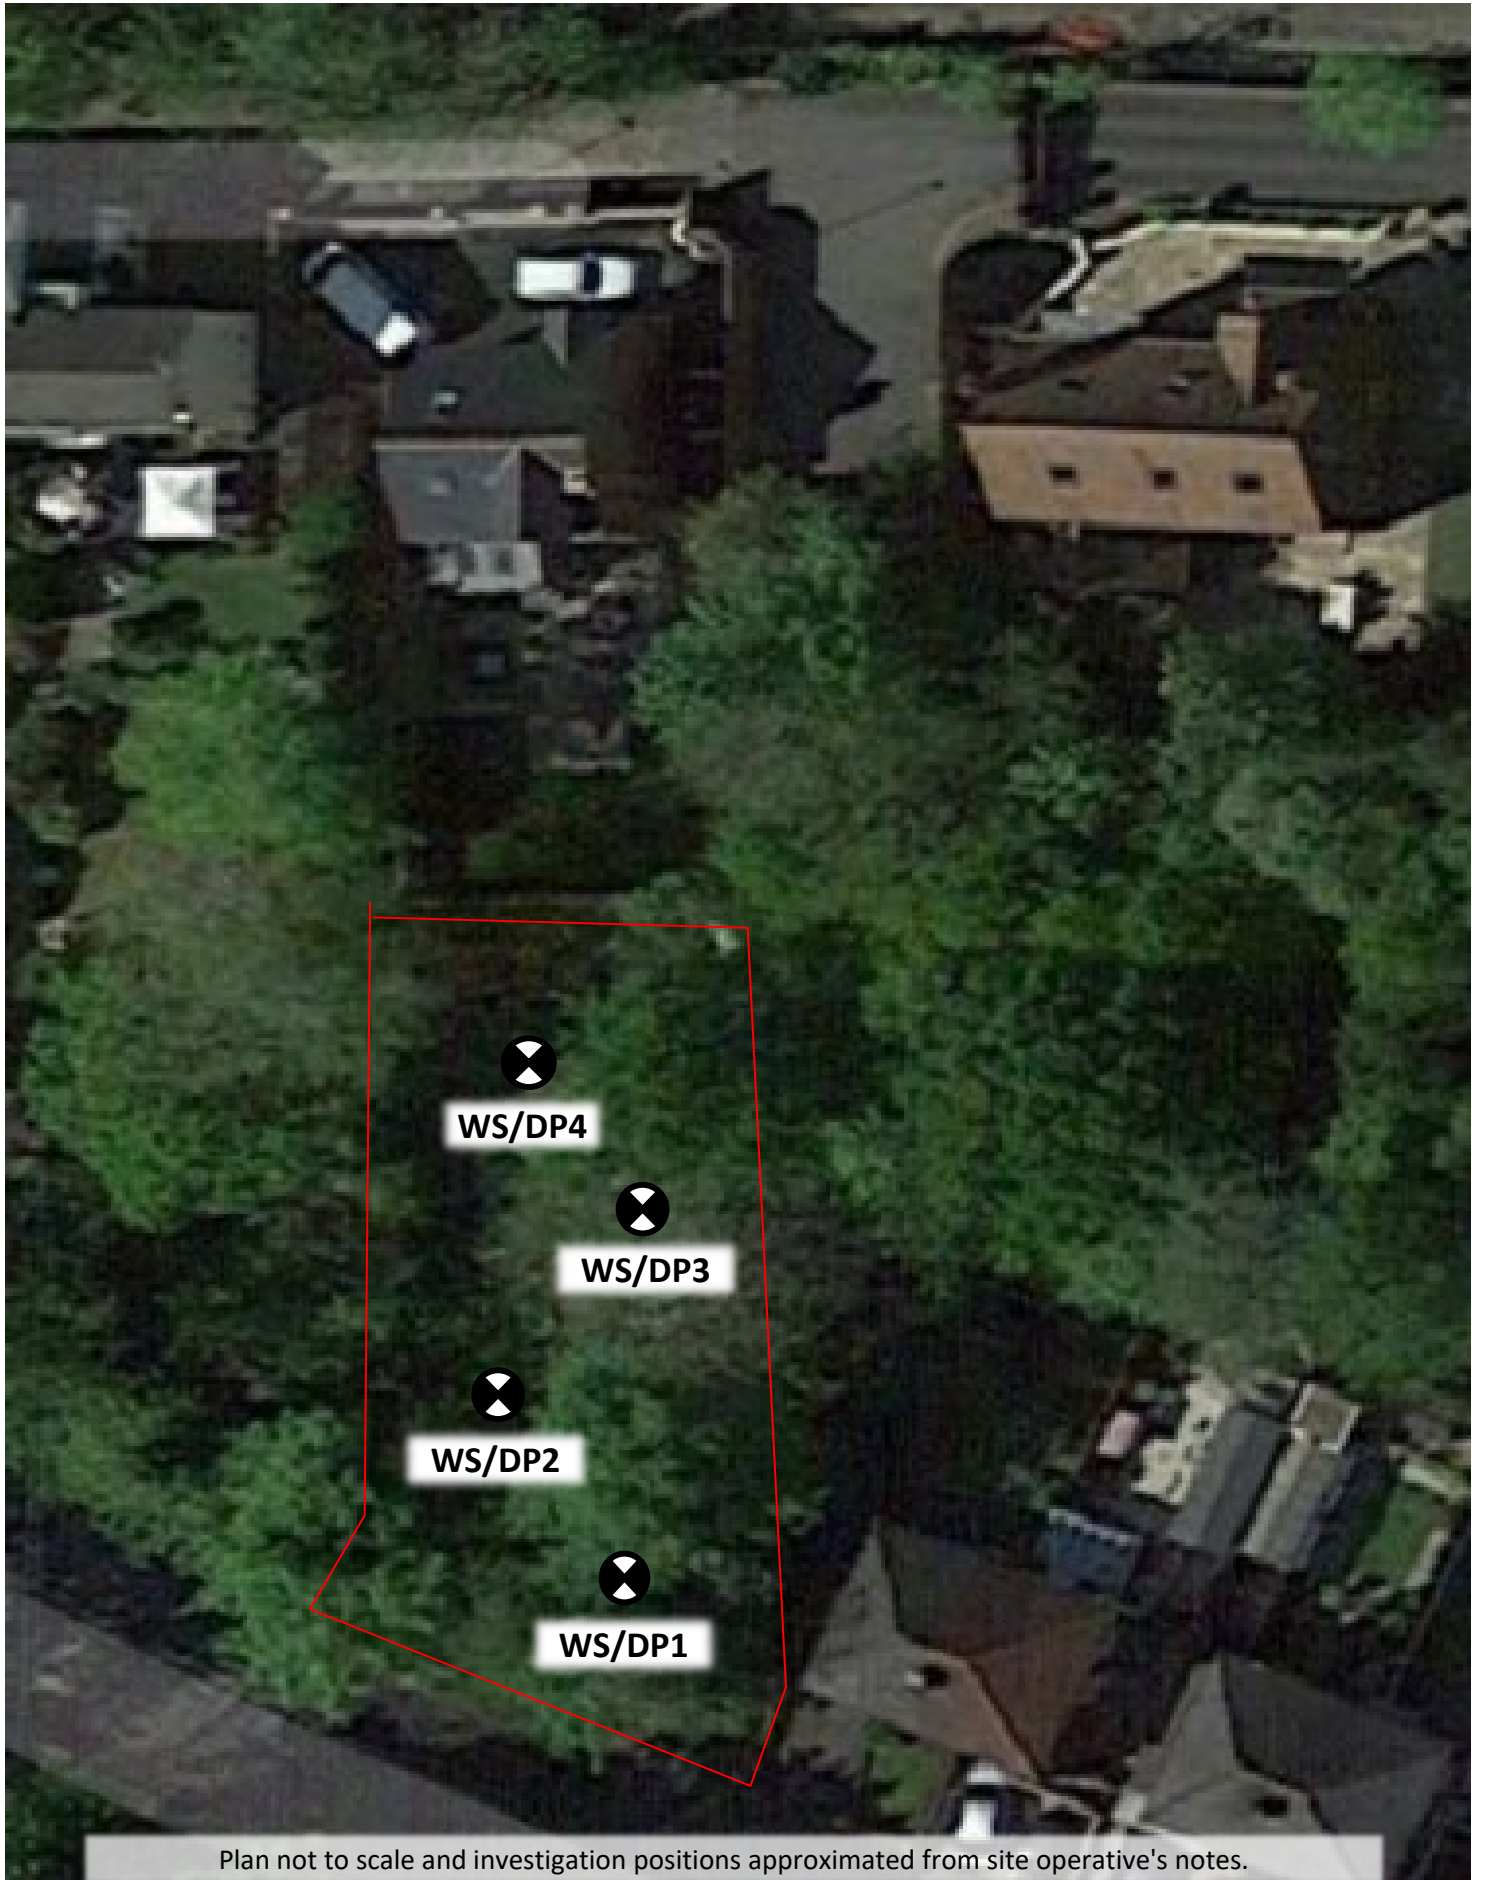
Title: **Investigation Location Plan**

The investigatory locations are shown on the site plan which is presented in Appendix 1 to this report.
