| dwg title: Existing & Proposed Elevation | | | |
| job title: Salmon Street | | | |
| dwg no: | A105 | | rev: |

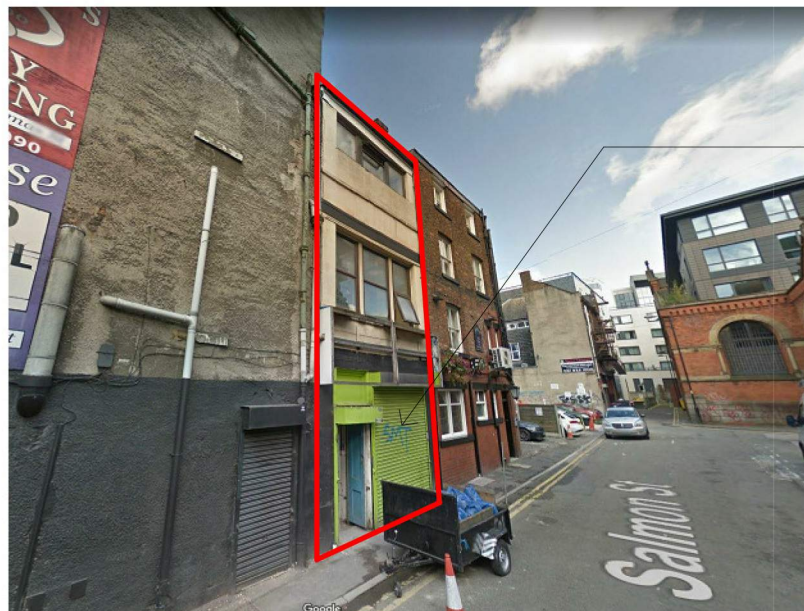
The photograph of the existing elevation shows the current condition of the front elevation along Salmon St.

The appearance of this elevation is very worn, un-tidy, un-appealing and run down. Given the area along Thomas Street is very nice, this building facade has been left un-cared for and fallen into a disrepair state.

Because of the un-attractive quality of this facade, the proposal would like to improve the general cosmetics to the facade to aid with allowing this building to fit in far better with the greater quality of bar establishments along Thomas St.

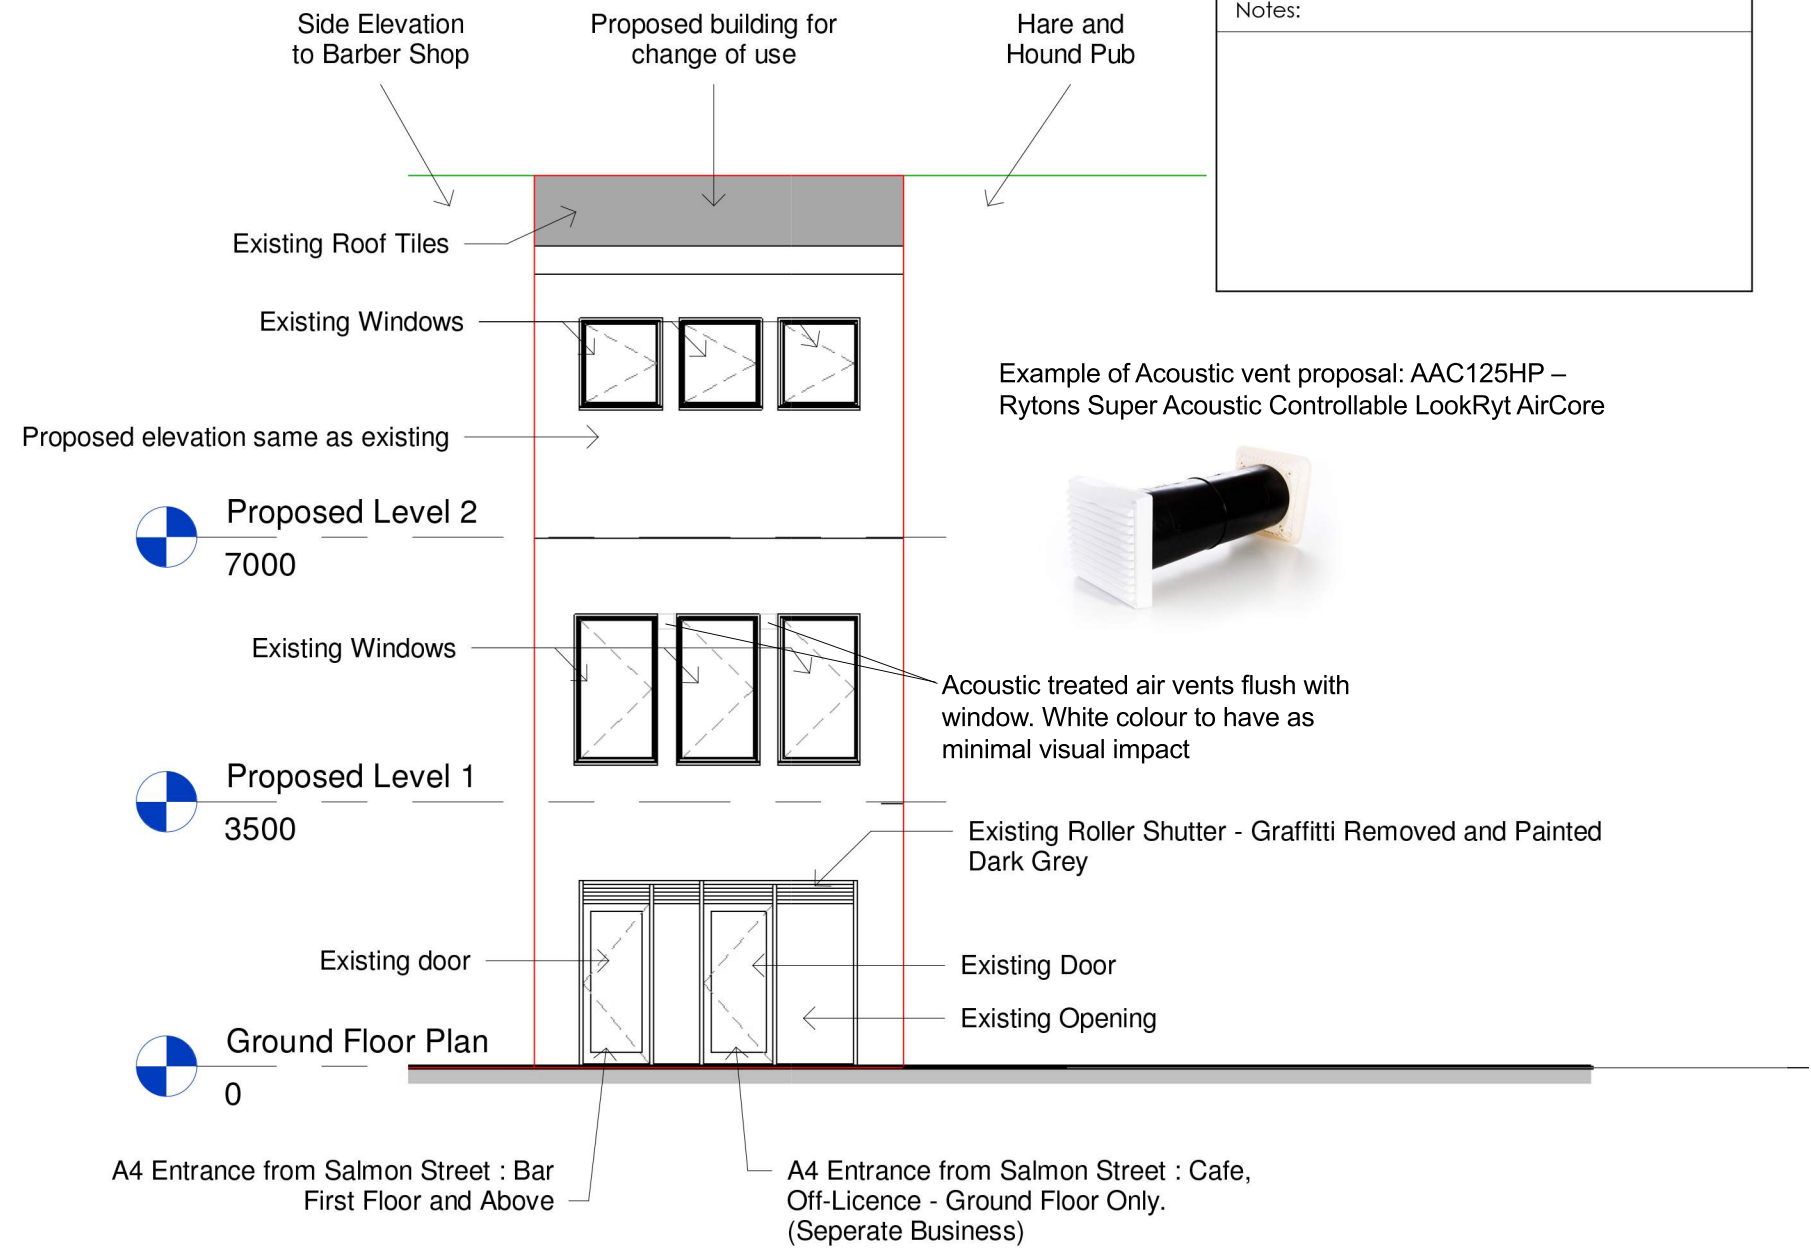
## Proposed Elevation - Salmon Street

The proposals design improvements would be to remove all un-used derelict signage & miscellaneous broken timbers left on the elevation, a coat of fresh paint, and improvements to the external shutter to aid with visual and security improvement.
